Inspection Photos

API: 061-05145

Operator: WESTERN OPERATING COMPANY

Inspection Date: 4/25/2022

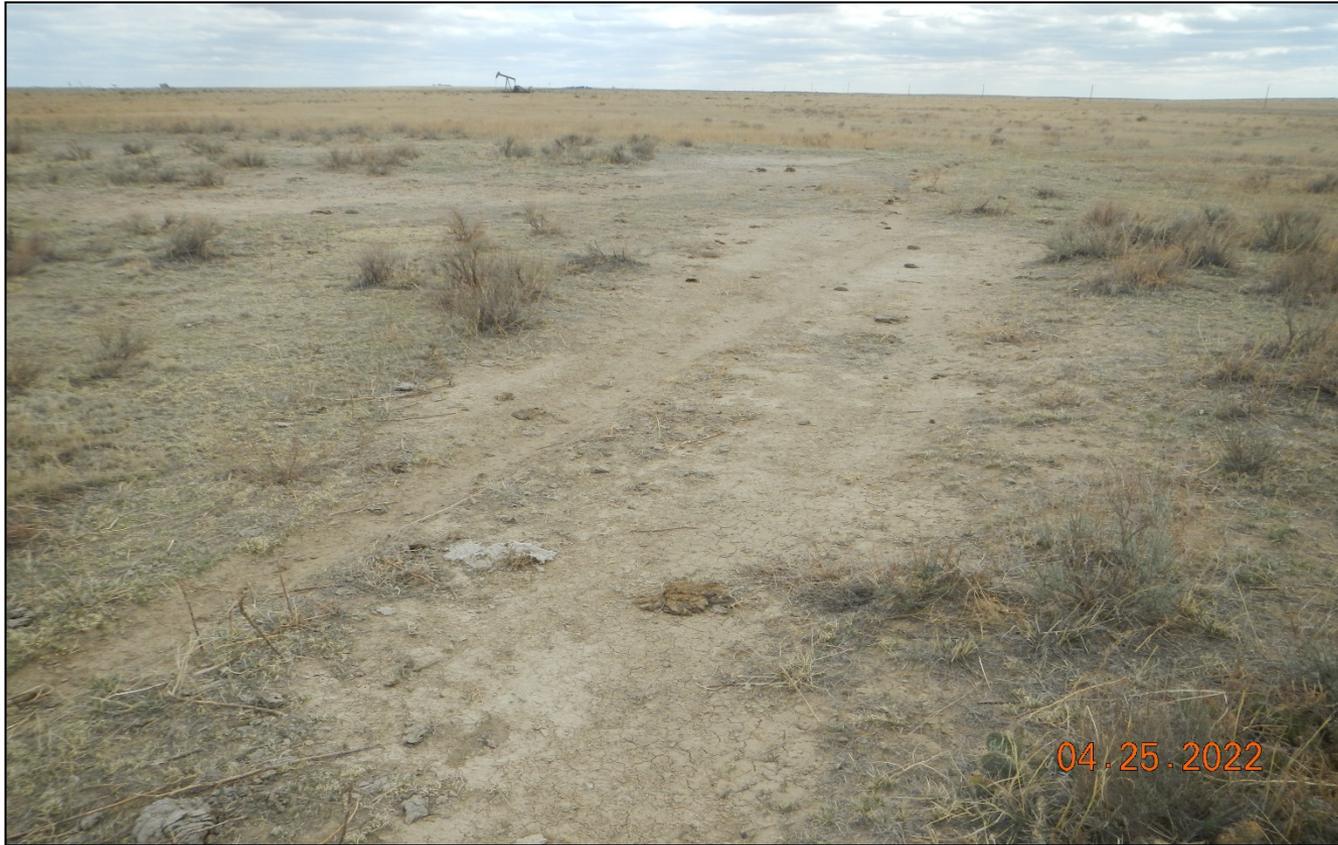
Photo 1. Facing south toward the location. There are areas at the location that are bare of vegetation.

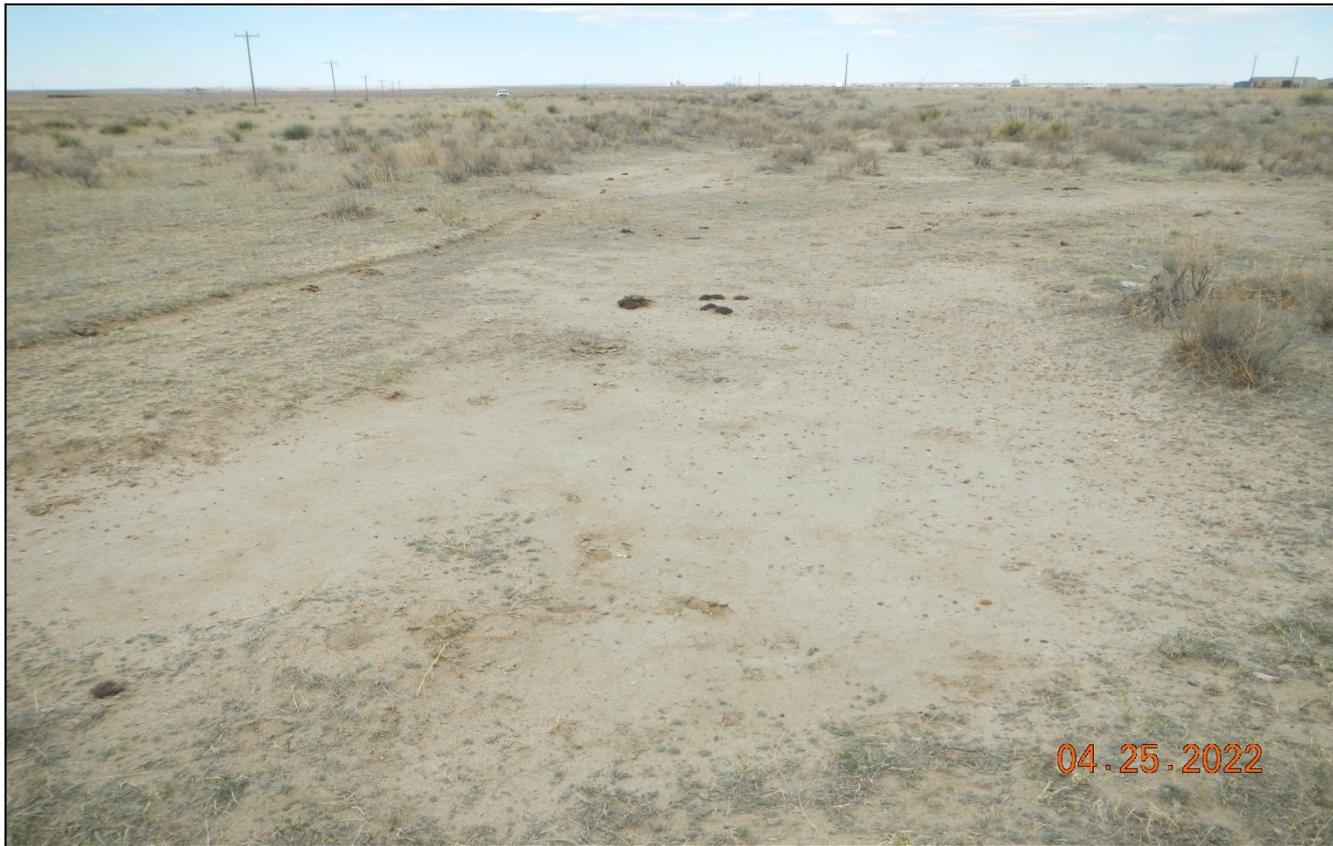
Photo 2. Facing north toward the location. There are areas at the location that are bare of vegetation.

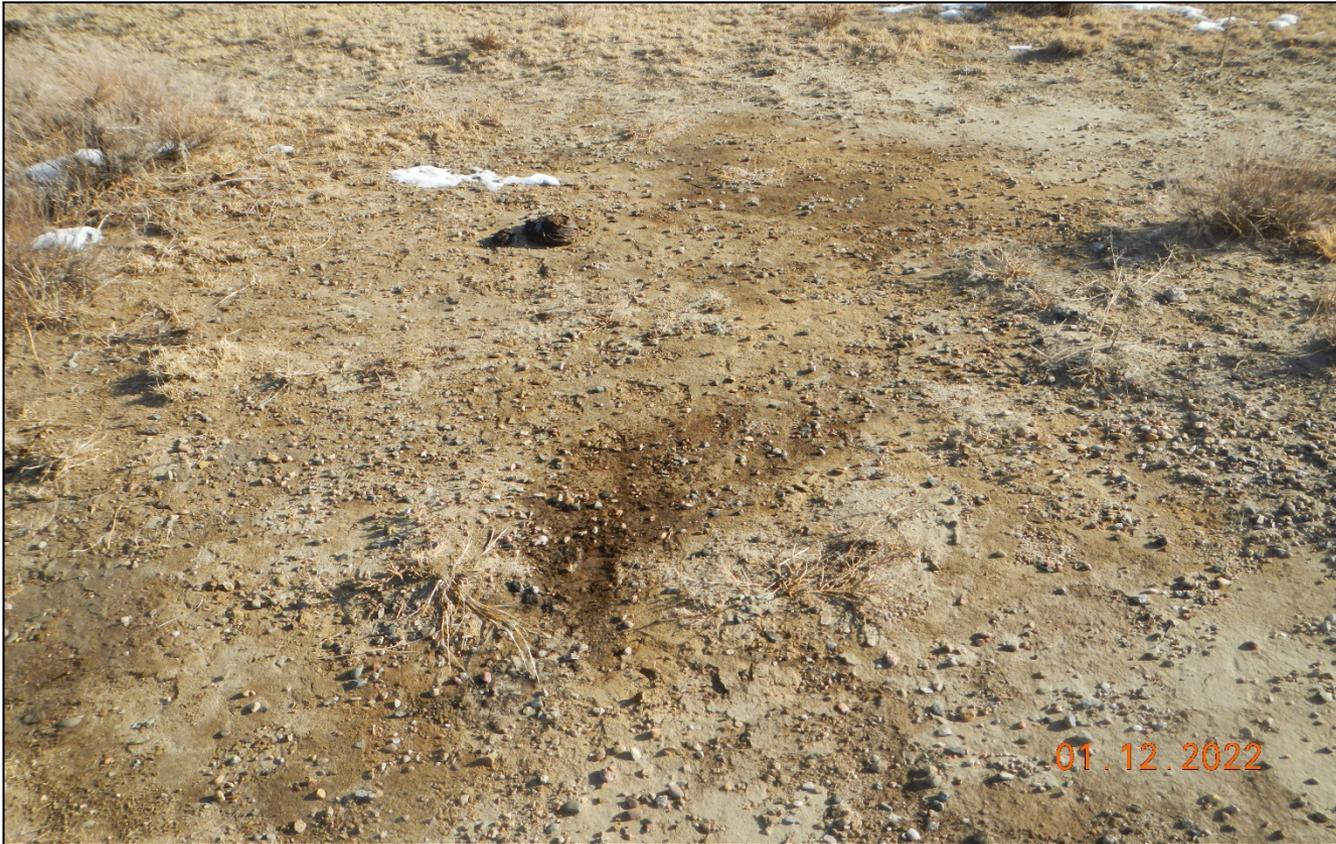
Photo 3. Ground cover at center of the location. There is darkened soils in this area with a hydrocarbon odor. Contaminated soils need to be properly removed and disposed.

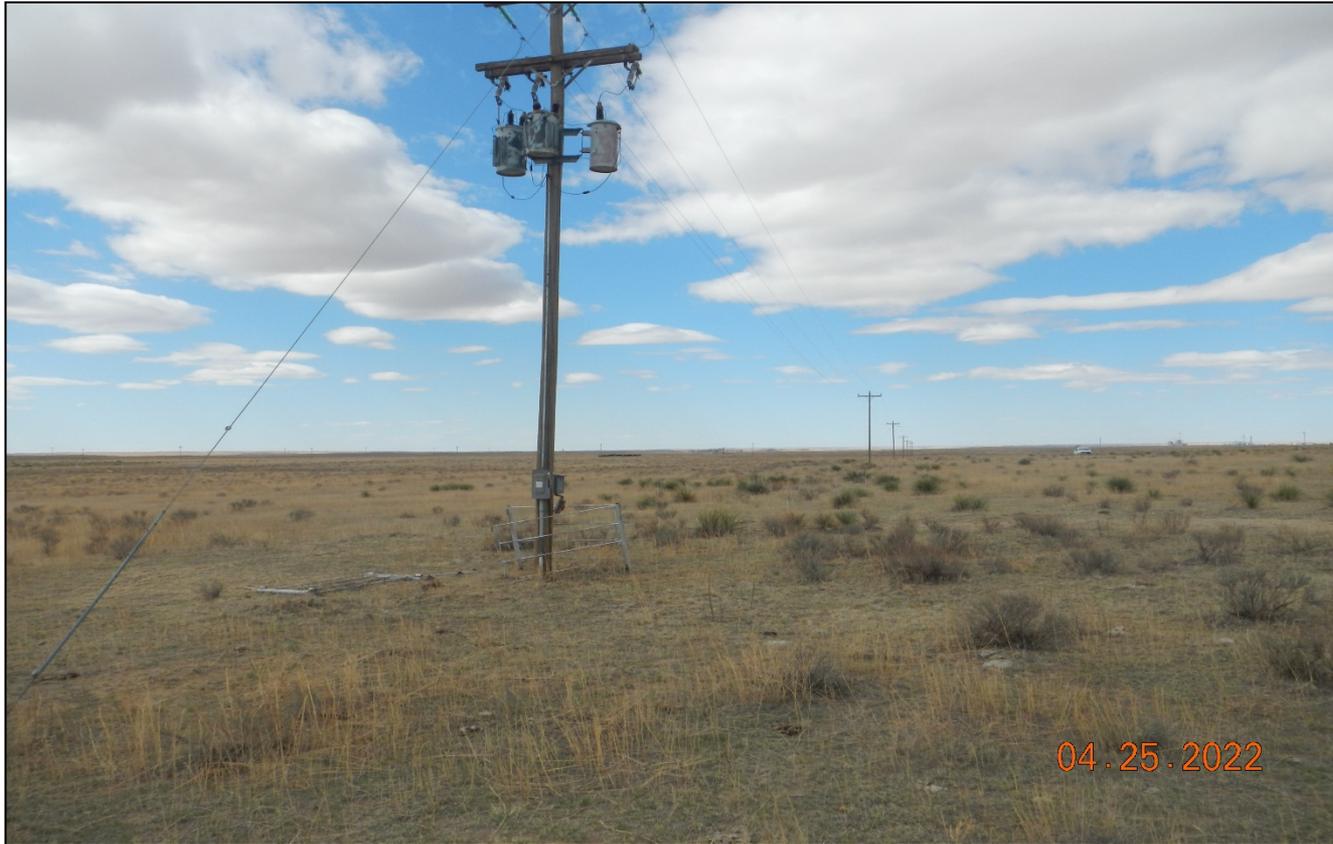
Photo 4. The powerline used for operating the well dead ends at the location and the entire unused portion of the powerline must be removed.
