Inspection Photos

Operator: SWN Production Company LLC - #10396

Location Name: Diamond T Sheep 7-92 /1-26

Inspection Document #: 702800155

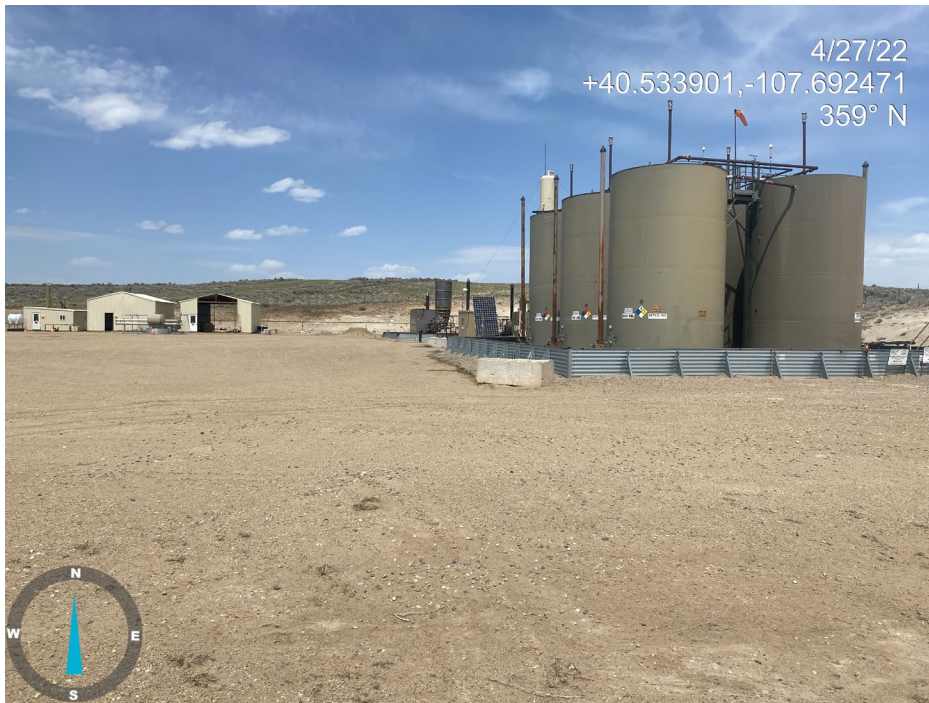
Photo 1. Photo taken from the Location entrance shows an overview of the Location. Sign in front of tank battery has correct Operator information.

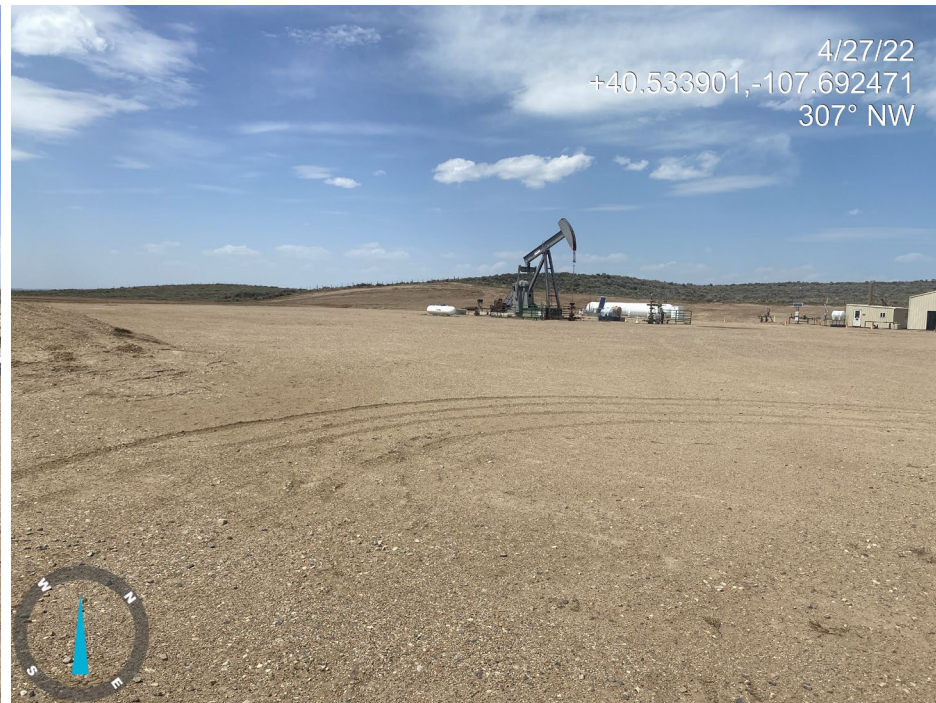
Photo 2. Photo taken from the Location entrance shows an overview of the Location. Photo also shows areas to the south and southwest of the wells not necessary for production which have not been reclaimed (in the left of the photo).

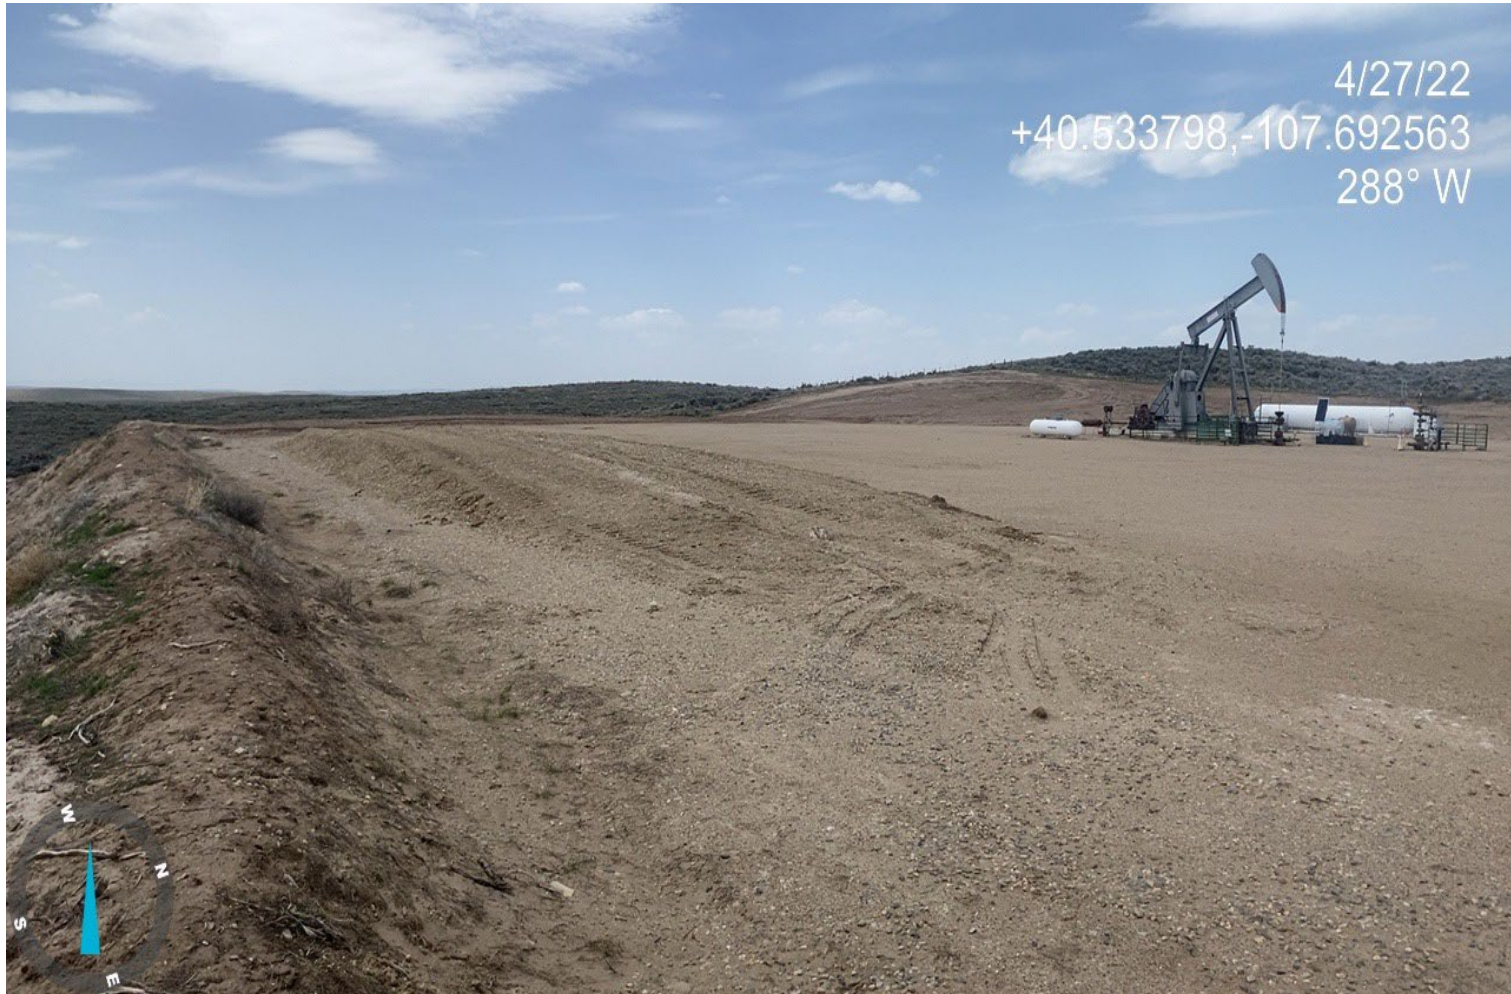
Photo 3. Photo taken from the southeast of the pad shows areas to the south and southwest of the wells not necessary for production which have not been reclaimed.

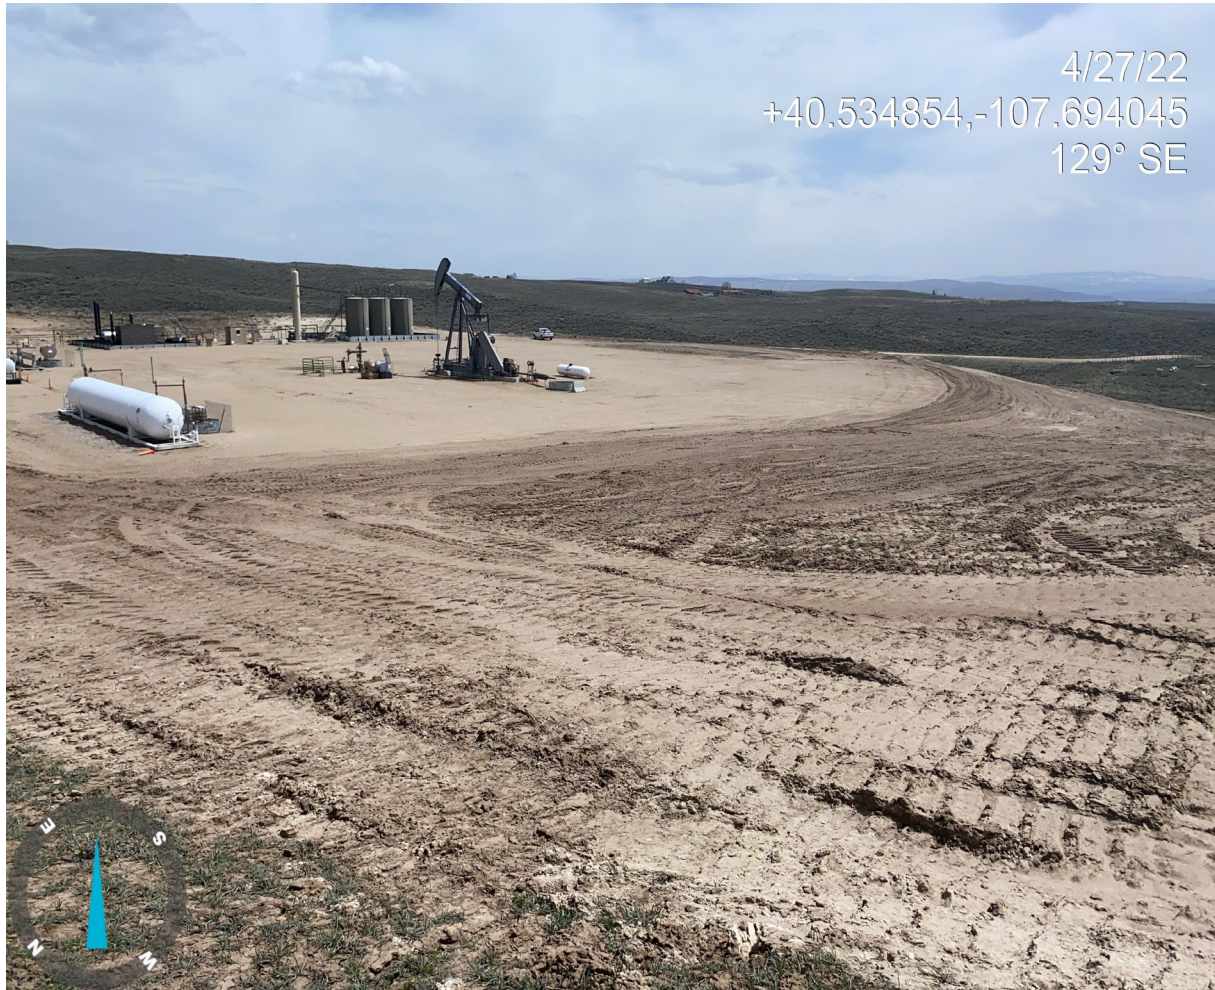
Photo 4. Photo taken from the northwest of the Location shows an overview of the Location and northwestern interim area.

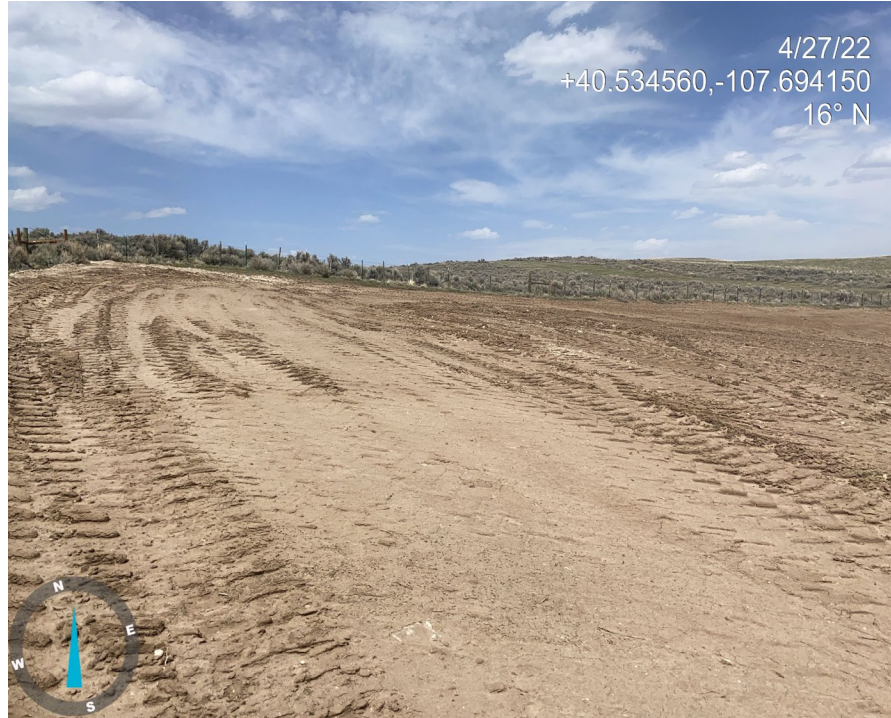
Photo 5. Photo taken from the northwest of the Location shows bare, unprotected soils in the interim areas.

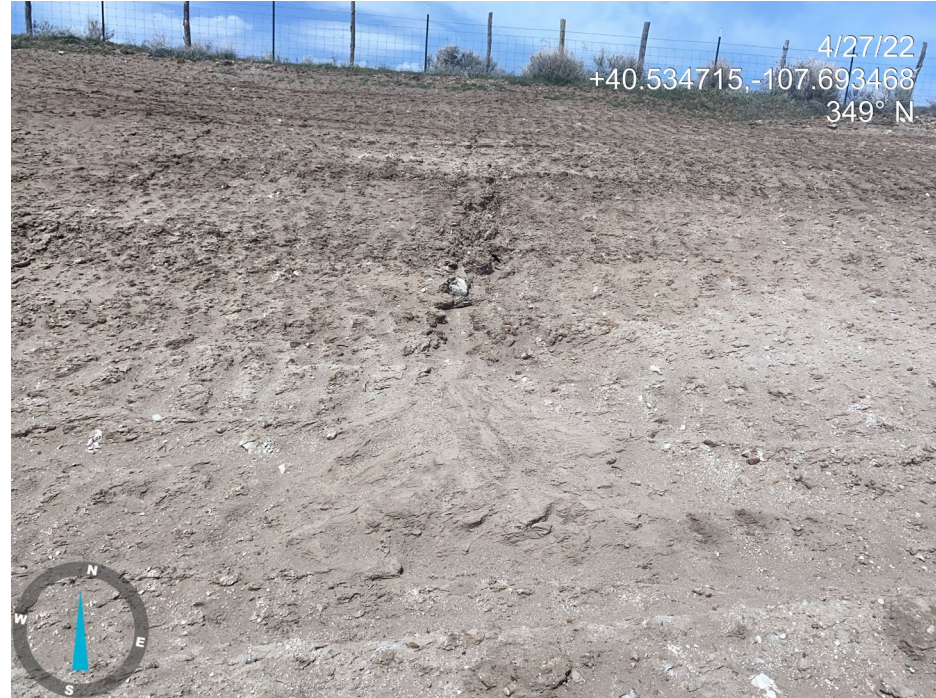
Photo 6. Photo taken from the north of the Location shows rill erosion occurring on bare soils of the interim areas. Photo also shows where surface roughening was improperly performed by tracking perpendicular to the slope.

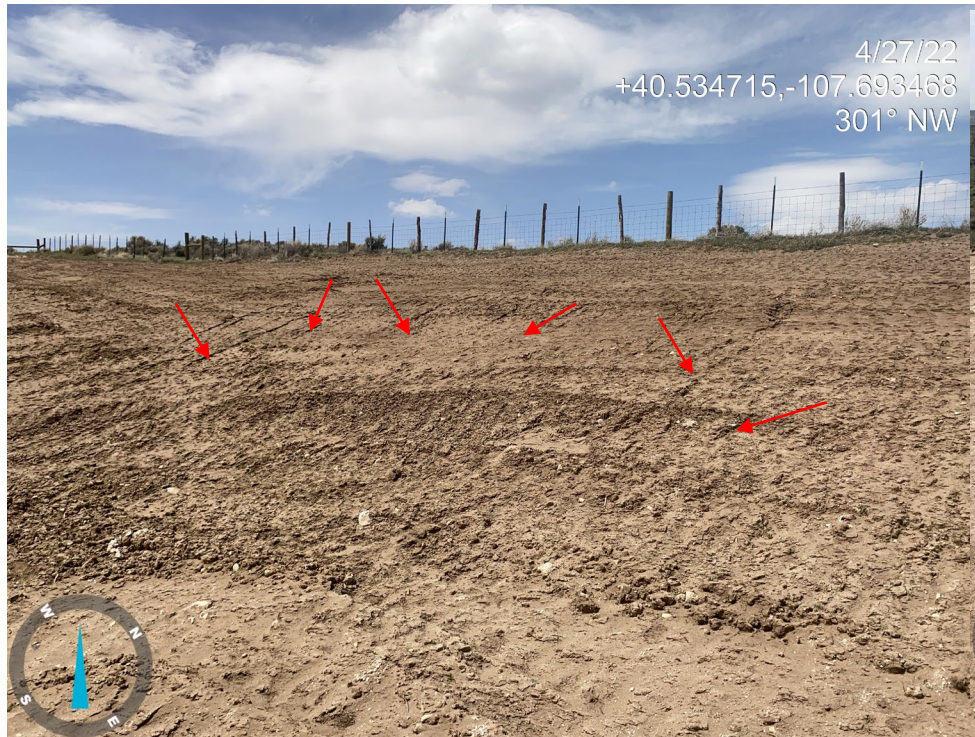
Photo 7. Photo taken from the north of the Location shows rill erosion occurring on bare soils of the interim areas.

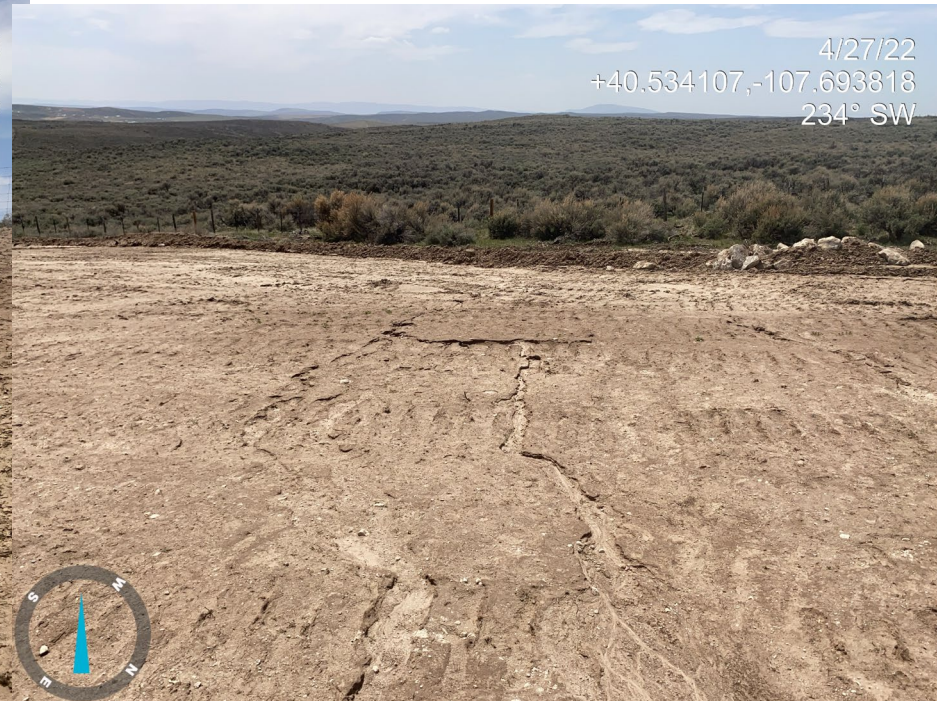
Photo 8. Photo taken from the west of the Location shows rill erosion occurring on bare soils of the interim areas.

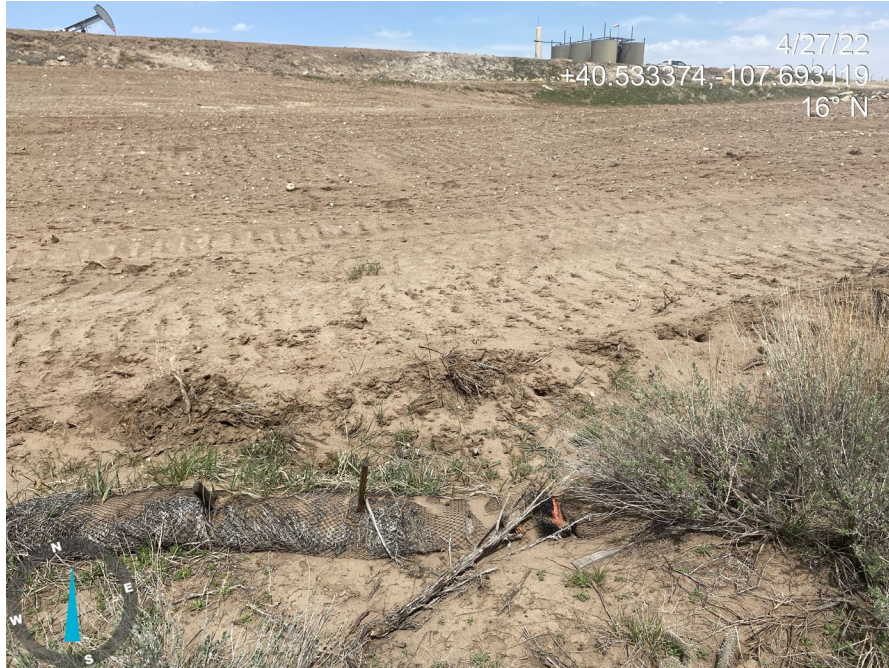
Photo 9. Photo taken from the south of the Location shows unmaintained erosion control BMPs. Soil has broken through the straw wattle and is accumulating offsite in native rangeland adjacent to the Location.

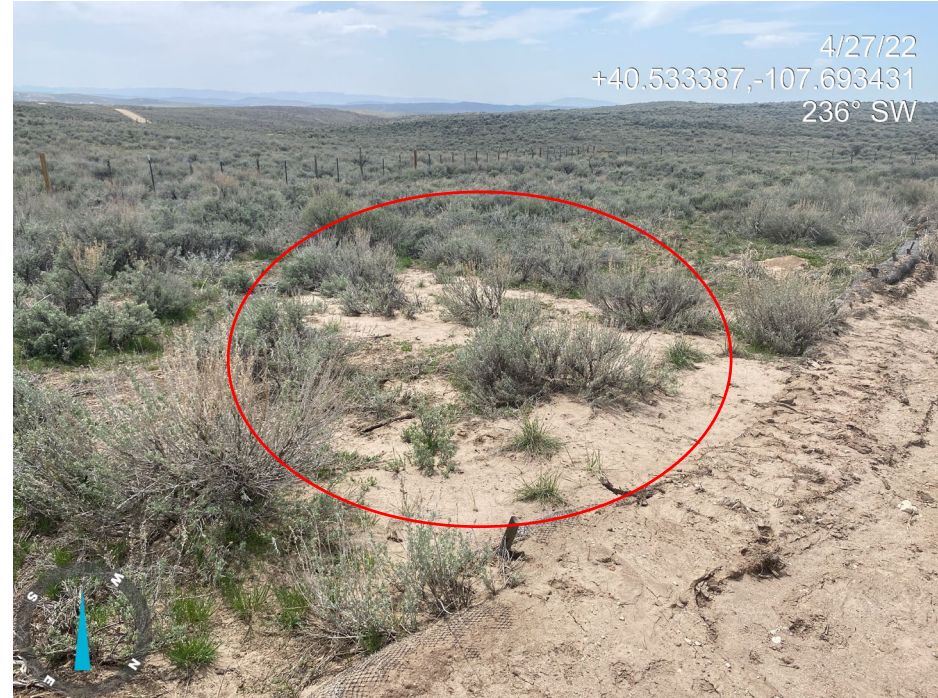
Photo 10. Refer to Photo 9 comment. Red circle shows soils accumulating in, and degrading adjacent areas.

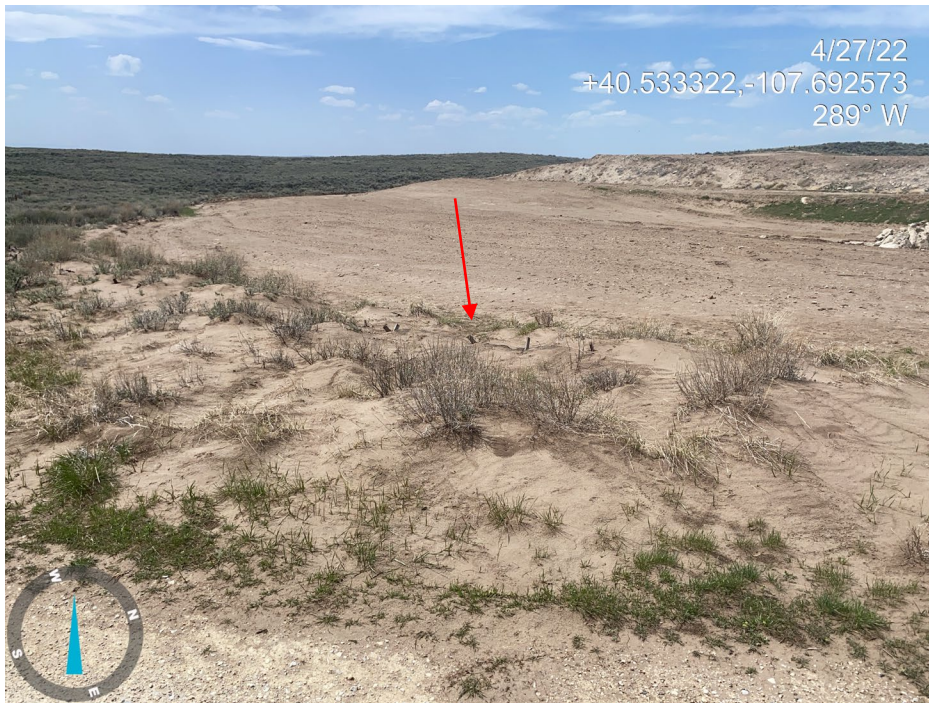
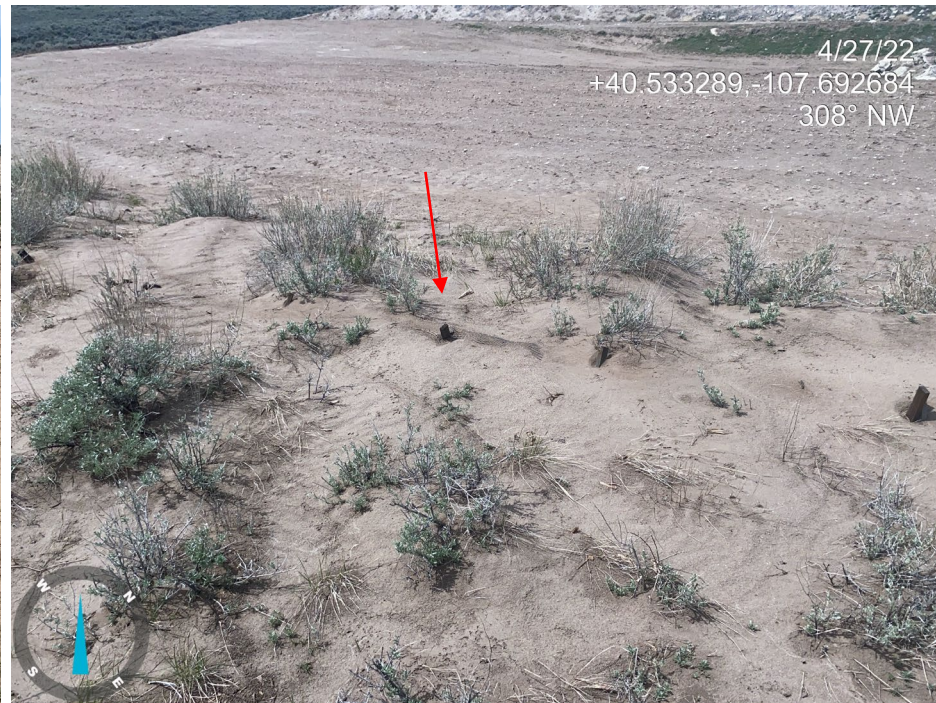
Photo 11. Photos taken from the southeast of the Location show wind eroded soil accumulating and smothering vegetation in native rangeland adjacent to the Location. Also note the stakes from the completely buried straw wattle (red arrow).

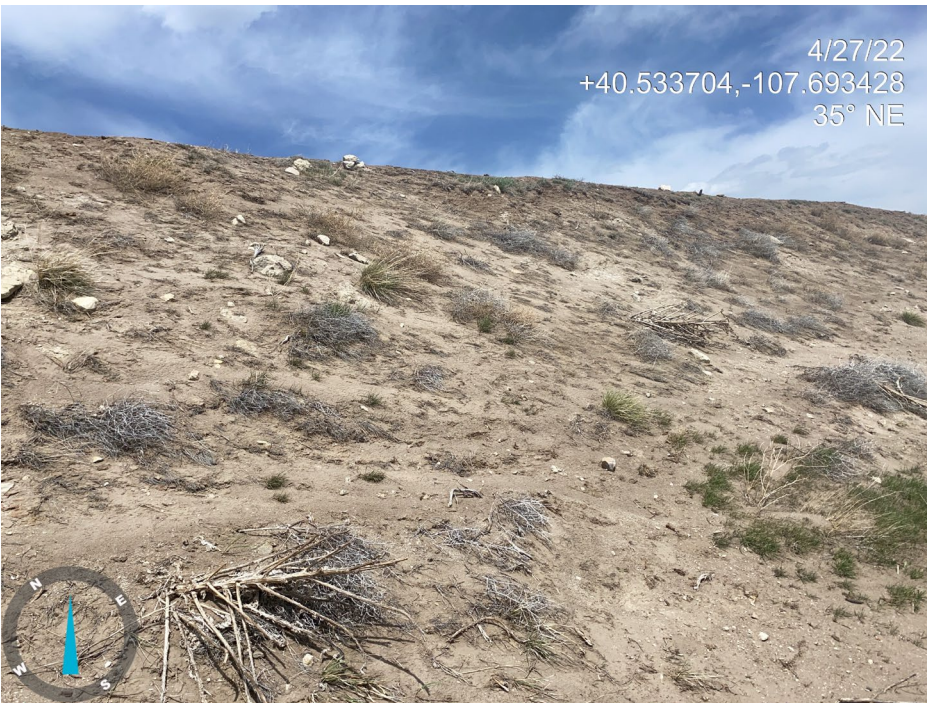
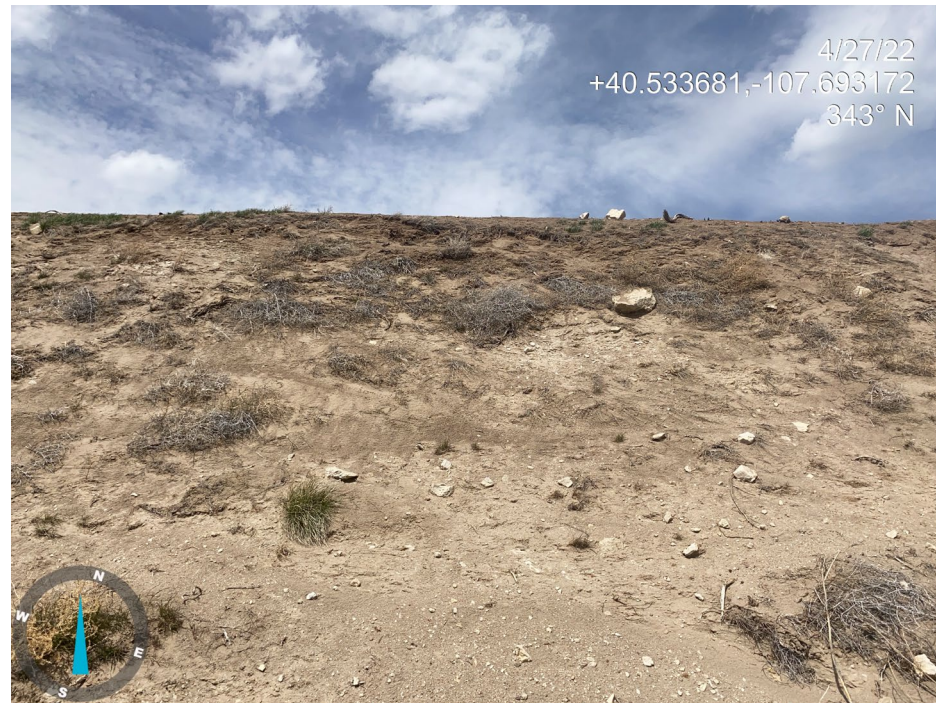
Photo 12. Photos taken from the fill slope at the south of the Location shows wind erosion occurring on unprotected soils. Vegetation on the slope is sparse and dominated by annual undesirable plant species/weeds.

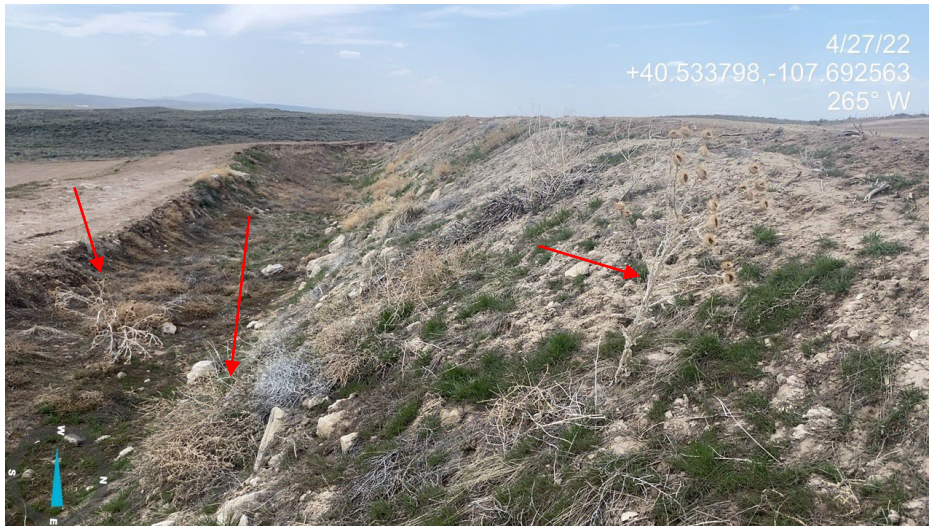
Photo 13. Photo taken from the south of the Location shows fill slopes with annual undesirable plant species/weed debris and weed skeletons which will soon become debris.

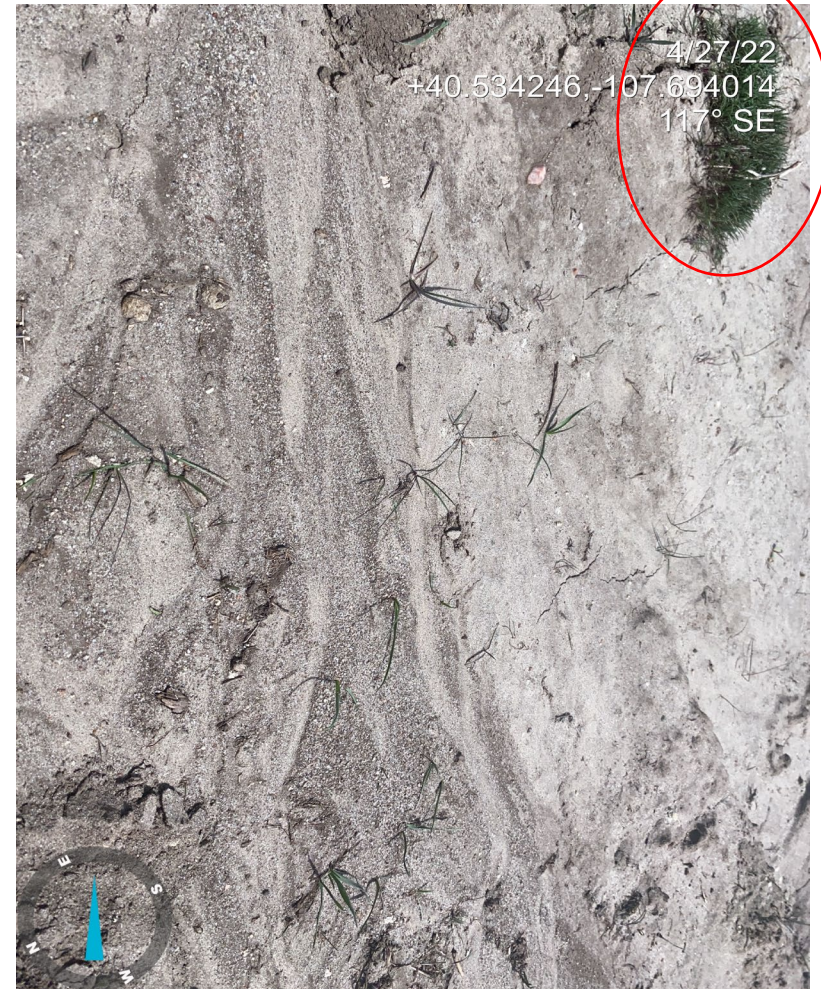
Photo 14. Photo taken from the interim area shows germination of cheatgrass throughout the photo and Russian thistle (red circle).

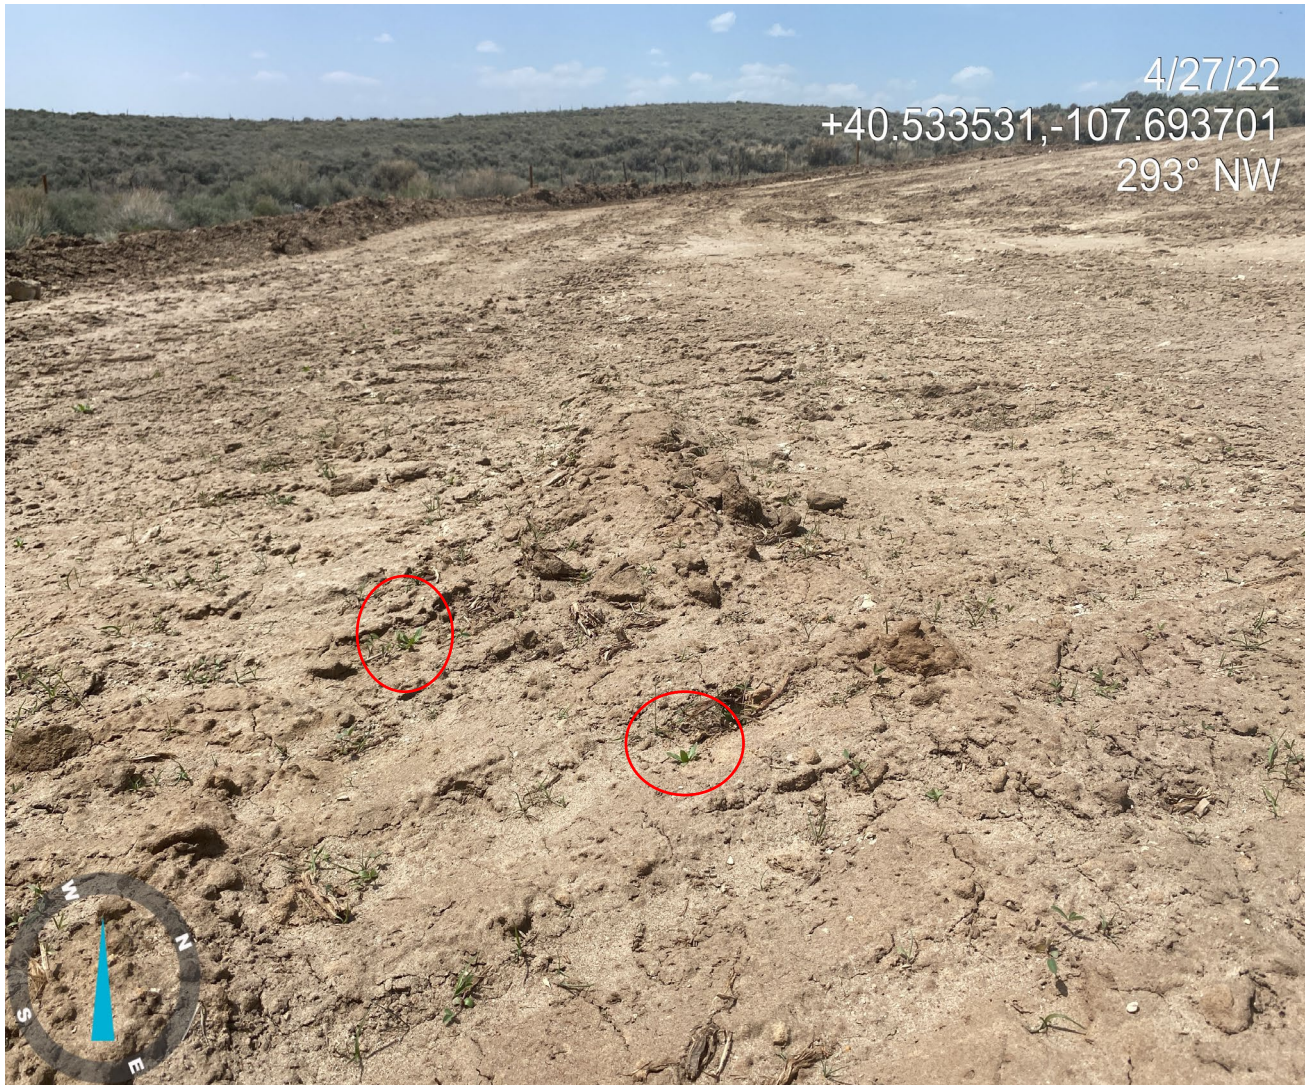
Photo 15. Photo taken from the south of the Location shows the basal rosettes of scotch thistle, a CO List B noxious weed in the interim area.

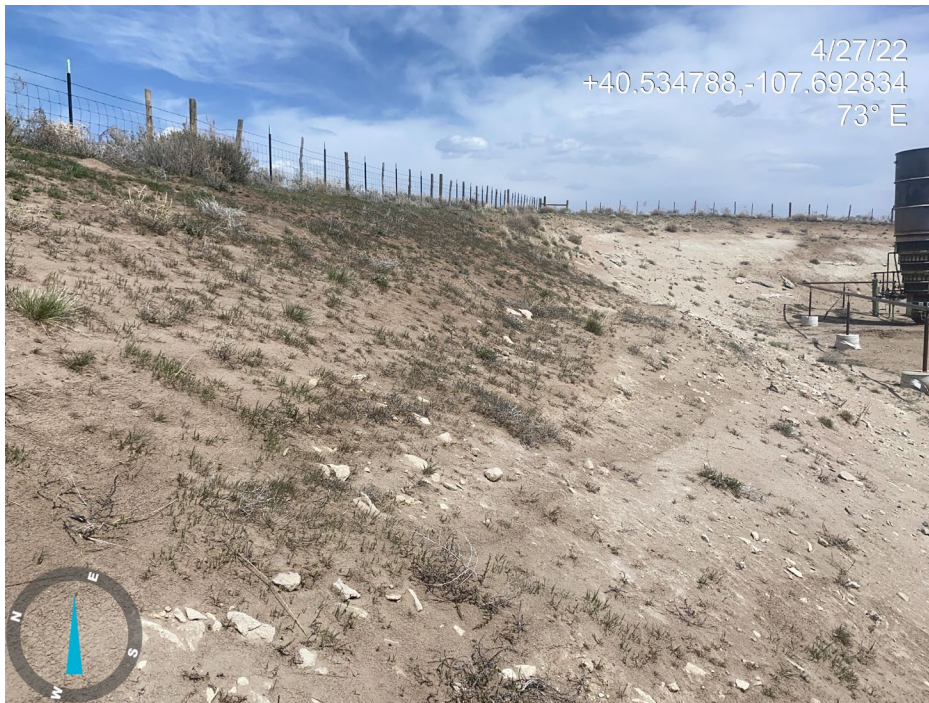
Photo 16. Photo taken from cut slope to the north of the Location shows the slope is unstabilized. Wind erosion was occurring. Photo also shows the slope is colonized by cheatgrass a CO List C noxious weed.

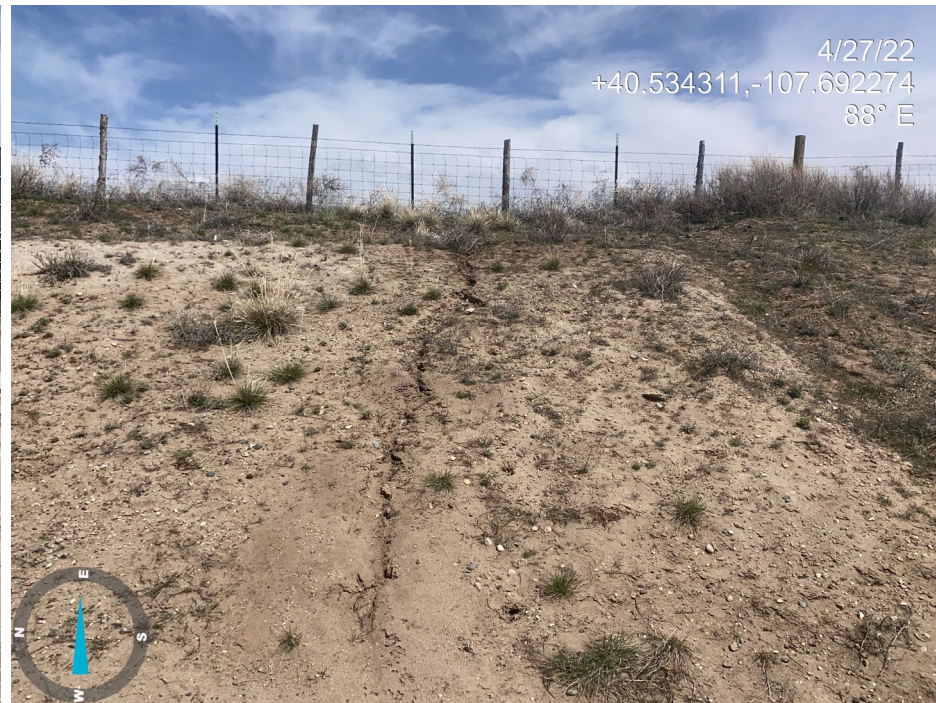
Photo 17. Photo taken from cut slope to the east of the Location shows rill erosion.

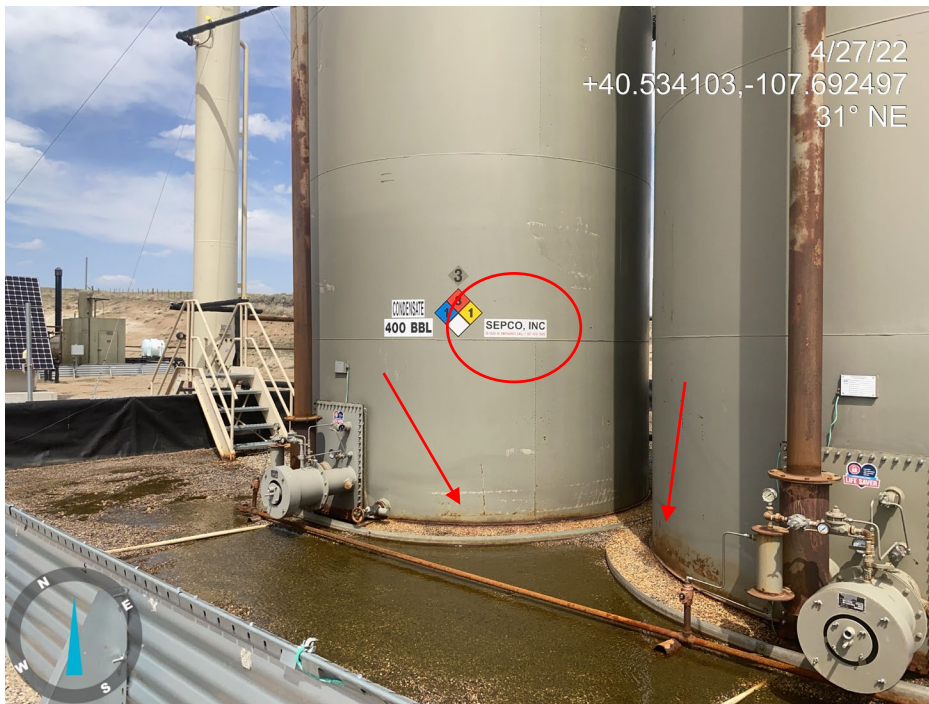
Photo 18. Photo taken from the tank battery shows tanks with incorrect Operator information (red circle); COGCC well file records show Operator as “SWN Production Company LLC #10396.” Photo also shows stained soils at the base of the tank (red arrow).

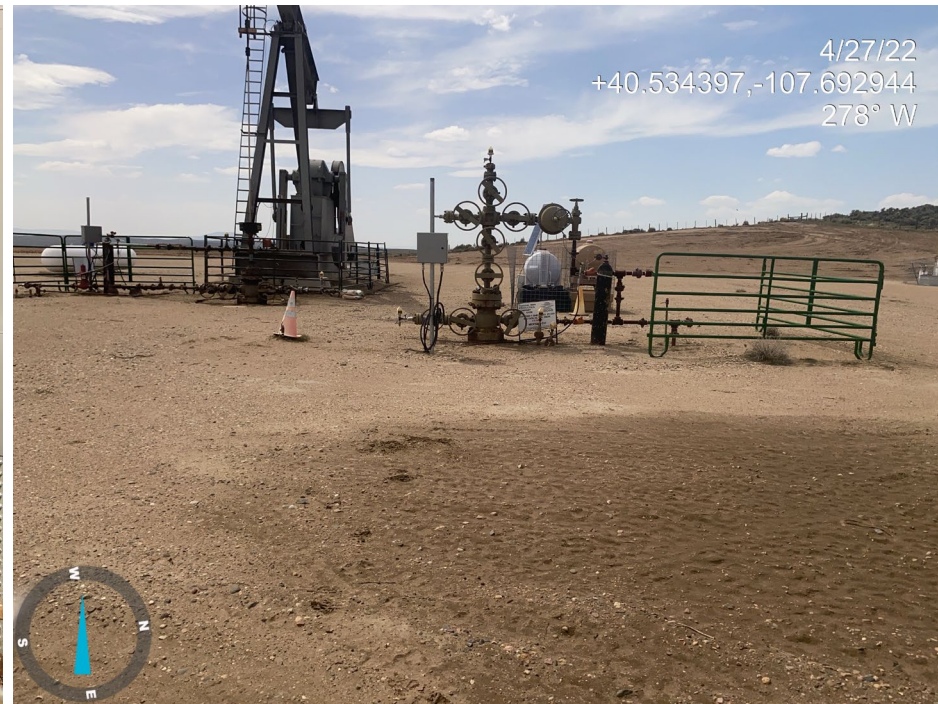
Photo 19. Photo shows a sign has been added to the well. The sign reads with correct Operator information.

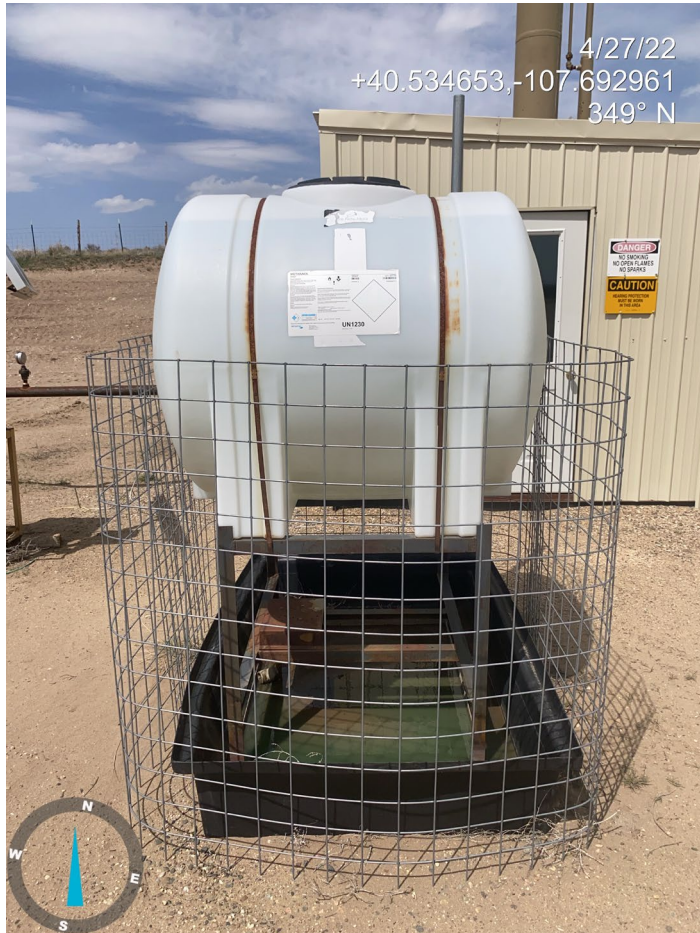
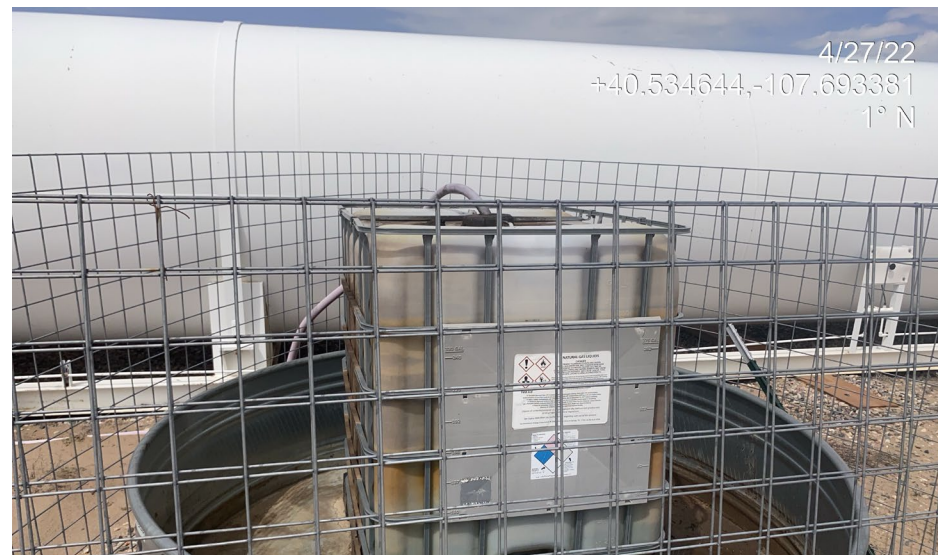
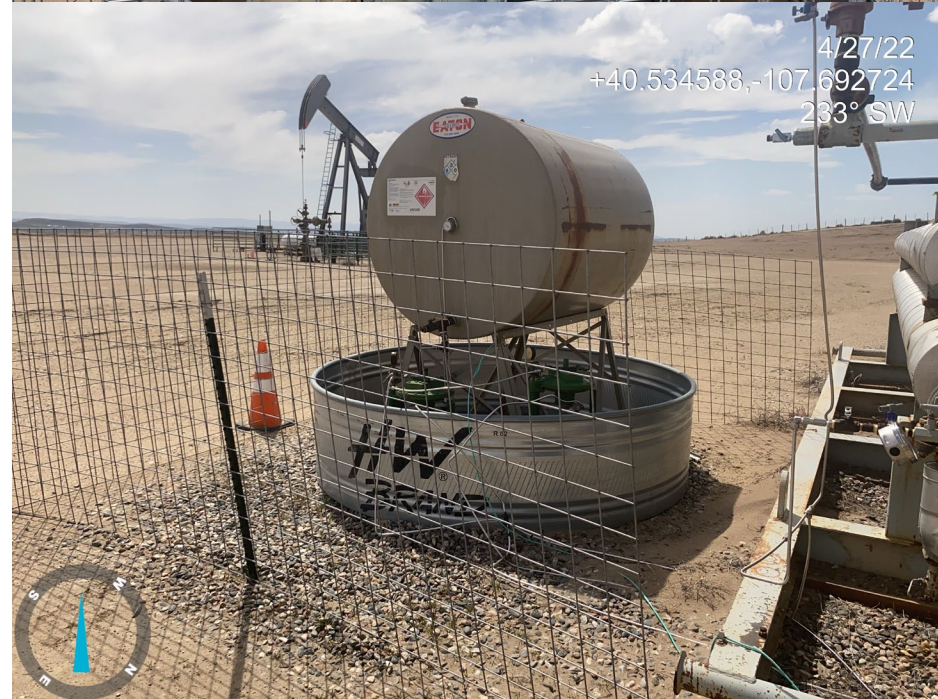
Photo 20. Photos show tanks where labeling has been applied. Photos also show wildlife protection equipment to prevent wildlife access to secondary containment is insufficient to prevent wildlife entry.

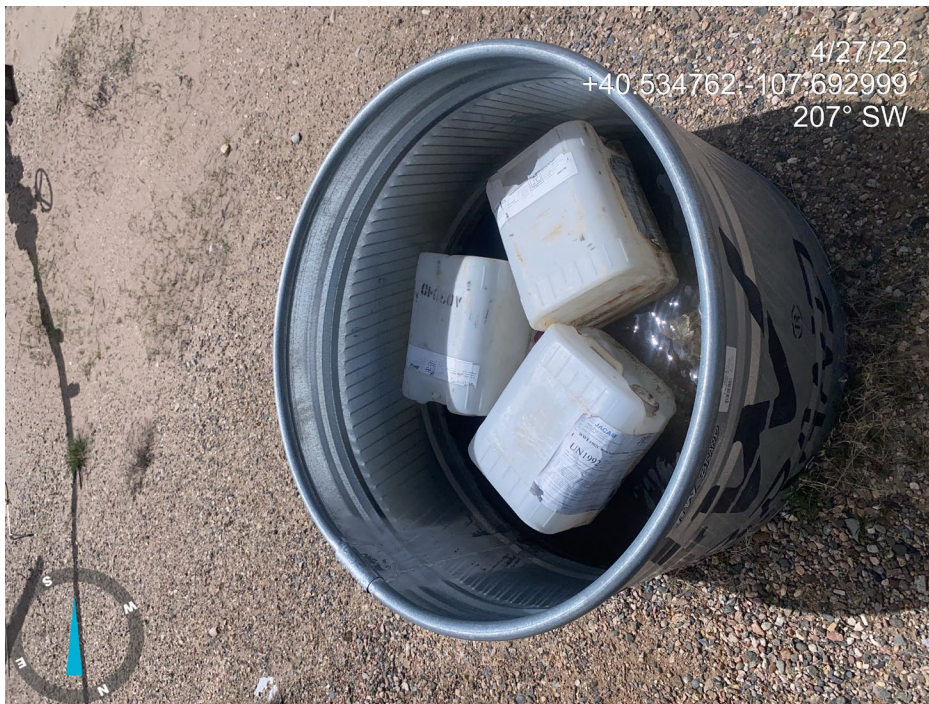
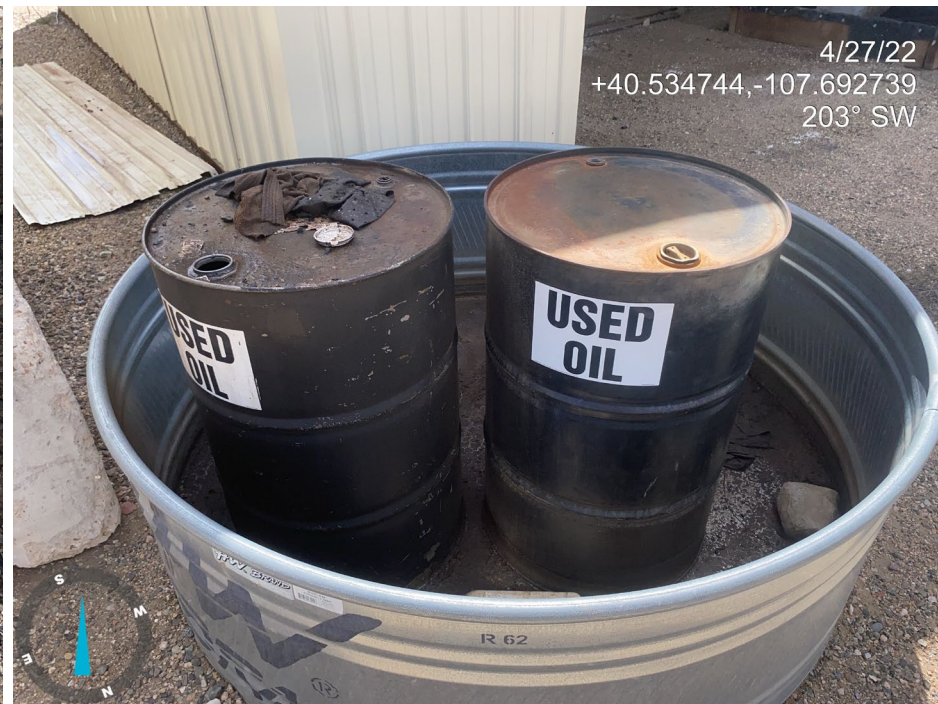
Photo 21. Photos show examples of unused equipment. Photos also show wildlife protection equipment to prevent wildlife access to secondary containment is missing or insufficient.

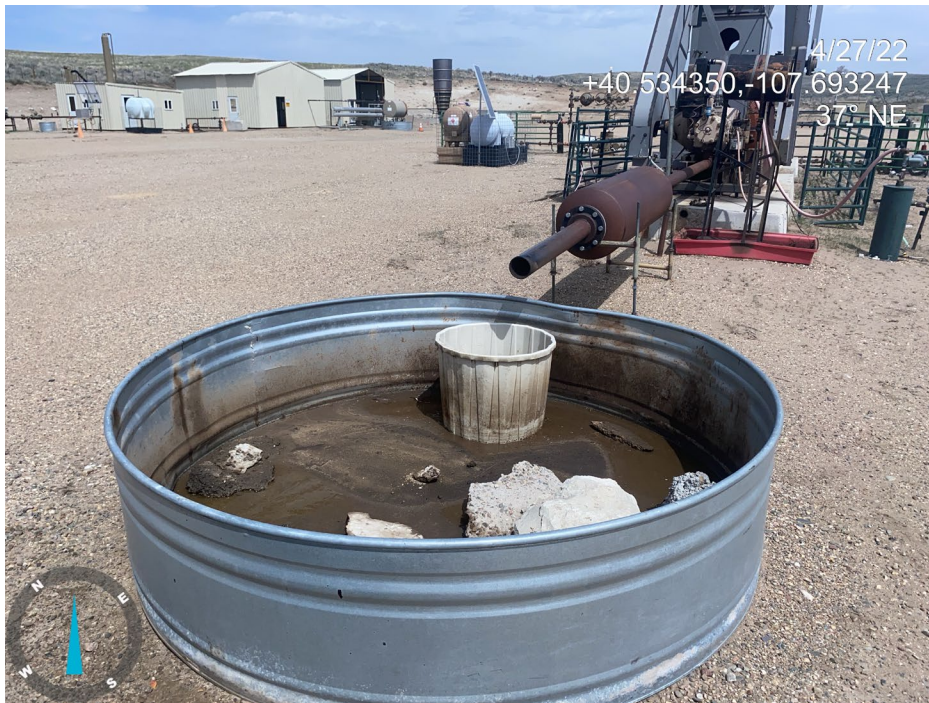
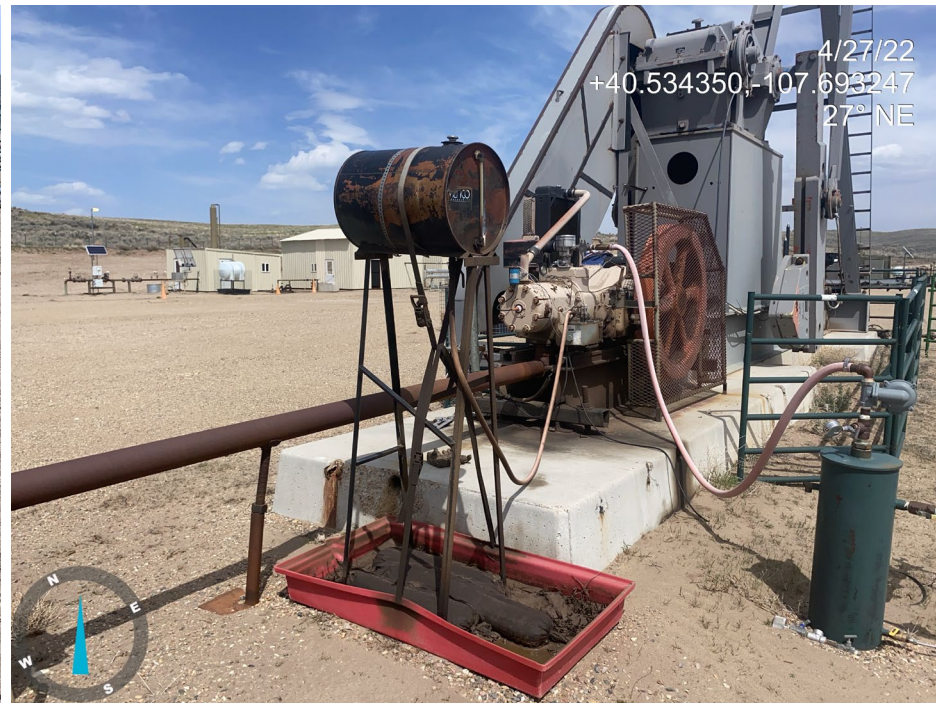
Photo 22. Photos show wildlife protection equipment to prevent wildlife access to secondary containment is missing or insufficient. No safety labeling applied identifying fluids within containers in both photos.
