Inspection Photos

Operator: SWN Production Company LLC - #10396

Location Name: Diamond T Sheep 7-92 /1-26

Inspection Document #: 702800155

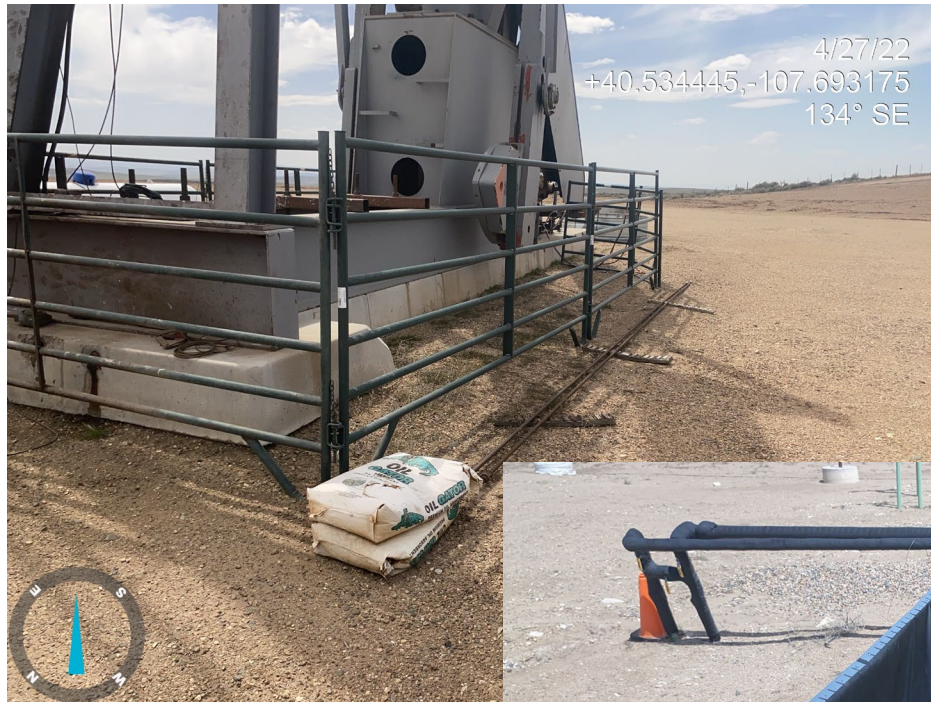
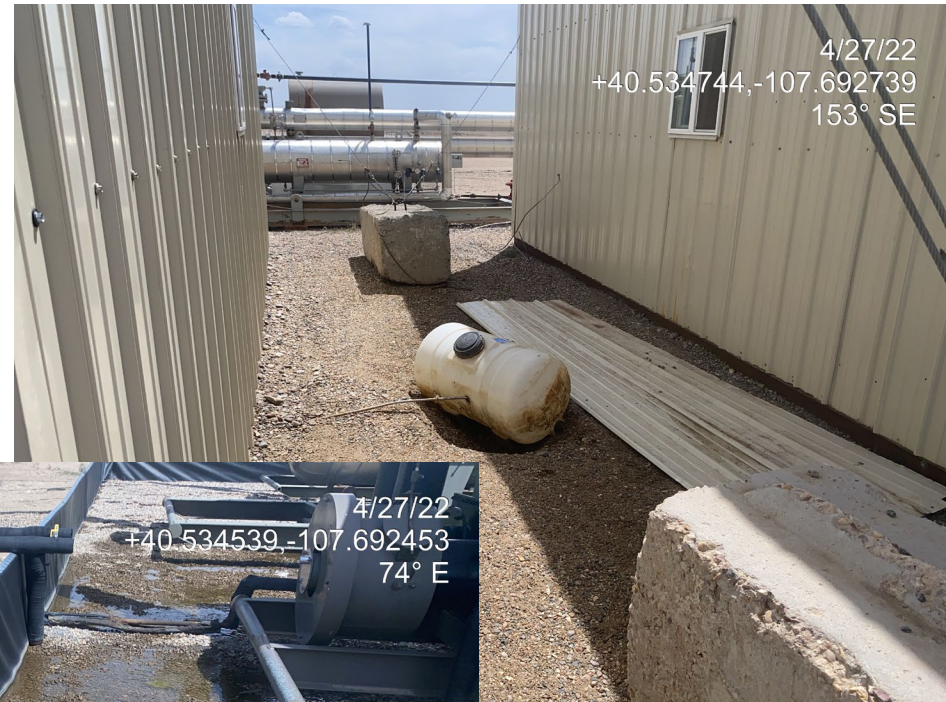
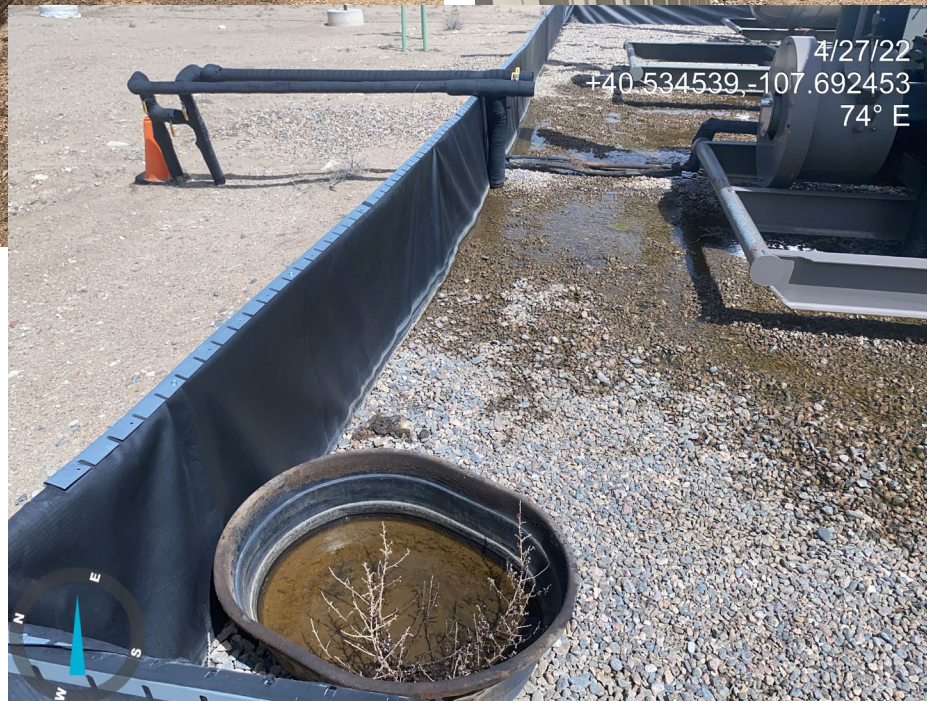
Photo 23. Photos show unused equipment throughout the Location.

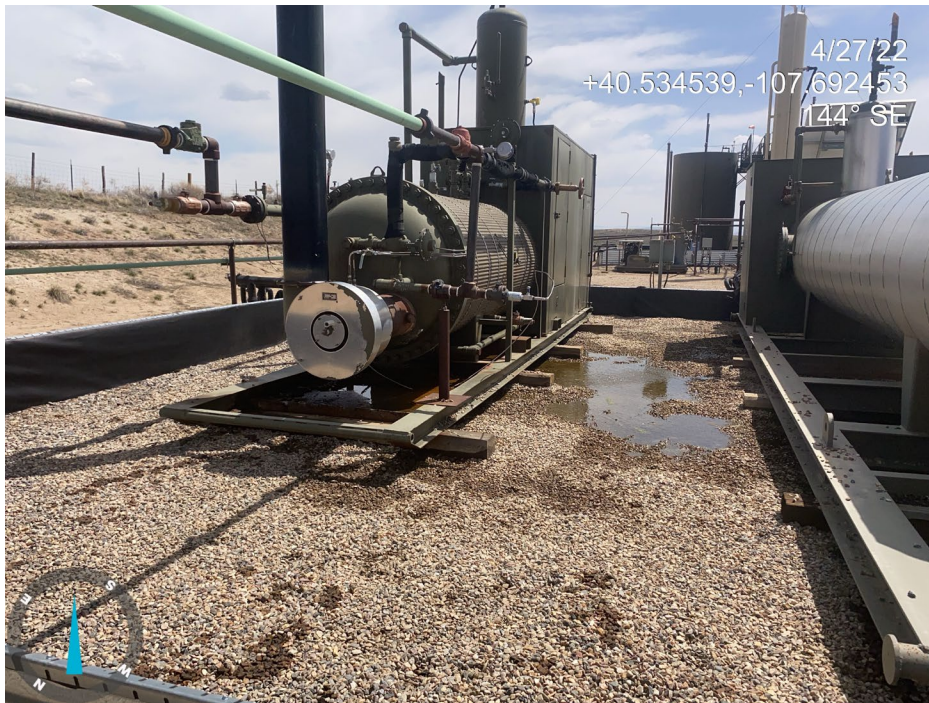
Photo 24. Photo shows stained soils within the compressor station secondary containment BMP.

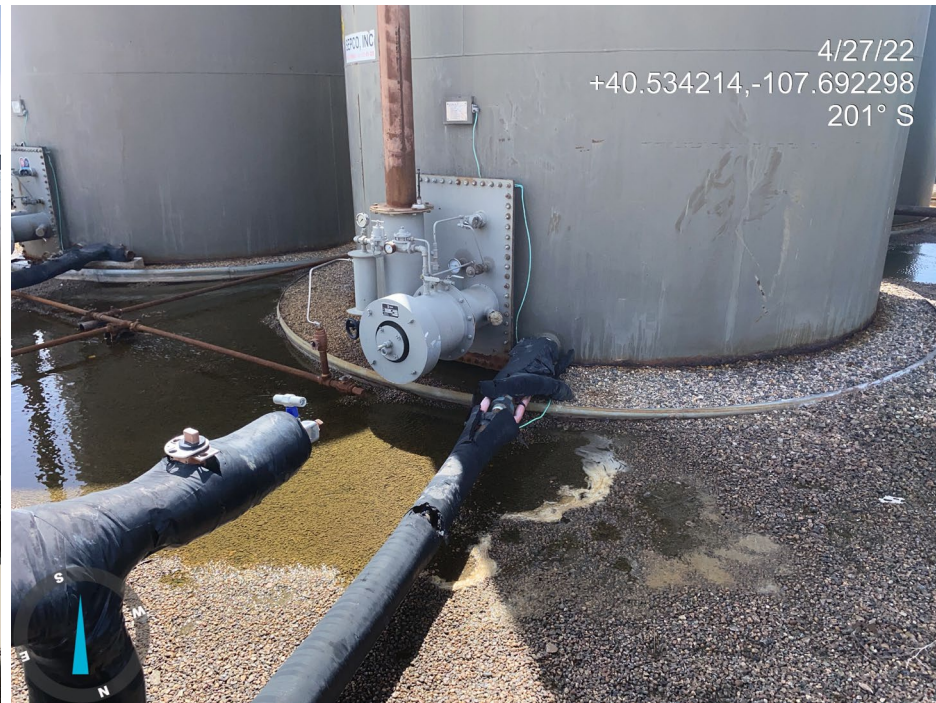
Photo 25. Photo shows stained soils within the tank battery secondary containment BMP.

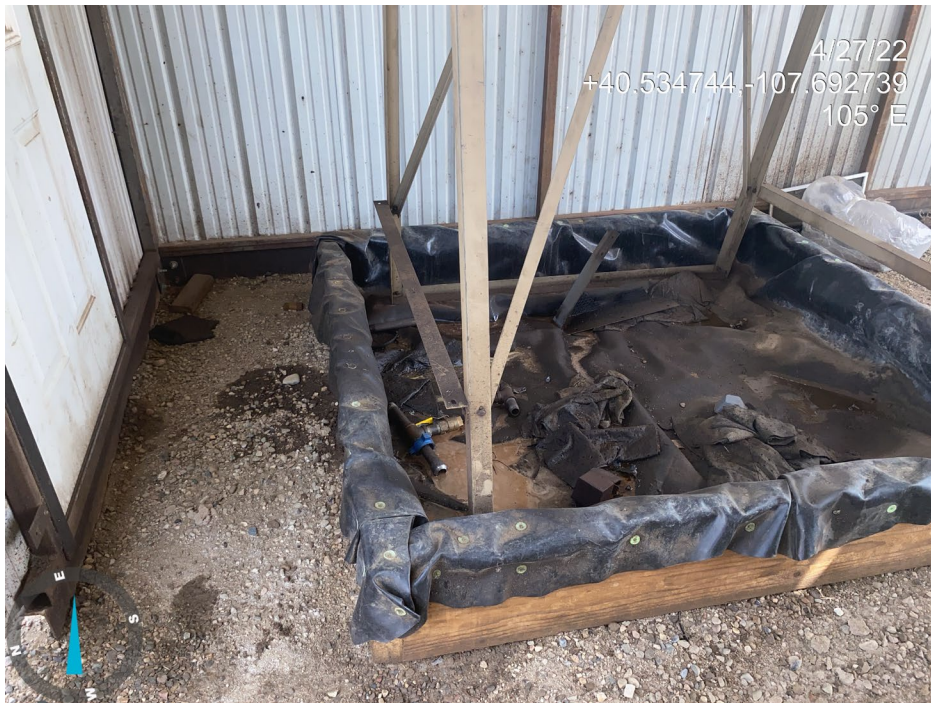
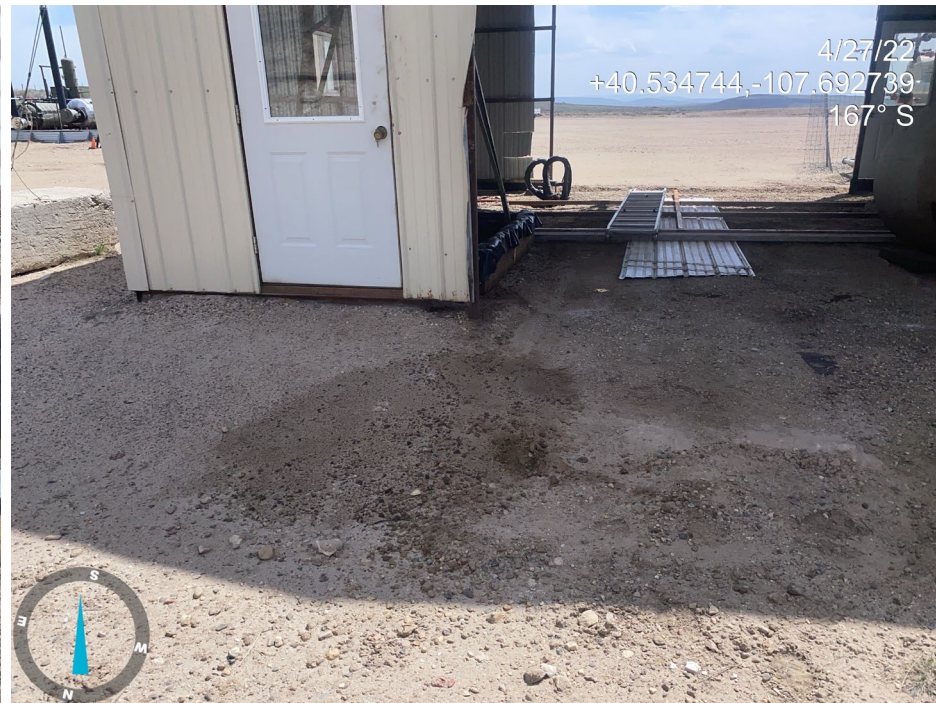
Photo 26. Photos shows stained soils and unused equipment throughout the compressor shed Located at the north of the Location.

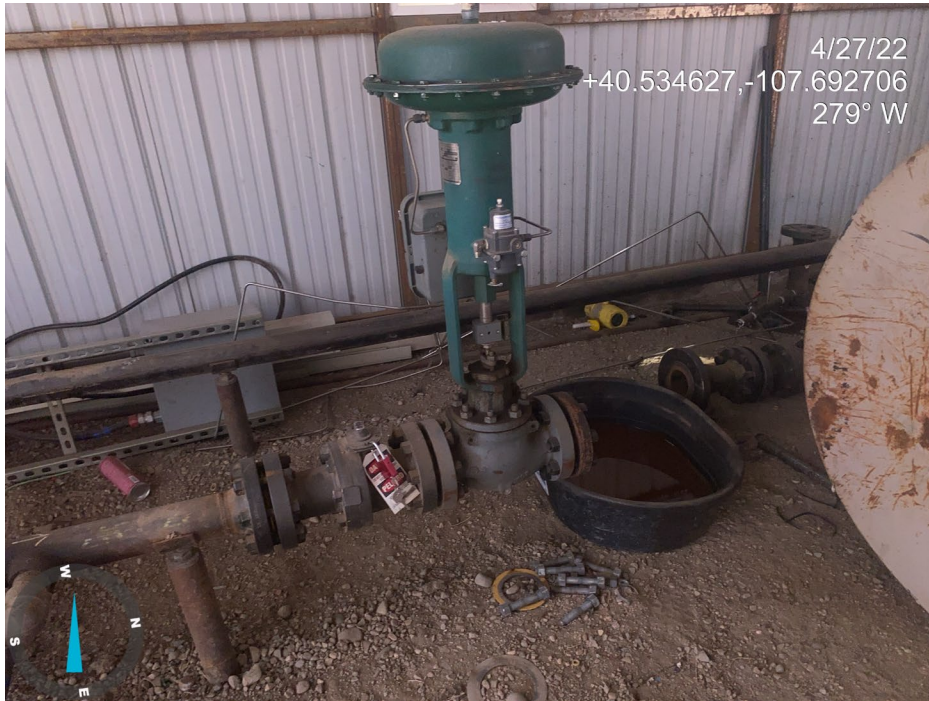
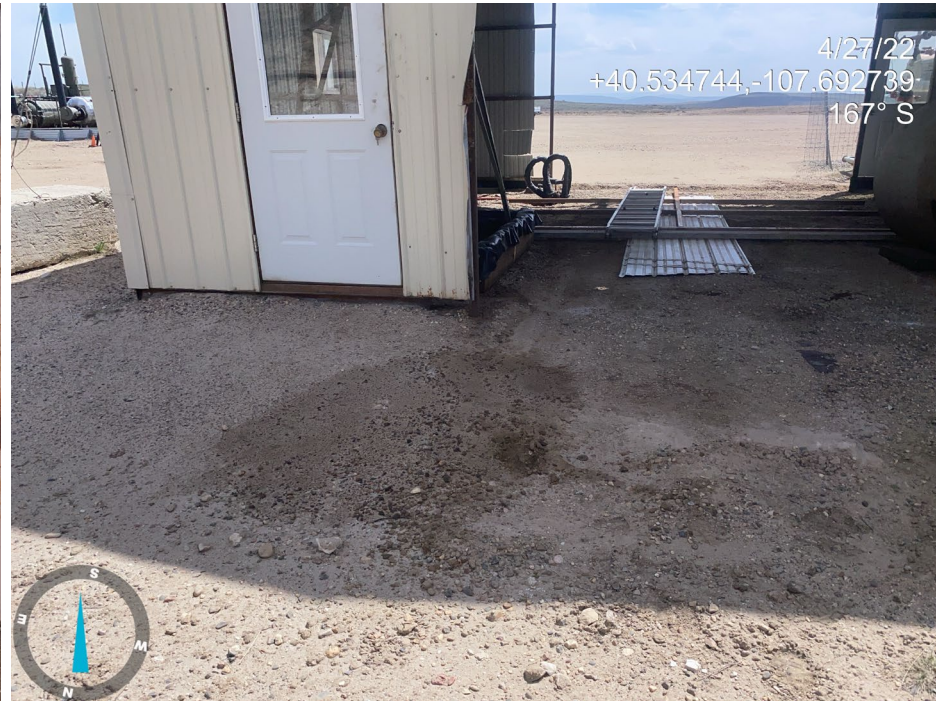
Photo 27. Photos shows unused equipment, tools etc. throughout the compressor shed Located at the north of the Location. Photo also shows wildlife protection equipment to prevent wildlife access to the fluid filled container is missing or insufficient. No safety labeling identifying the fluid.

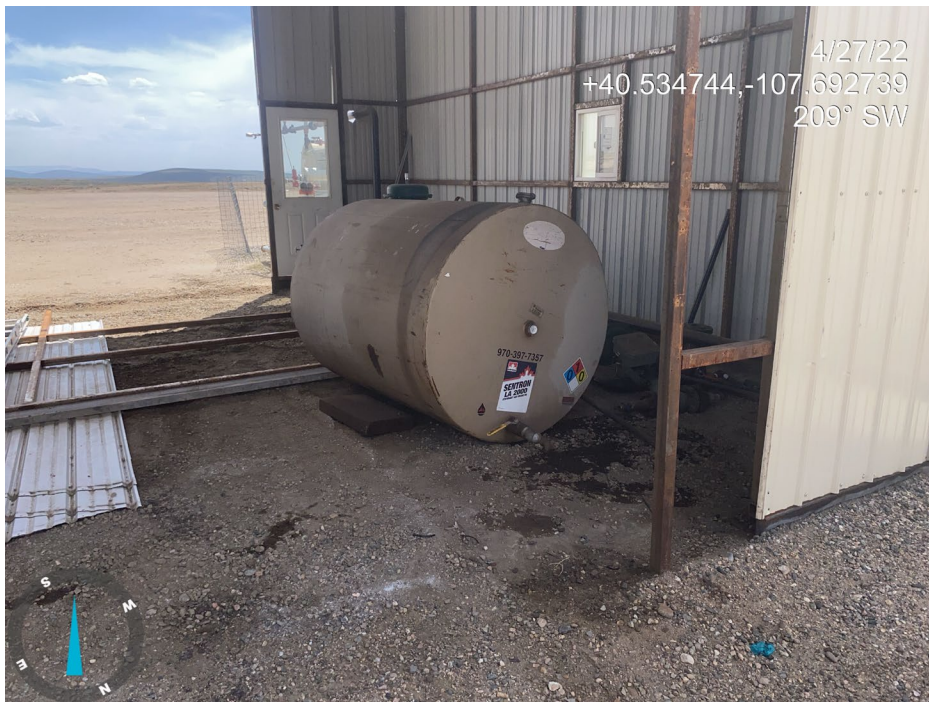
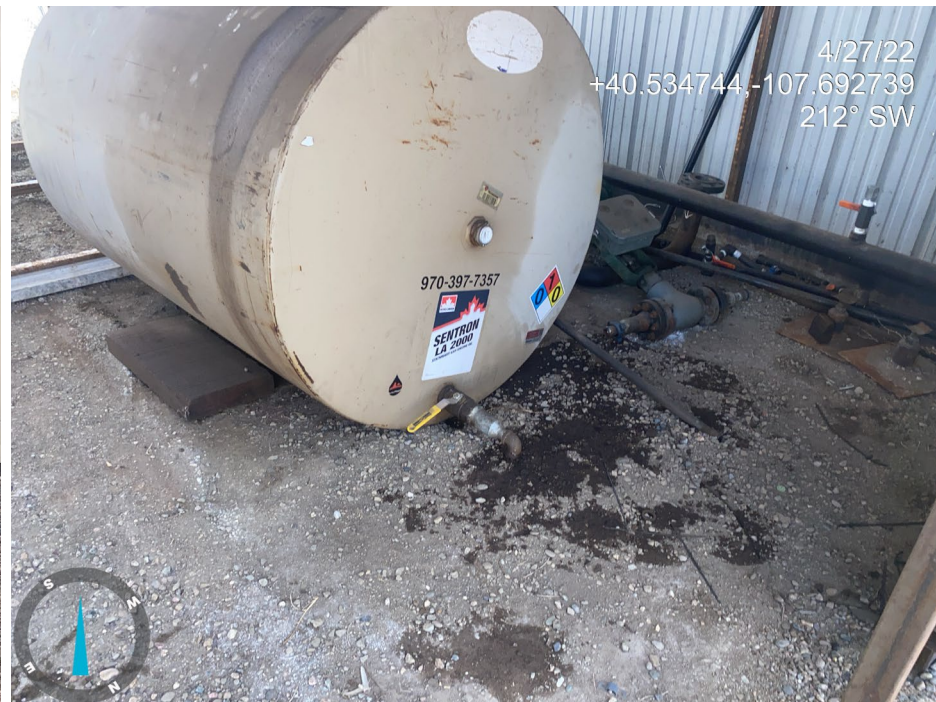
Photo 28. Photos show stained soils and unused equipment throughout the compressor shed Located at the north of the Location.

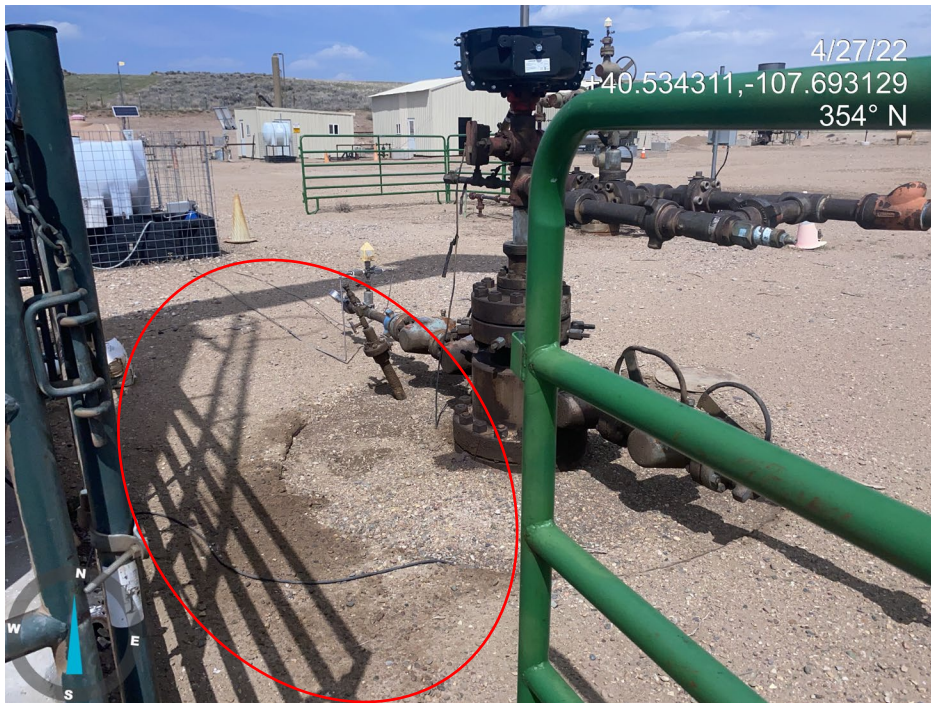
Photo 29. Photo shows stained soils around well API # 05-081-07817

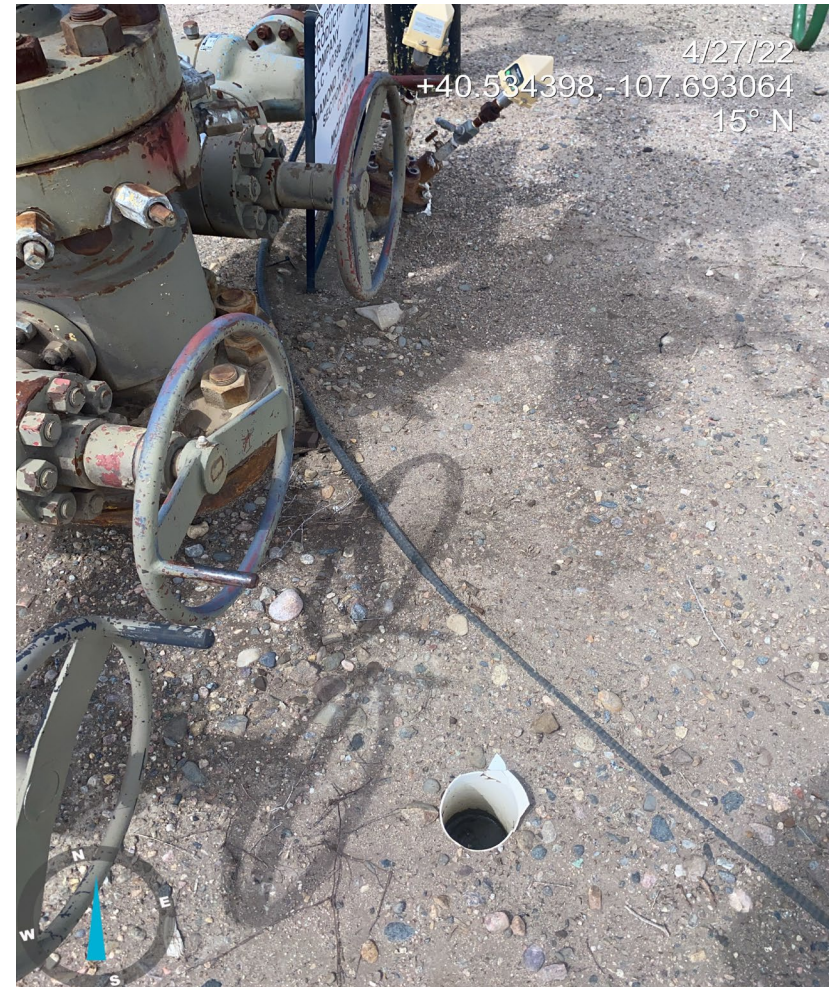
Photo 30. Photo shows an open pipe at well API # 05-081-07804.
