# Inspection Photos

Location Name: Wilson Creek Unit-63N94W /34NWNE

Inspection Document #: 702800181

Anna O'Malley  
Reclamation Specialist, COGCC

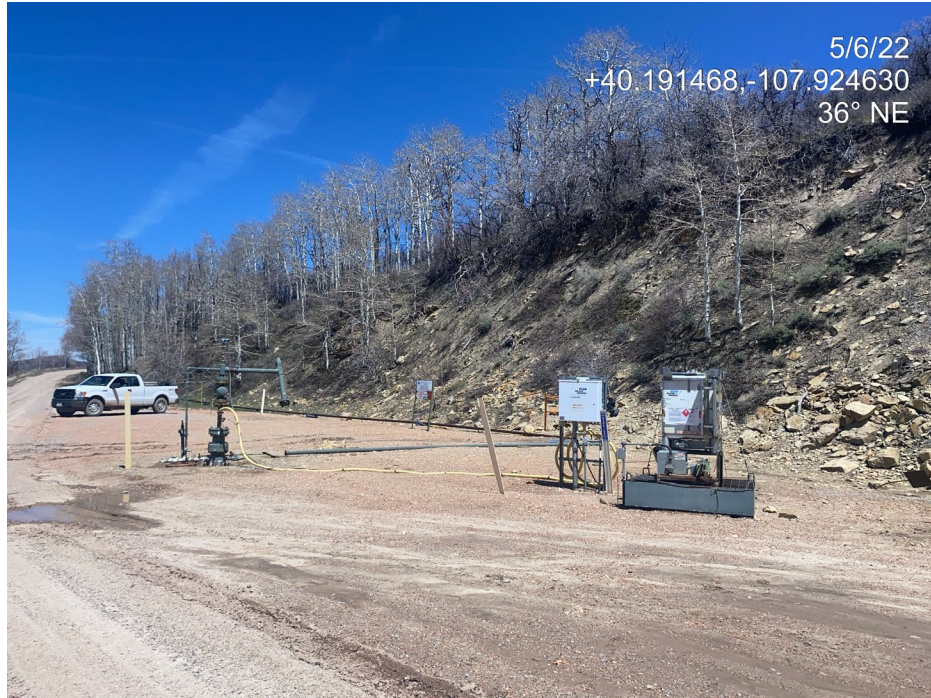
5/6/22  
+40.191468,-107.924630  
36° NE

**Photo 1.** Photo taken from the center of the Location shows an overview of the northern portion of the Location.

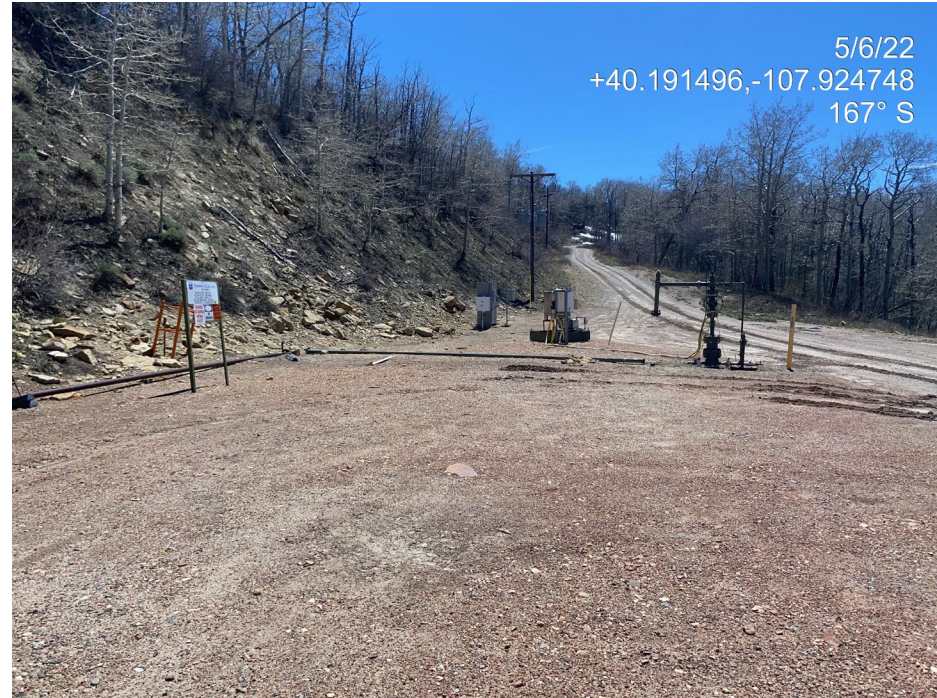
5/6/22  
+40.191496,-107.924748  
167° S

**Photo 2.** Photo taken from the center of the Location shows an overview of the southern portion of the Location.

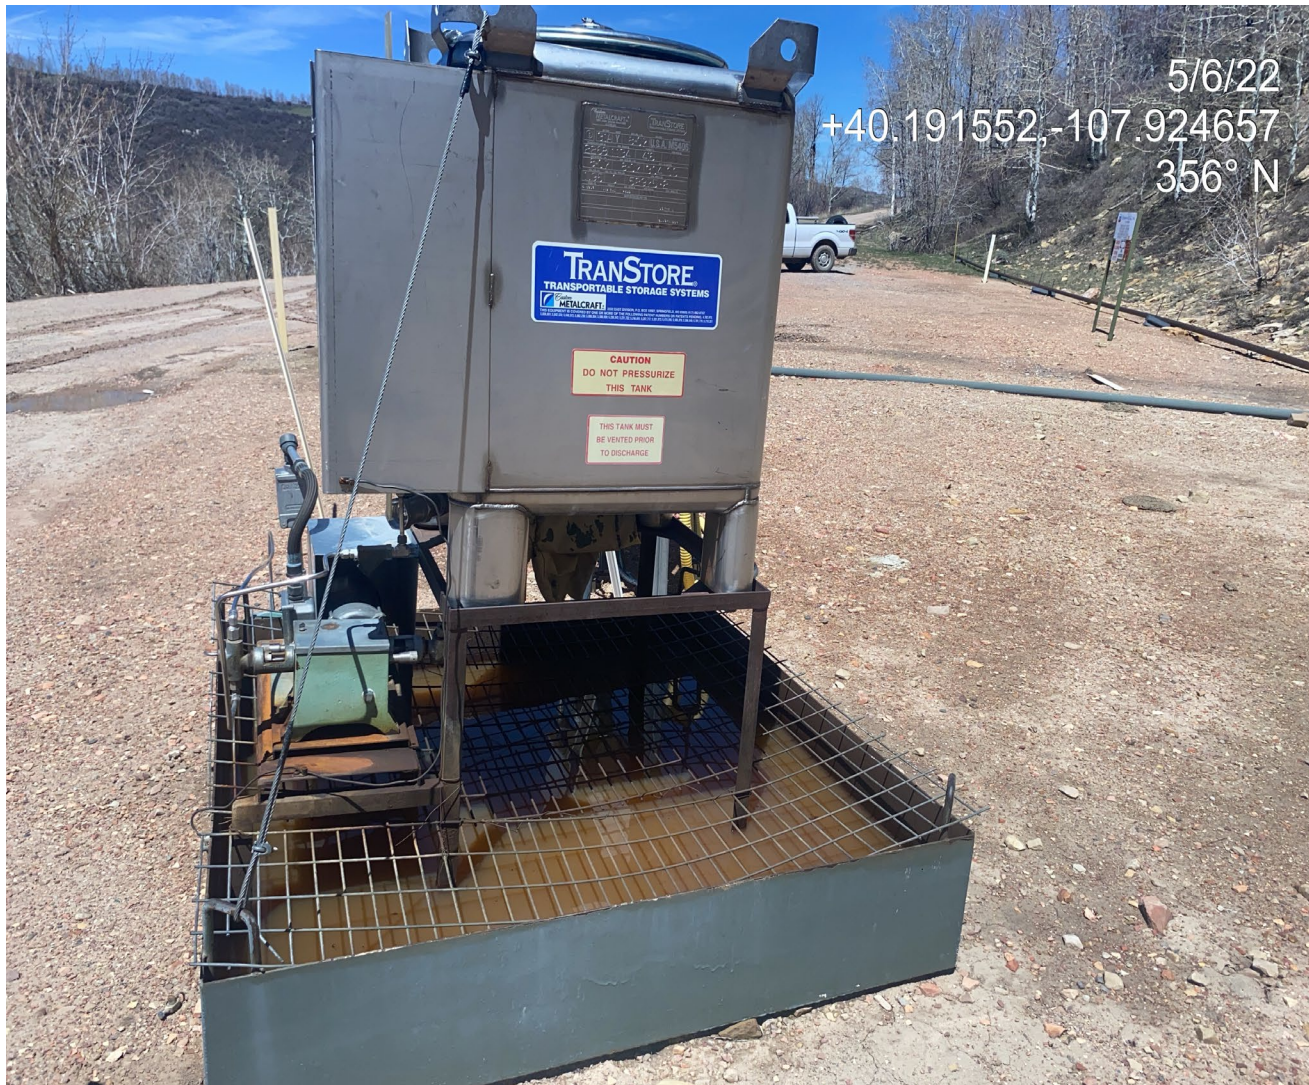
**Photo 3.** Photo shows a secondary containment BMP filled with fluid. Wildlife protection BMPs to enable wildlife egress are missing or insufficient.

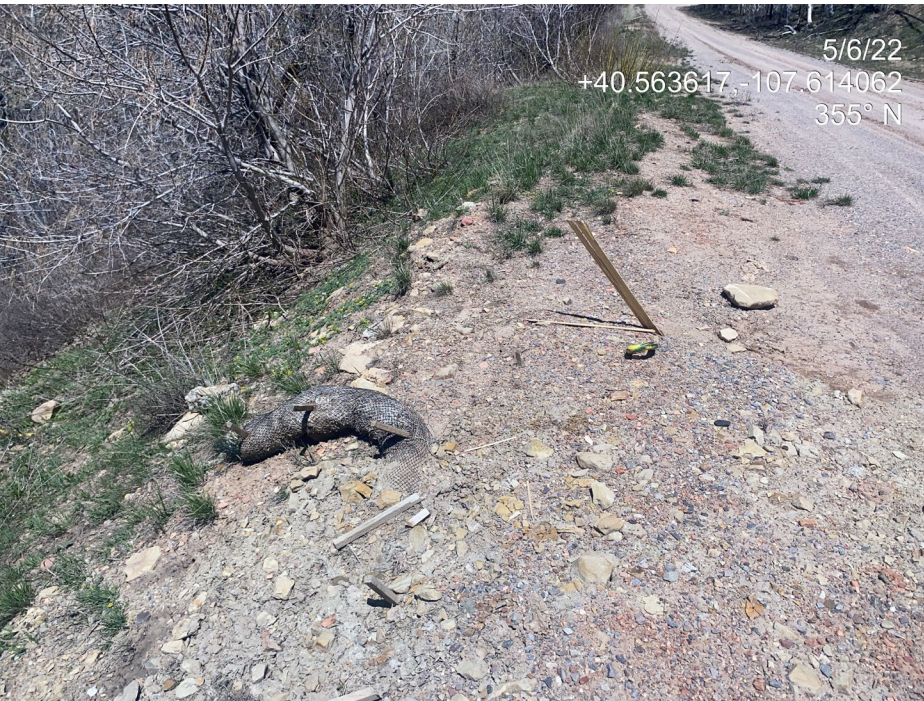
**Photo 4.** Photo taken from the west of the Location shows a straw wattle not in proper functioning condition. Erosion is occurring throughout the slope at the western perimeter of the Location. Sediment leaving the Location appears to be causing degradation to areas offsite.

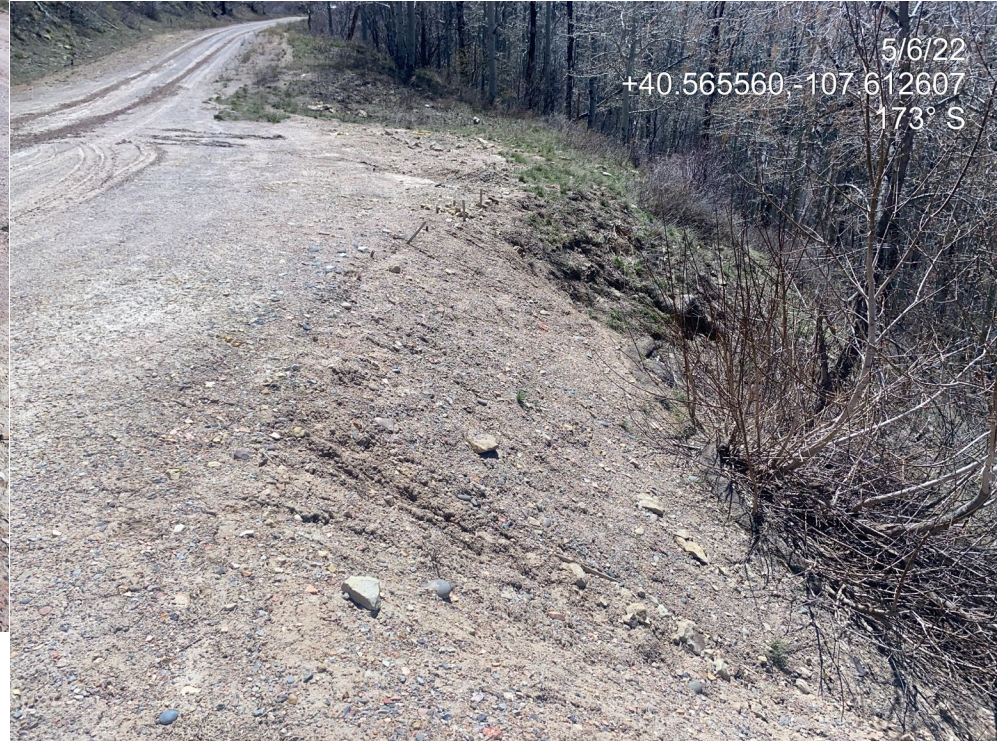
**Photo 5.** Refer to Photo 4 comments.

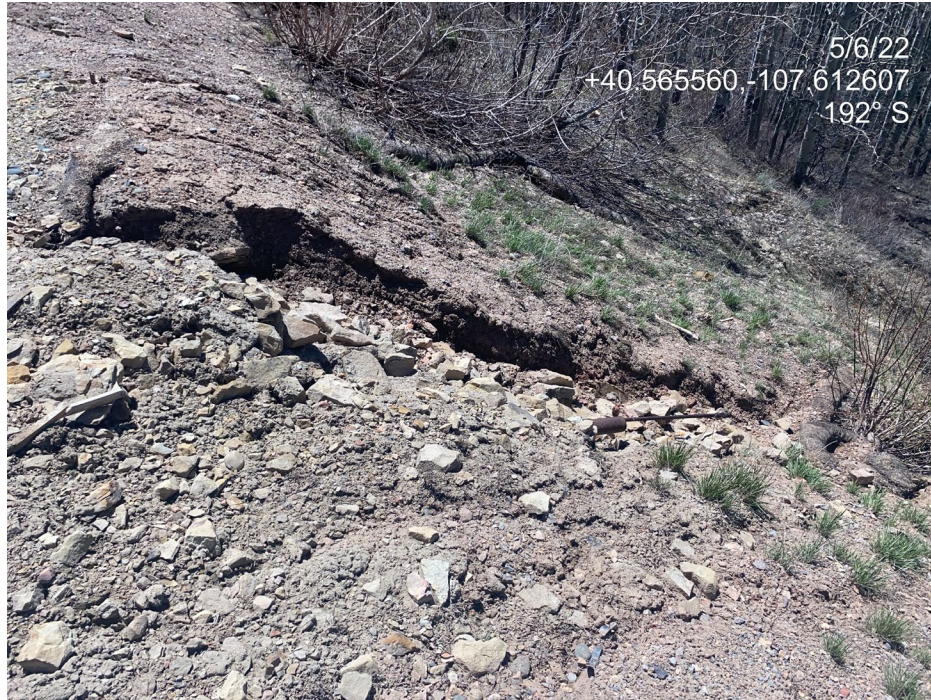
**Photo 6.** Photo taken from the west of the Location shows gully erosion.

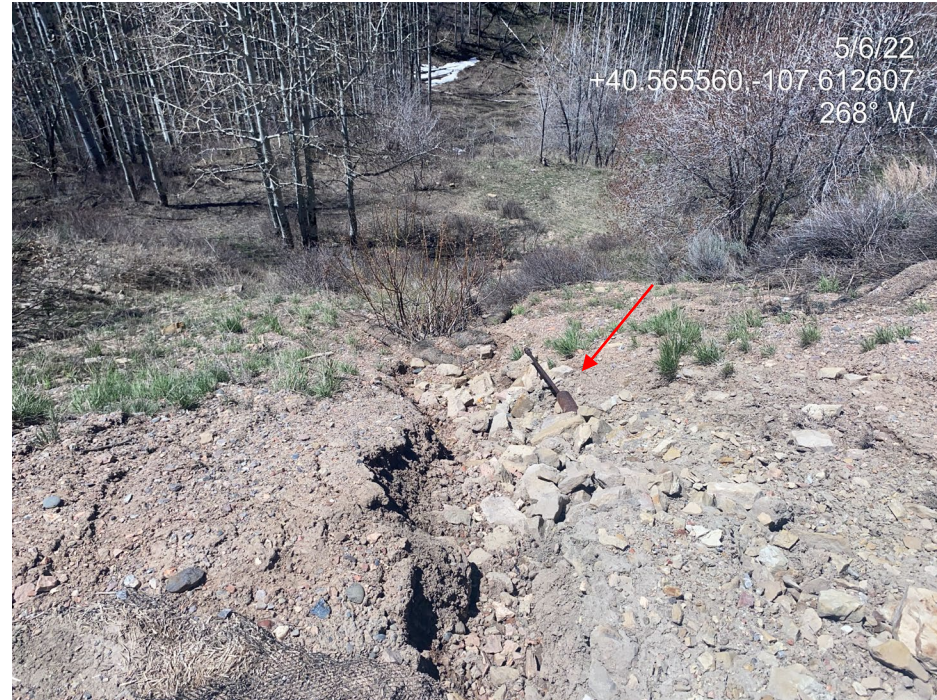
**Photo 7.** Photo taken from the west of the Location shows gully erosion. Photo also shows buried pipe which will need to be removed during reclamation.
