Inspection Photos

Operator: Chevron USA Inc - #16700

Location Name: Wilson Creek Unit-63N94W /34NENW

Inspection Document #: 702800180

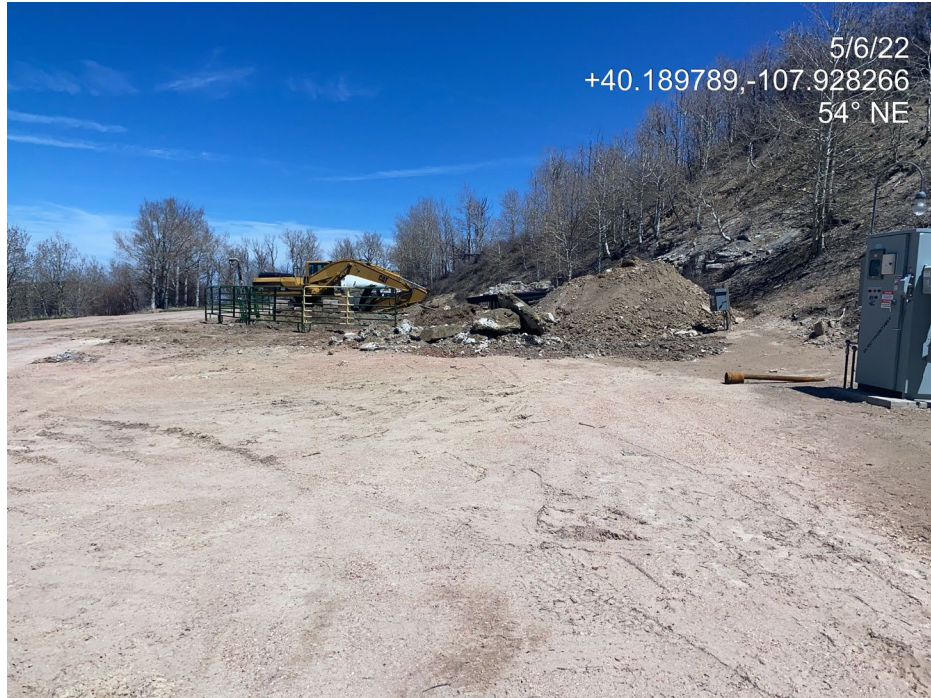
Photo 1. Photo taken from the southwest of the Location shows an overview of the Location.

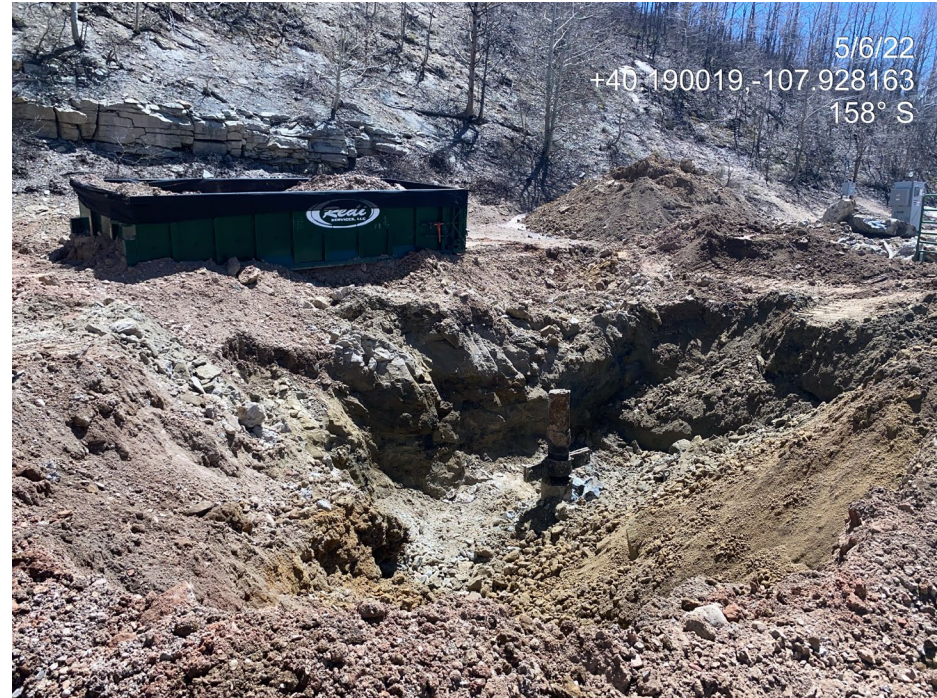
Photo 2. Photo taken from the northeast of the Location shows the excavated well. A strong hydrocarbon odor was present. Photos also shows the sides of the pit may be too steep to allow wildlife escape and fencing to prevent access does not completely enclose the excavated area.

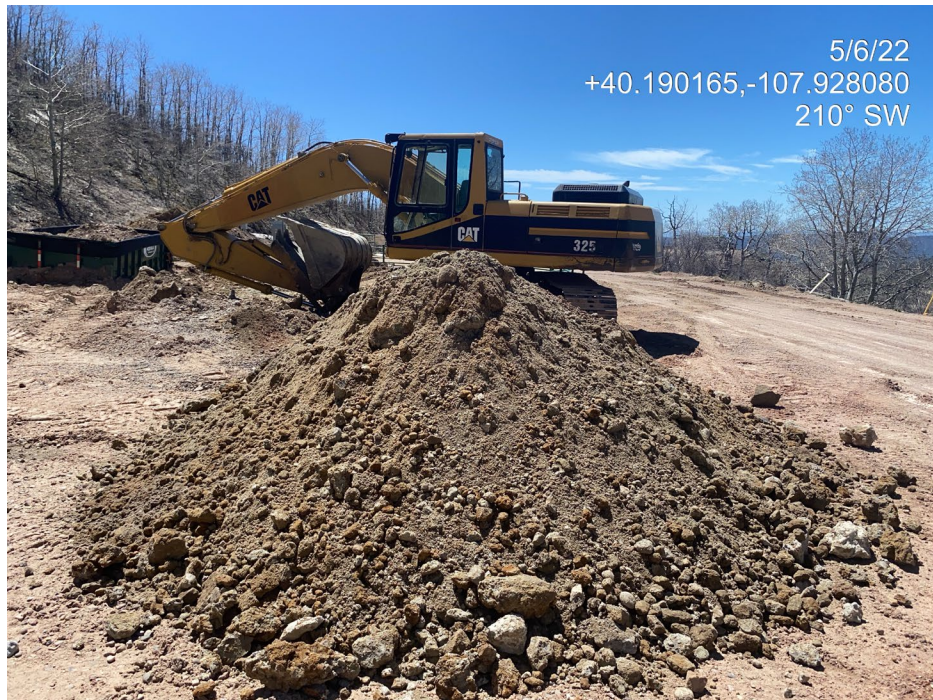
Photo 3. Photo taken from the northeast of the Location shows a pile of material excavated from around the well. BMPs to prevent the E&P waste from migrating off the Location were not present.

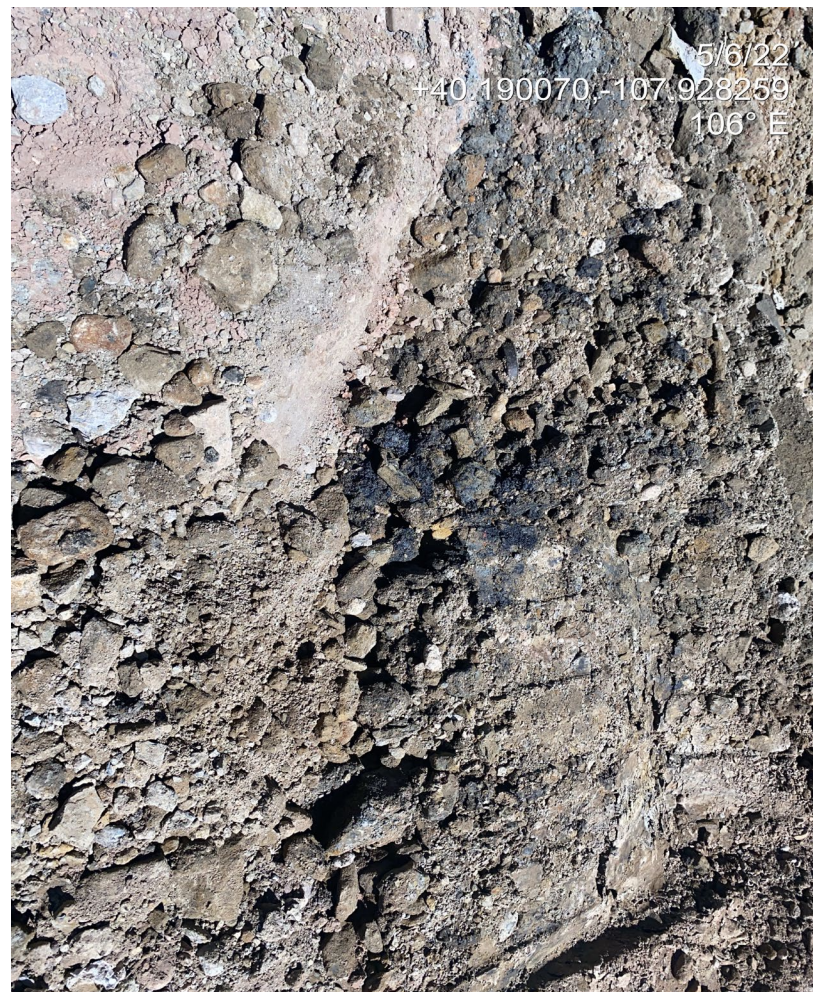
Photo 4. Photo taken from the area of the excavated well shows stained soils around the well. A strong hydrocarbon odor was present at the time of this inspection.

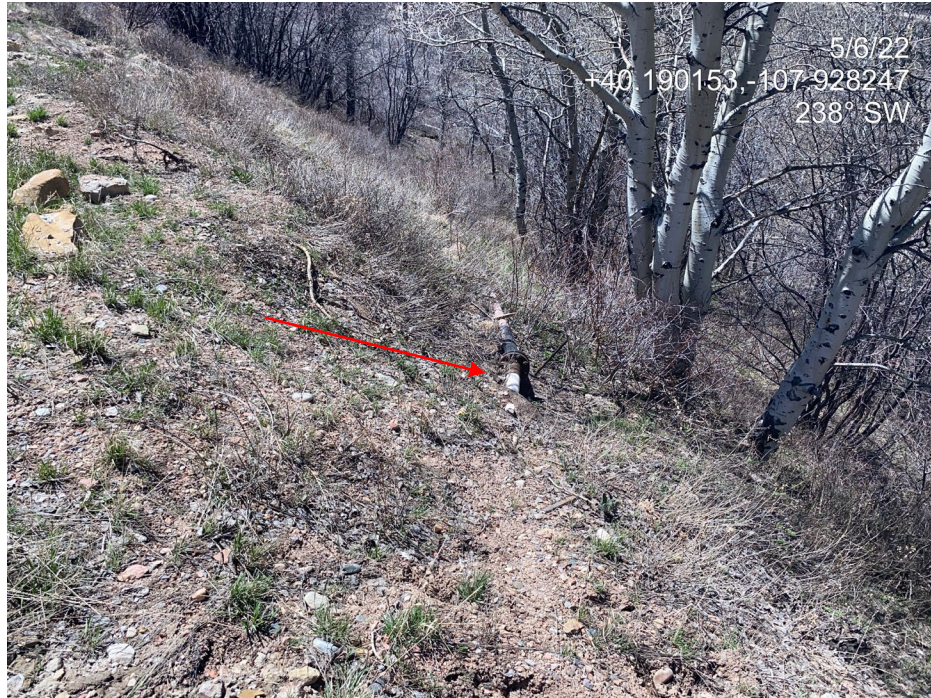
Photo 5. Photo taken from the northwest of the Location shows a flowline which will need to be removed during final reclamation.

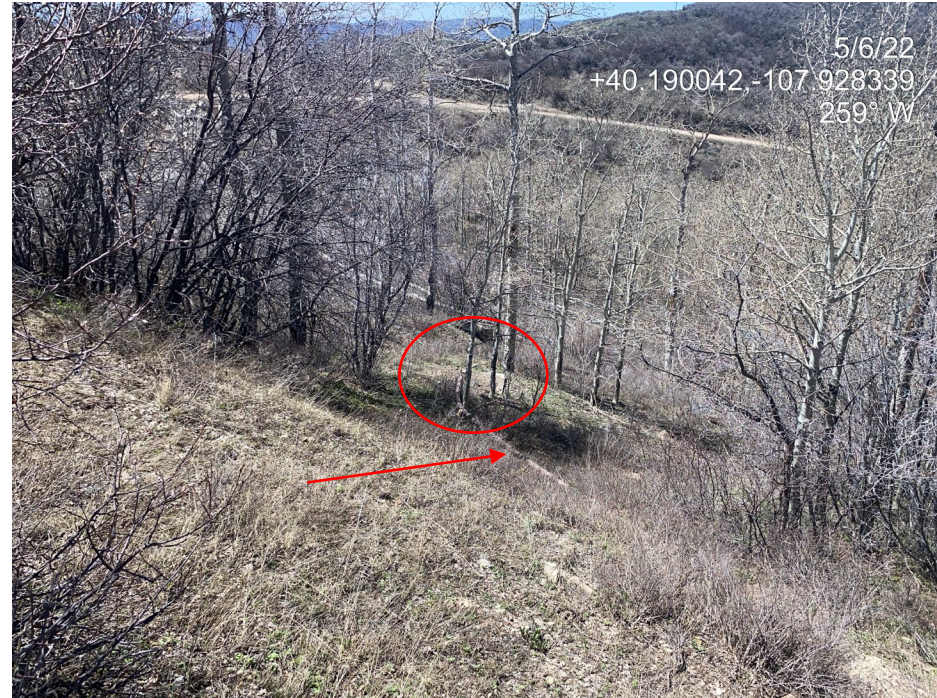
Photo 6. Photo taken from the northwest of the Location shows a flowline (arrow) and pad (circle) which will need to be removed during final reclamation.

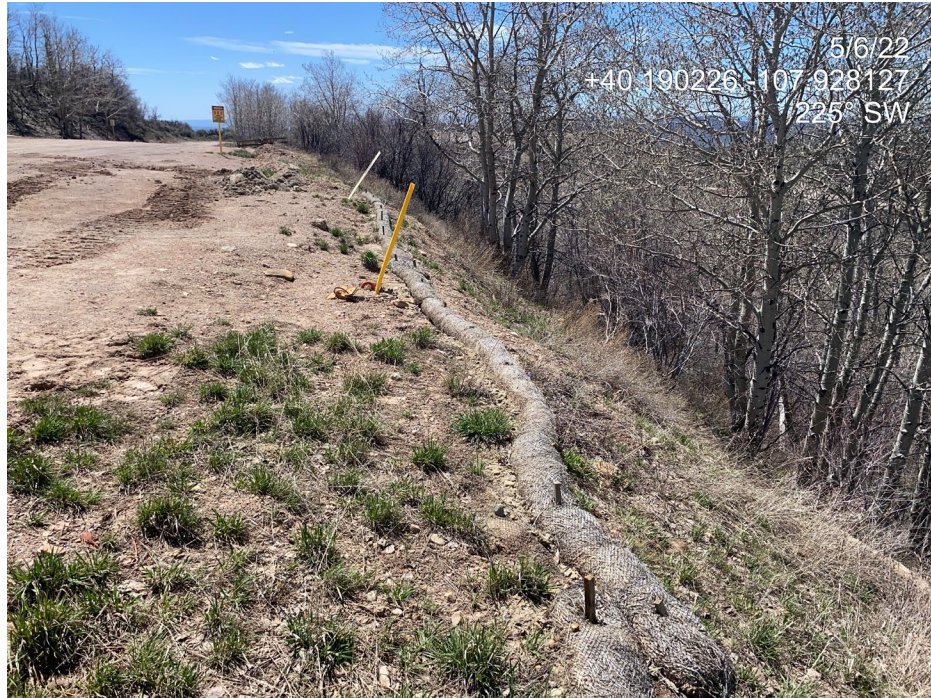
Photo 7. Photo taken from the northwest of the Location shows a straw wattle, which is presently in proper functioning condition to manage stormwater on the Location.

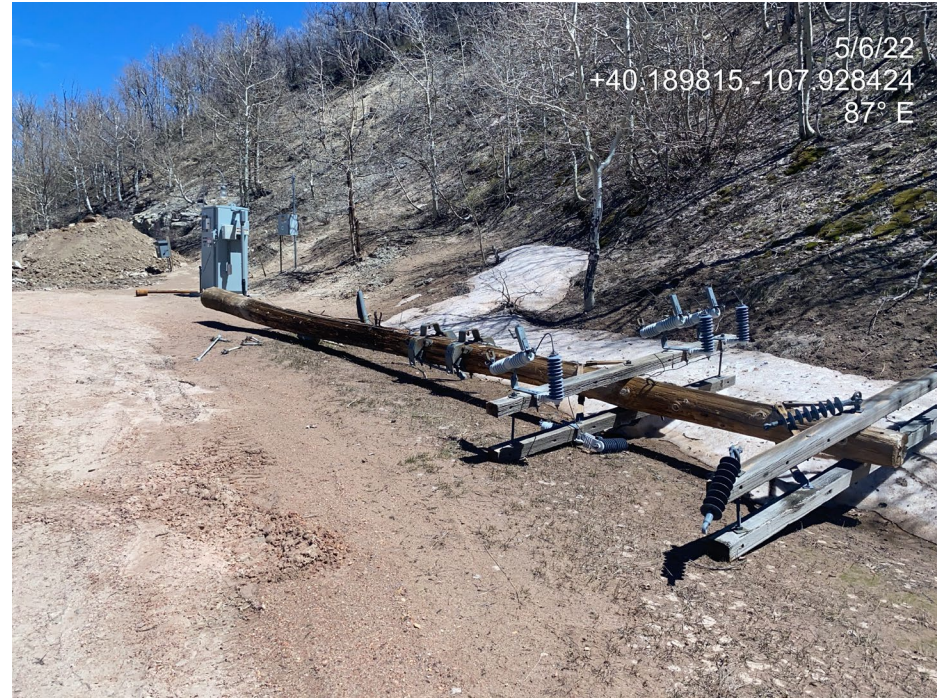
Photo 8. Photos shows power lines being decommissioned at the Location.
