Inspection Photos

5/10/2022

Operator: BLACK HILLS PLATEAU
PRODUCTION LLC - 10150 / LARAMIE ENERGY
LLC - 10433

Location ID: 312420
Mesa County, CO

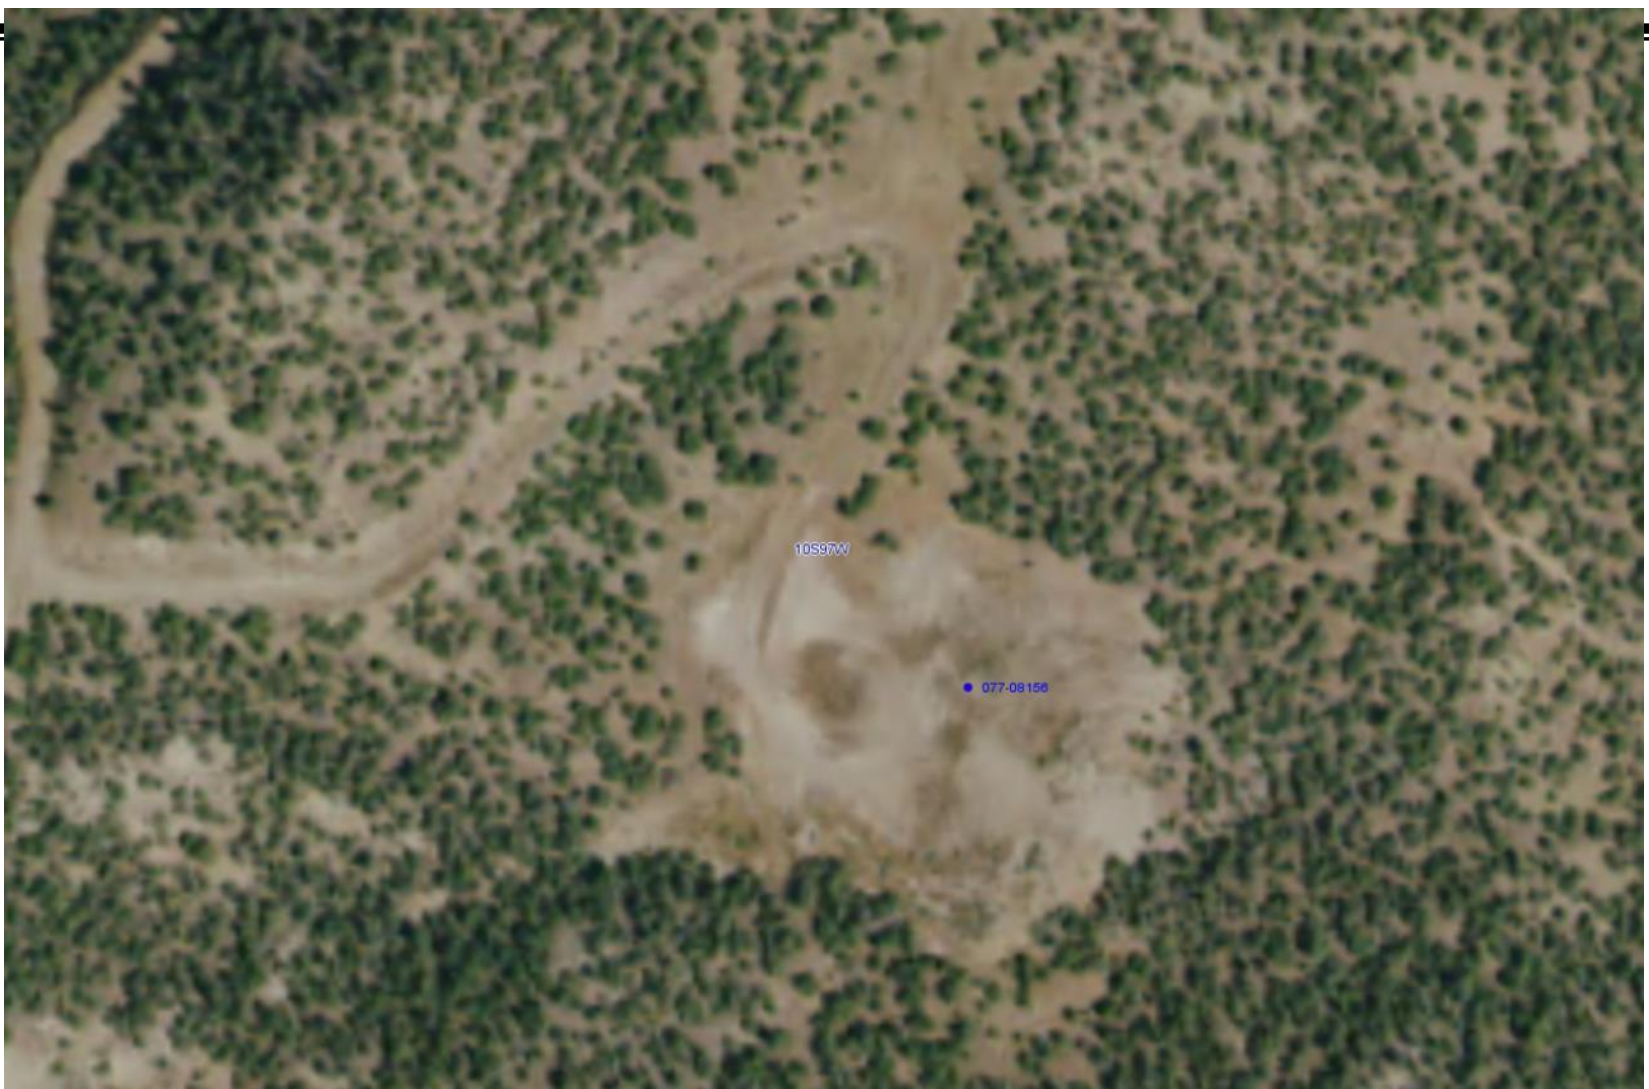
Photo 2: 2005 google earth aerial image of the Location with inserts from page 1 showing area pre-disturbance (bottom left), and area post disturbance (bottom right). Image shows location's disturbance area (red polygon), as well as equipment such as a tank (arrow). Location remains relatively unchanged.

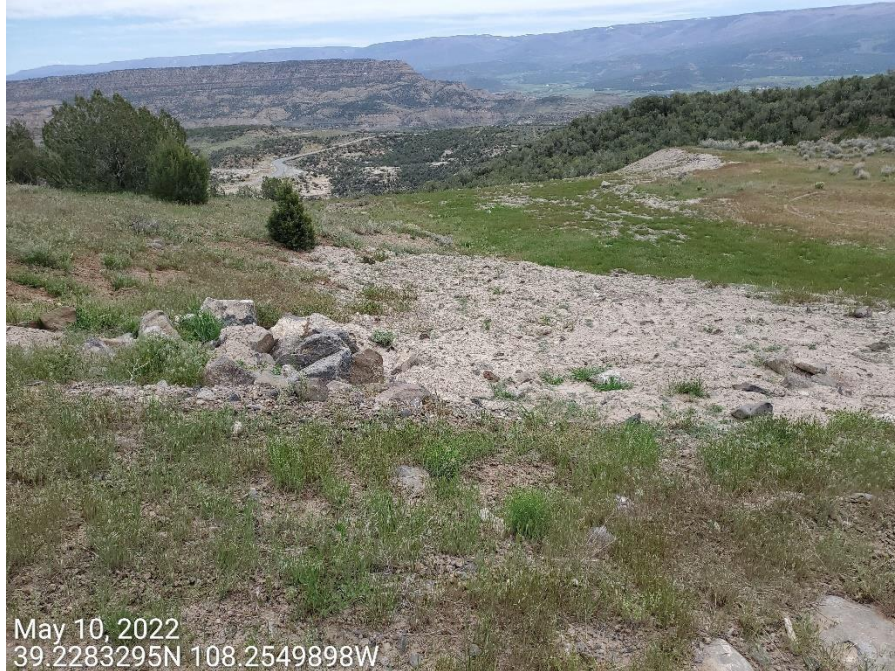
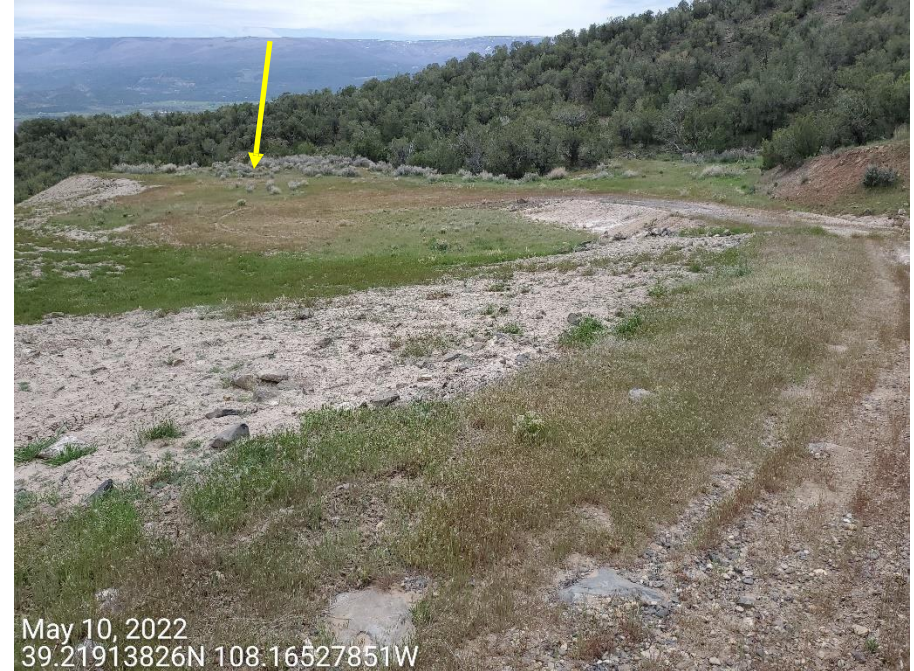
Photo 4: Photos taken from the west end of the Location, facing east and southeast. Photo provides overview of the Location. Photo shows Location has not been recontoured, regraded and reclaimed in accordance with COGCC 1004 requirements. Arrow shows approximate location of tank battery evident in photo 2.

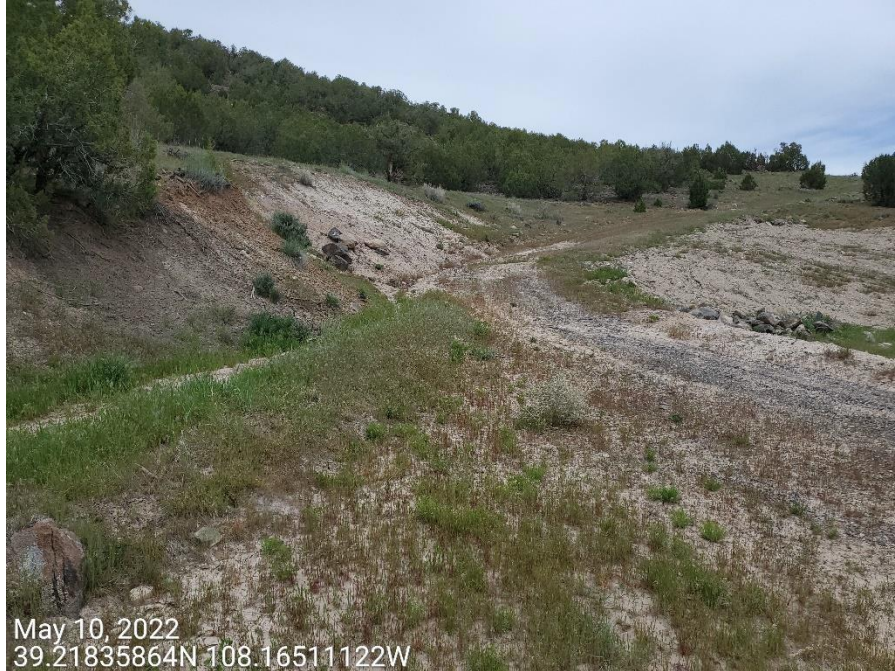
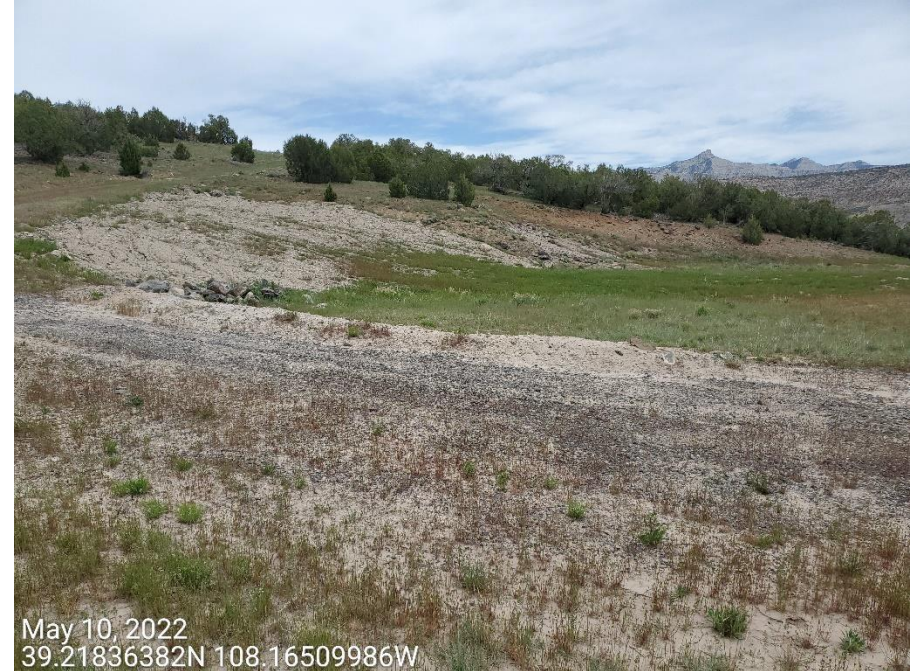
Photo 5: Photos 5-6 taken from the west end of the Location. Photos provide an overview of the Location from north, northeast, east to southeast. Photo shows Location and access road has not been recontoured, regraded and reclaimed in accordance with COGCC 1004 requirements. Arrow shows approximate location of tank battery evident in photo 2.

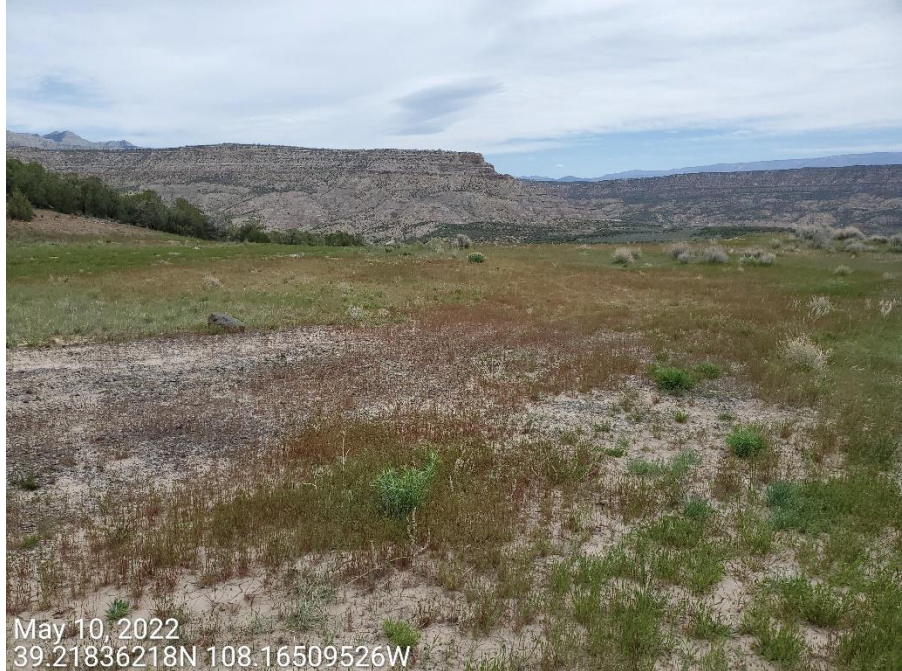
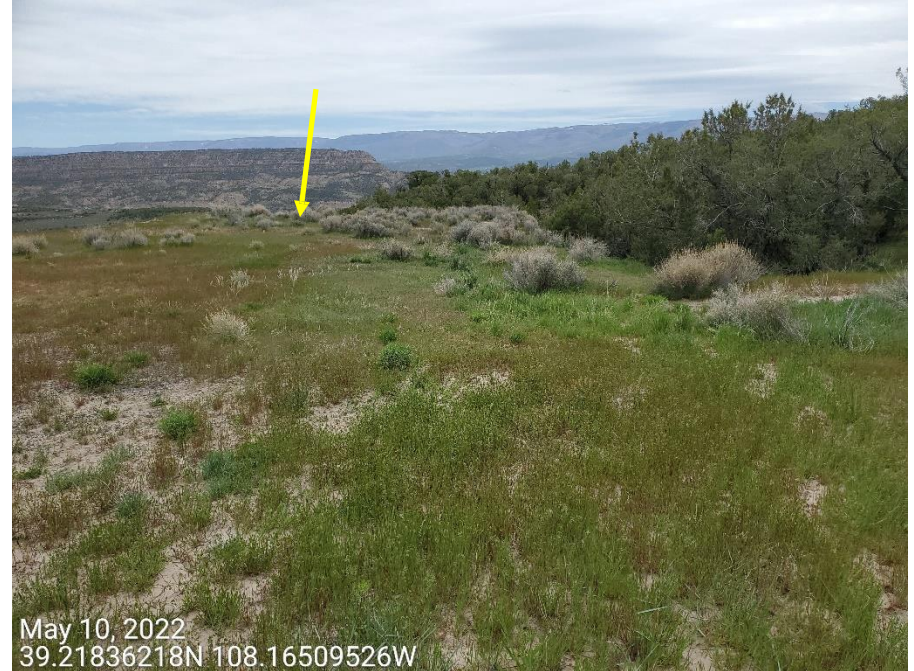
Photo 6: See comments under photo 5. Arrow shows approximate location of tank battery evident in photo 2.

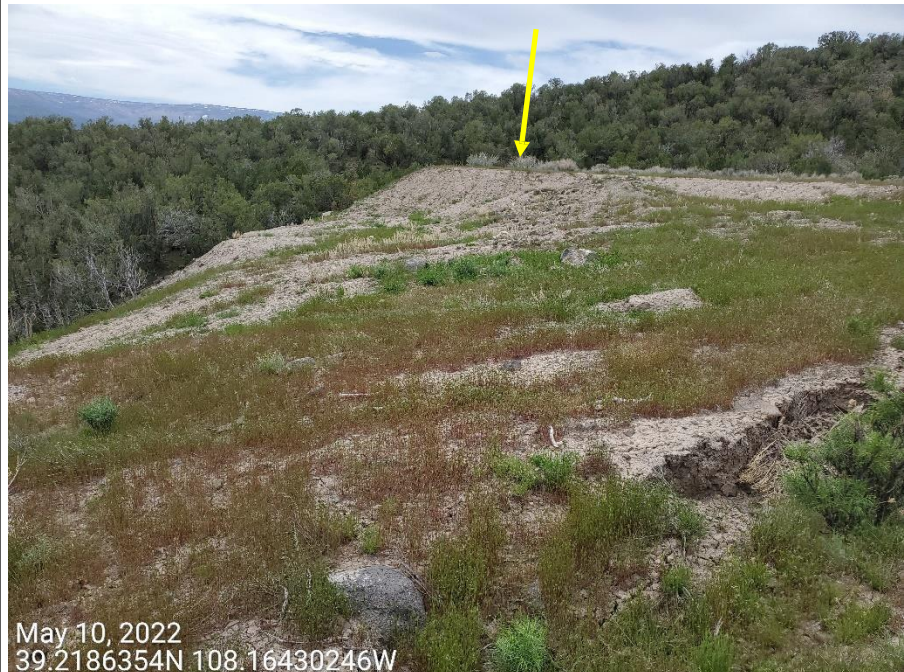
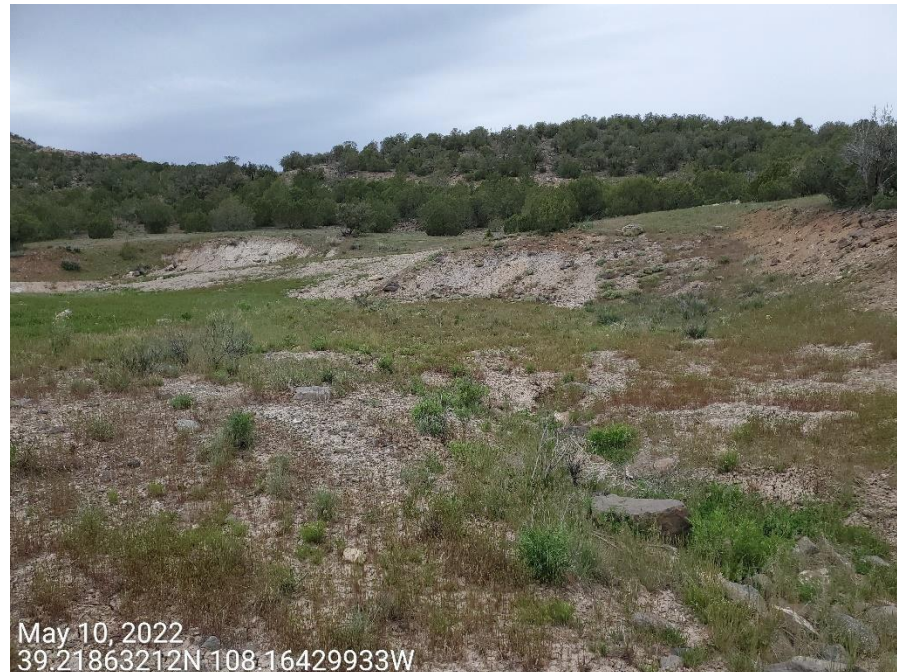
Photo 7: Photos 5-6 taken from the northeast end of the Location. Photos provide an overview of the Location from southwest and northwest. Photo shows Location and access road has not been recontoured, regraded and reclaimed in accordance with COGCC 1004 requirements. Arrow shows approximate location of tank battery evident in photo 2.

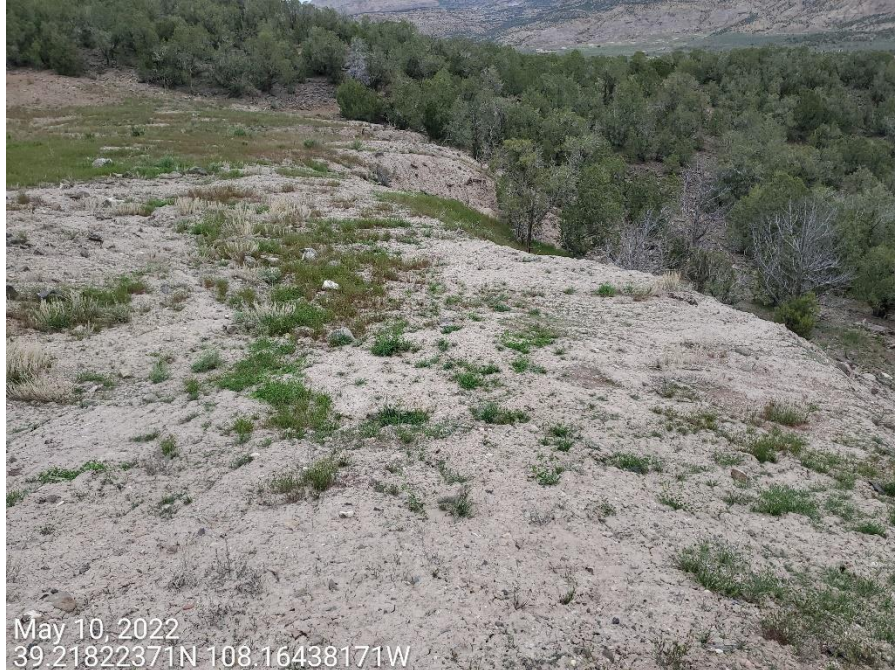
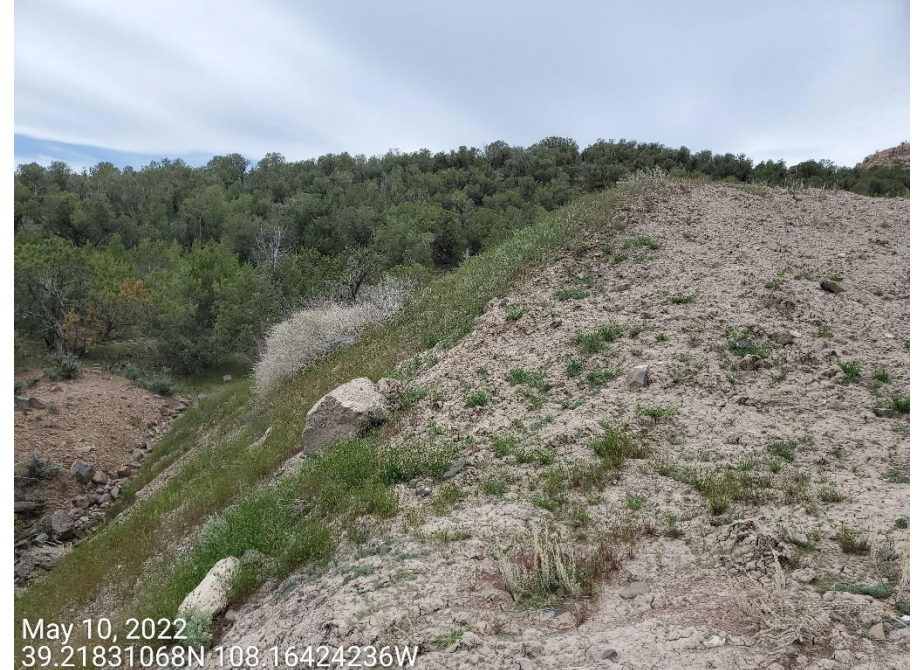
Photo 8: Photos provide examples of the remaining fill slopes on the east end of the Location. Location has not been recontoured, regraded and reclaimed in accordance with COGCC 1004 requirements.

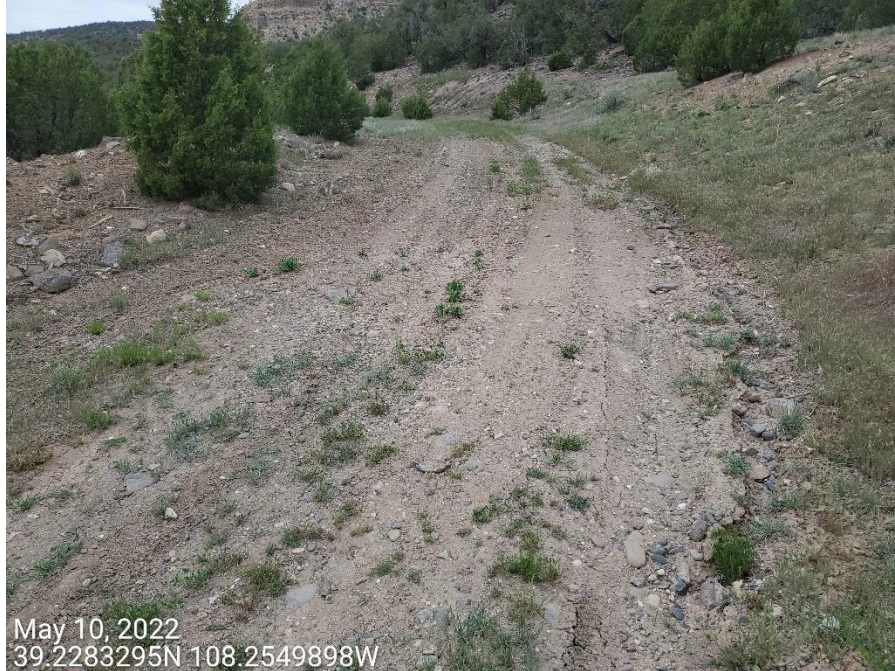
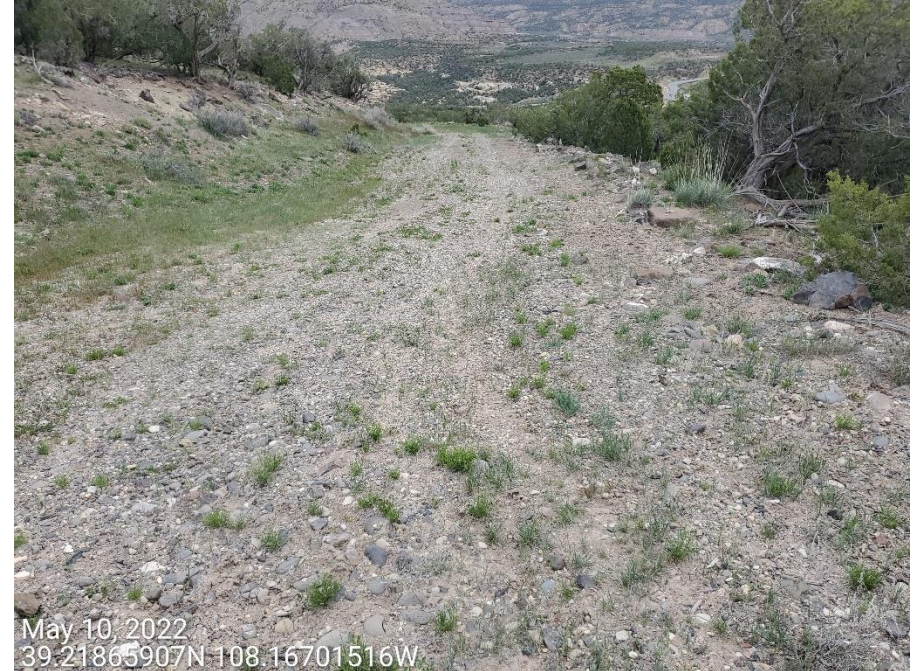
Photo 9: Photos examples showing access road has not been recontoured, regraded and reclaimed; gravel/road base remains evident.

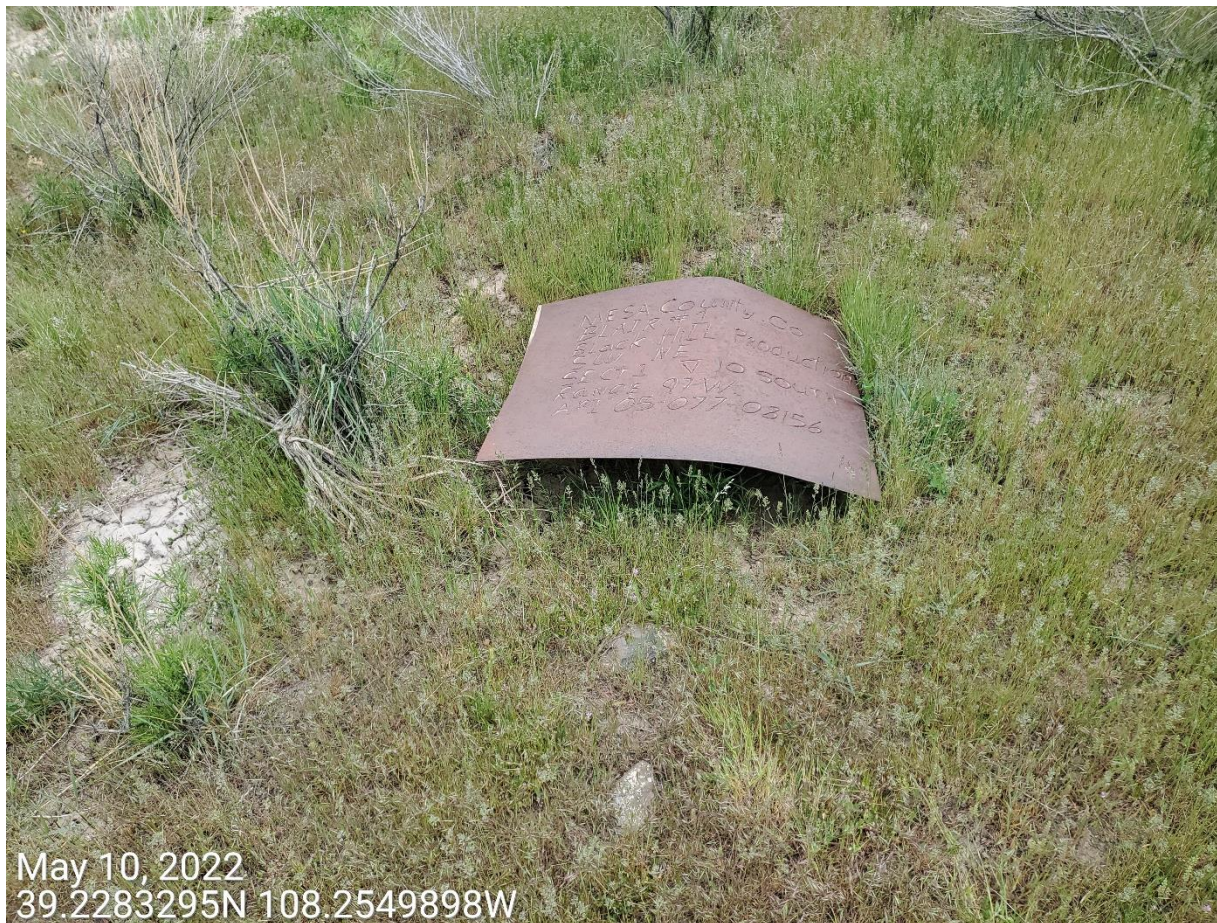
Photo 10: Photo shows welded plate representing the well marker left at the surface. Rules at time of plugging required permanent monuments marking well at surface was required to be a piece of pipe not less than 4 inches in diameter and not less than 10 feet in length, of which 4 feet shall be above the general ground level; monument left at surface does not comport with abandoned well marker requirements.
