Inspection Photos

API: 073-06747

Operator: GRAND MESA OPERATING

Inspection Date: 5/16/2022

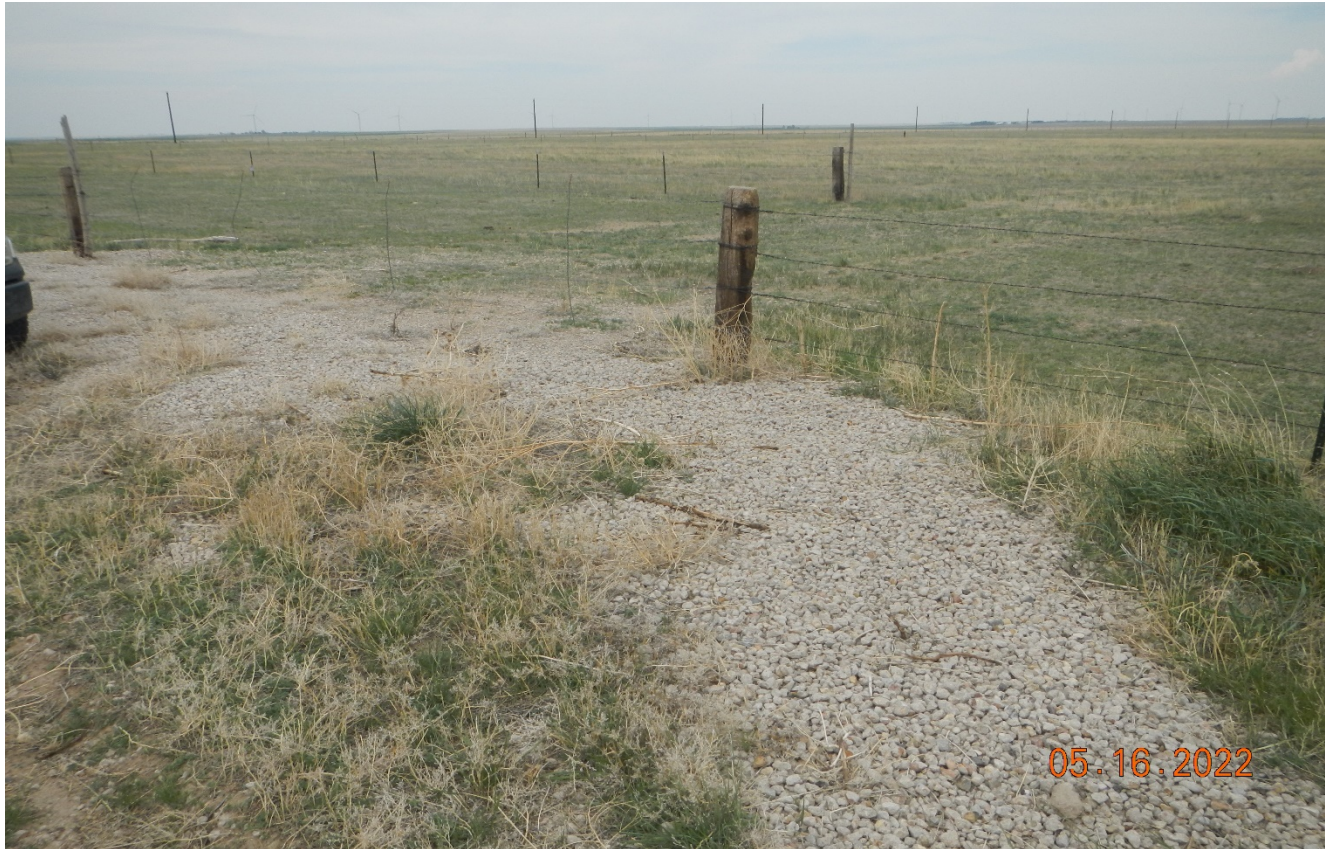
Photo 1. Facing toward the access point off of the County Road. There is gravel that remains that needs to be removed and regraded.

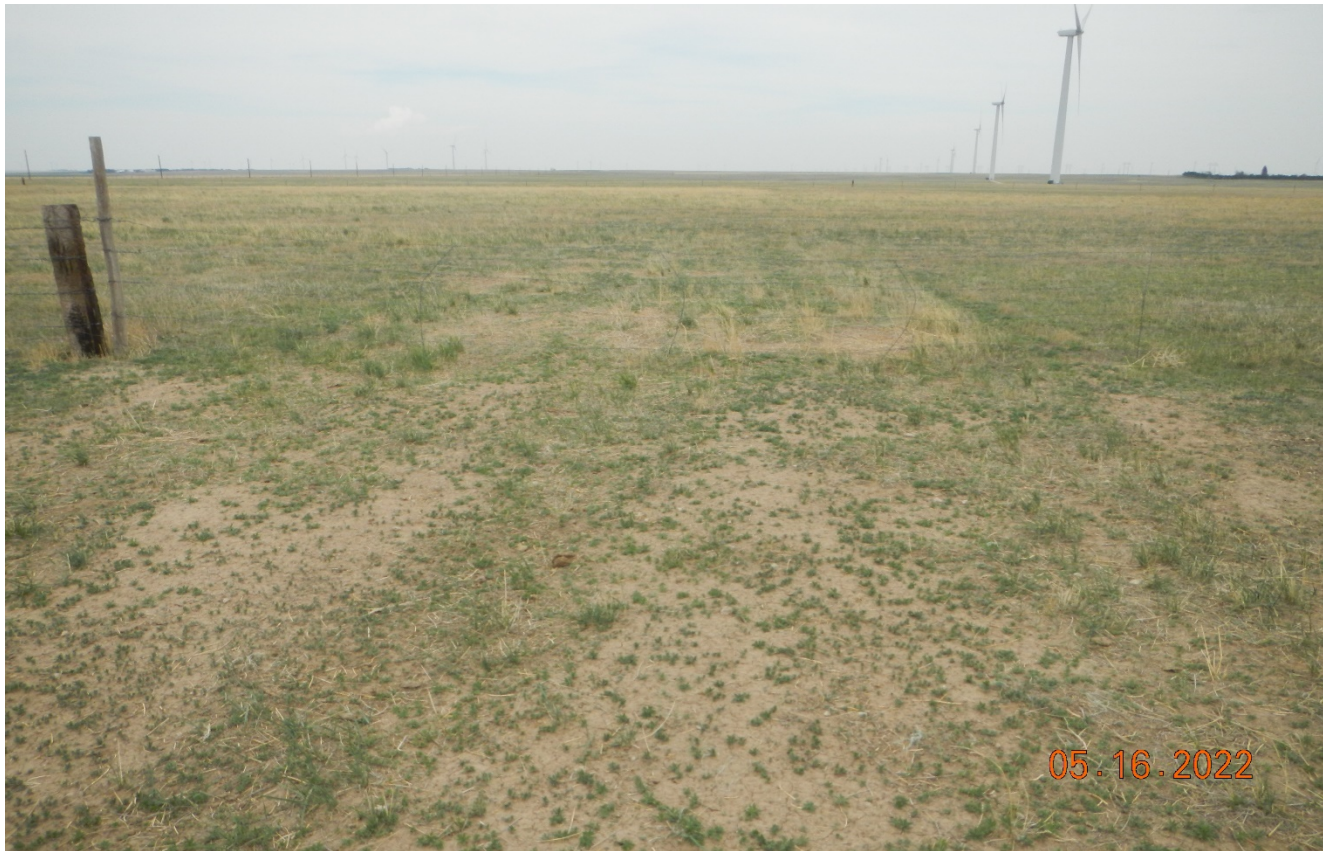
Photo 2. Facing east toward the fenced location.

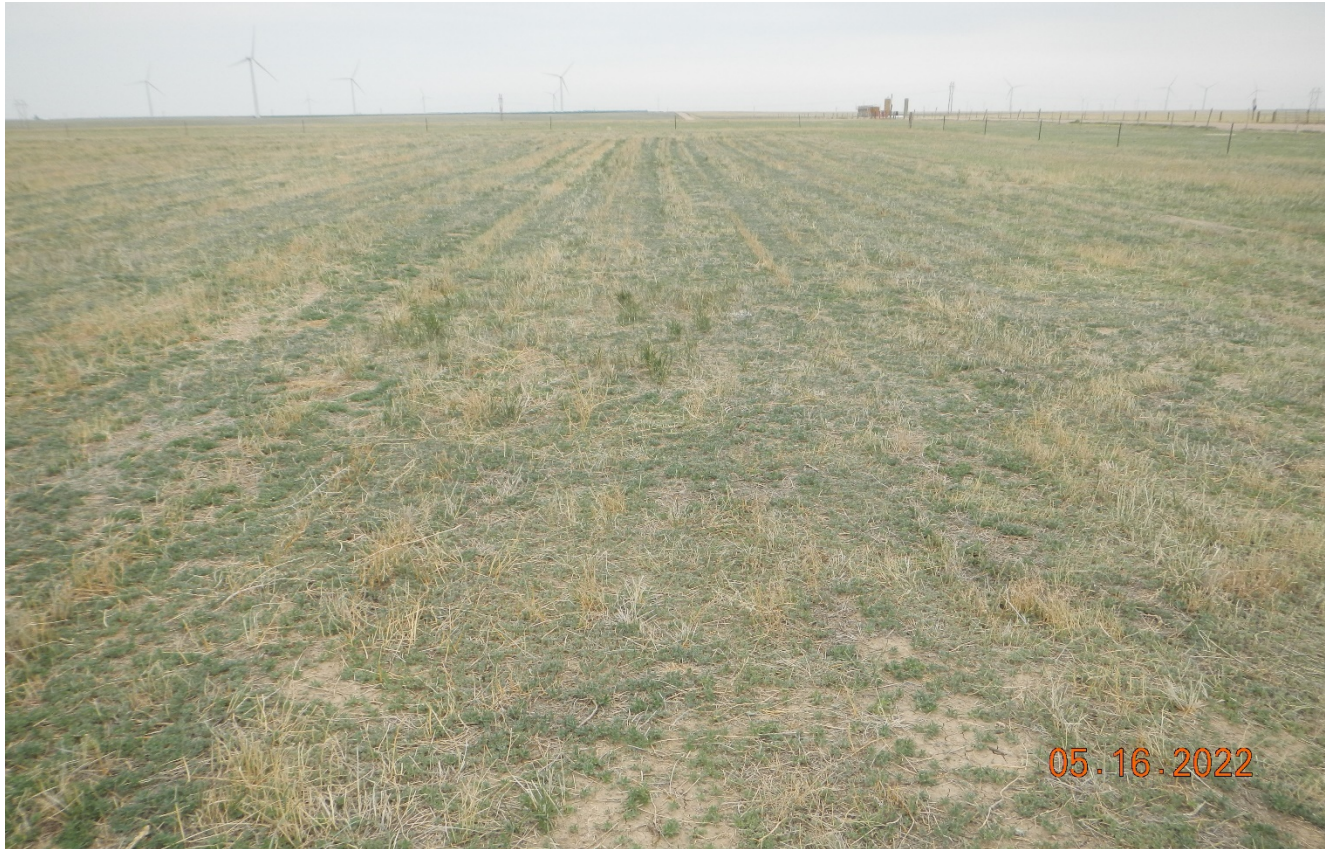
Photo 3. Facing south toward the southwest portion of the location. This area shown in the photo is mostly undesirable weeds (*Kochia* sp.). This area needs to be reseeded and weeds controlled.

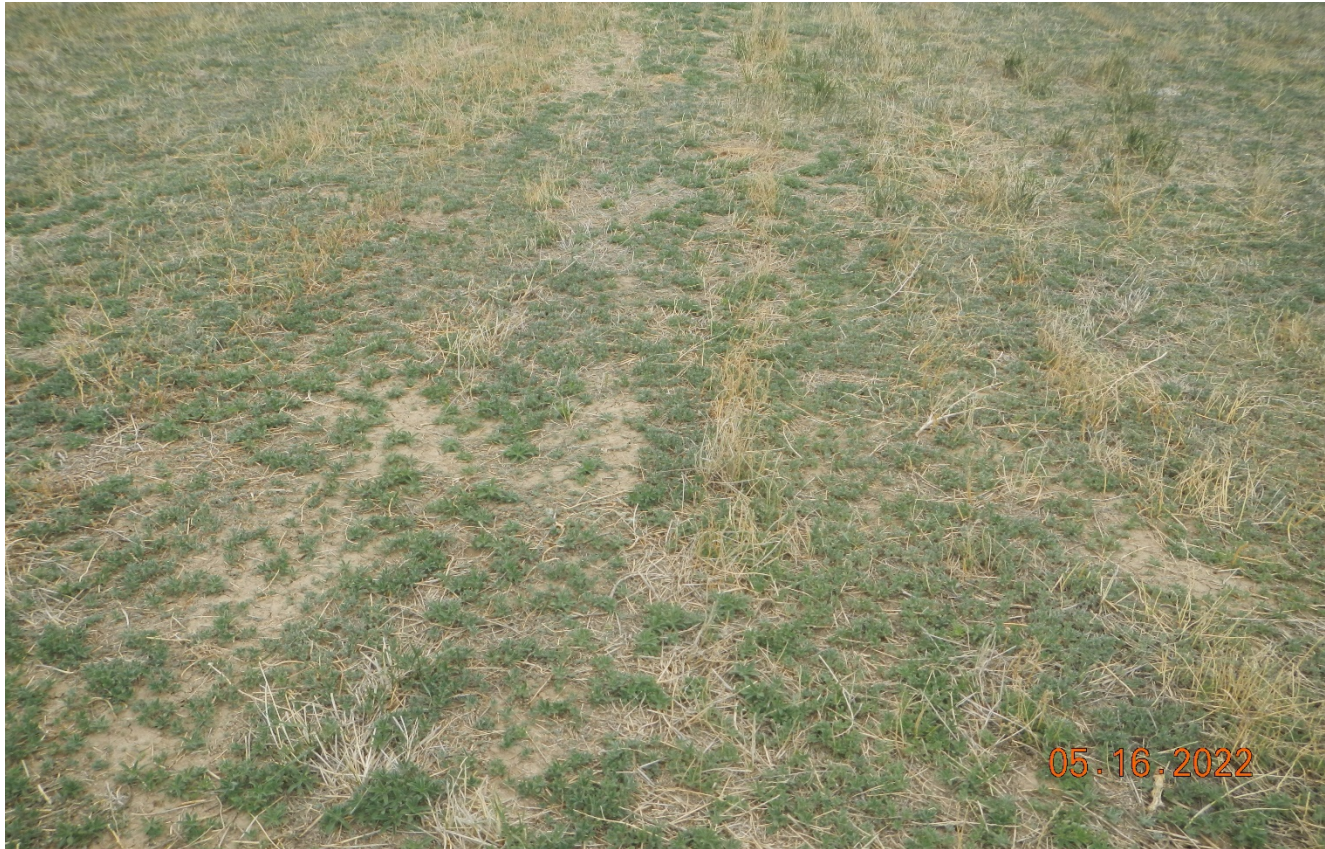
Photo 4. View of groundcover shows mostly undesirable weeds (*Kochia* sp.) observed in the southwest portion of the location.

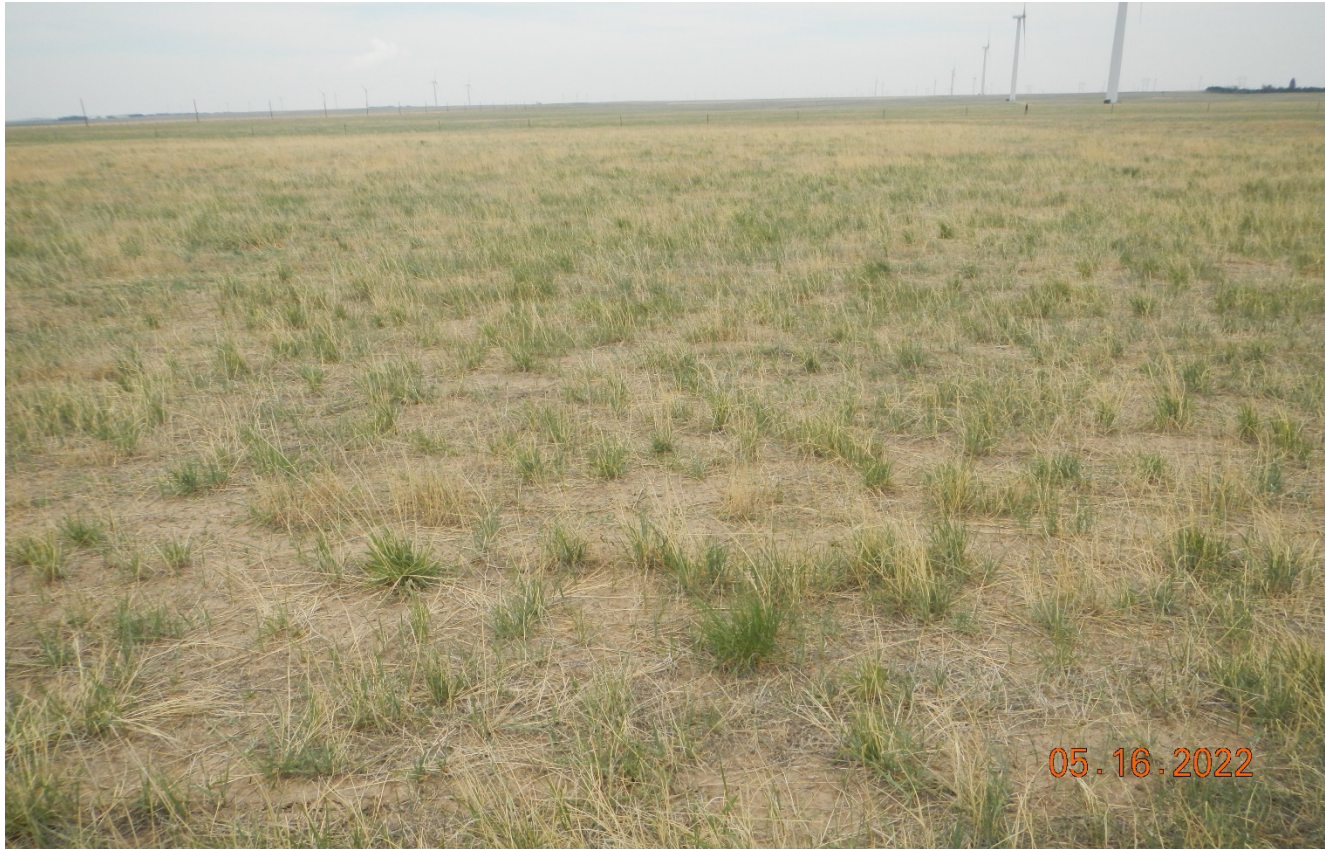
Photo 5. Center of the location facing north. The desirable vegetation appears to be progressing in other areas of the location but has not reached 80% cover..

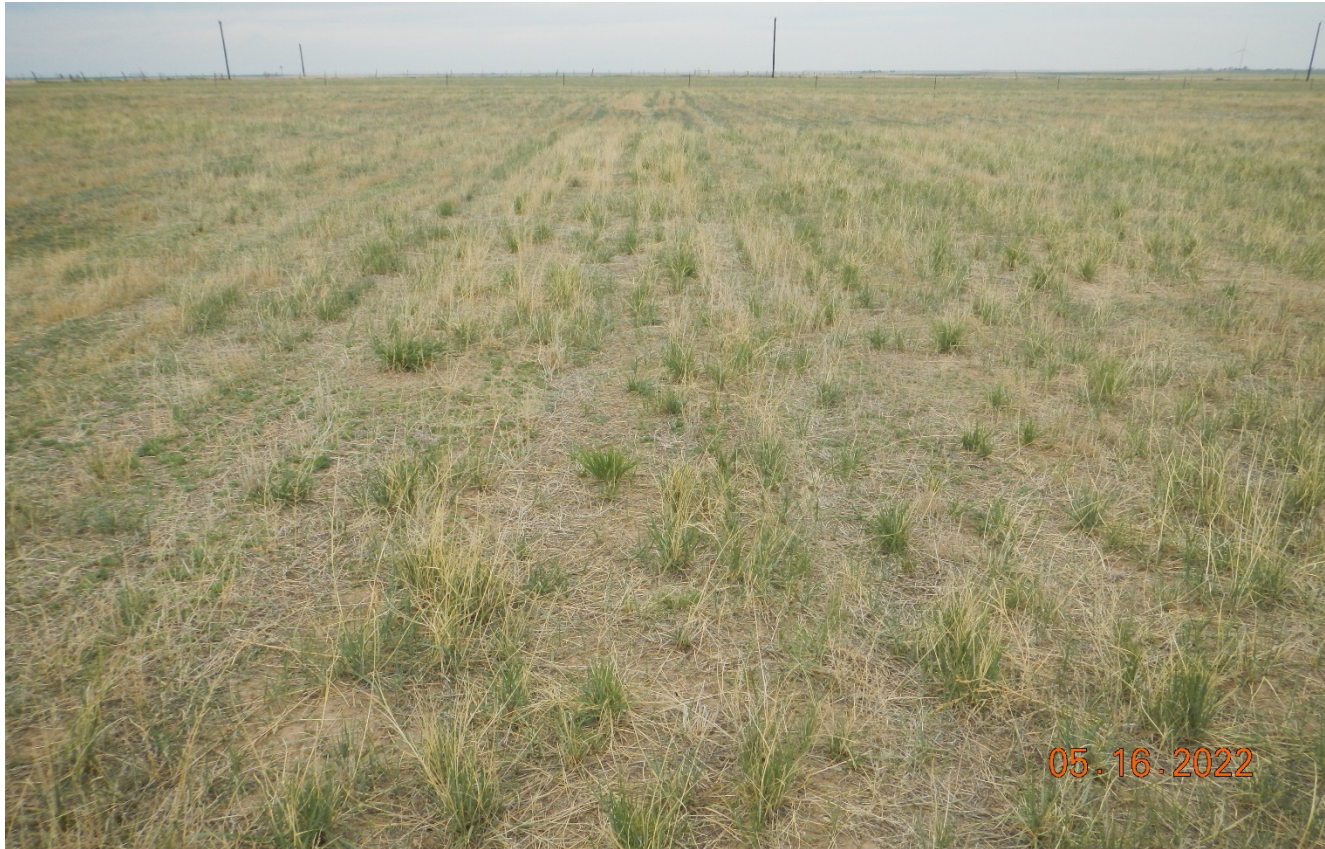
Photo 6. Center of the location facing west. The desirable vegetation appears to be progressing in other areas of the location but has not reached 80% cover..

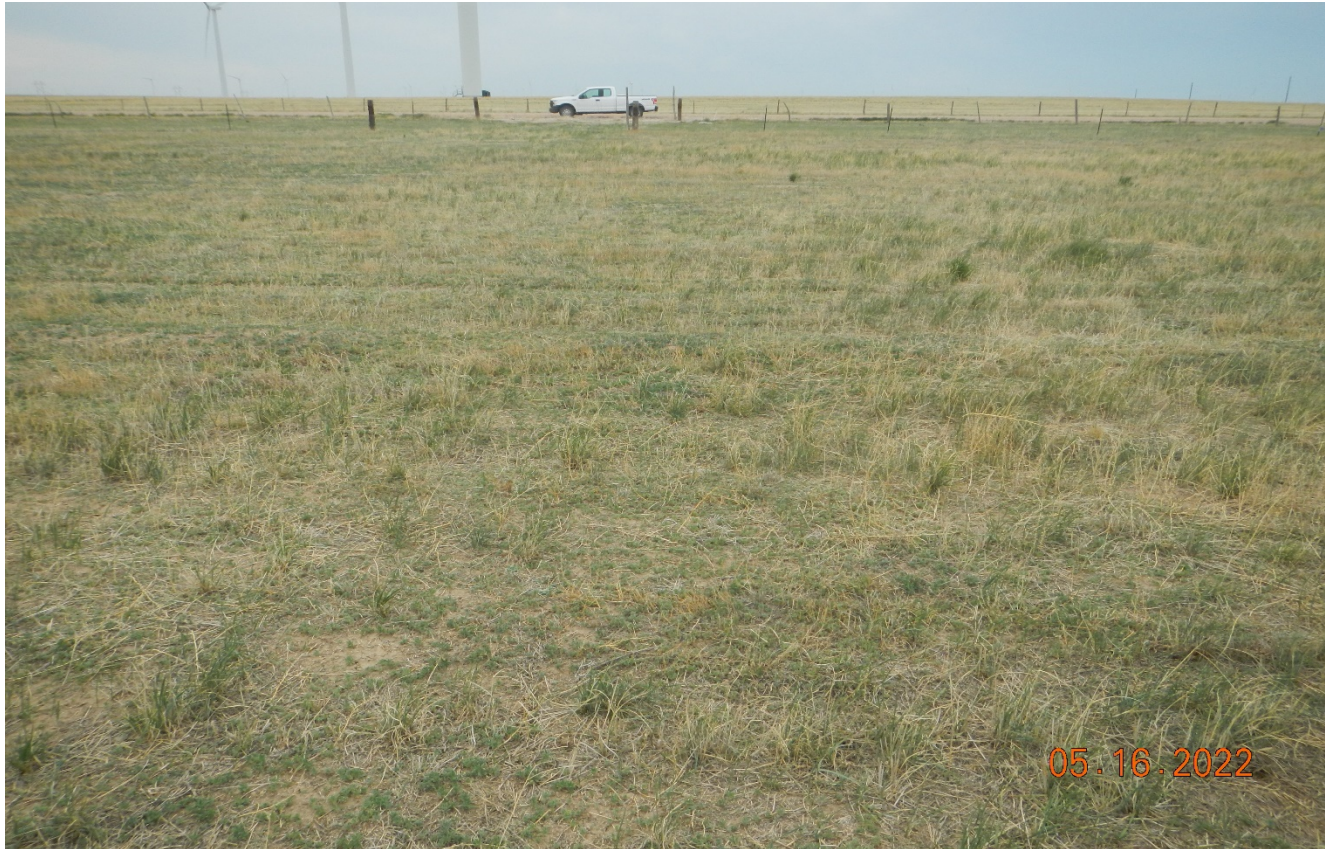
Photo 7. Center of the location facing south. The desirable vegetation appears to be progressing in other areas of the location but has not reached 80% cover..

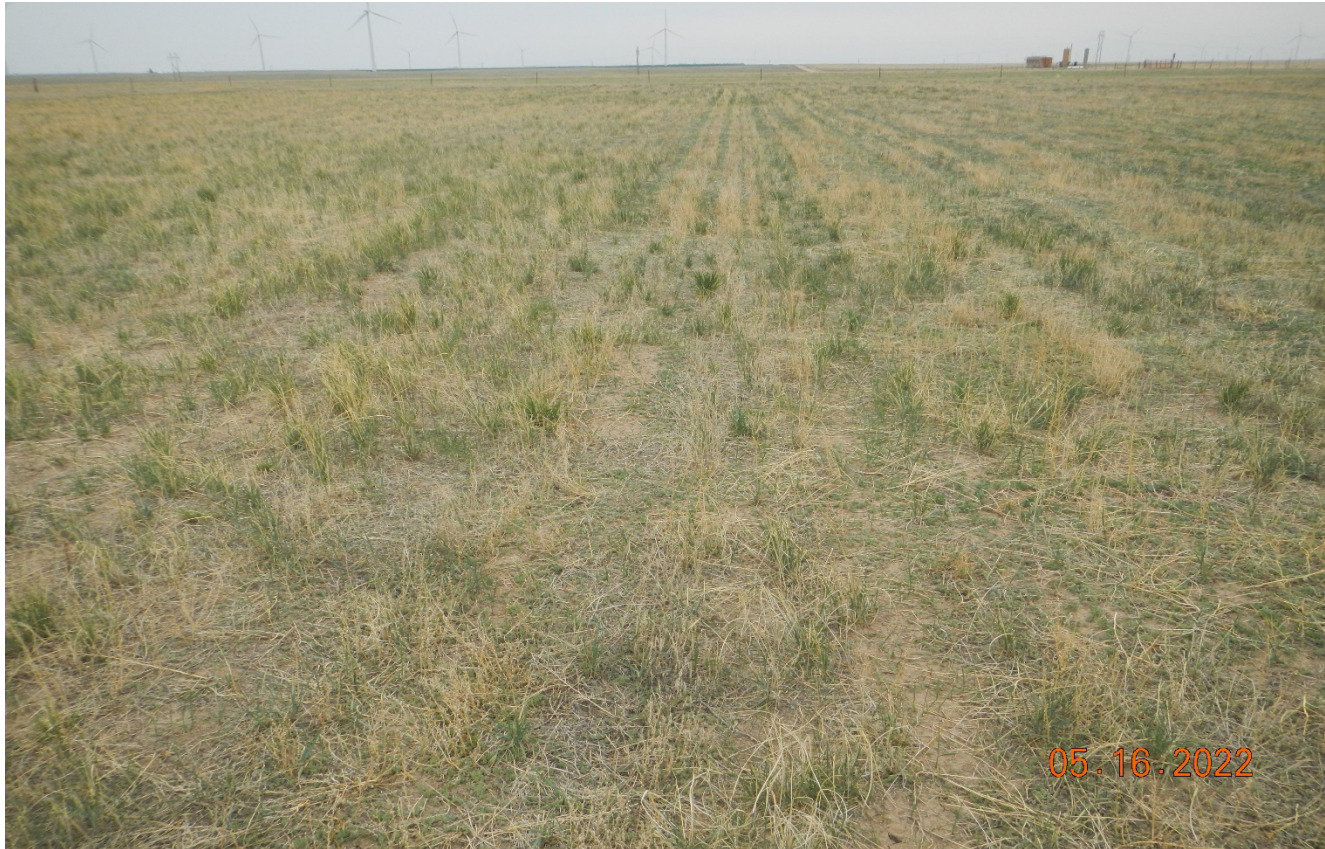
Photo 8. Center of the location facing east. The desirable vegetation appears to be progressing in other areas of the location but has not reached 80% cover..
