Final Reclamation Inspection

Operator: KERR MCGEE OIL & GAS ONSHORE LP #47120

Location ID: 329652

Inspection Photos
Location Name: CANNON RED W #3-12
Location ID: 329652

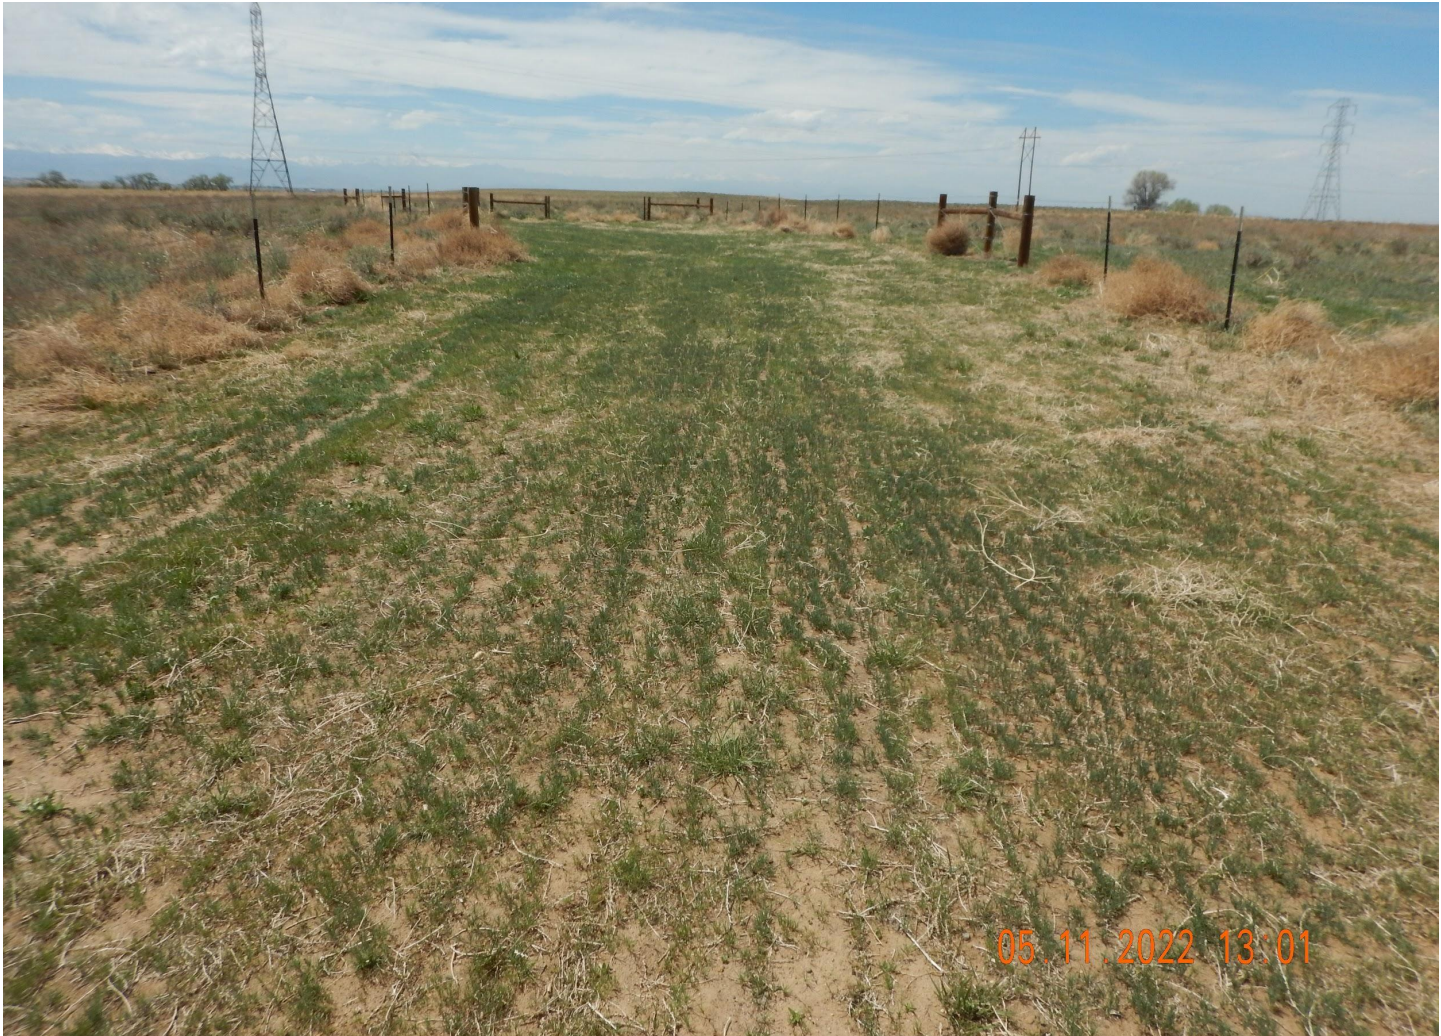
Photo 1. Photo taken from the eastern well location, facing West. Photo illustrates Operator has performed final reclamation activities; however, the entire location has established with mostly Russian thistle. The fence around the location appears to be catching Russian thistle which is then depositing its seeds onto location.

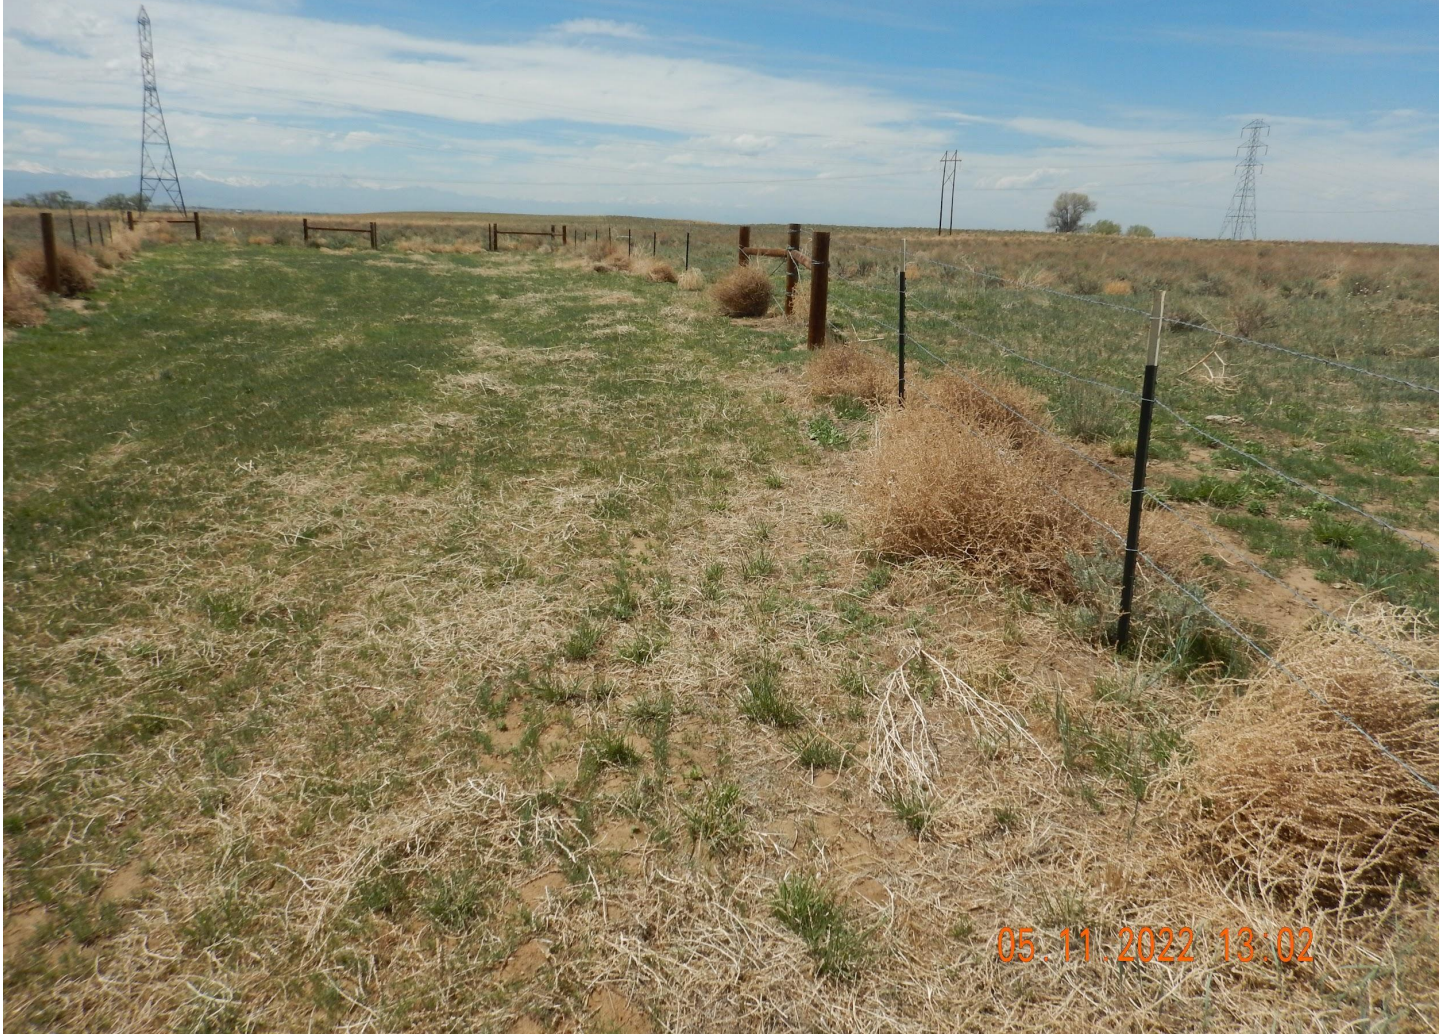
Photo 2. Photo taken from the central well location, facing West. See comments under Photo 1.

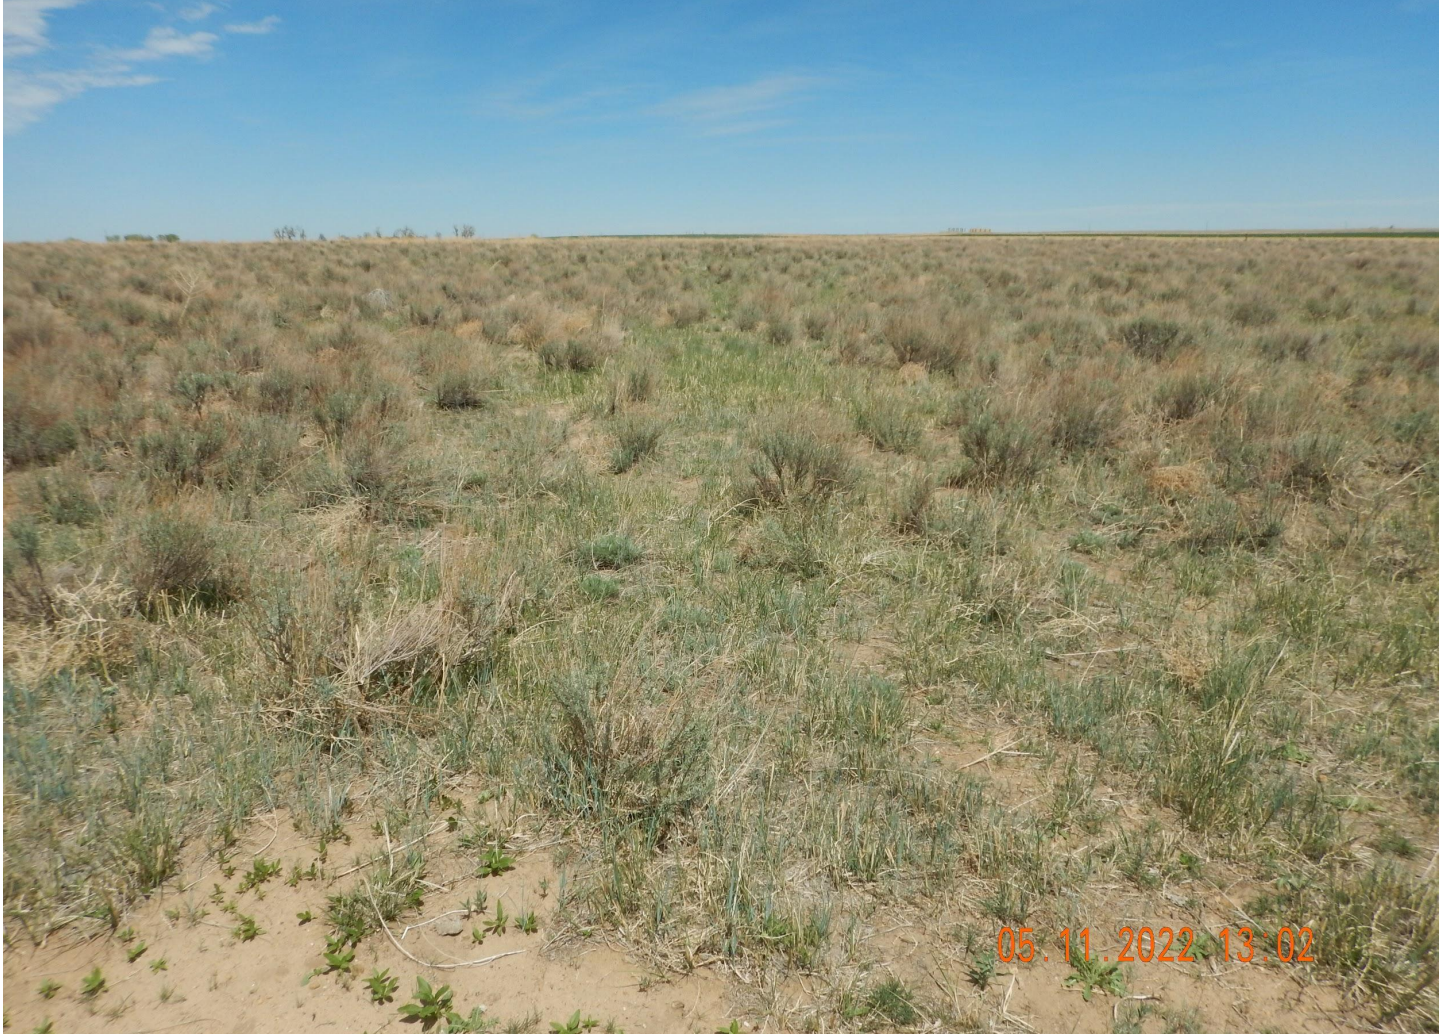
Photo 3. Reference photo taken from the well location, facing East. Photo illustrates sand sage and there is an understory of native grass species.

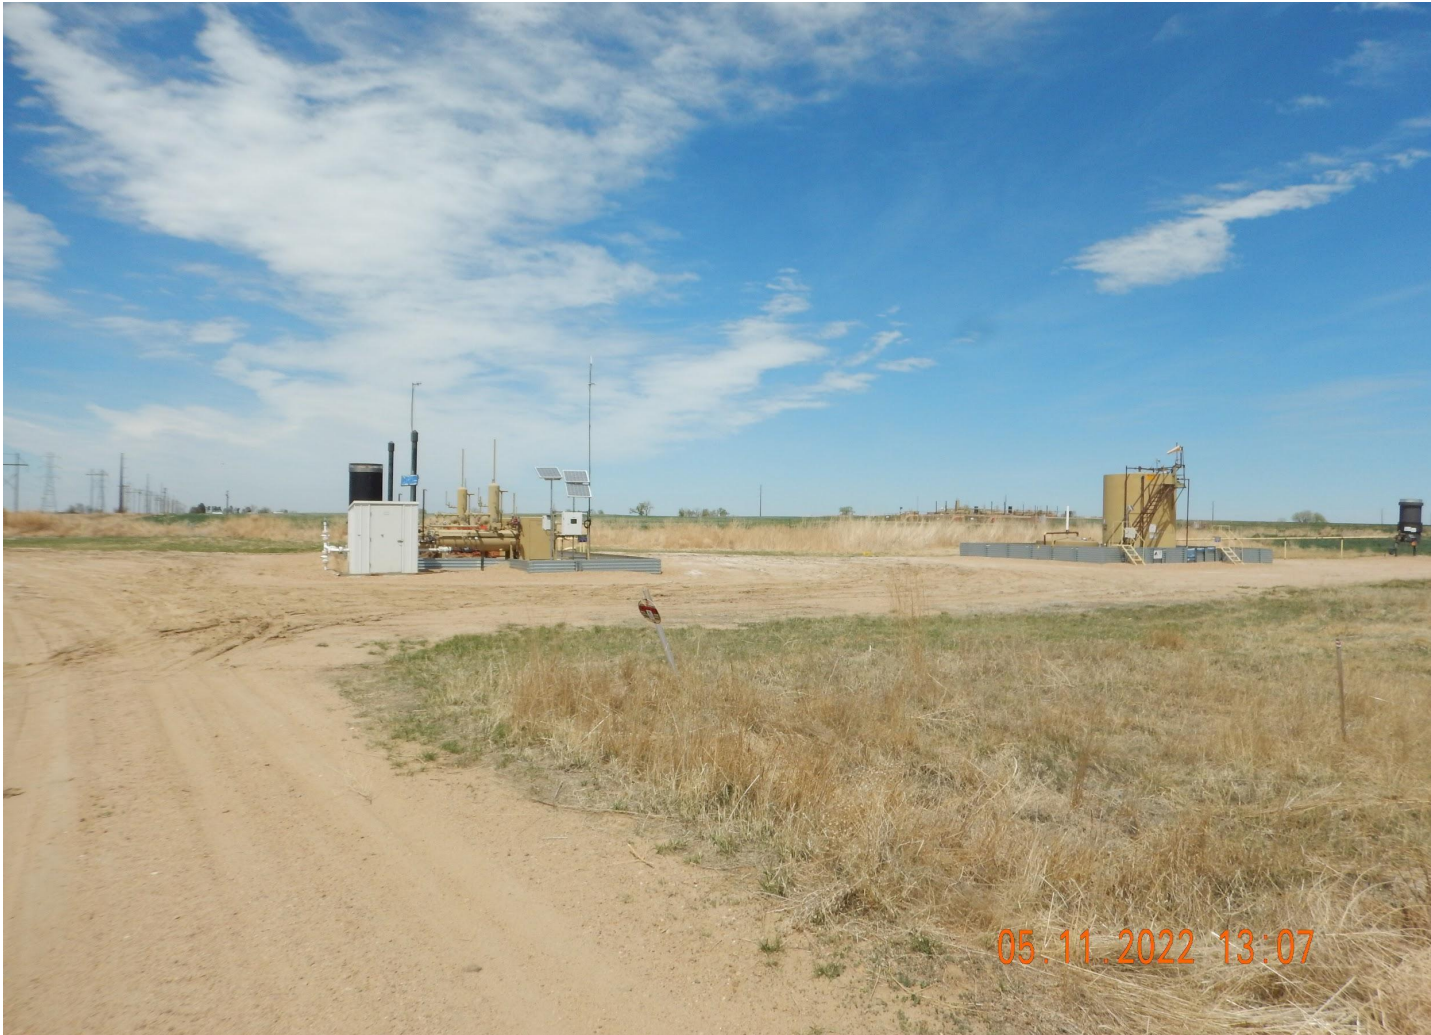
Photo 4. Photo taken from the associated offsite tank battery location, facing North. Photo illustrates the tank battery is still active for other nearby wells.
