# Inspection Photos

Location ID: 428570

Location Name: Simoes /31-30

Inspection Document #: 702800234

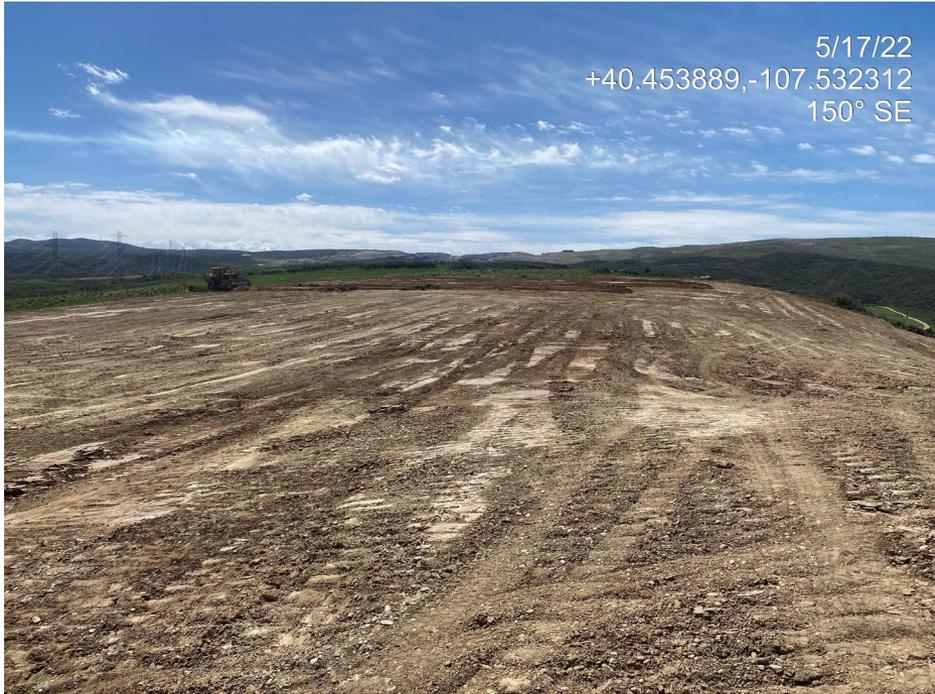
**Photo 1.** Photo taken from the north of the Location shows an overview of the Location. Final reclamation activities have been initiated. A dozer can be seen in the background replacing topsoil before decompacting the Location.

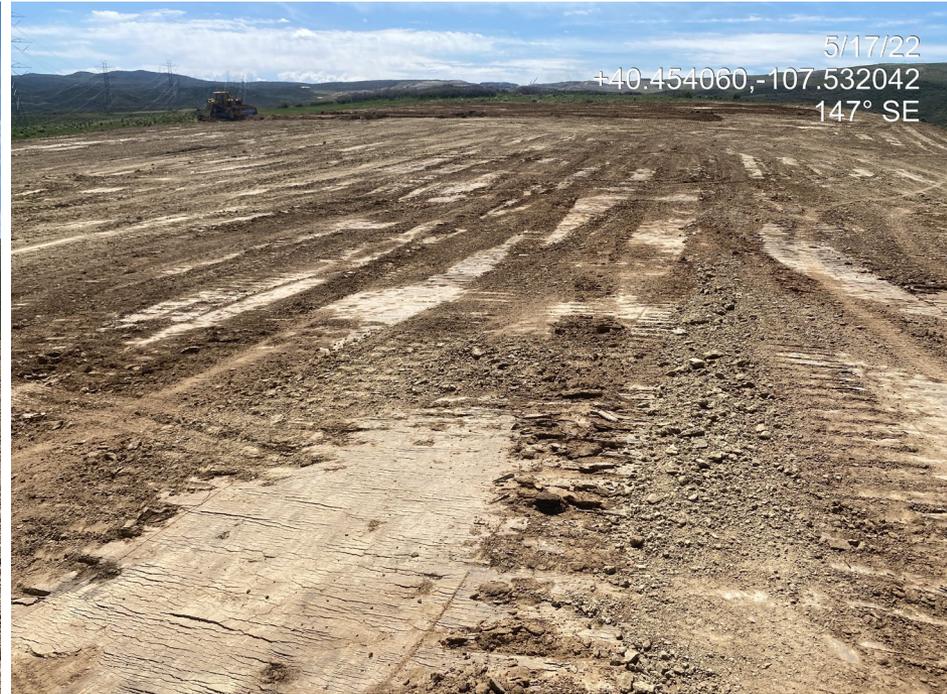
**Photo 2.** Refer to Photo 1 comment.

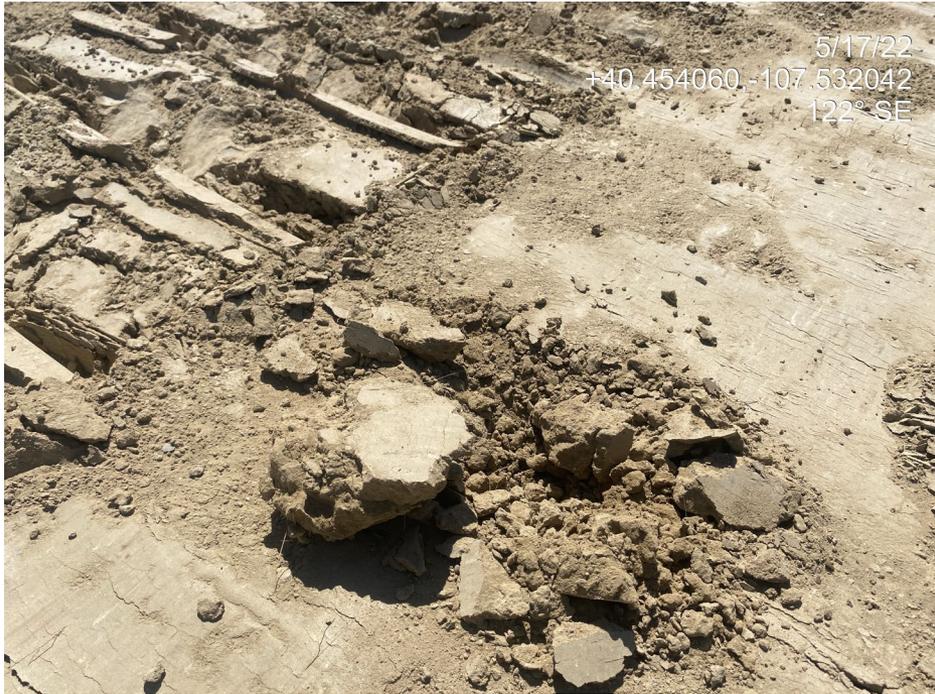
**Photo 3.** Photo taken from the north of the Location shows highly compacted soils which were very difficult to penetrate with a shovel. Decompanction had not been performed.

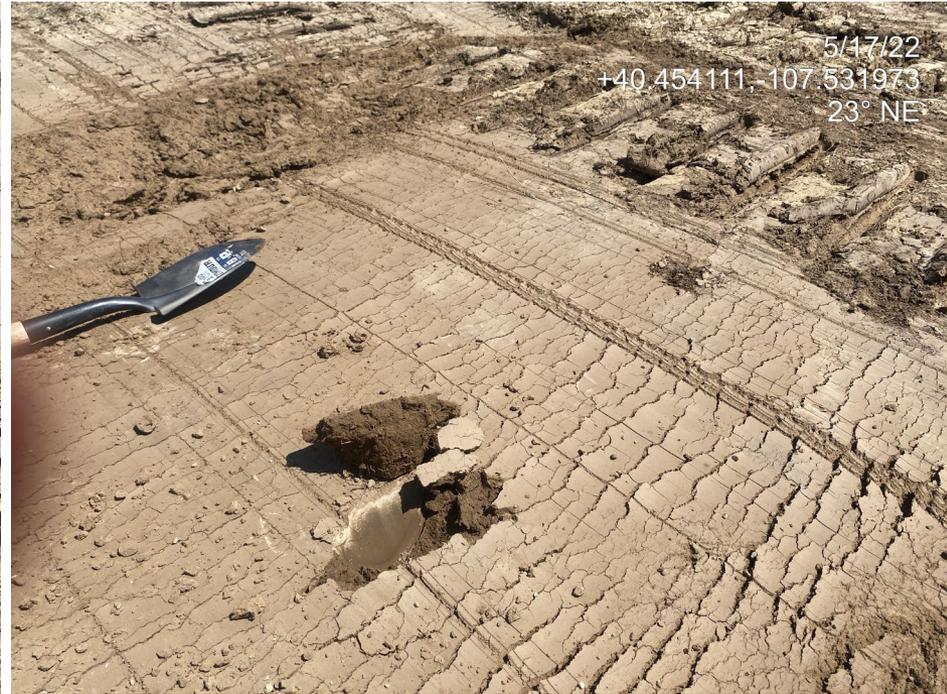
**Photo 4.** Refer to Photo 3 comment.
