# Inspection Photos and Issue Report

5/24/2022

Operator: XOG OPERATING LLC - 10144

Location ID: 312540

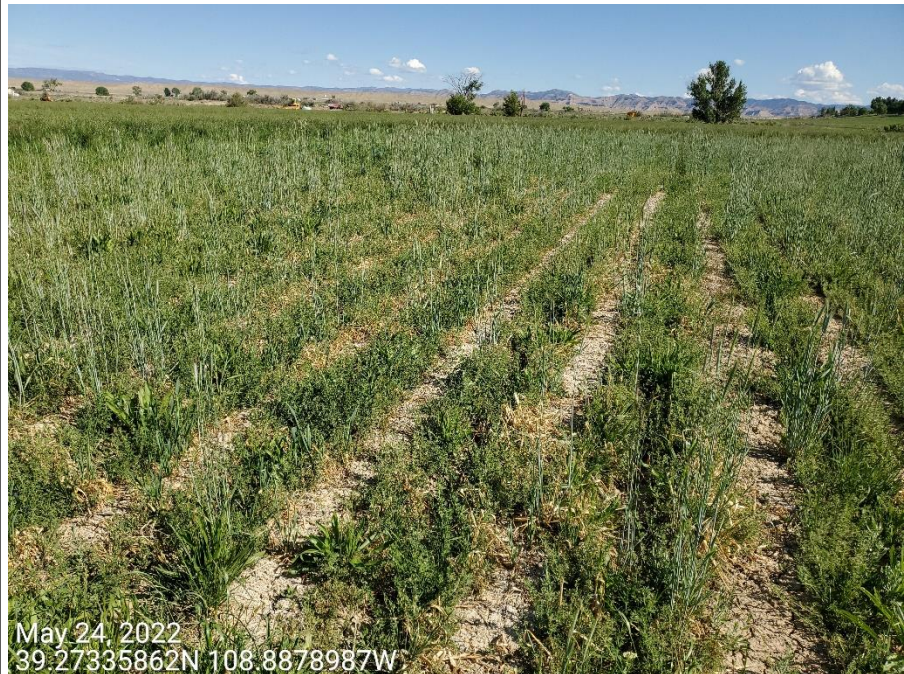
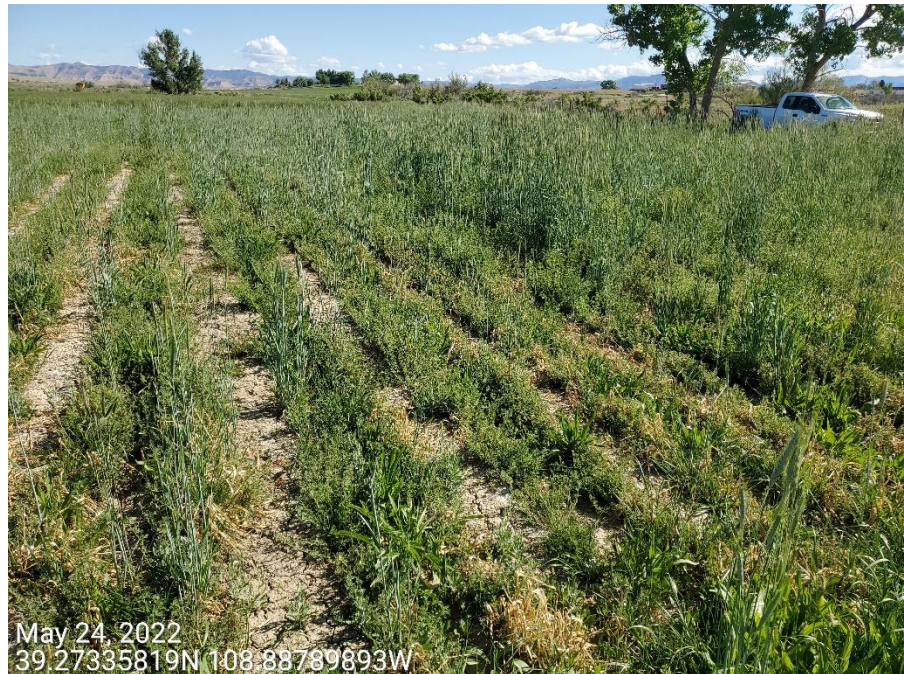
**Photo 1:** Photos taken from the south end of the Location, facing north. Photos provide overview of the reclamation area. Adjacent reference perennial cropland appears to be predominantly orchard grass. Species observed within the reclamation area not reflective of the adjacent reference.

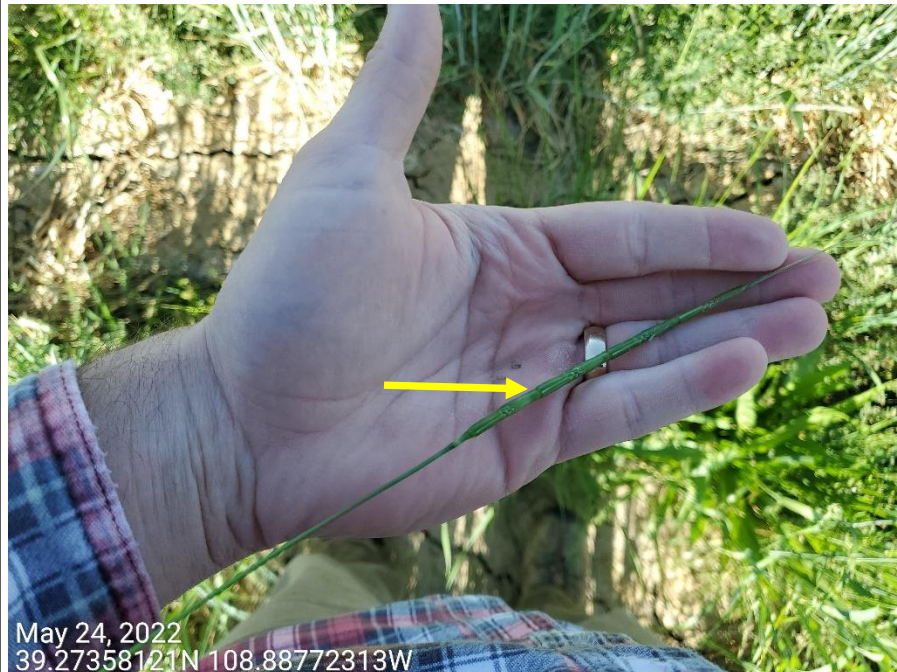
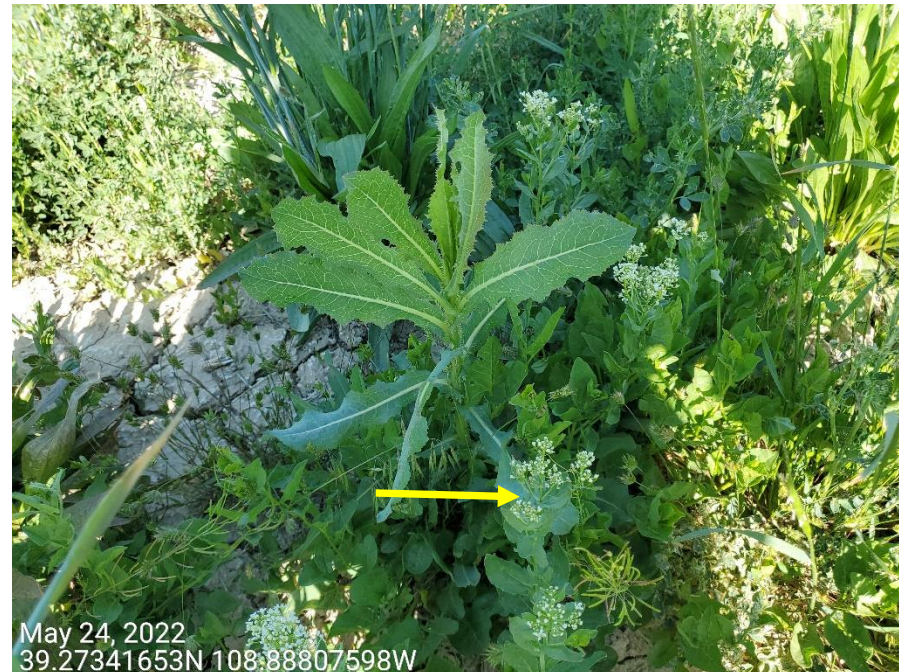
**Photo 2:** Photo shows examples of noxious weeds (Jointed goatgrass, Hoary cress) observed on the Location. Bindweed also observed on the Location.
