Inspection Photos

Location Name: McLin A Pad

Inspection Document #: 702800284

Anna O'Malley
Reclamation Specialist, COGCC

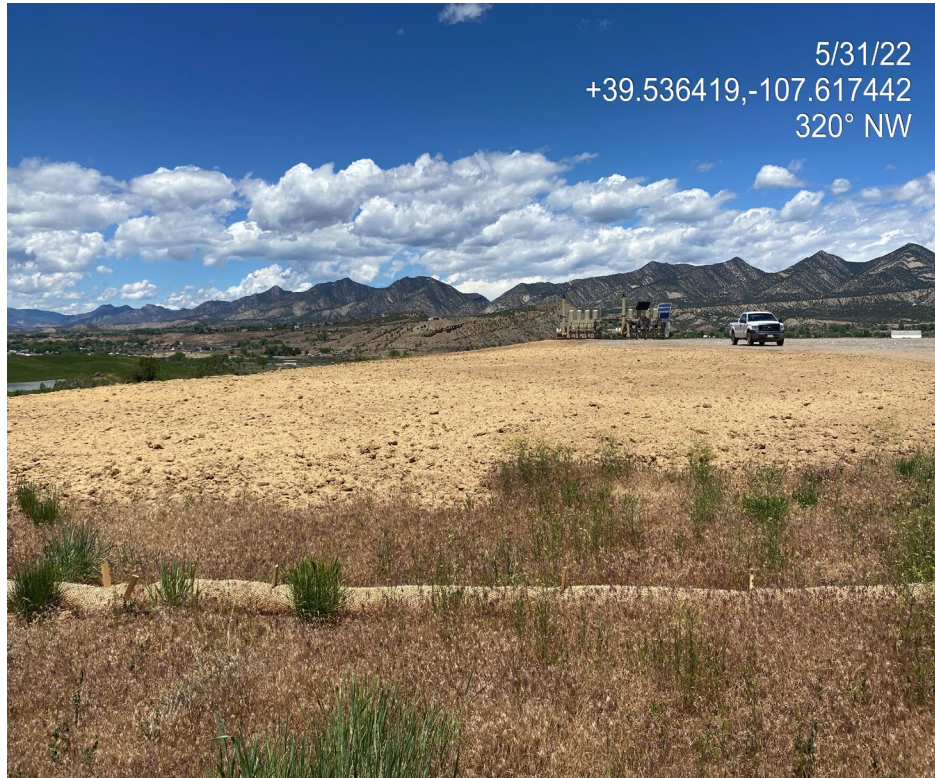
Photo 1. Photo taken from the west of the Location shows the recent interim reclamation and a perimeter stormwater control. Note the dense cover of cheatgrass in the foreground.

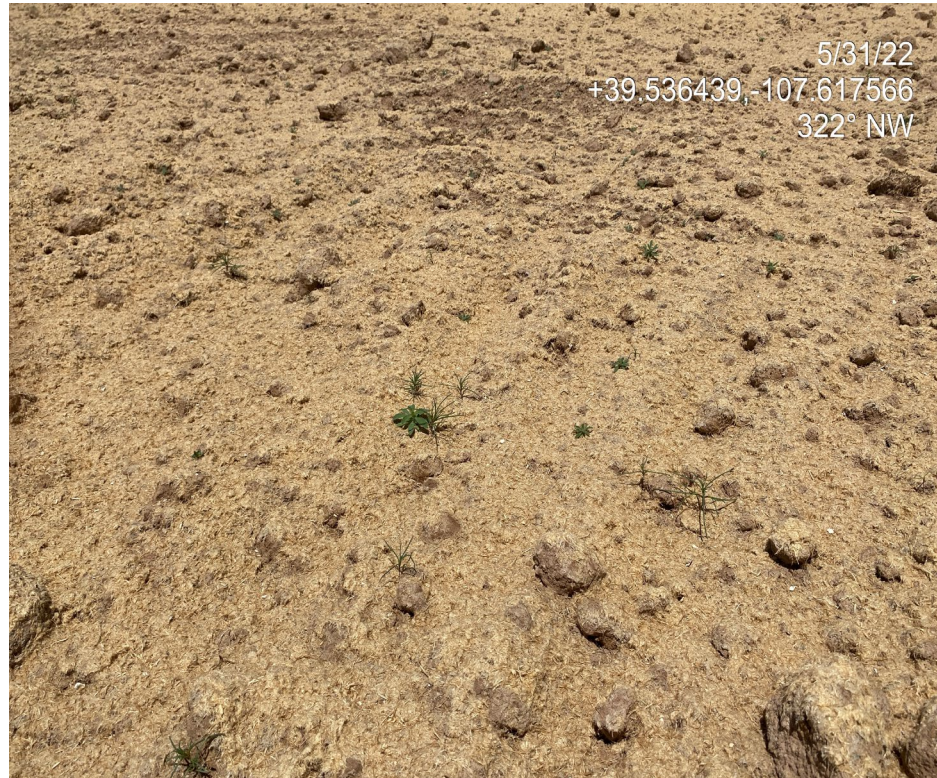
Photo 2. Photo taken from the west of the Location shows the recent interim reclamation. Only kochia and Russian thistle (undesirable plant species) were observed germinating.

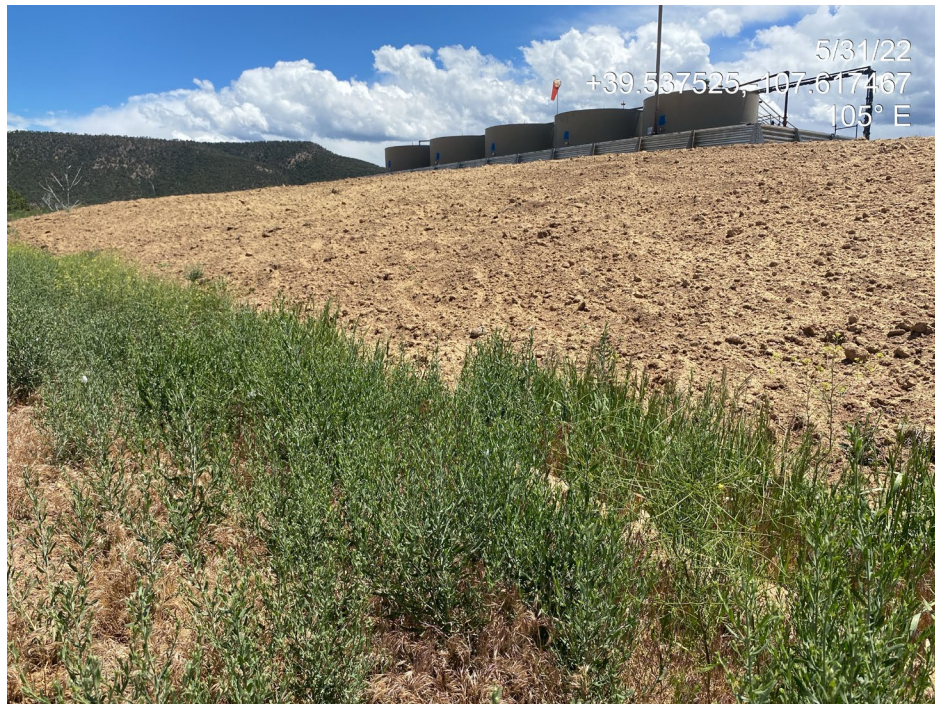
Photo 3. Photo taken from the north of the Location shows the recent interim reclamation and a patch of the CO State List B Noxious Weed Russian knapweed in the foreground.

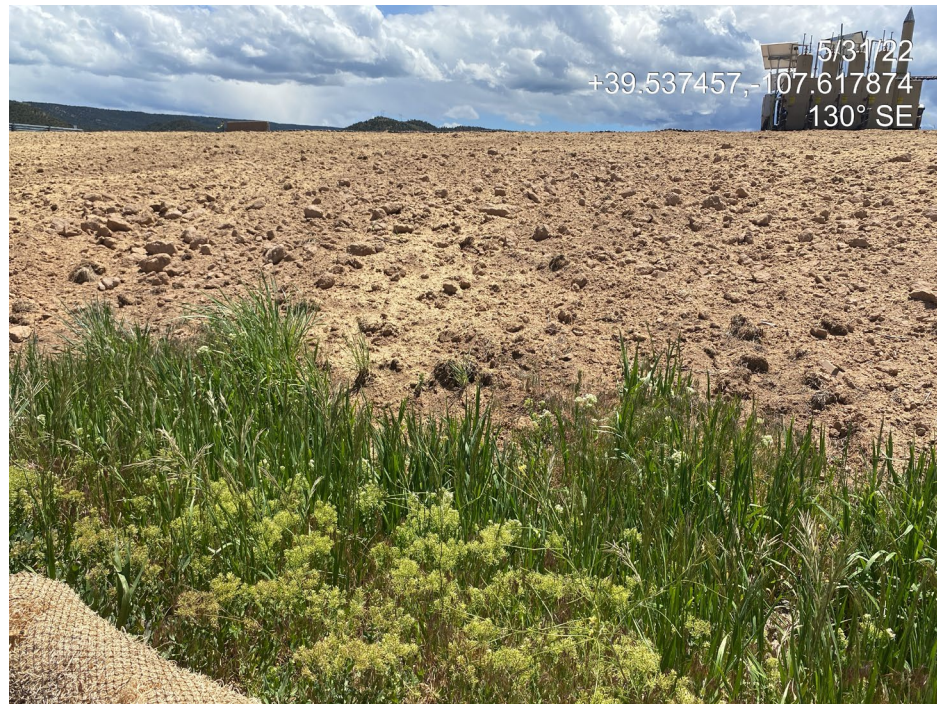
Photo 4. Photo taken from the north of the Location shows the recent interim reclamation and a patch of the CO State List B Noxious Weed whitetop in the foreground.

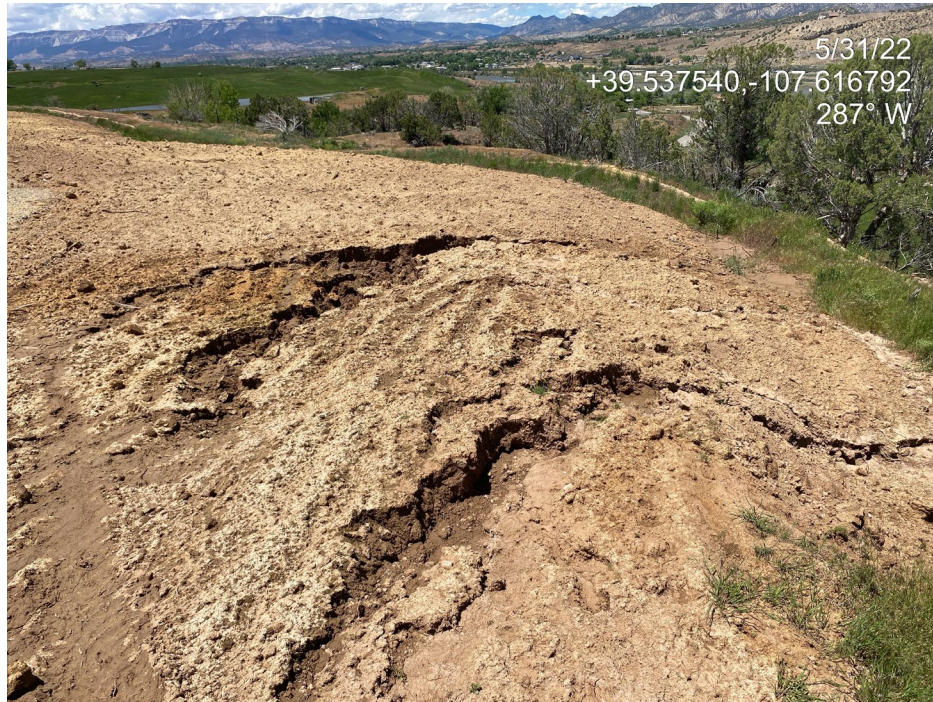
Photo 5. Photo taken from the northeast of the Location shows rill and gully erosion occurring in the interim area.

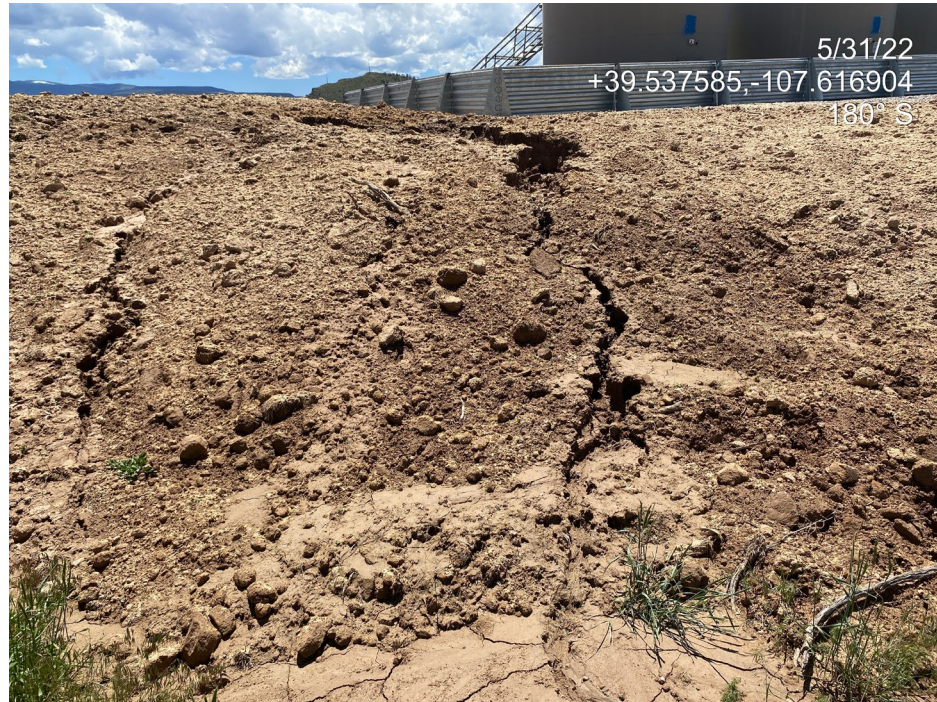
Photo 6. Photo taken from the northeast of the Location shows rill and gully erosion occurring in the interim area.

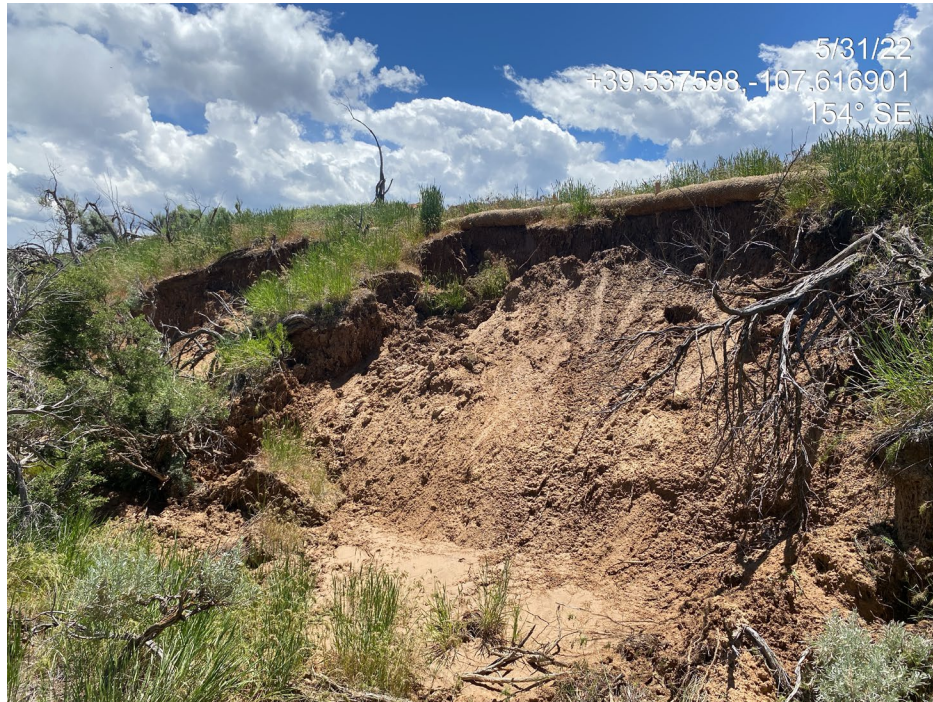
Photo 7. Photo taken from the northeast of the Location shows slumping that has occurred on the fill slope, below the interim area with rill and gully erosion.

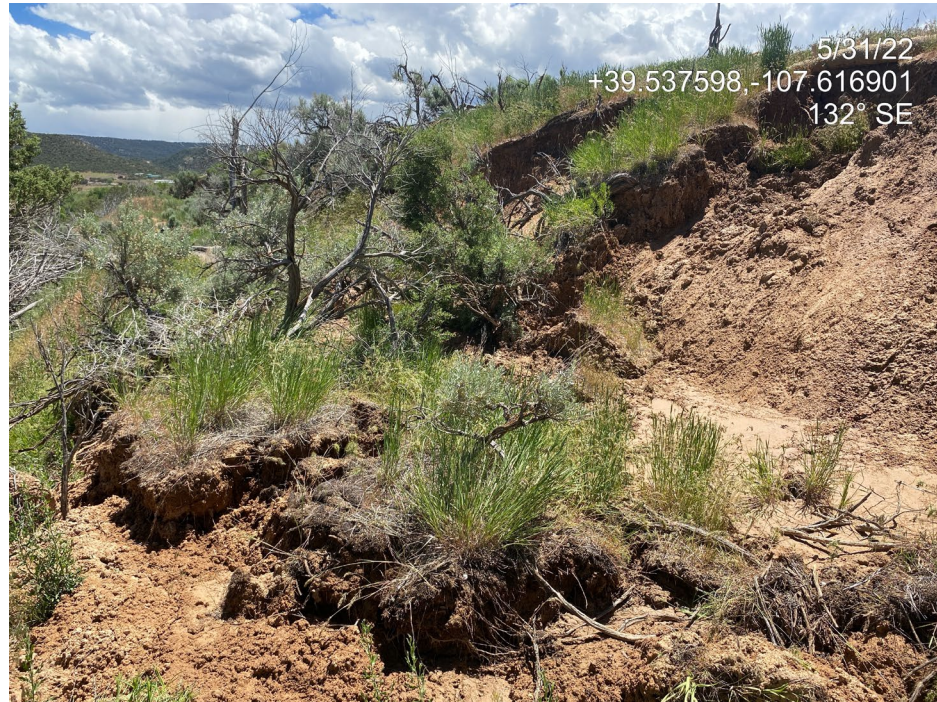
Photo 8. Refer to Photo 7 comment.

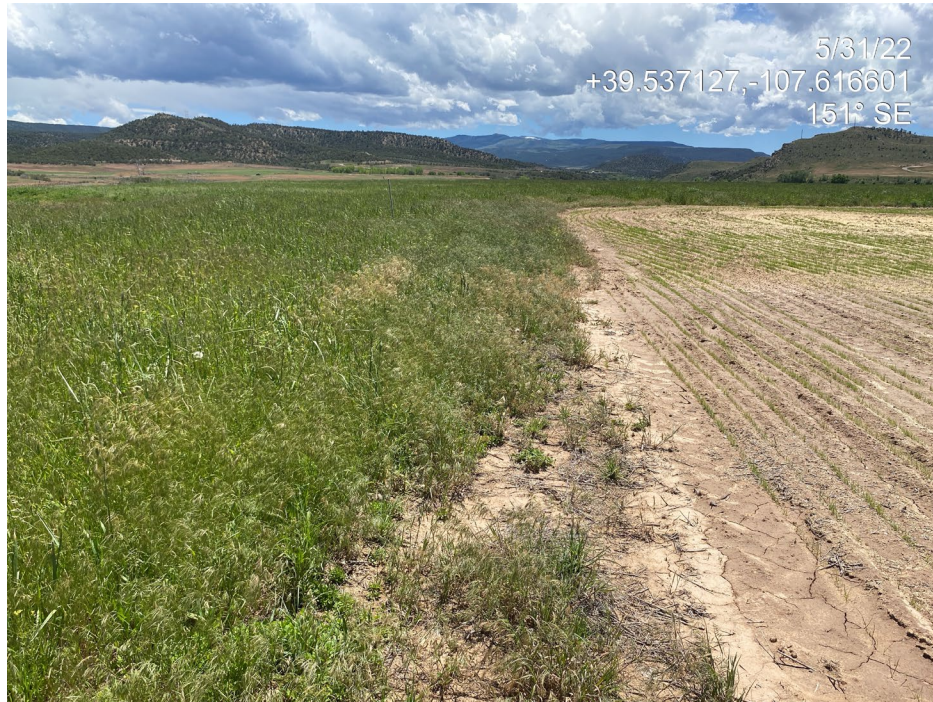
Photo 9. Photo taken from the east of the Location shows the adjacent reference hay field (left) consists of orchard grass and sanfoin, and grass germination in the interim area (right).

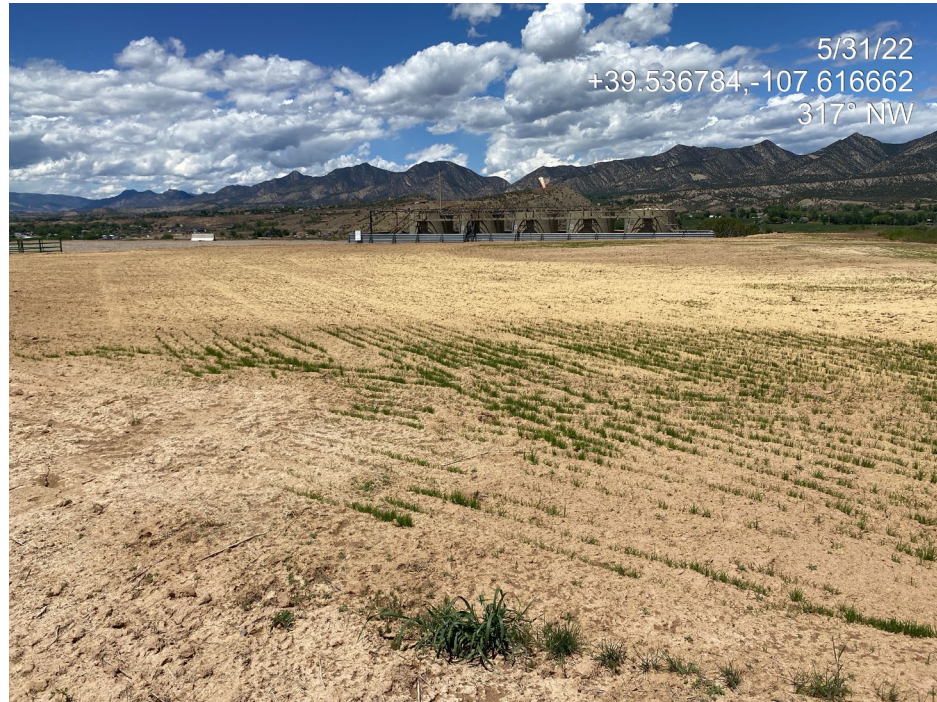
Photo 10. Photo taken from the east of the Location shows grass germination in the interim area.
