Inspection Photos and Issue Report

6/07/2022

Operator: GORDON ENGINEERING INC

Location ID: 334074

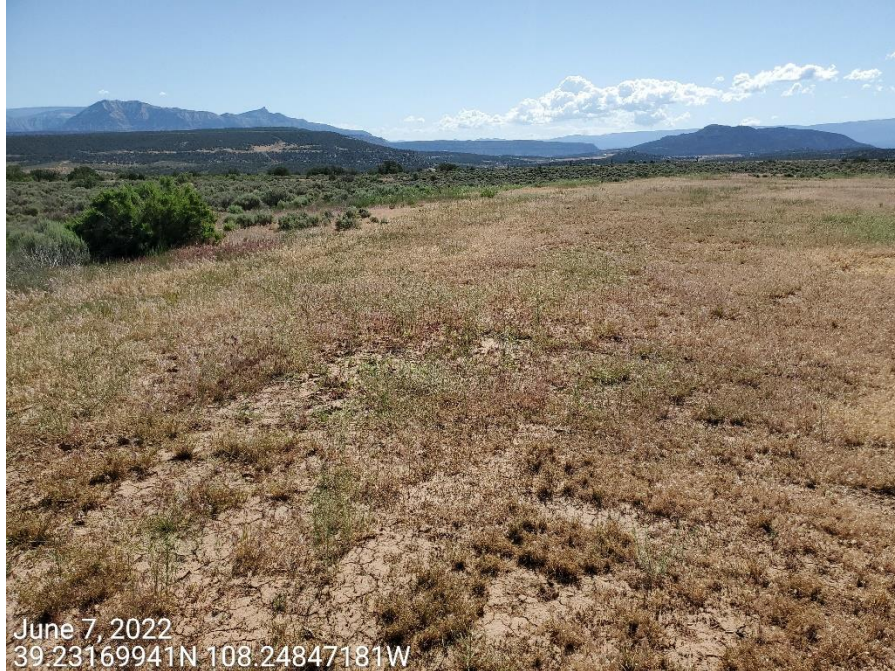
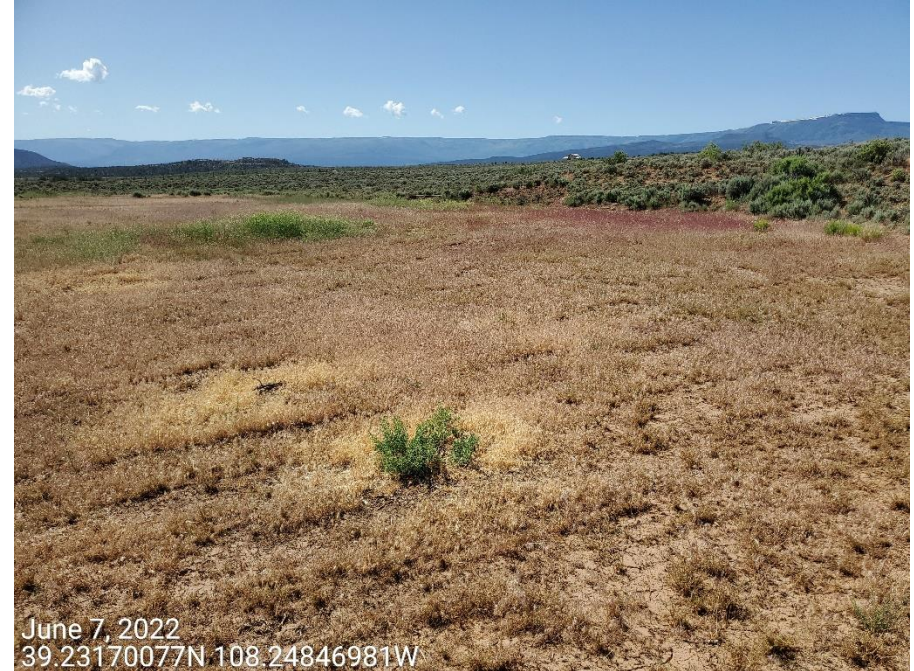
Photo 1: Photos taken from the west end of the Location, facing northeast and east. Photo provides overview of the Location. Operator appears to have conducted revegetation activities; however work including, but not limited to, compaction alleviation (cross ripping to a minimum depth of 18 inches), recontouring and regrading of the Location/access road has not been performed in accordance with 1004 reclamation requirements. Vegetation observed in photo is predominantly undesirable and noxious plant species monoculture, such as cheat grass.

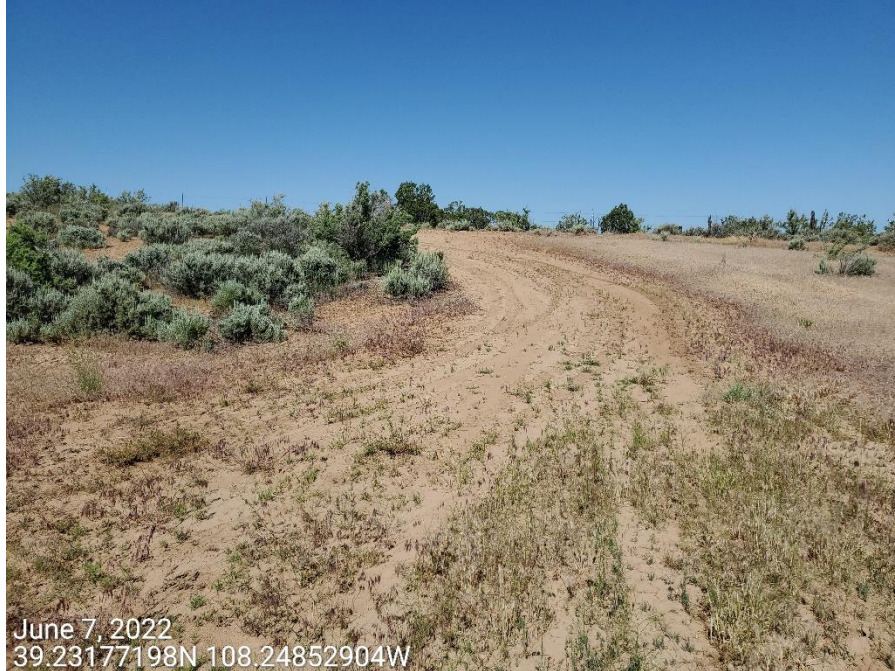
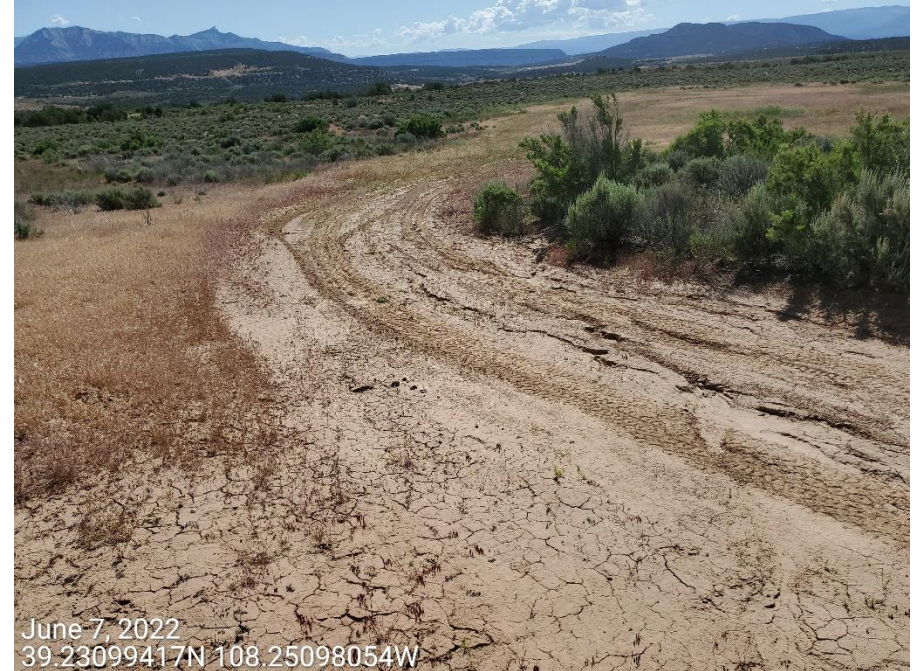
Photo 2: Photos show access road leading to Location has not been reclaimed.

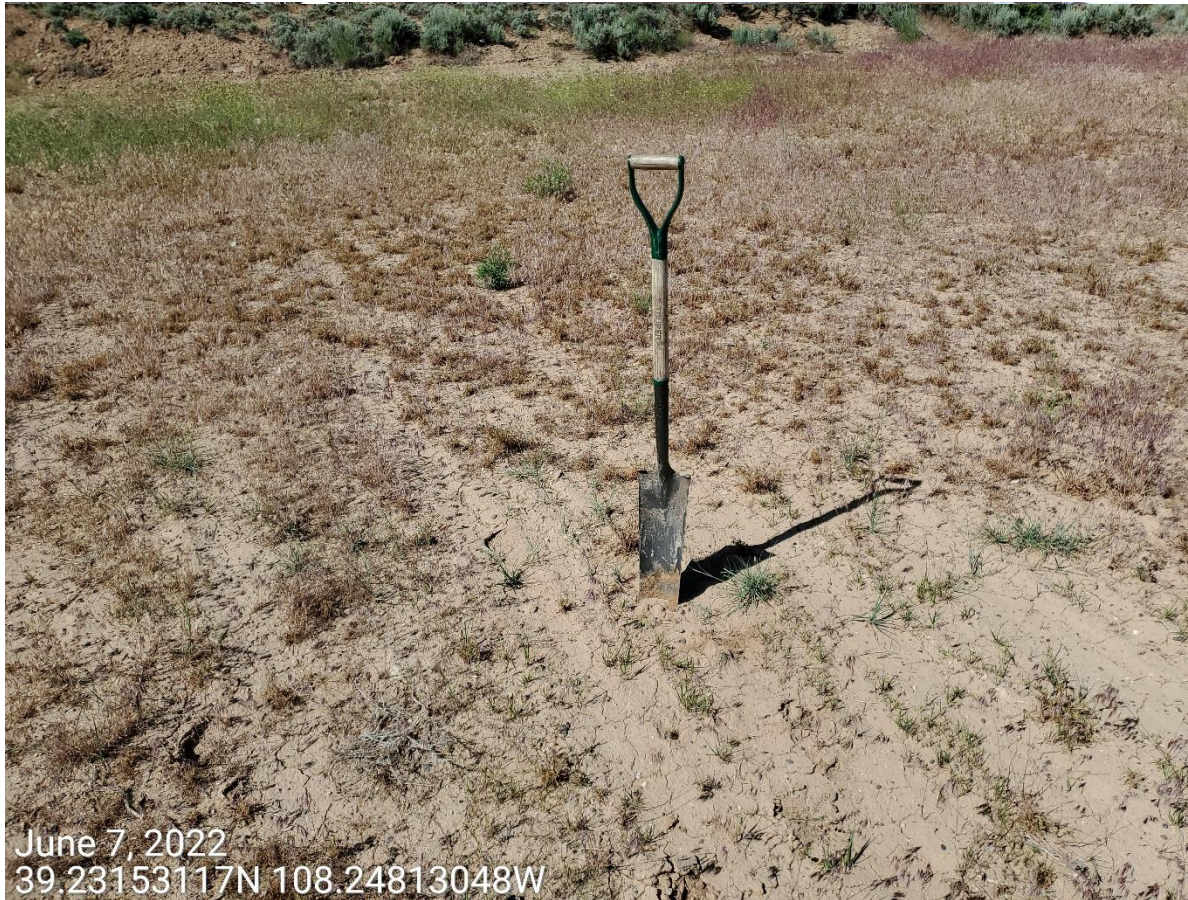
Photo 3: Photo shows compaction issues are evident; Location has not been decompacted.

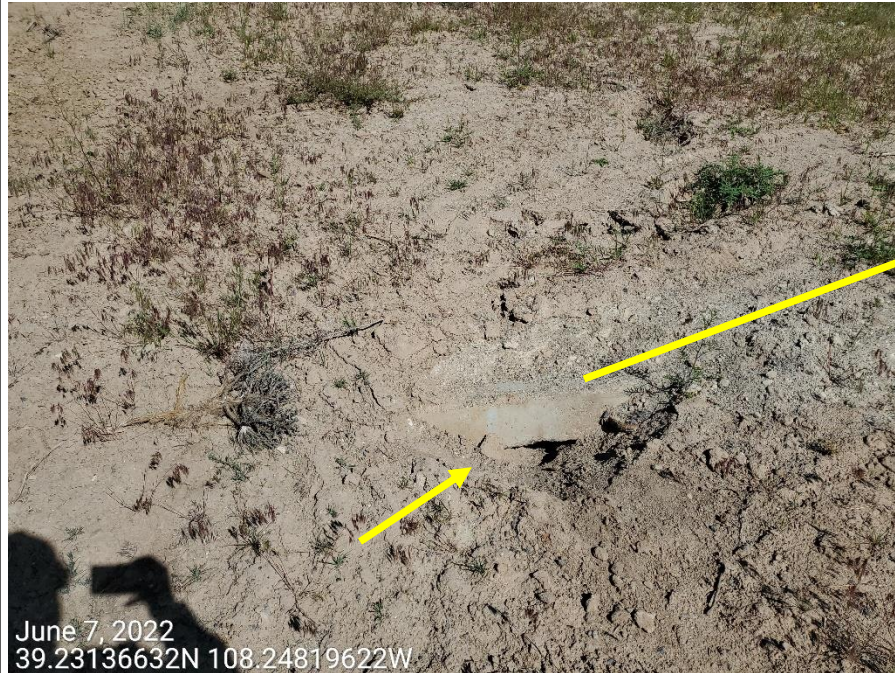
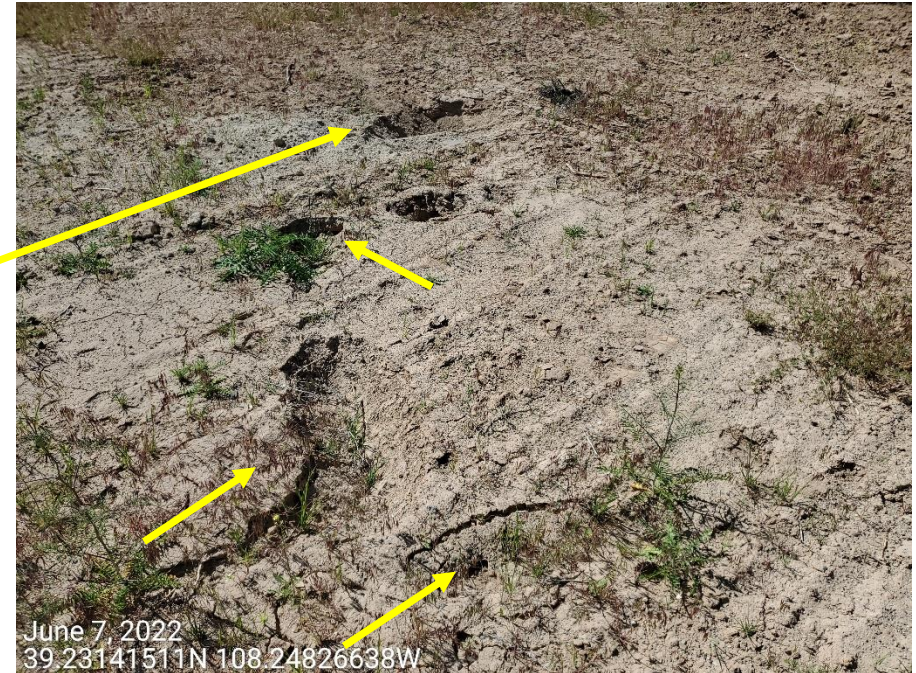
Photo 4: Photos taken from the south end of the Location. Photo shows buried non-E&P waste material has not been removed and properly disposed. Photo also show subsidence concerns within the immediate area, likely related to the buried material.

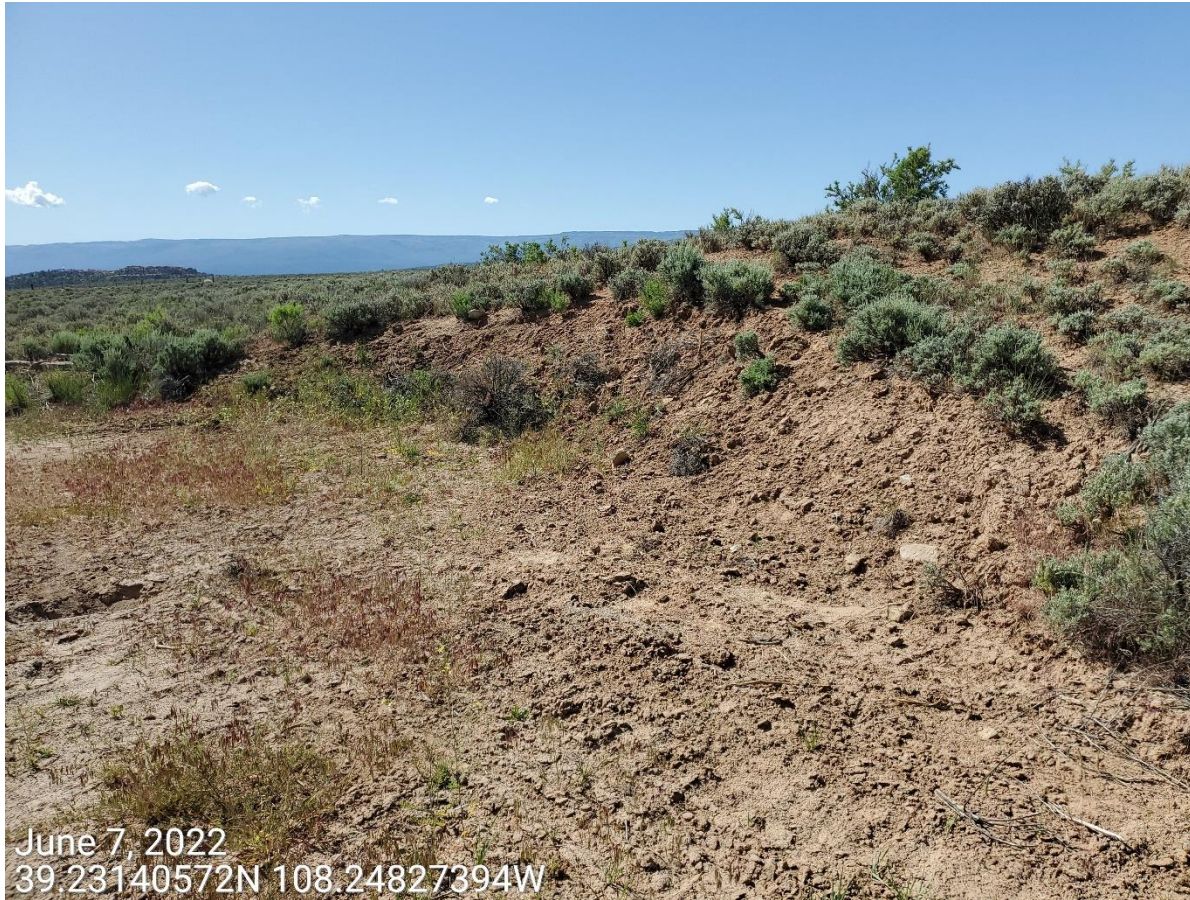
Photo 5: Photo example showing areas of the cut slope that remain evident; area appears to have been used as a “borrow area” in the past.
