# Inspection Photos and Issue Report

6/14/2022

Operator: PRE RESOURCES INC - 10241

Location ID: 322302

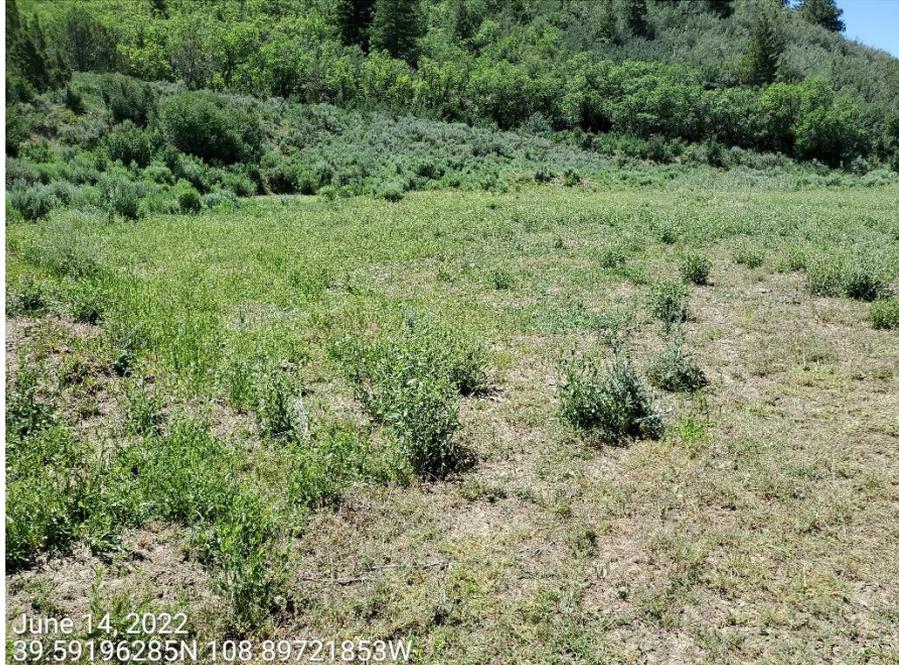
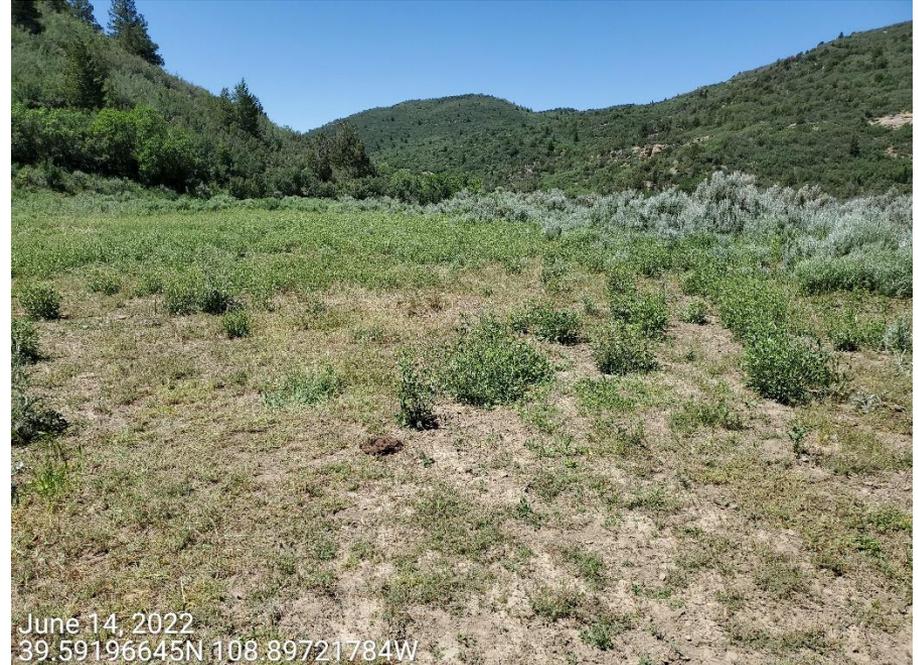
June 14, 2022  
39.59196285N 108.89721853W

June 14, 2022  
39.59196645N 108.89721784W

**Photo 1:** Photos taken from the north end of the Location, facing southeast / south. Photos provides an overview of the Location; Location has not been reclaimed in accordance with Rule 1004.a: Location and access road have not been decompacted, recontoured and reclaimed- Cut/fill slope remains evident, secondary containment berms remain evident, gravel has not been removed; surface equipment (pipe) remaining on northwest end of the Location; Vegetation on Location is predominantly Undesirable and Noxious Plant Species including, but not limited to, Field Bindweed, Redstem filaree, Hoary Cress, etc...

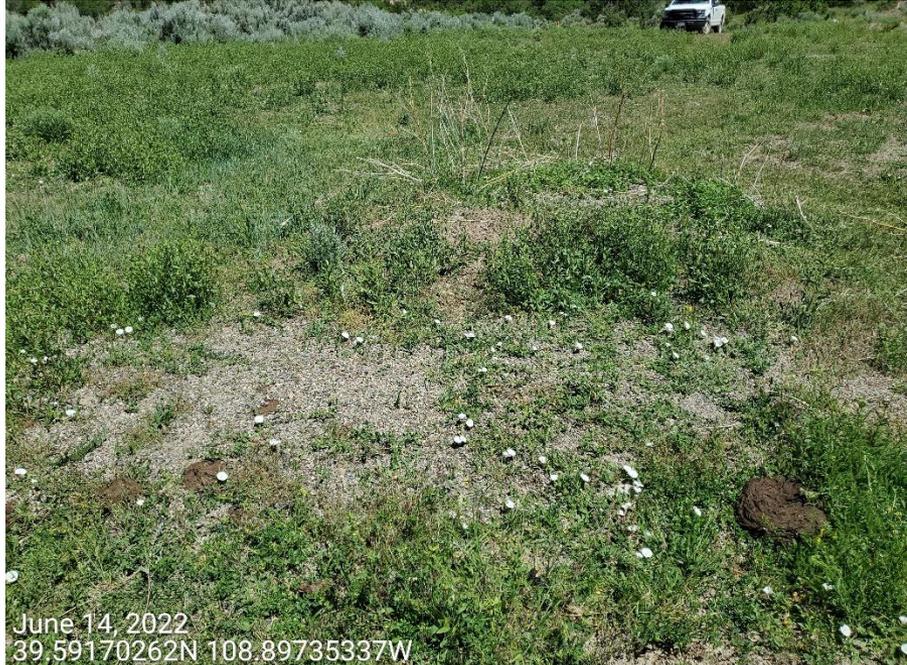
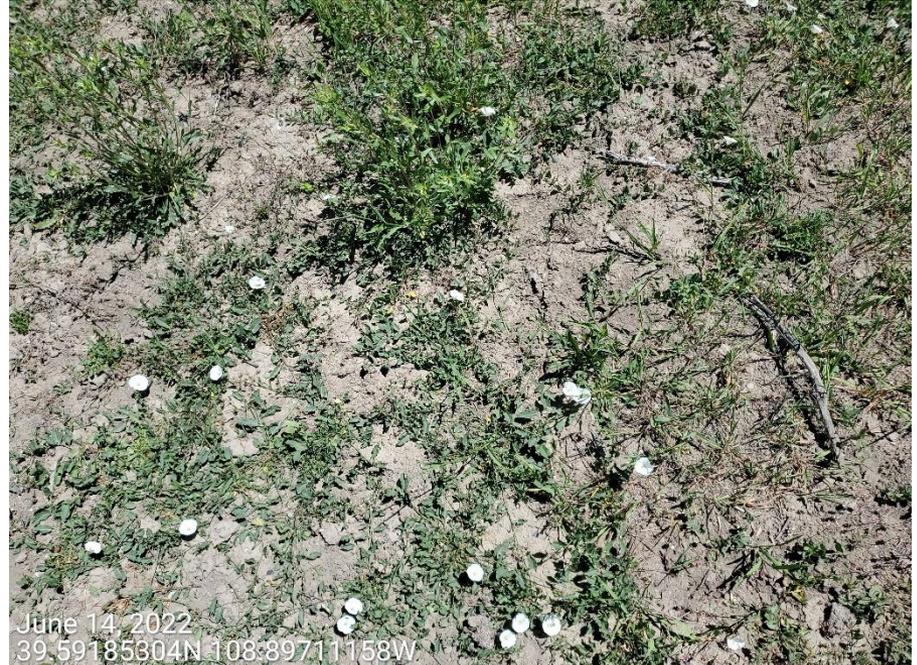
**Photo 2:** Photos show vegetation on Location is predominantly Undesirable and Noxious Plant Species including, but not limited to, Field Bindweed, Redstem filaree, Hoary Cress, etc... Weed management inadequate on the Location, and is required until site receives a passing final reclamation inspection.

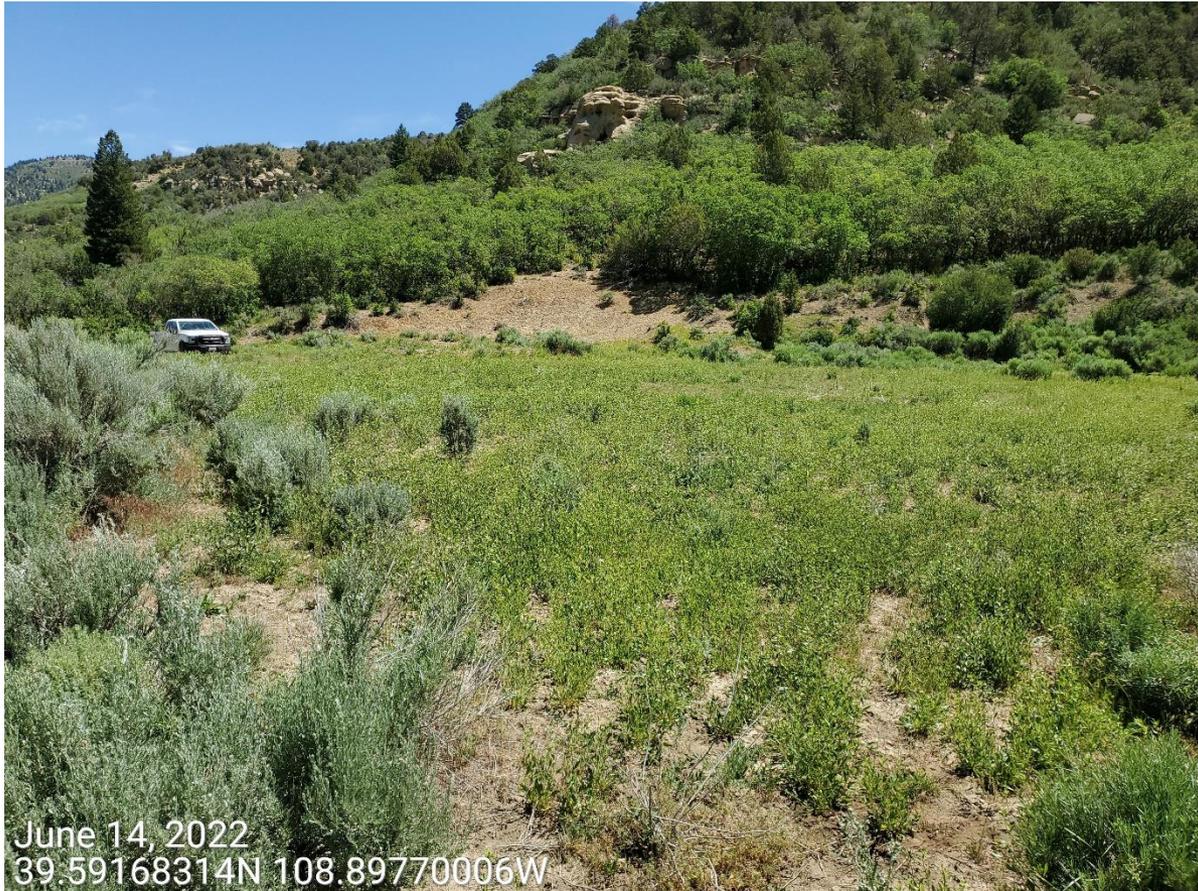
**Photo 3:** Photo shows cut slope remaining; location has not been recontoured/regraded.

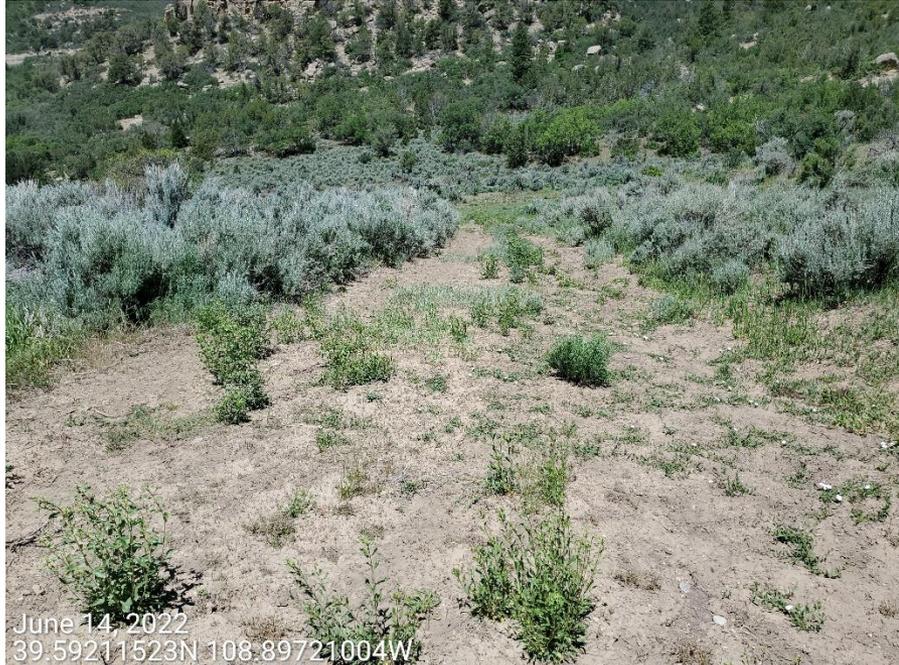
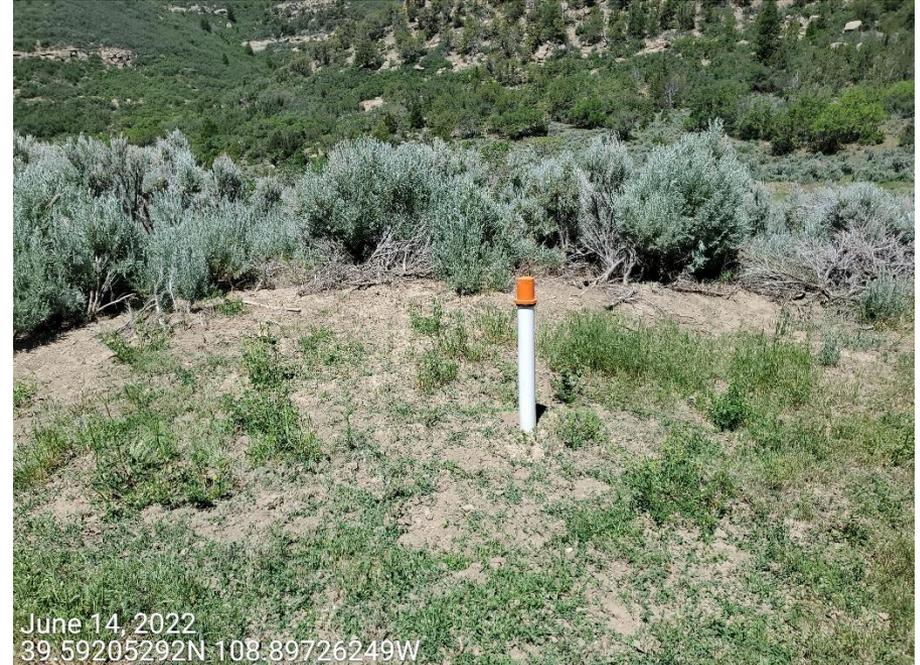
**Photo 4:** Photo left shows access road has not been reclaimed. Photo right shows pipe equipment remaining t on the Location

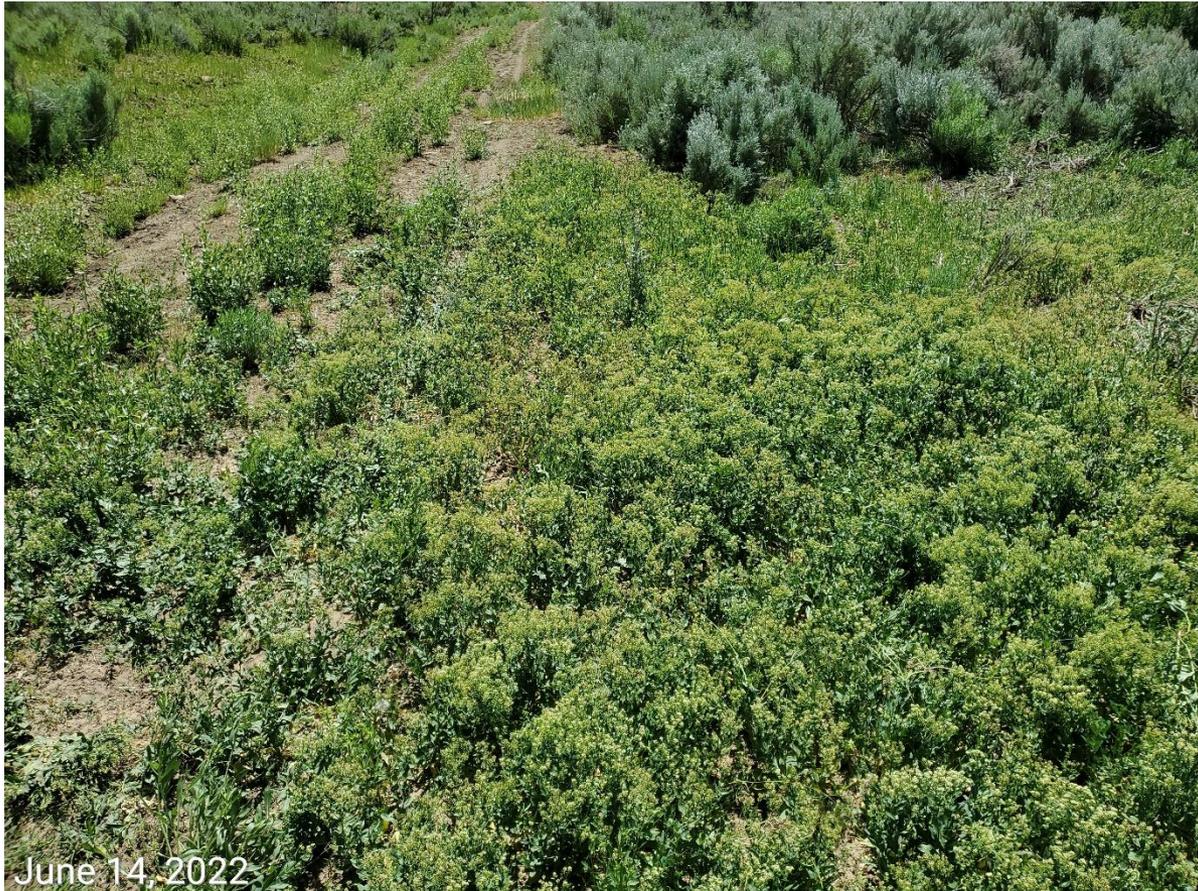
**Photo 5:** Photo shows Hoary cress established along the un-reclaimed access road.
