# Inspection Photos

Operator: TEP Rocky Mountain- #96850

Location Name: Youberg-66S94W /35SESE

Inspection Document #: 702800369

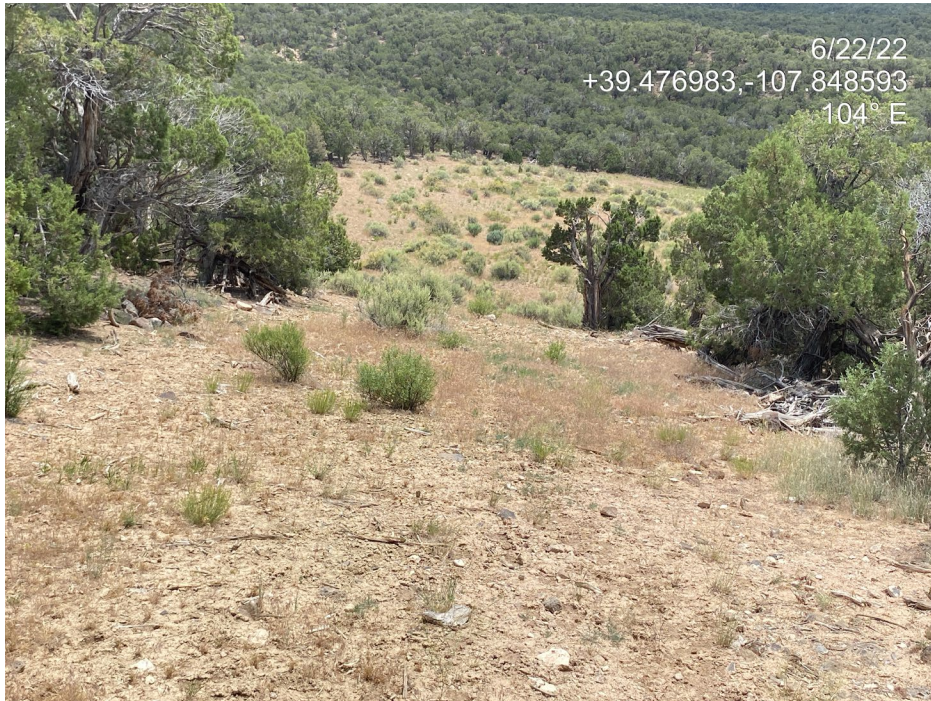
**Photo 1.** Photo taken from the northwest of the Location on the access road shows an overview of the reclaimed access road and Location.

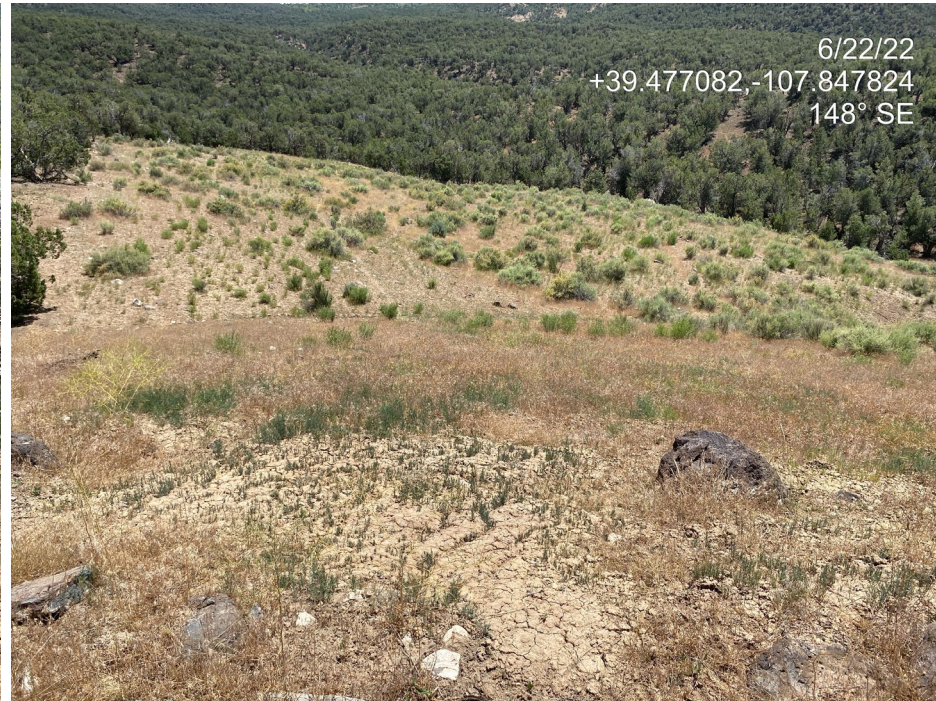
**Photo 2.** Photo taken from the north of the Location shows an overview of the reclaimed Location. Photo shows the northern portion of the Location (foreground) dominated by noxious weeds and undesirable plant species cheatgrass and Russian thistle.

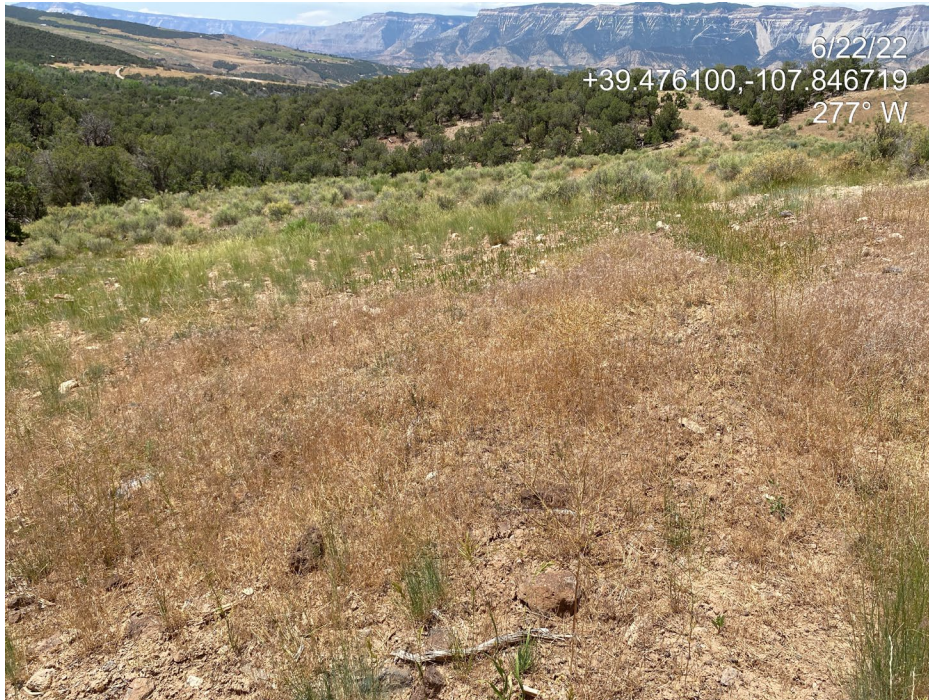
**Photo 3.** Photo taken from the southeast of the Location shows that establishment of desirable perennial plants is not uniform. Some areas are vegetated with native and seeded non-native perennial species (middleground), while others are dominated by noxious weeds and undesirable plant species (foreground).

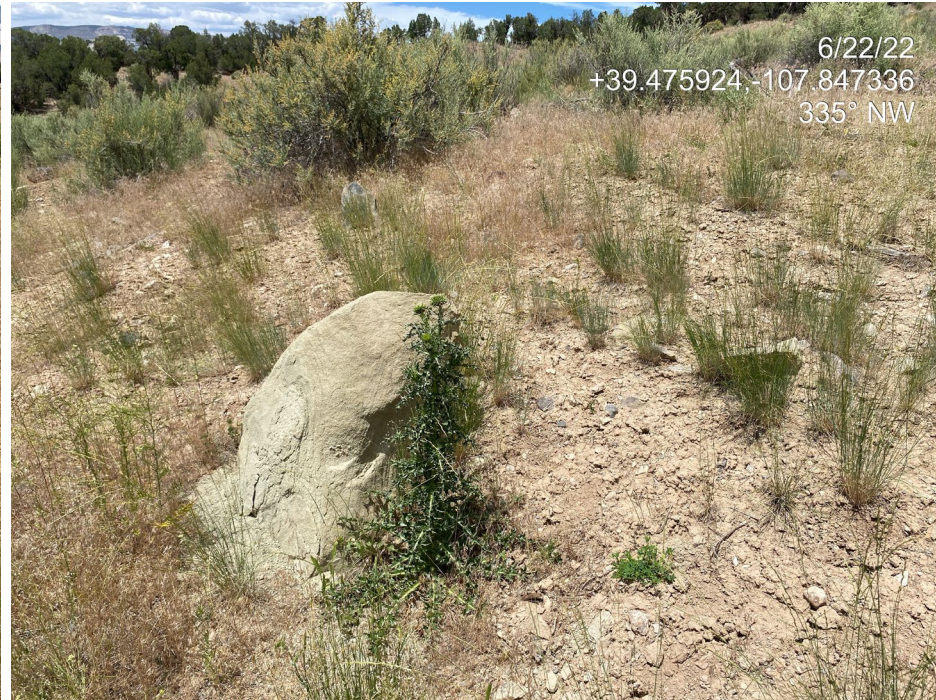
**Photo 4.** Photo taken from the south of the Location shows musk thistle, a CO List B Noxious Weed.

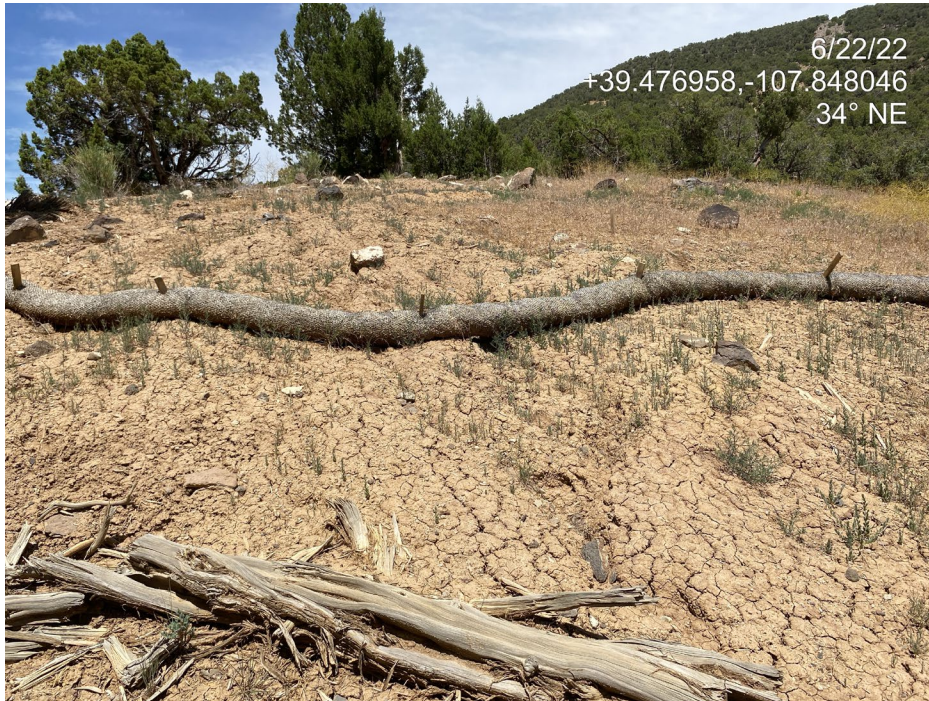
**Photo 5.** Photo taken from the north of the Location shows straw wattles in disrepair. Stormwater is cutting underneath the wattles and some have come unstaked. Also note, the stage of Russian thistle development for determining appropriate control methods.

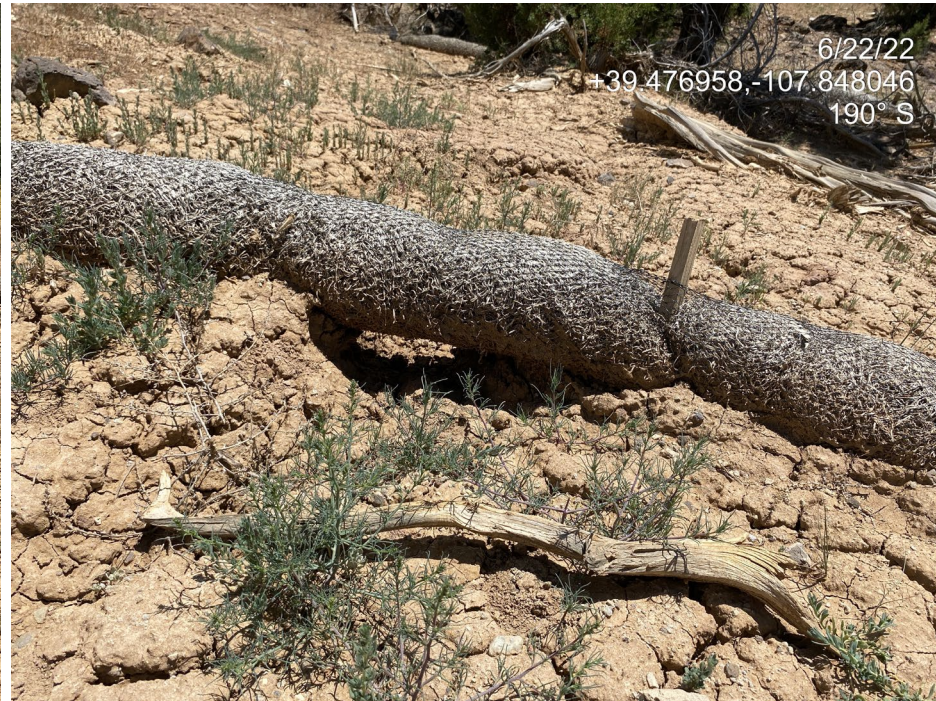
**Photo 6.** Refer to photo 5 comment.

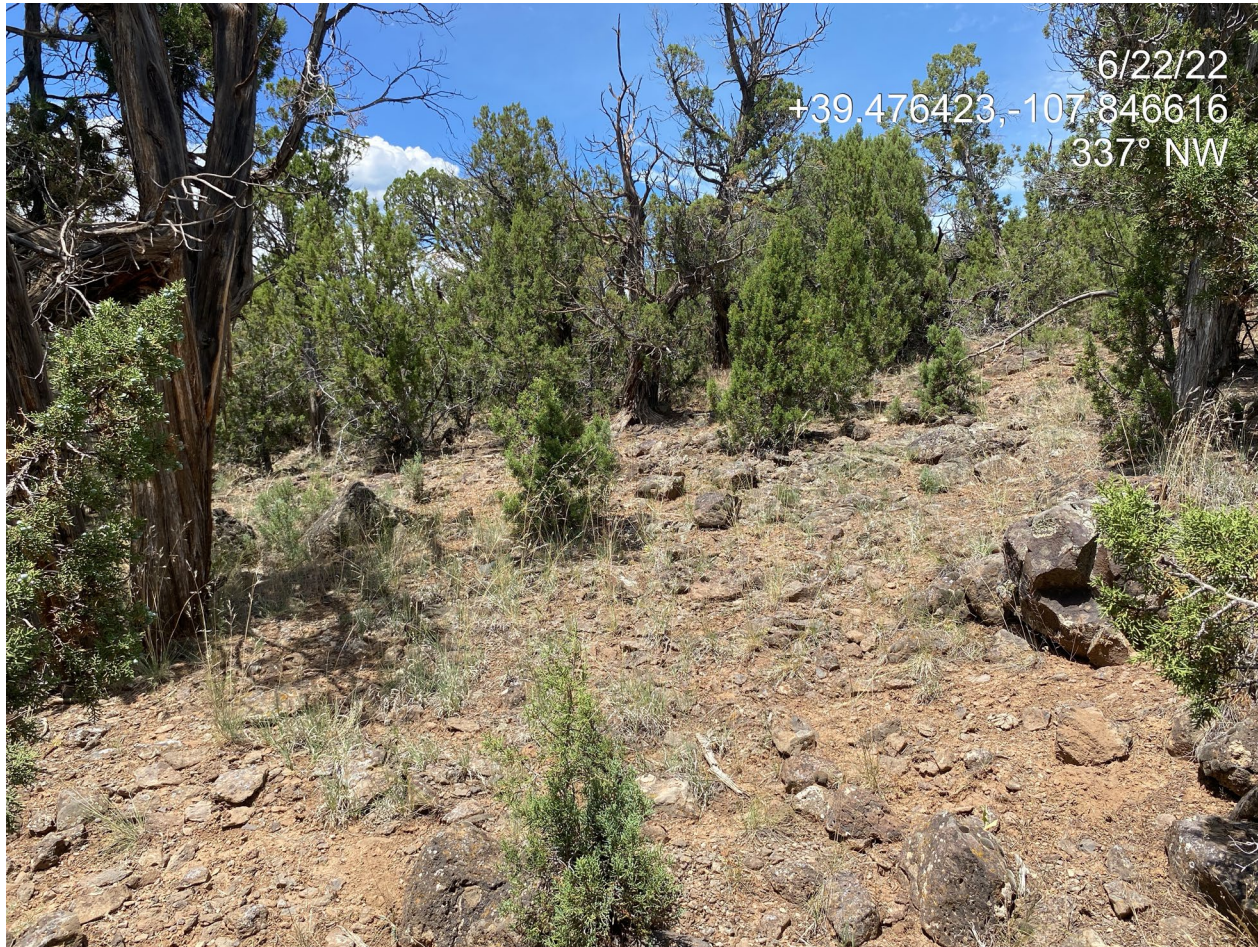
**Photo 7.** Photo taken to the east of the Location shows the reference area vegetation community is dominated by pinyon and juniper with a native forb and grass understory.
