Final Reclamation Inspection

Operator: PDC ENERGY INC - 69175

Location ID: 327207

Inspection Document #: 701900369

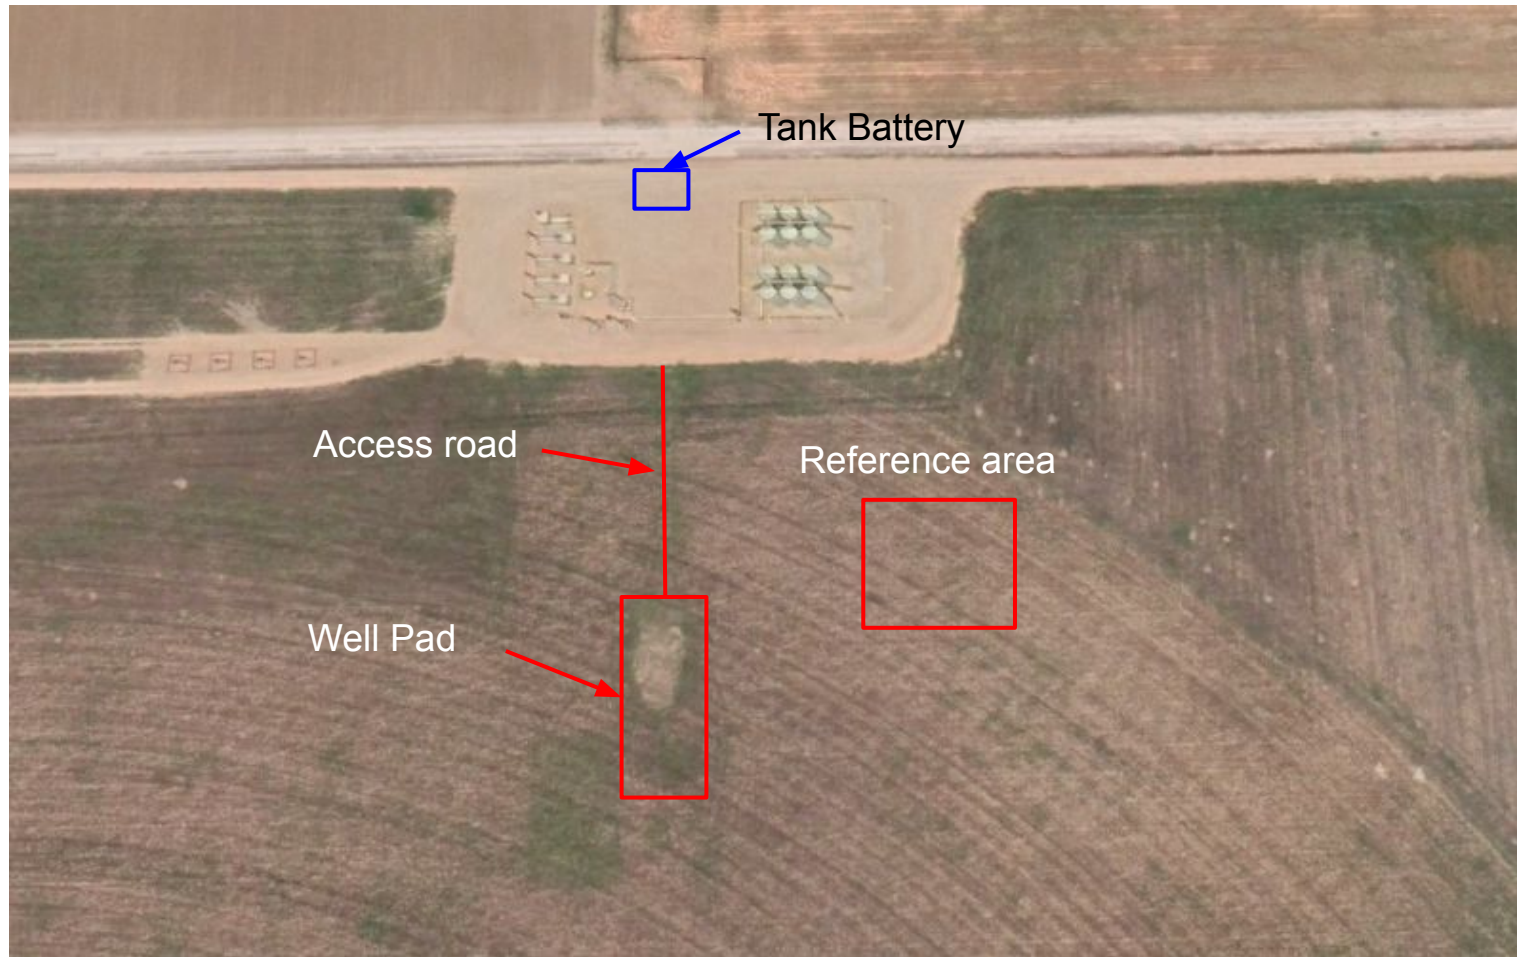
Photo 1. 2021 aerial imagery of the well pad, tank battery, access road and reference area.
Note: the tank battery has been absorbed by the Ram Land production facility.

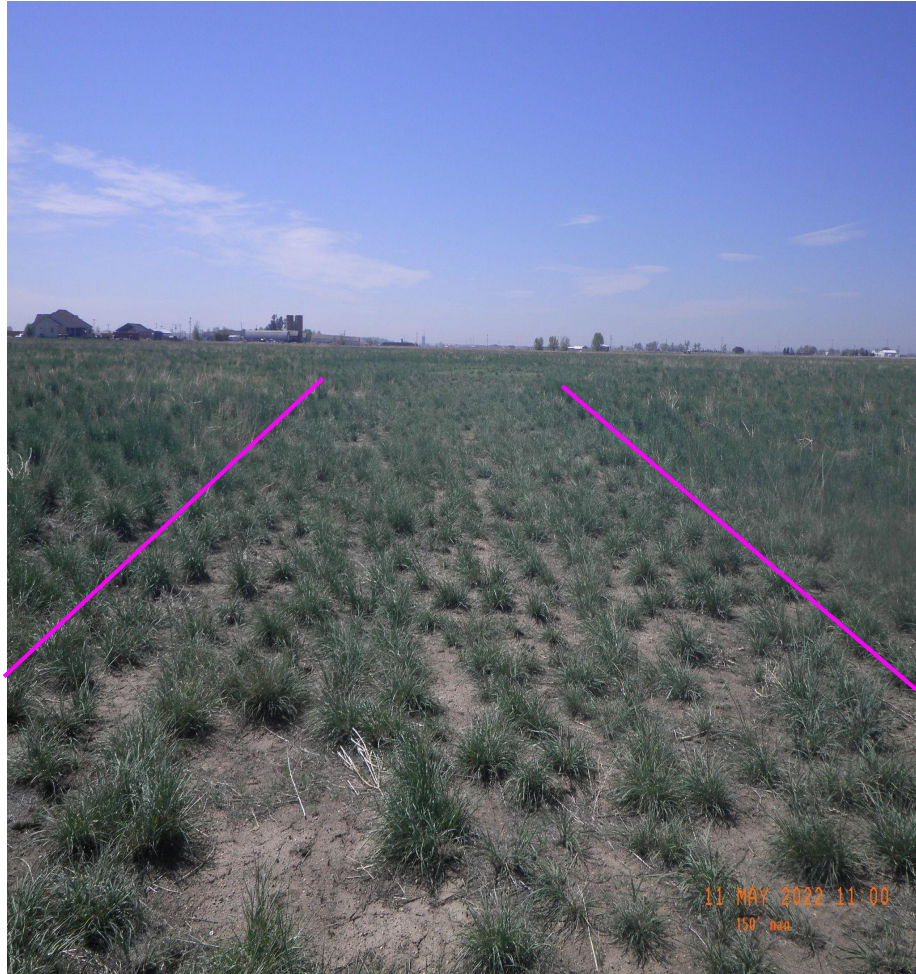
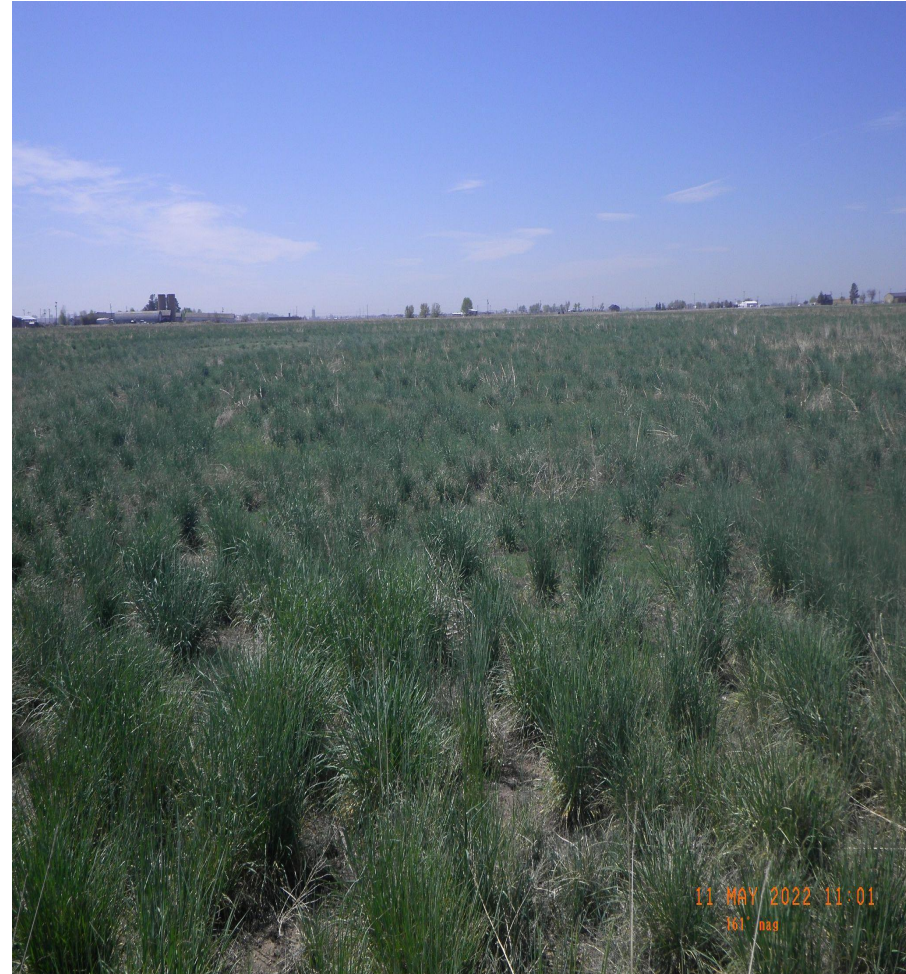
Photo 2. Left photo taken from the northern edge looking south down the access road towards the well pad. Campartiviley, right photo taken at the same orientation (north to south) taken just west of the access road. Note: Left photo shows stunted plant growth (Russian wildrye).

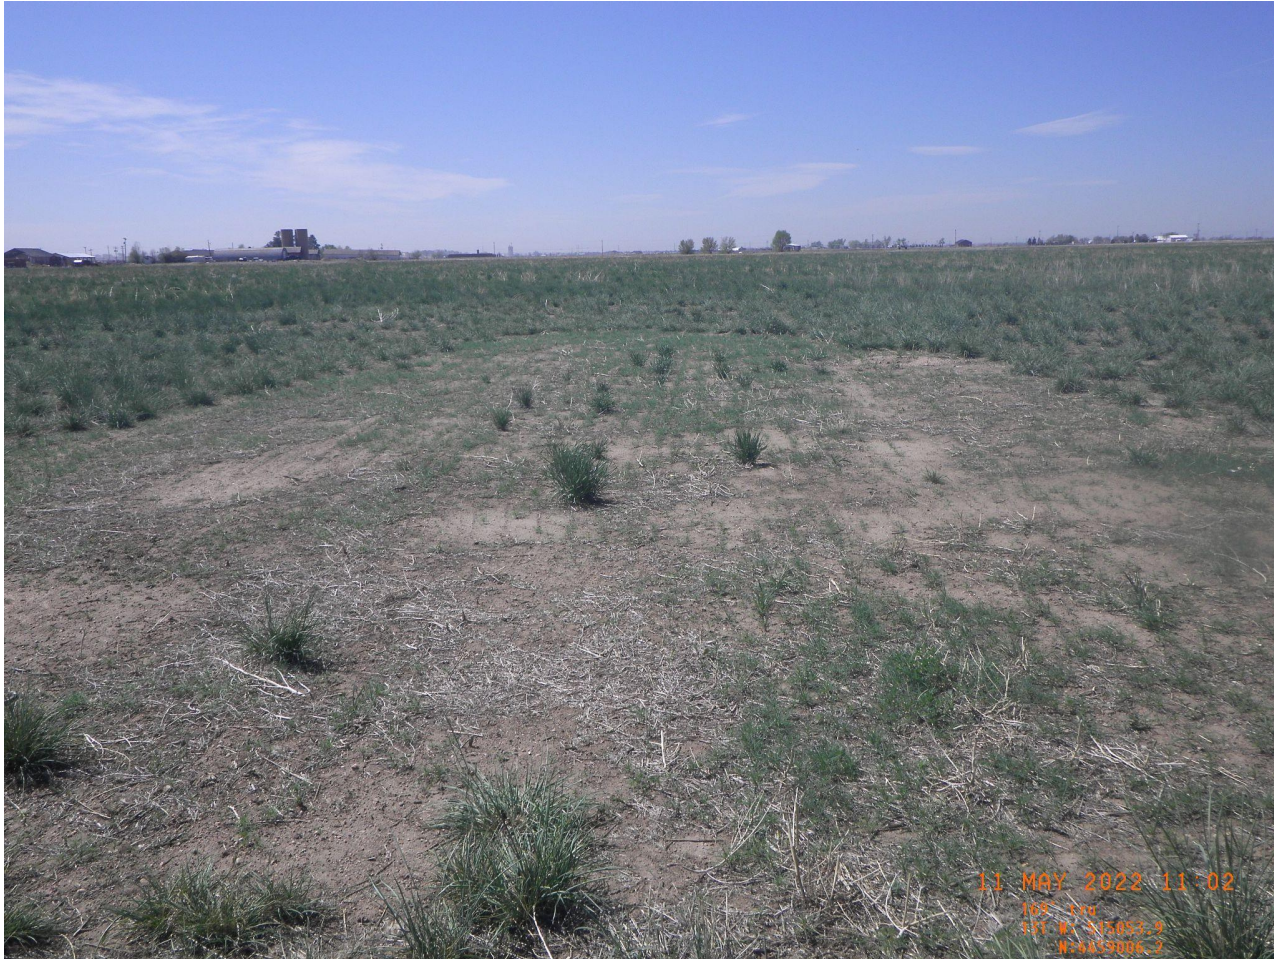
Photo 3. Overview photo of northern well pad disturbance taken at ground level from the northern disturbance edge looking south. Note: disturbance shows little plant establishment and doesn't appear consistent with adjacent reference area (see photo 5).

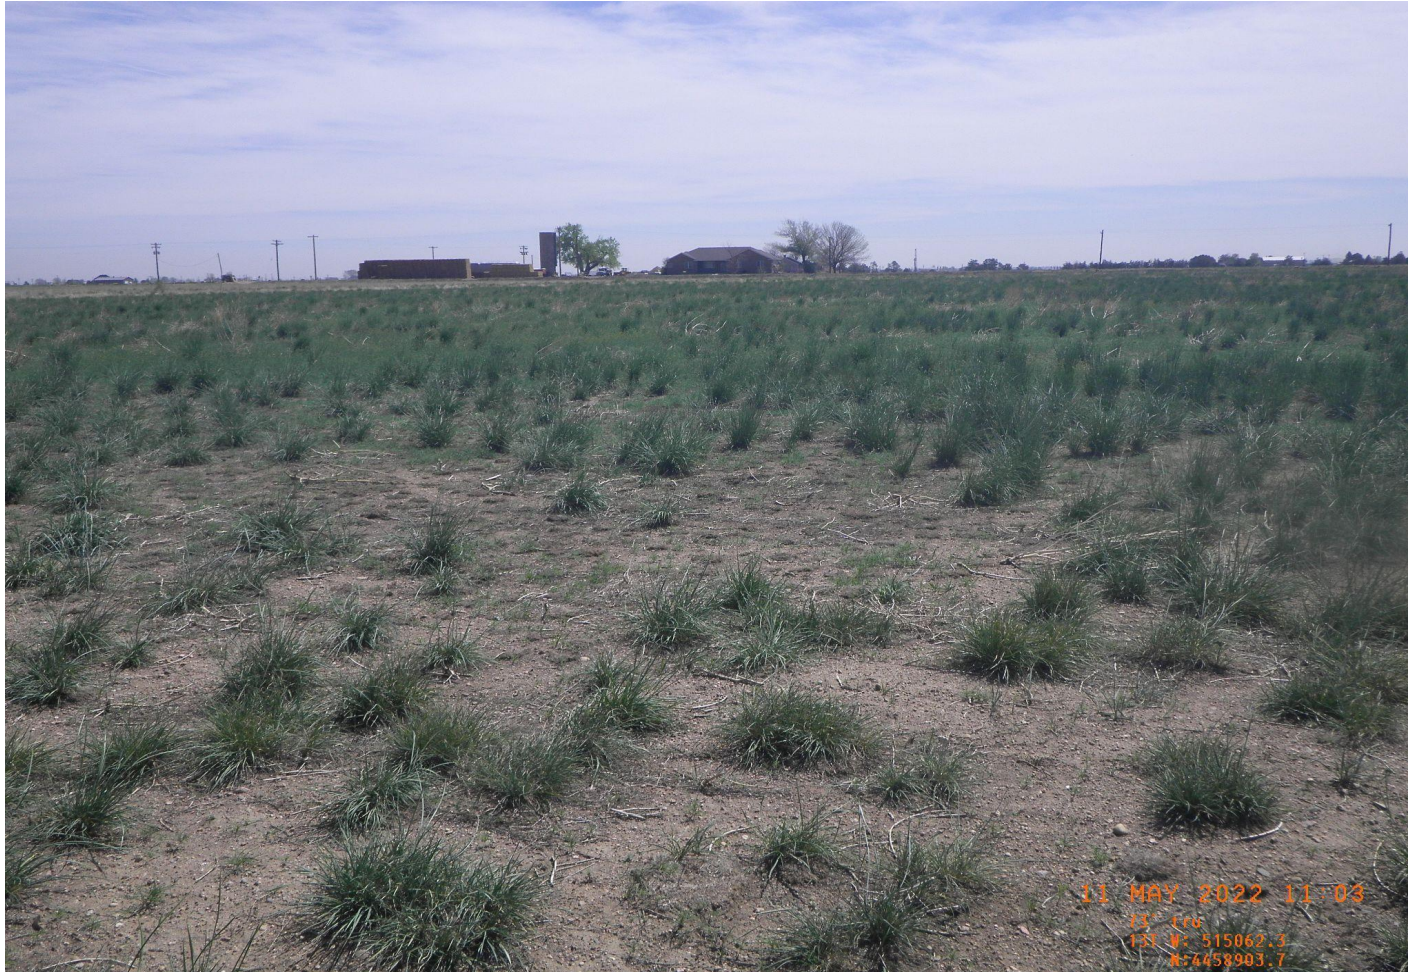
Photo 4. Overview photo of southern well pad disturbance taken at ground level from the northern disturbance edge looking south. Note: disturbance shows little plant establishment and doesn't appear consistent with adjacent reference area (see photo 5).

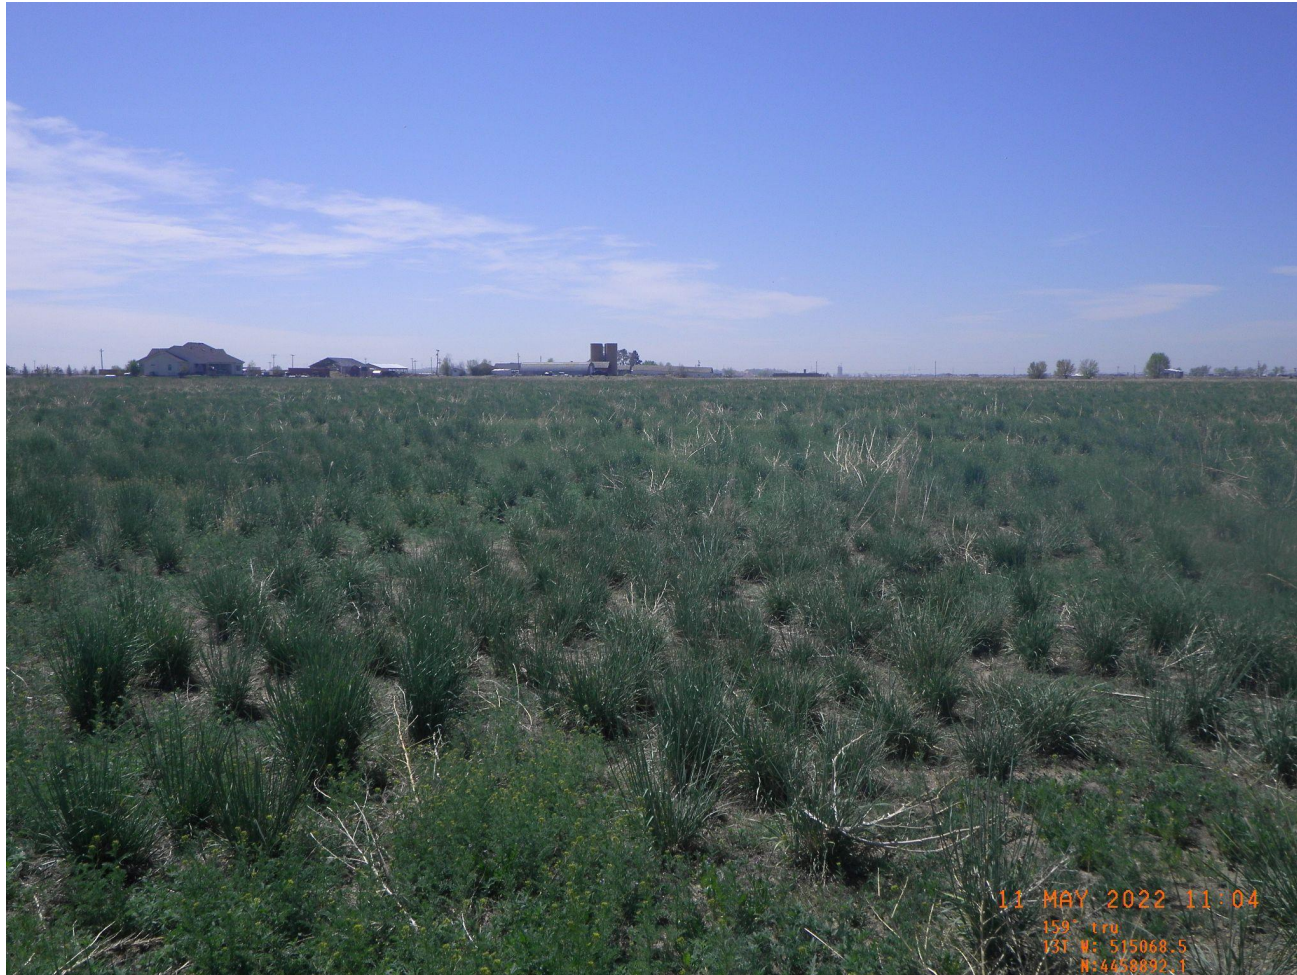
Photo 5. Reference area.

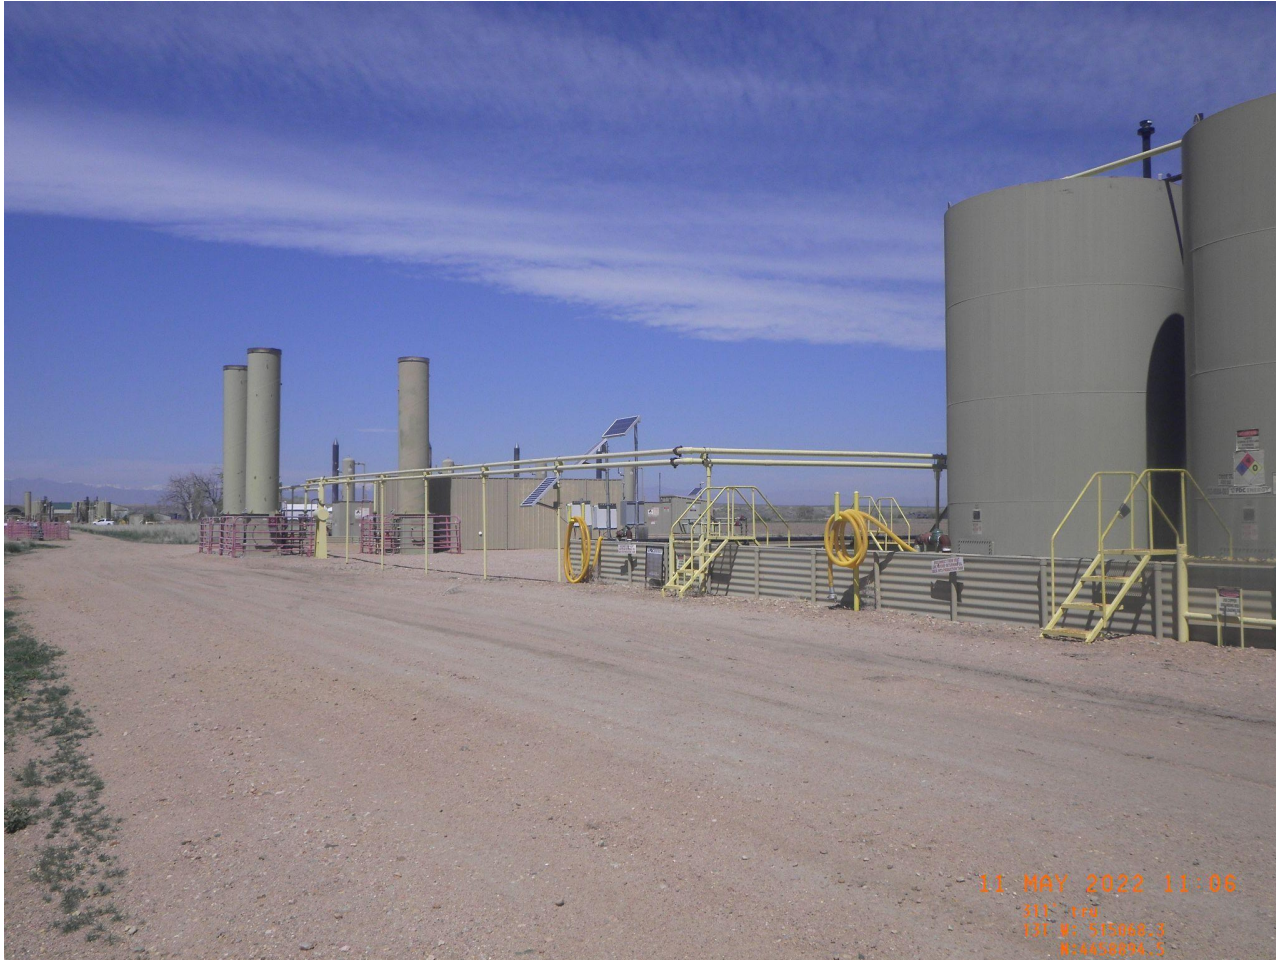
Photo 6. Tank battery. Note: absorbed by new Ram Land production facility. Note: no weed or erosion issues observed.
