Inspection Photos

Operator: Caerus Piceance LLC - #10456

Location Name: Benzel/26-6H (F25NWB)

Inspection Document #: 702800414

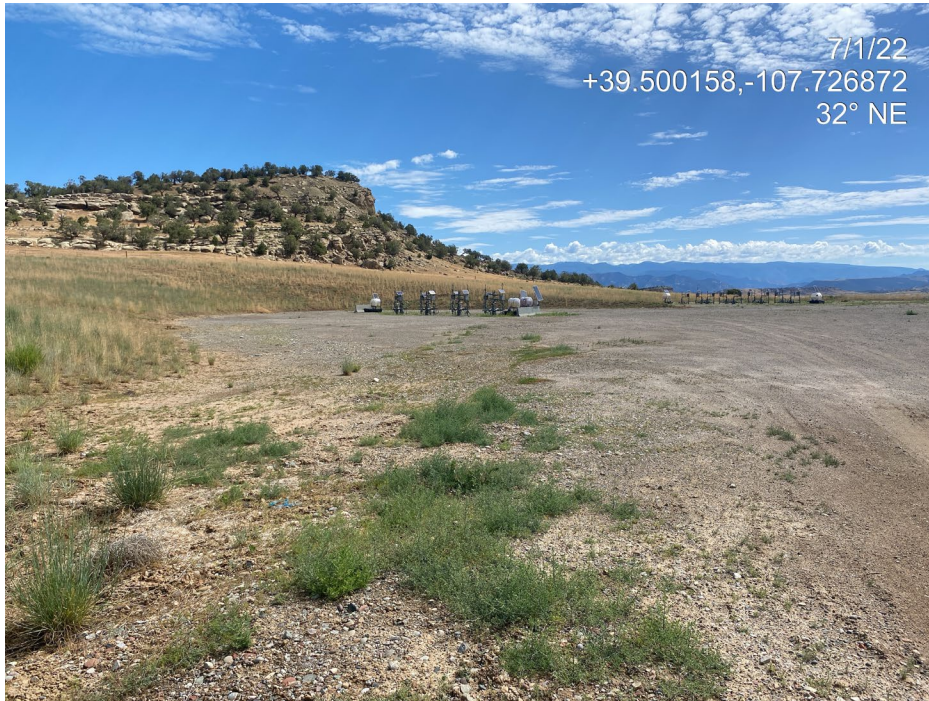
Photo 1. Photo taken from the west at the Location entrance shows an overview of the northern production area.

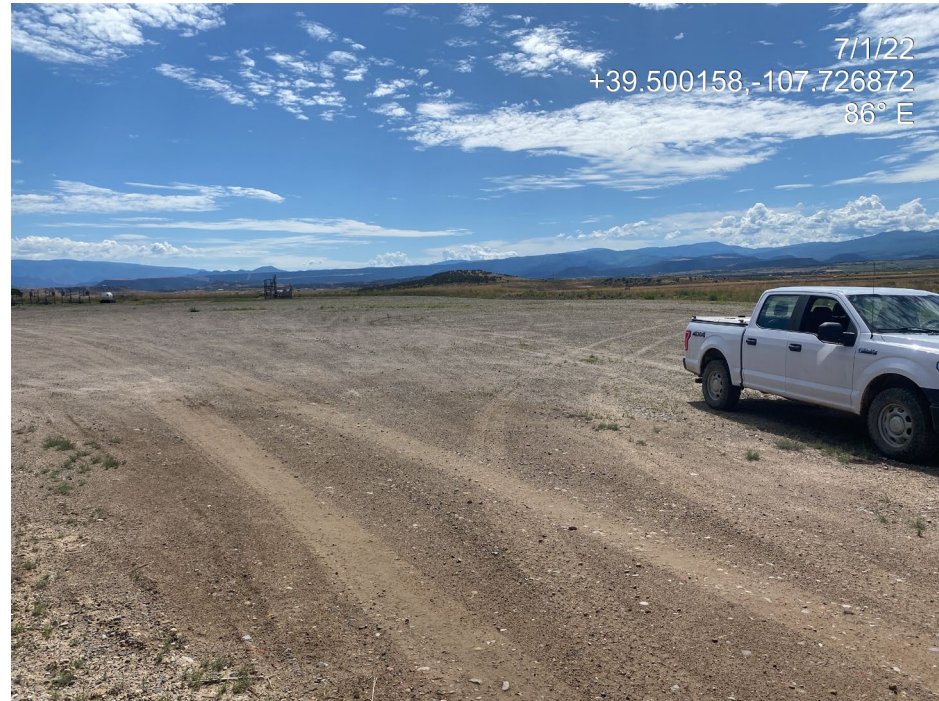
Photo 2. Photo taken from the west at the Location entrance shows an overview of the southern production area. Photo also shows areas at the southwest of the working pad area which can be reduced and reclaimed.

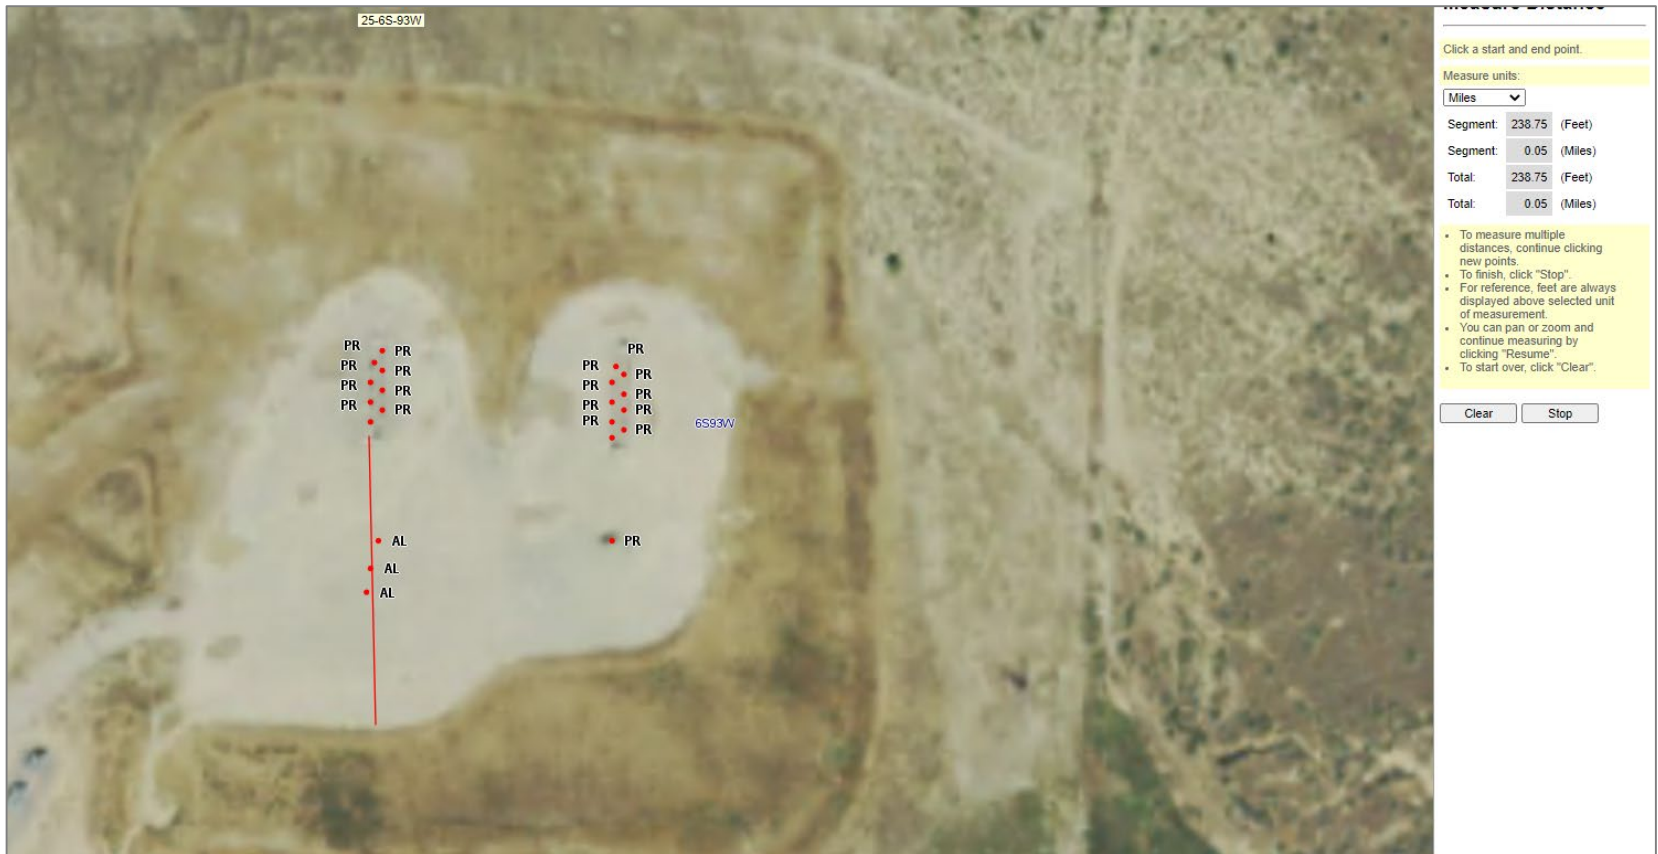
Photo 3. Map shows the distance from the producing wells at the northwest of the Location to the southwestern edge of the pad is approximately 140 feet. Areas at the southwest of the working pad area not necessary for production operations can be reduced and reclaimed.

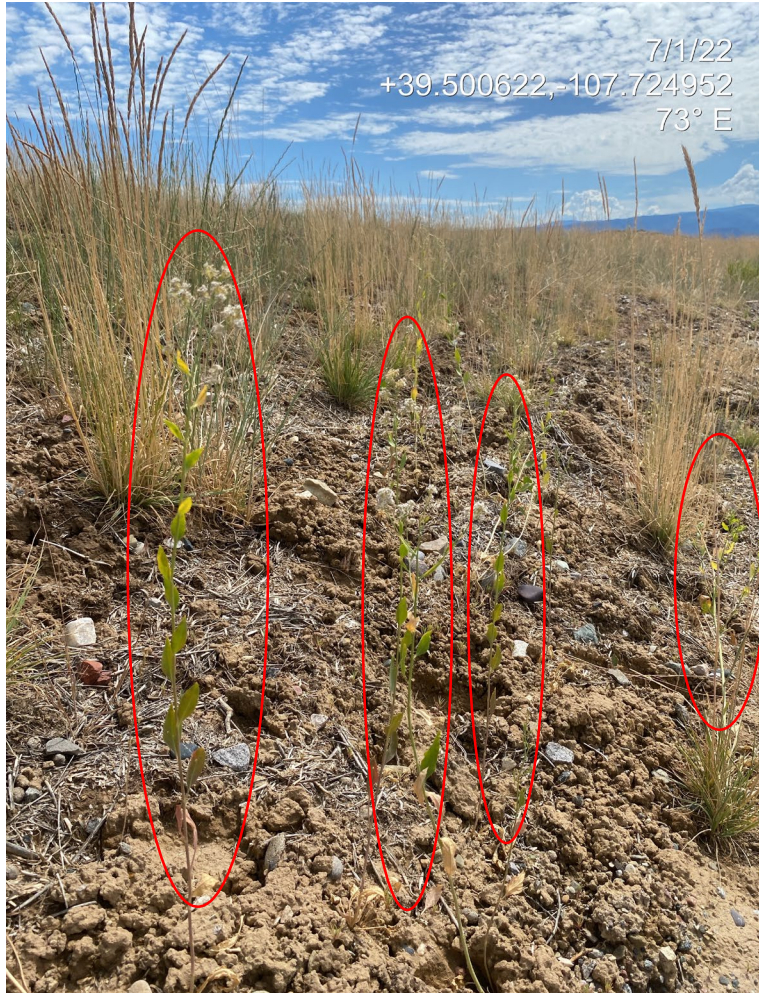
Photo 4. Photo taken from the east of the Location shows perennial pepperweed (CO List B Noxious Weed).

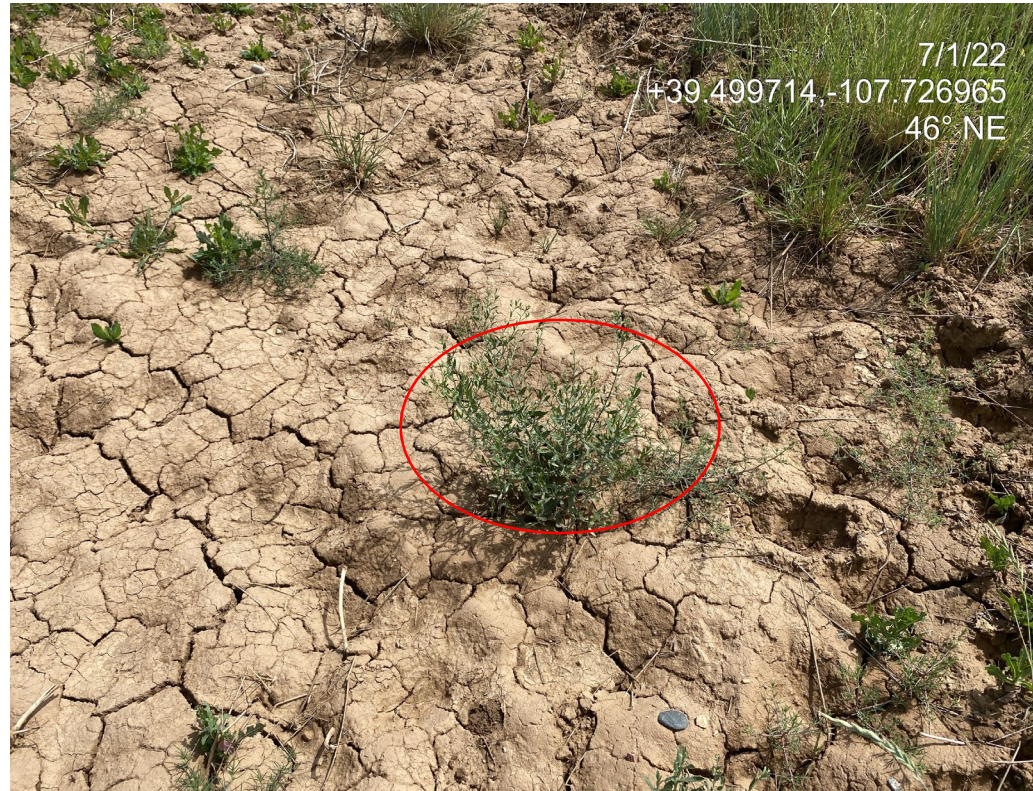
Photo 5. Photo taken from the sediment pond at the southwest of the Location shows Russian knapweed (CO List B Noxious Weed).

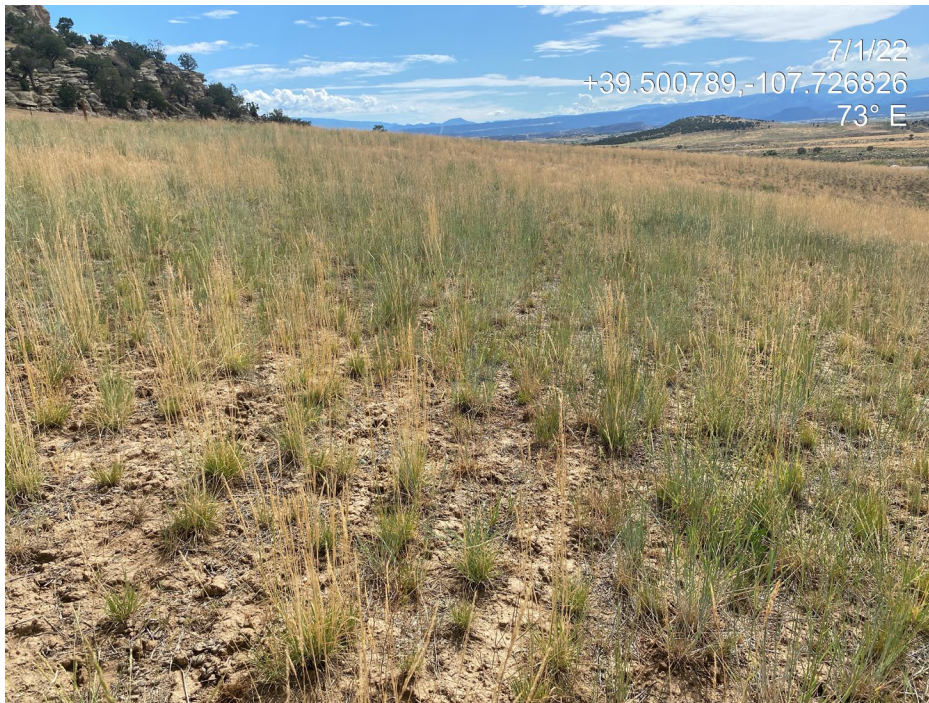
Photo 6. Photo taken from the north of the Location shows the northern interim area is dominated by seeded species including Russian wildrye, intermediate wheatgrass, and tall wheatgrass (non-native perennial grasses). Some western wheatgrass (native perennial grass) is occasionally present.

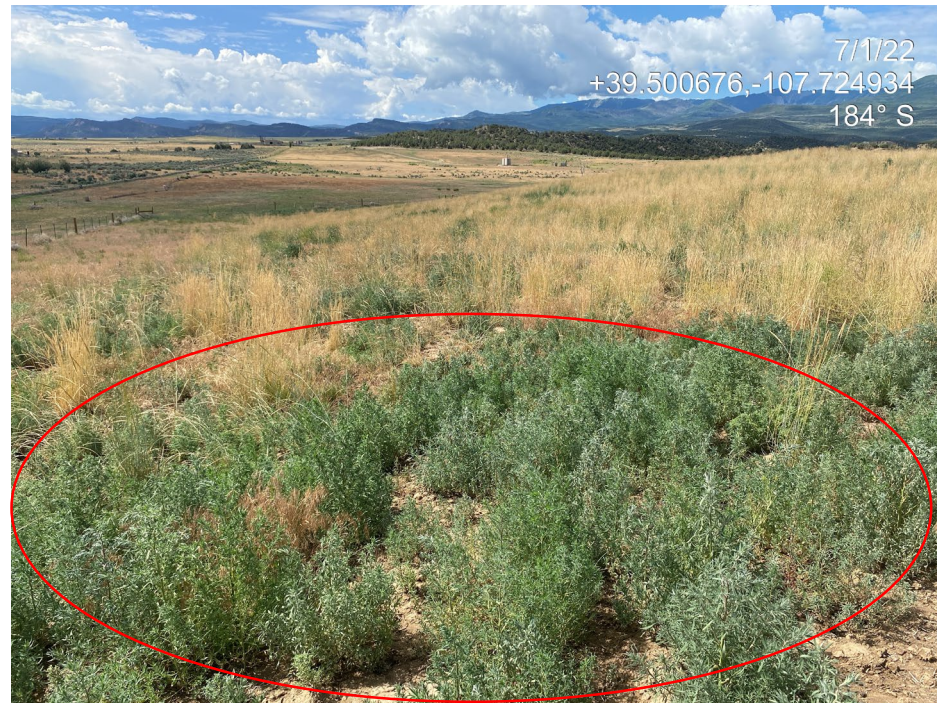
Photo 7. Photo taken from the east of the Location shows the eastern interim area is dominated by seeded perennial grasses. Photo also shows an example of an area with poor perennial grass establishment colonized by Russian thistle and kochia (undesirable plant species).

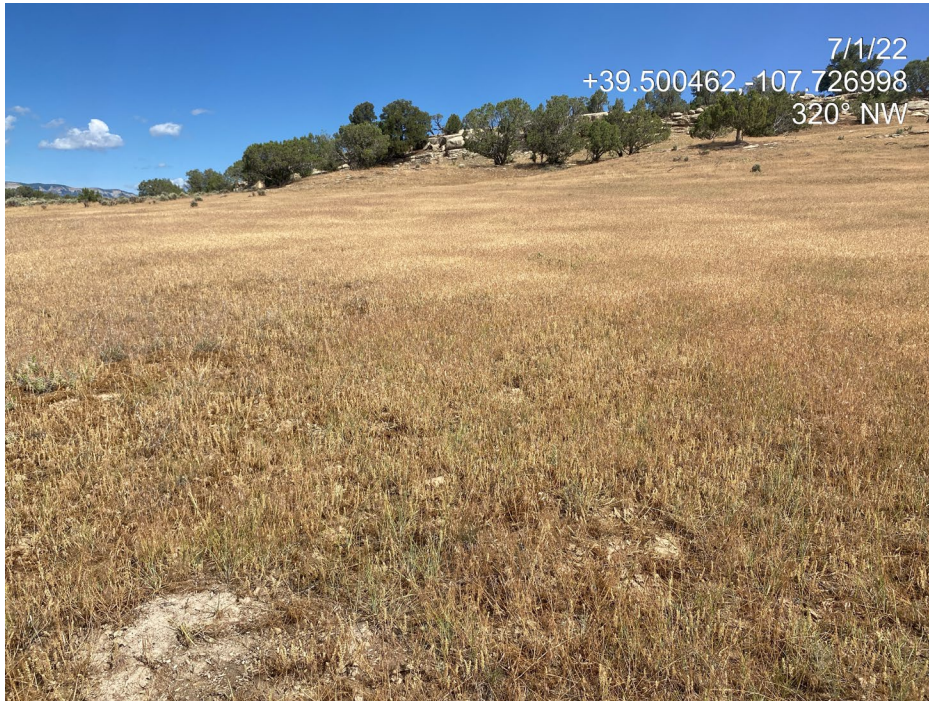
Photo 8. Photo taken from the north of the Location shows the adjacent reference area is dominated by cheatgrass (annual, CO List C Noxious Weed) and sparse western wheatgrass (native perennial grass).

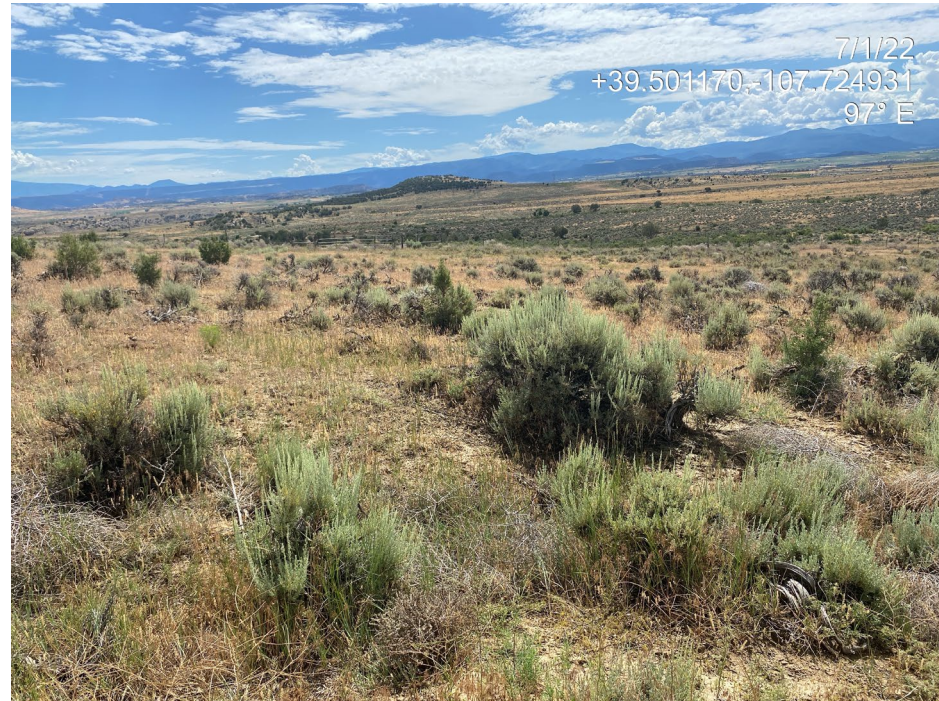
Photo 9. Photo taken from the east of the Location shows the adjacent reference area is dominated by sagebrush, cheatgrass (annual, CO List C Noxious Weed) and sparse western wheatgrass (native perennial grass).
