# Inspection Photos and Issue Report

Operator: CHEVRON USA INC #16700

Location #324266

Garfield County, CO

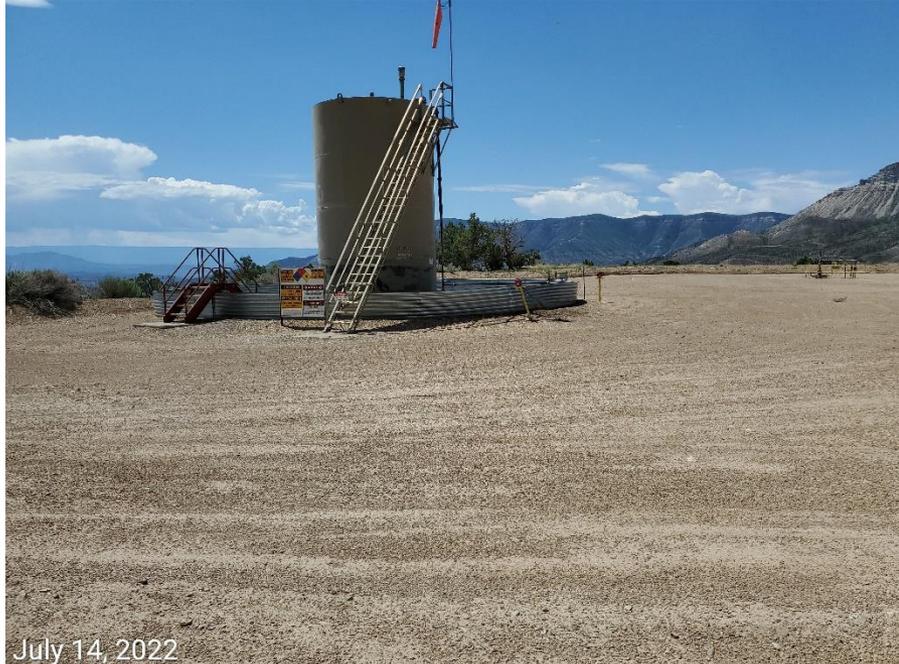
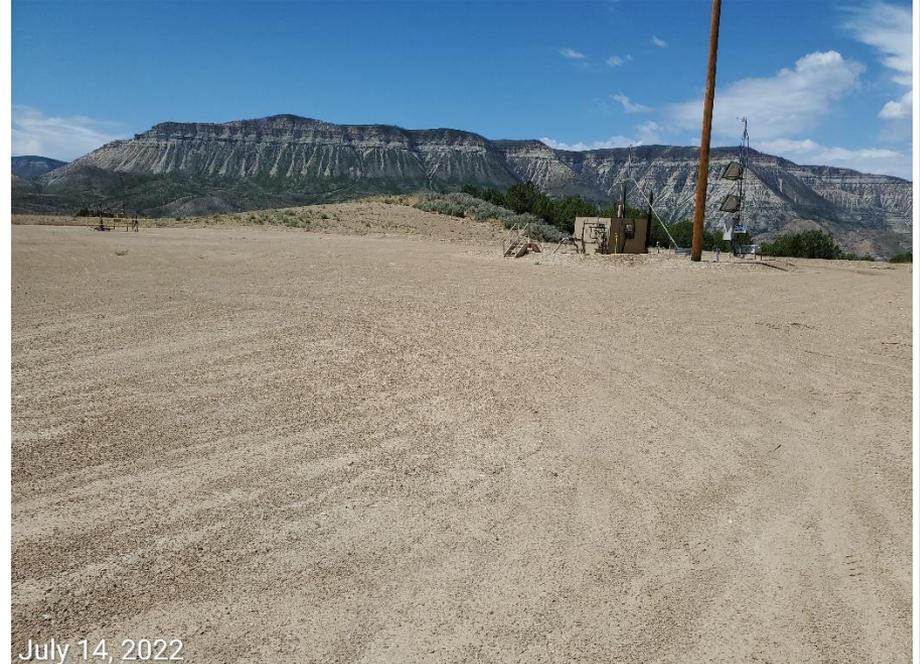
**Photo 1:** Photos taken from the north end of the production pad. Photos provide an overview of the Location facing southeast and southwest.

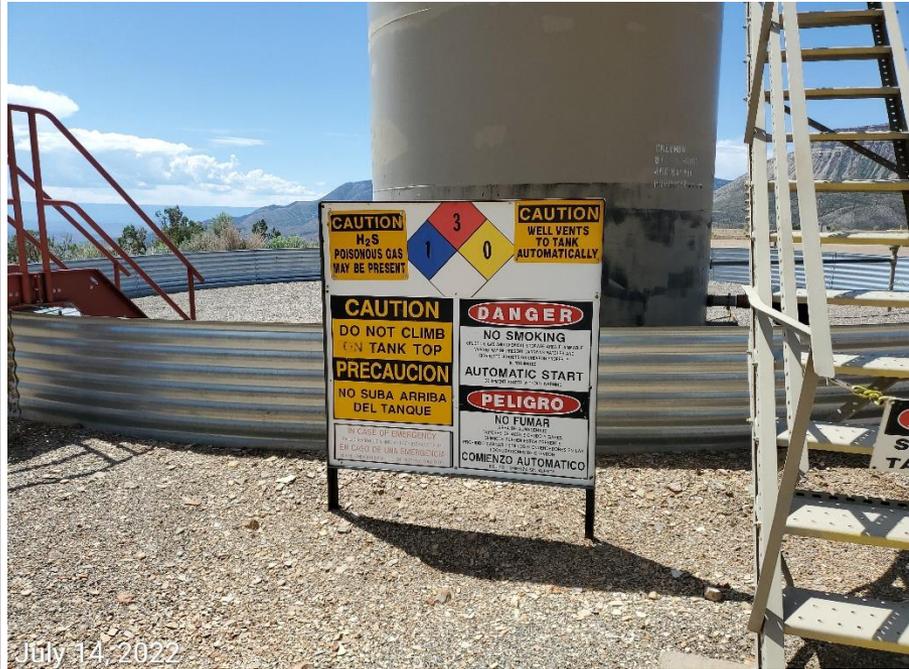
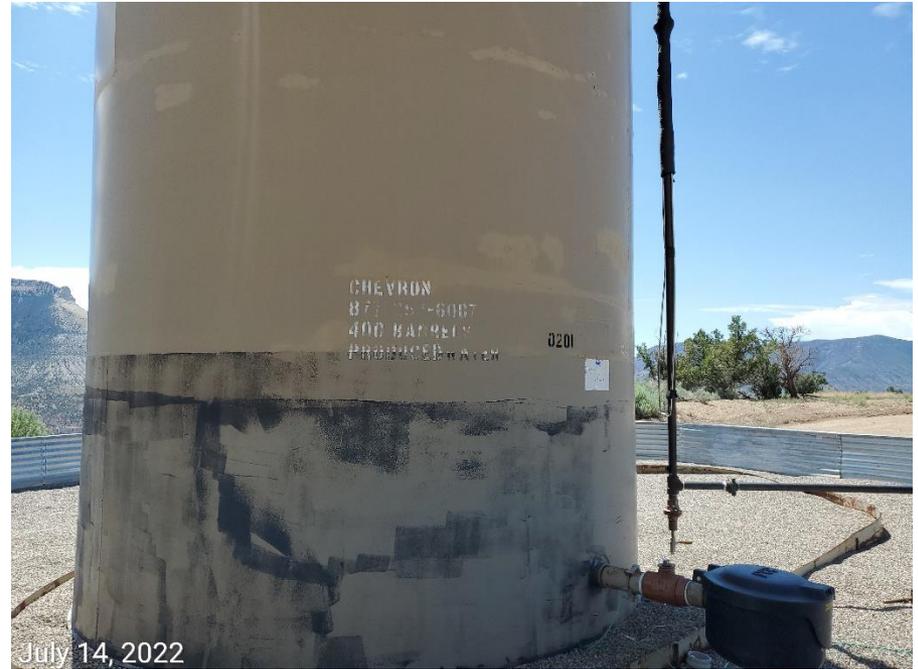
**Photo 2:** Photos show tank battery sign, and tank labels. Signage is beginning to degrade/fade. Maintenance is advised in order to ensure signage/labels remain legible.

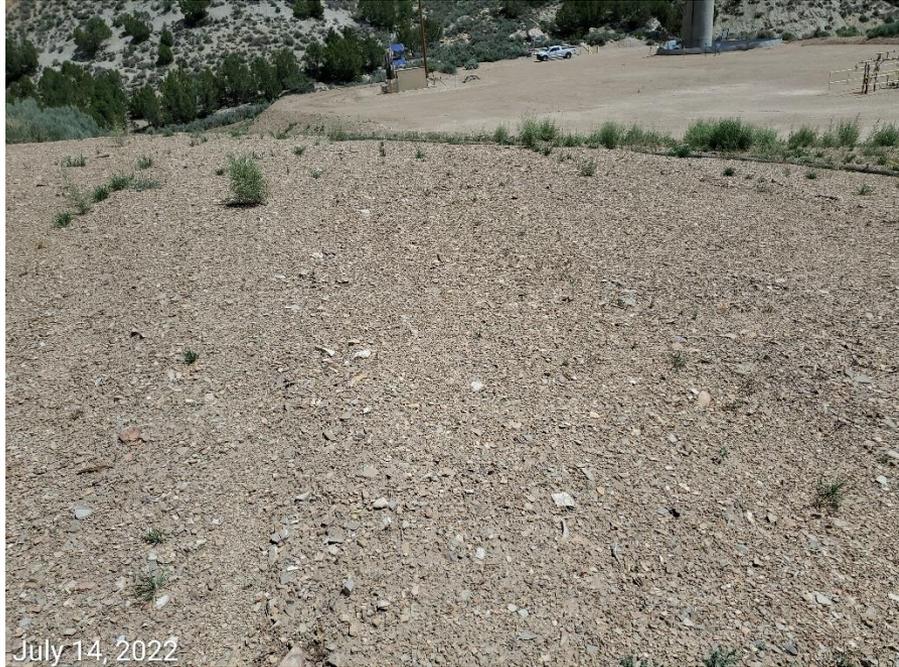
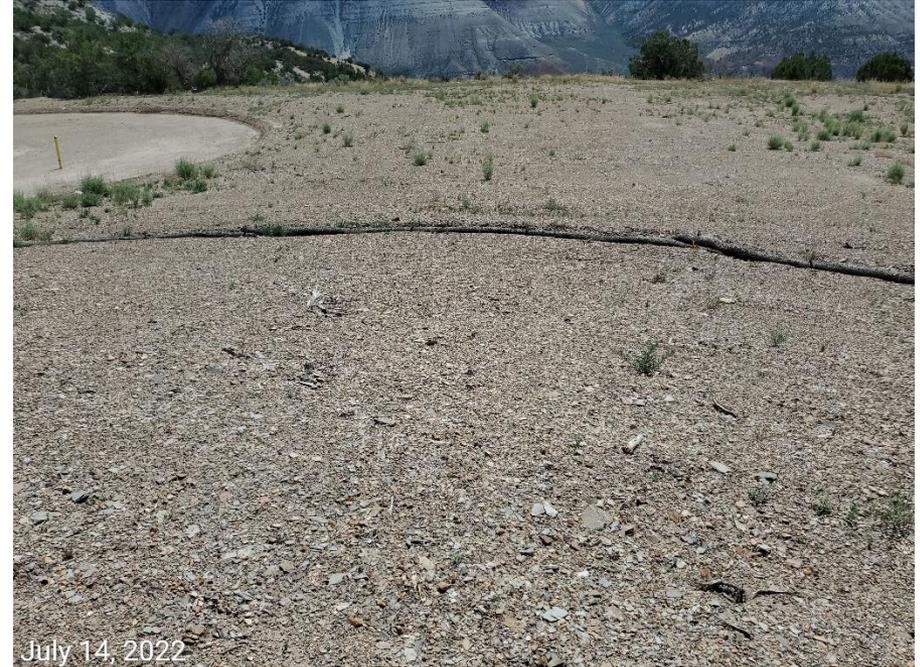
**Photo 3:** Photos taken from then interim areas of the Location; areas not necessary for production have been reclaimed. Photos also show large areas of the reclamation area where desirable plant germination and establishment is not occurring; areas predominantly bare and not progressing towards COGCC 1003 uniform desirable vegetative establishment.
