Inspection Photos

API: 125-09755

Operator: ENERGY QUEST II LLC

Inspection Date: 7/20/2022

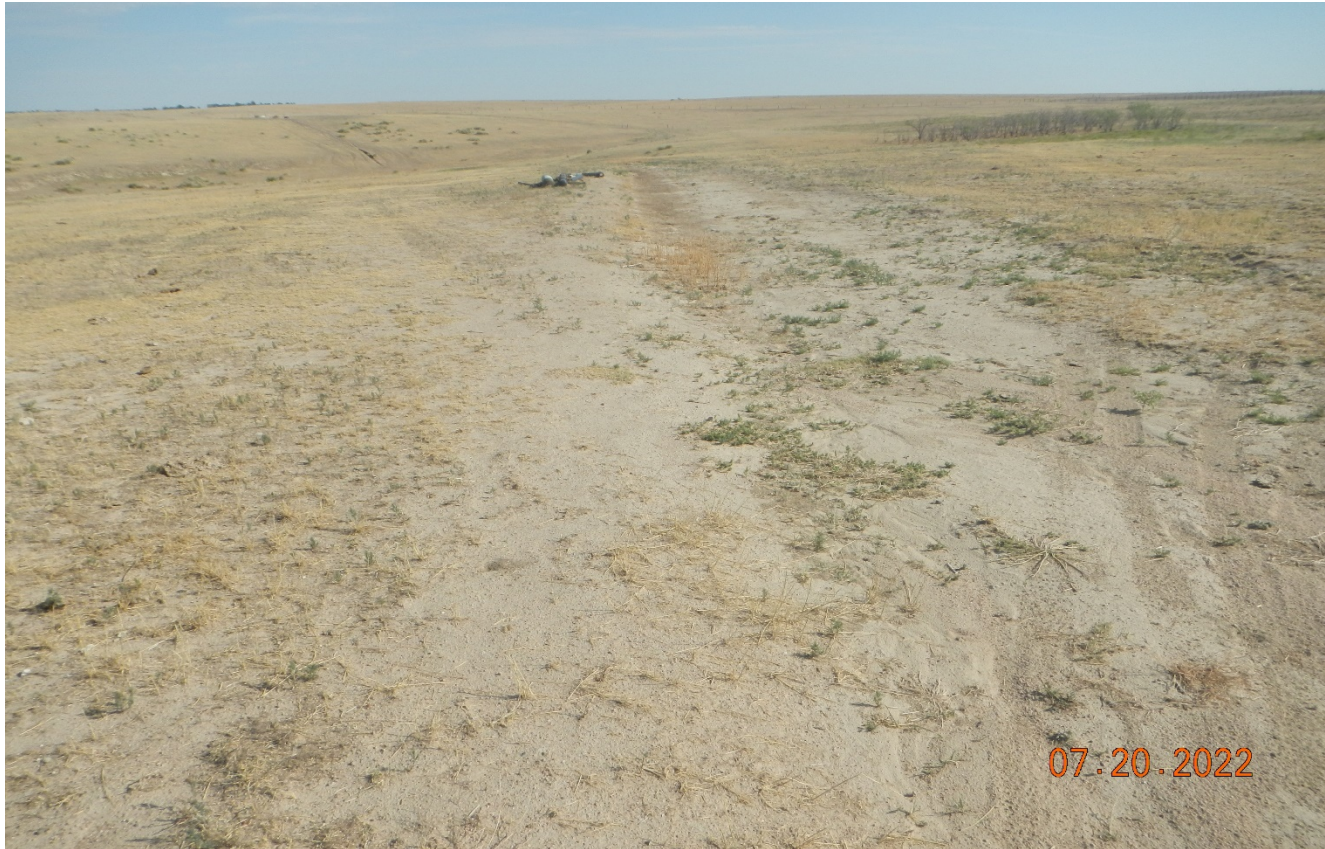
Photo 1. Facing north toward the access road which has not been reclaimed. The access road should have been recontoured and reclaimed per 1004 Rules.

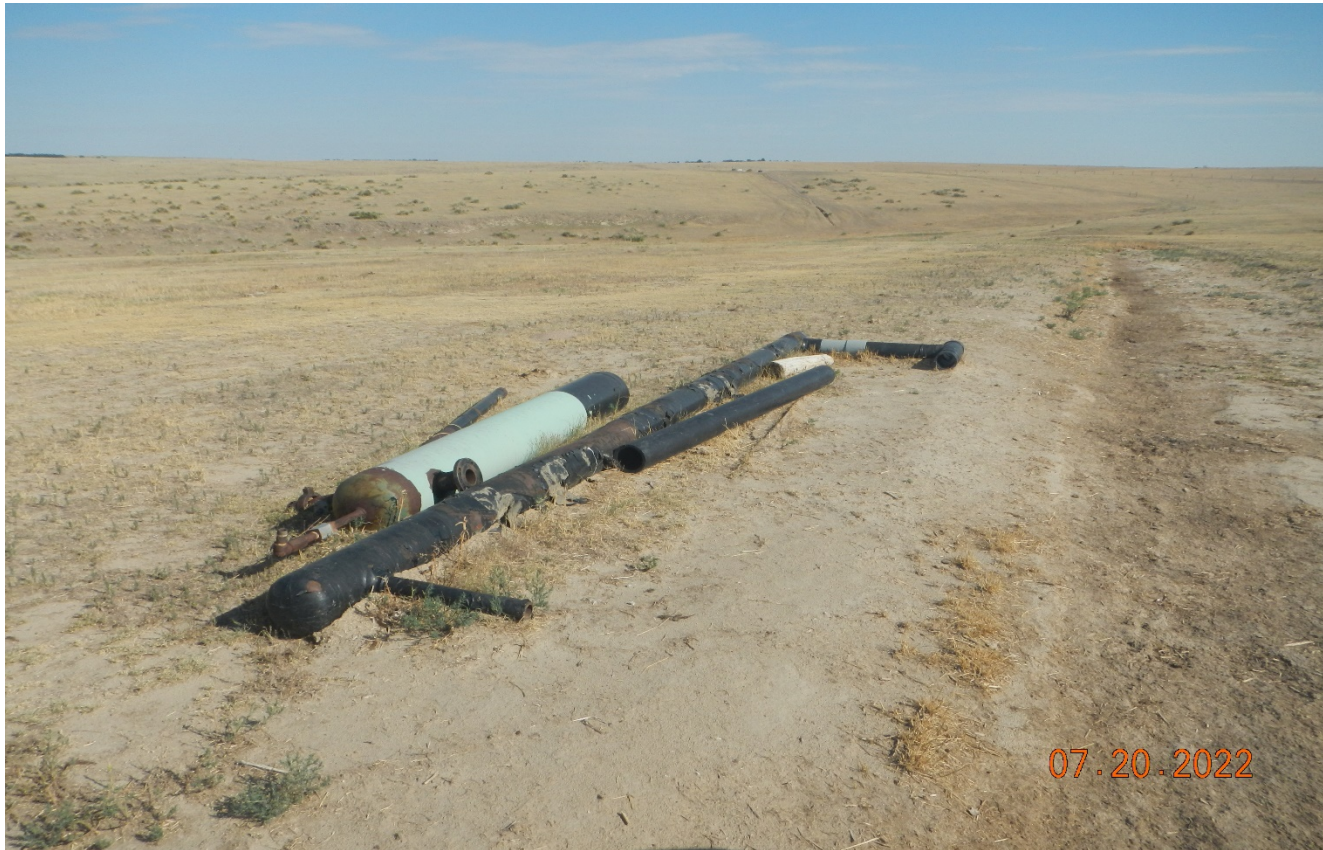
Photo 2. There is oil and gas equipment that remains adjacent to the access road that must be removed.

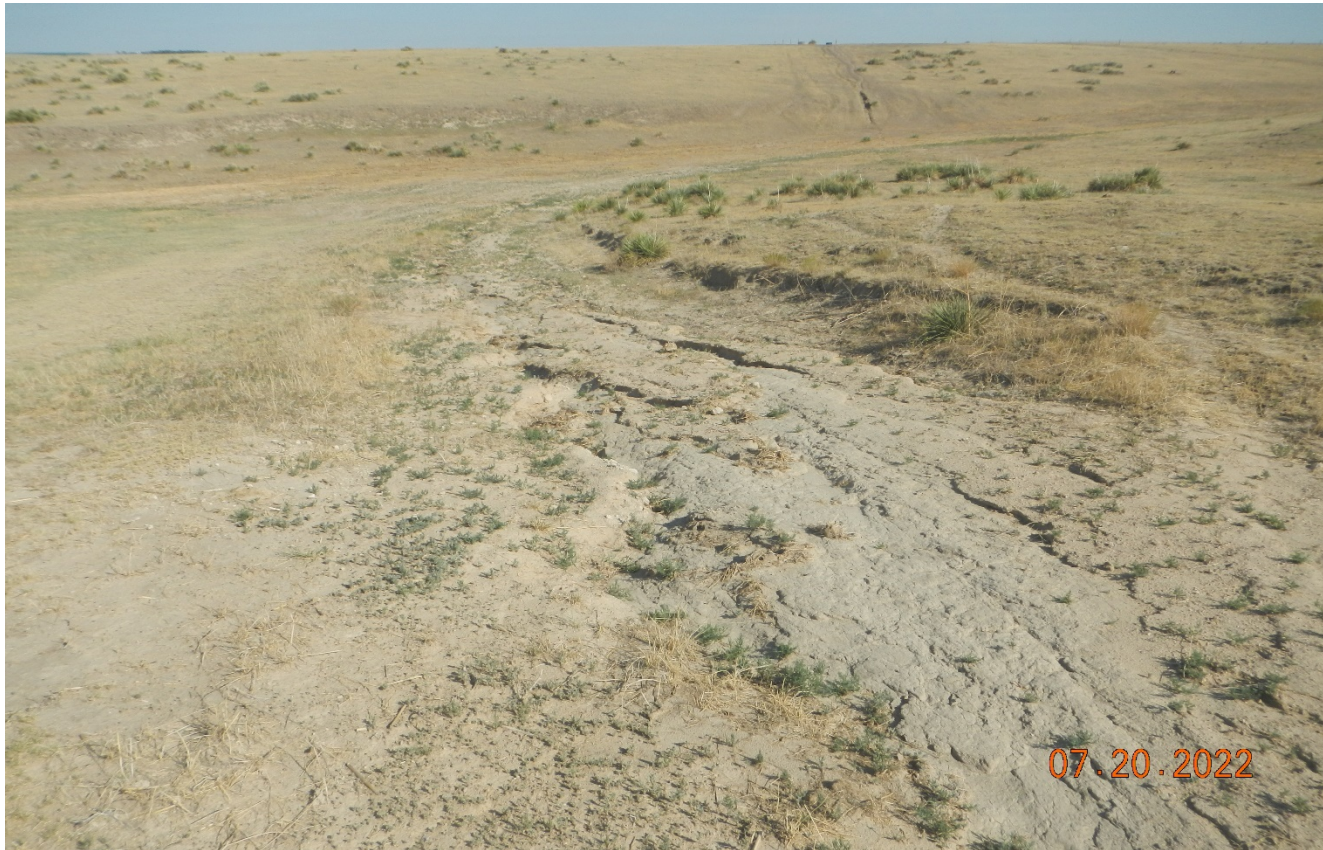
Photo 3. Facing north along the access road. There is erosion along the road which has not been reclaimed and stabilized.

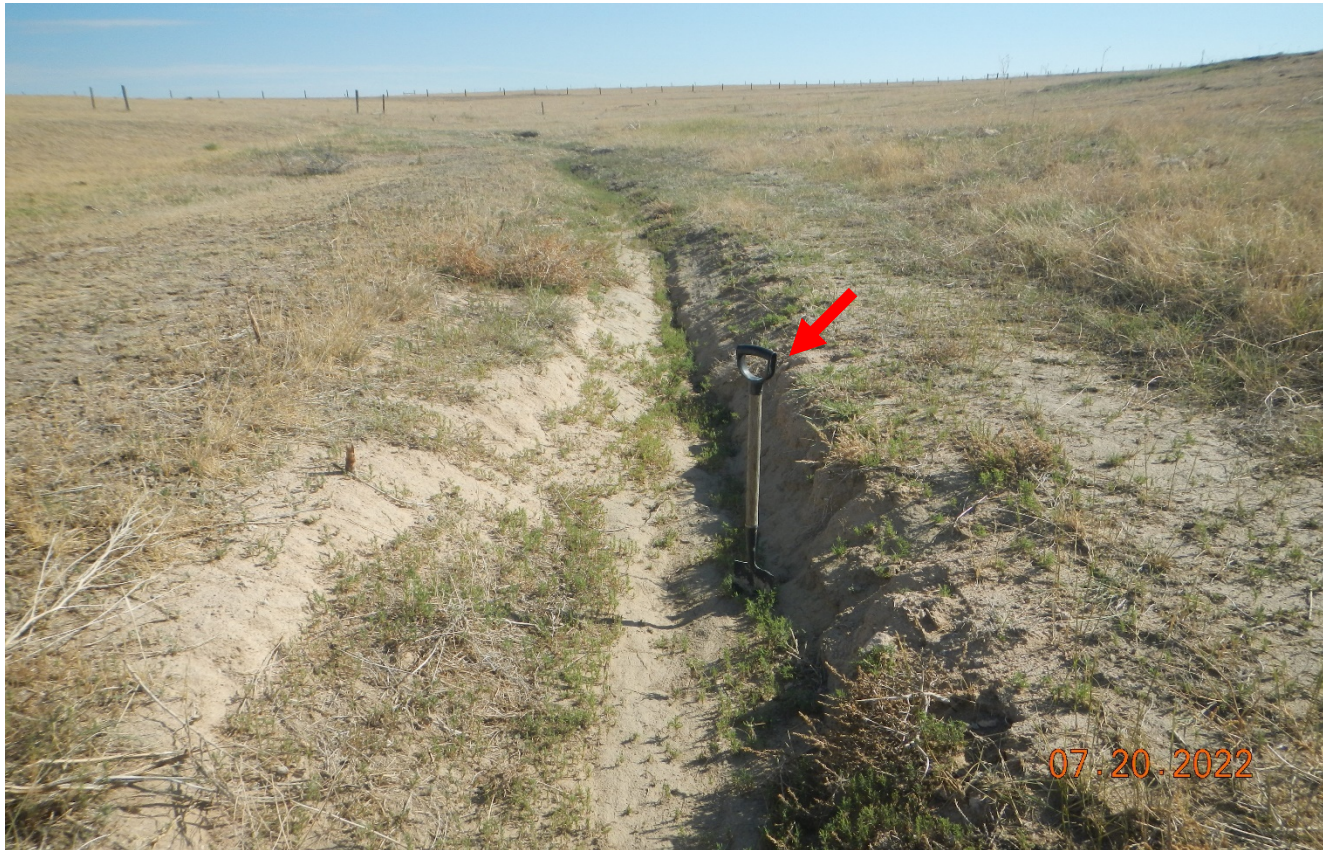
Photo 4. Facing northeast along the access road. There is erosion along the road. The red arrow points to a 4 ft shovel for scale of erosion channel.

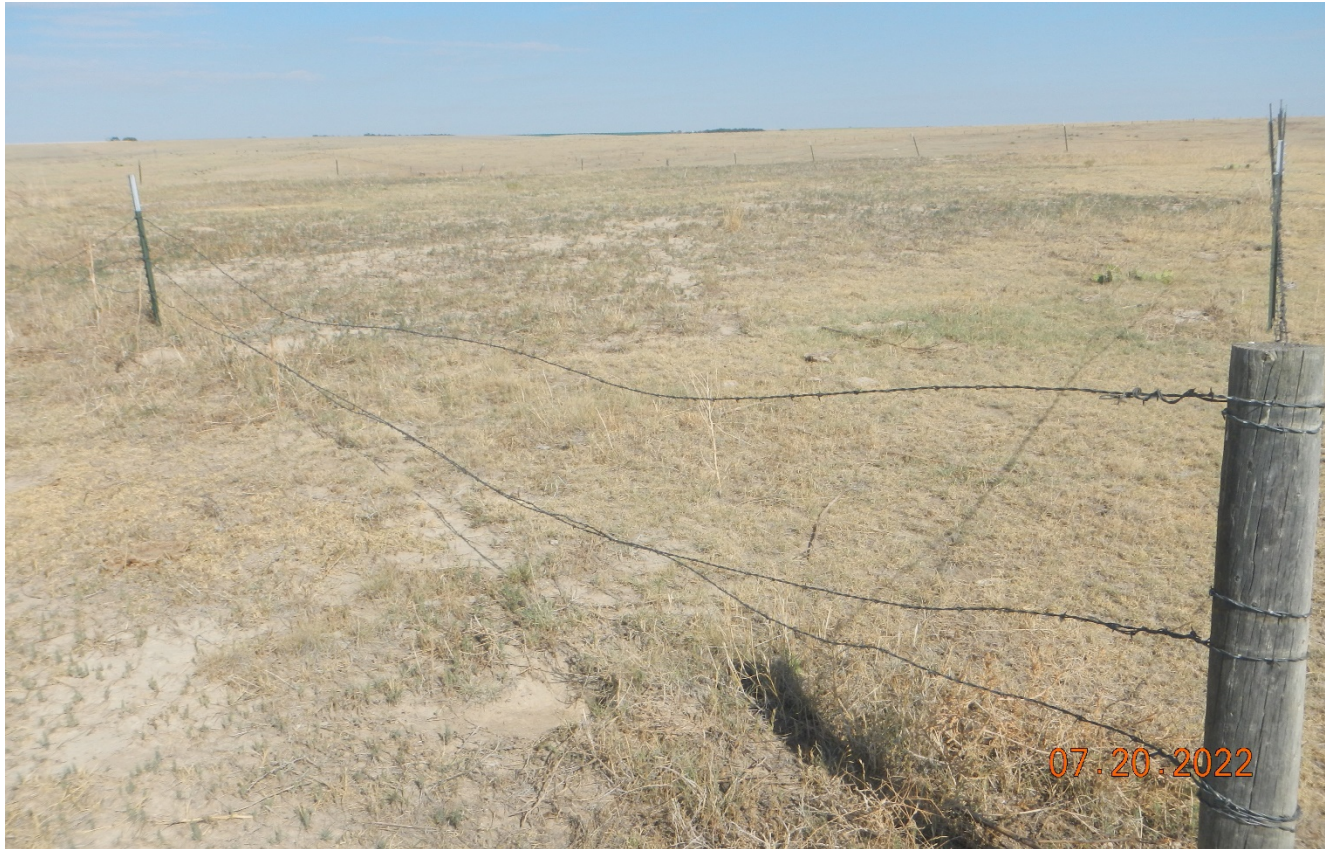
Photo 5. Facing northwest at the location. There is a perimeter fence around the location that is not maintained to prevent livestock entry.

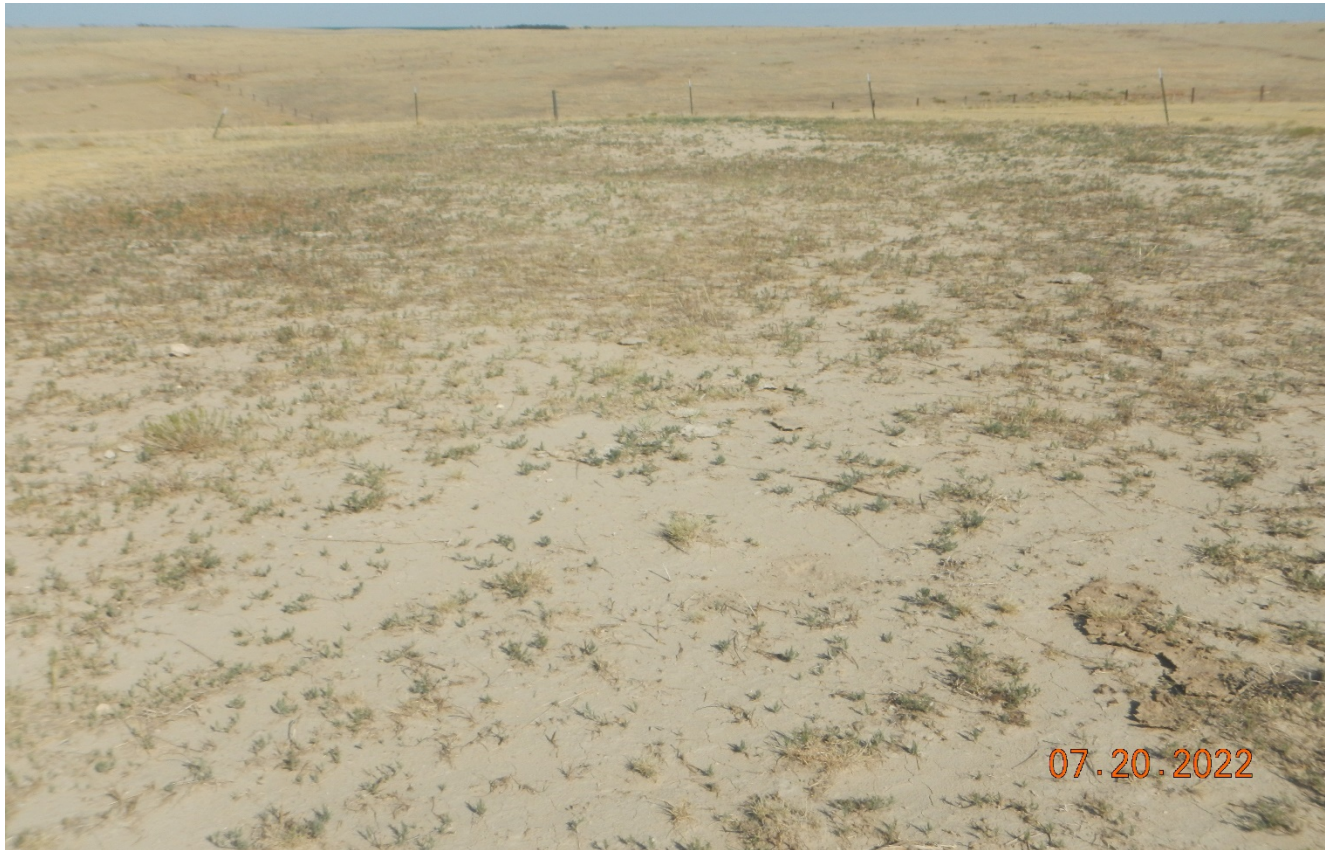
Photo 6. Facing northwest at the location. The desirable vegetation is sparse throughout the location and there are undesirable weeds (Kochia).

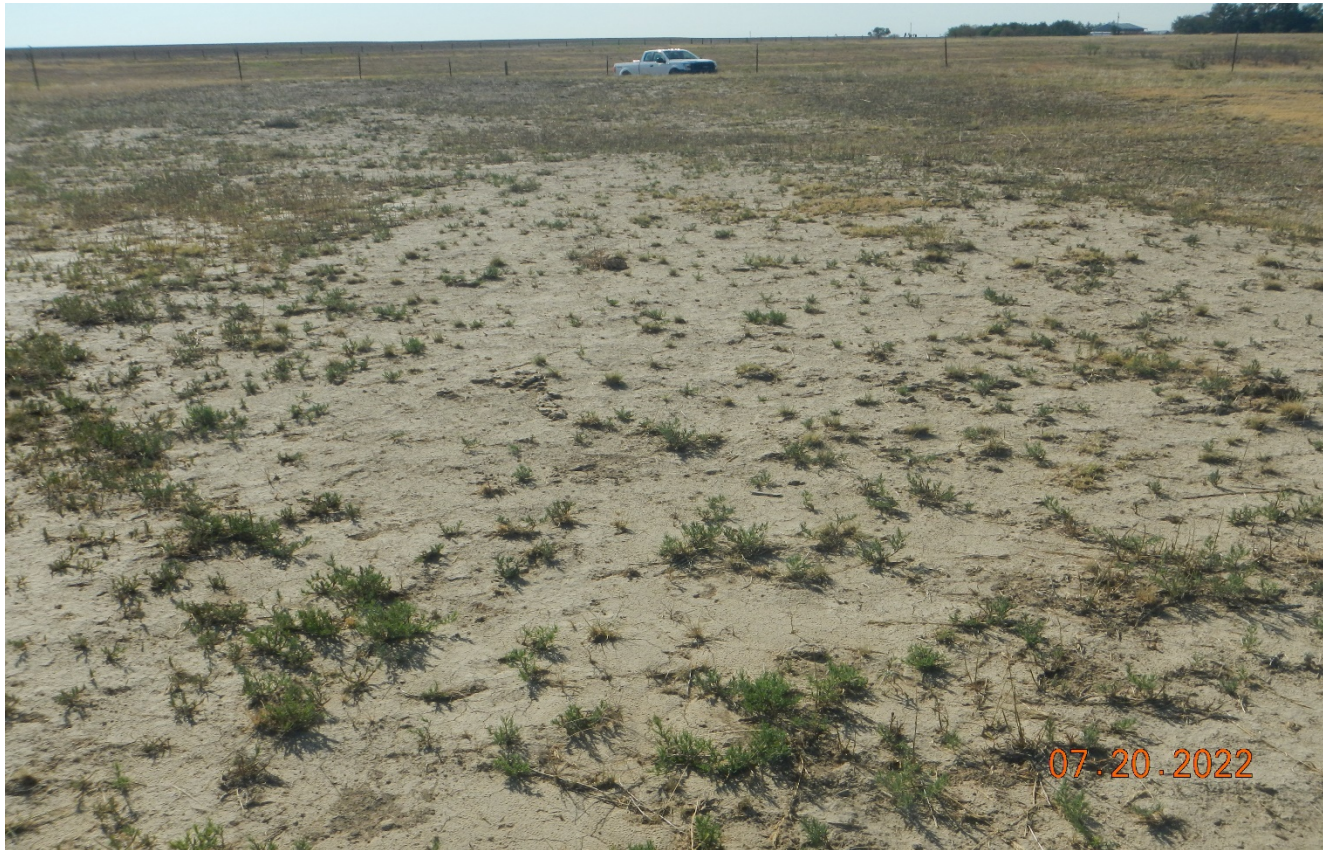
Photo 7. Facing southeast at the location. The desirable vegetation is sparse throughout the location and there are undesirable weeds (Kochia).

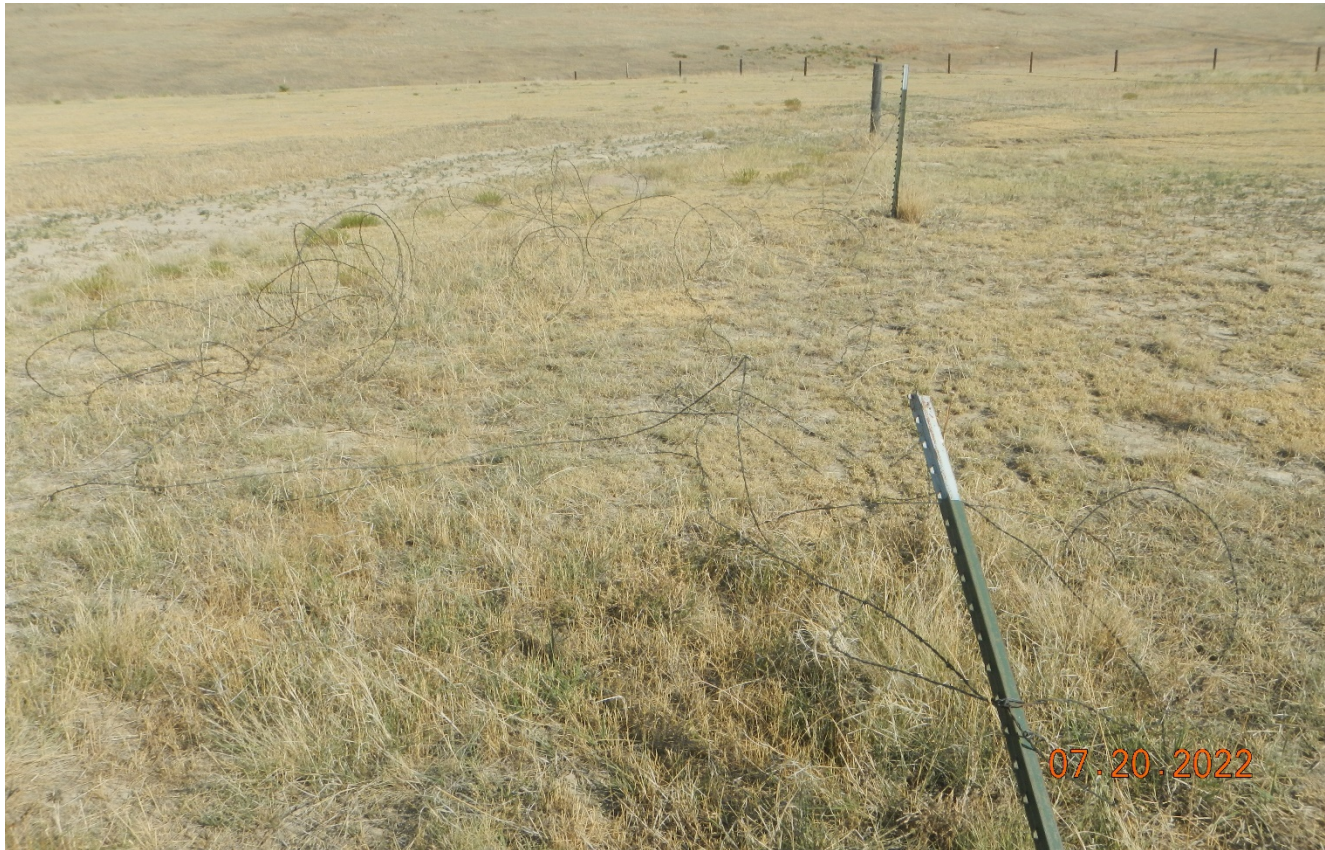
Photo 8. The fence around the location is in disrepair and barbed wire is stung out on the ground.

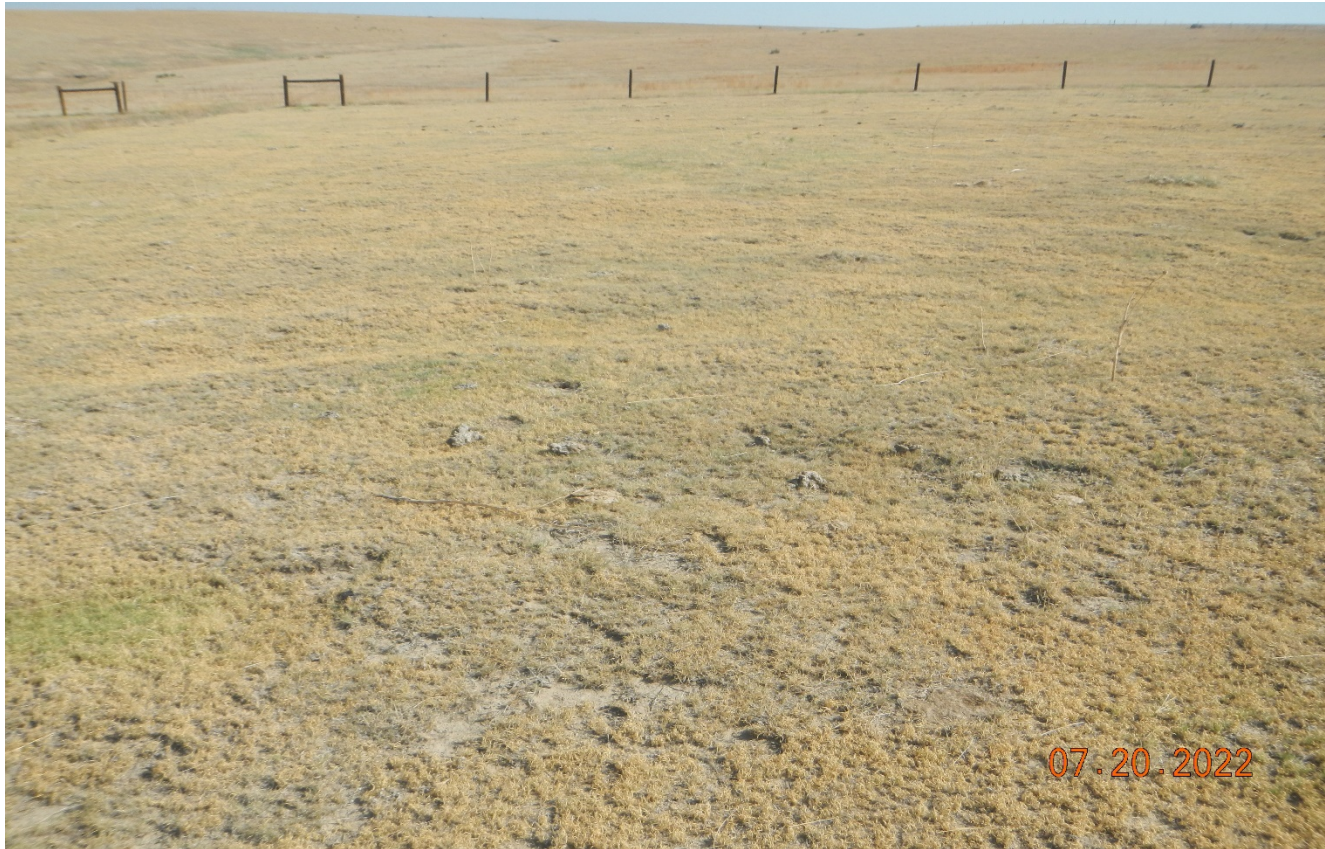
Photo 9. Facing north toward the surrounding undisturbed pasture consisting of Buffalo grass among other native species.
