Inspection Photos and Issue Report

Operator: CAERUS PICEANCE LLC # 10456

Location #479185

Rio Blanco County, CO

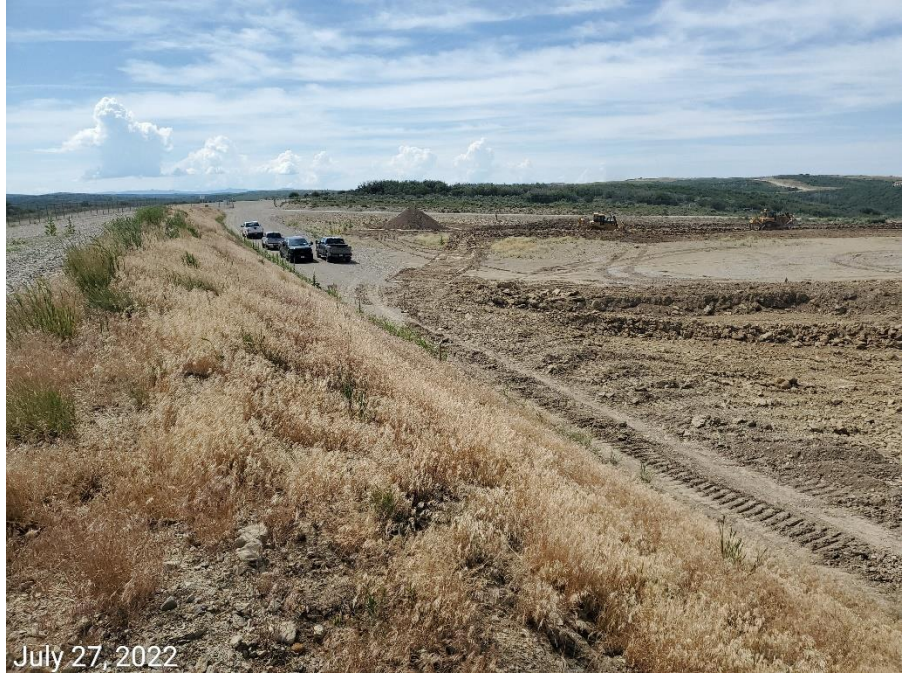
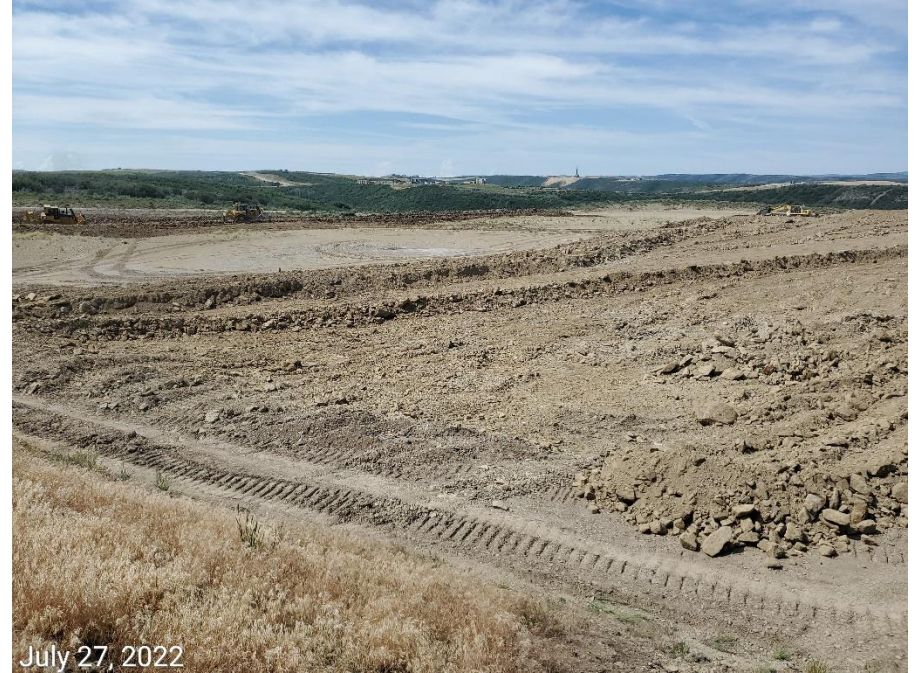
Photo 1: Photos 1-2 taken from the east end of the Location. Photos provide an overview of the Location, construction activities “in-process”, and the pre-existing TLQ facility.

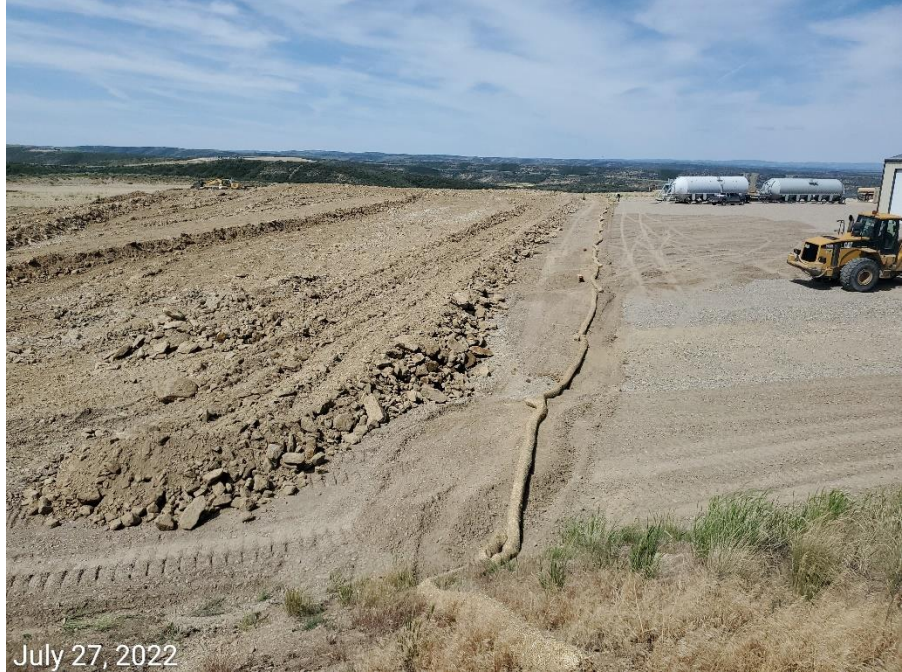
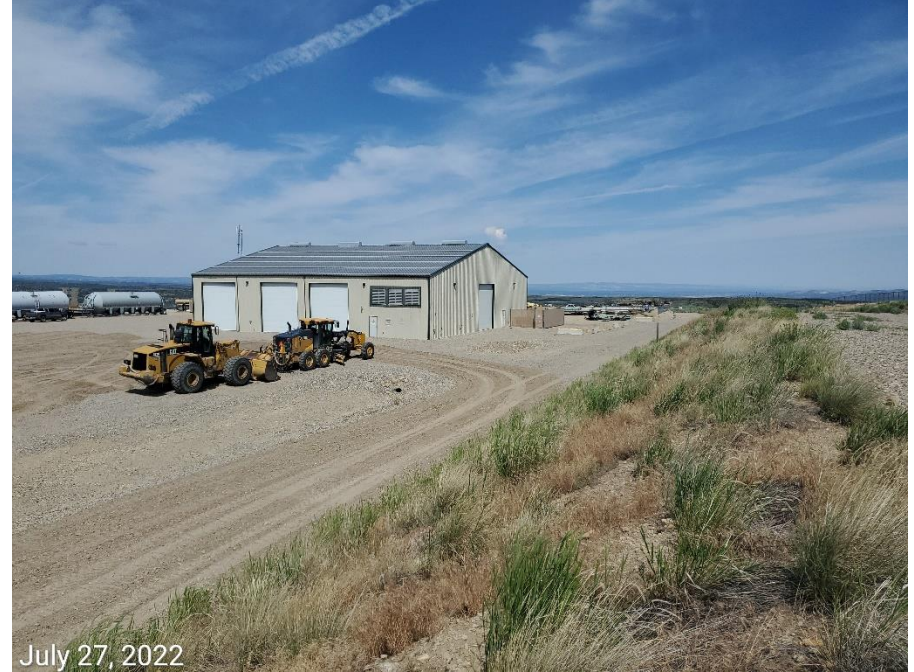
Photo 2: See comments under photo 1.

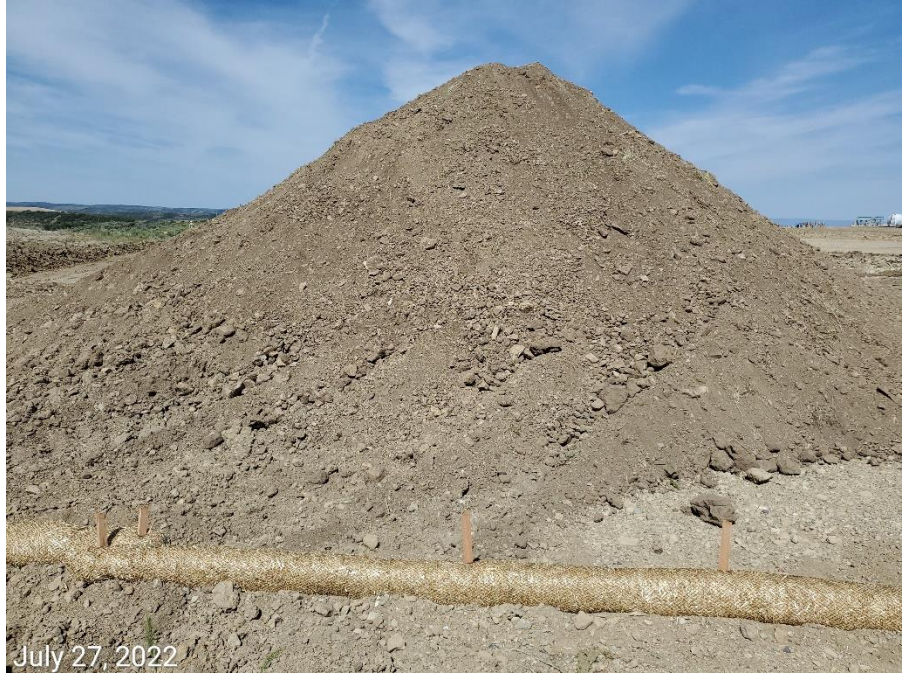
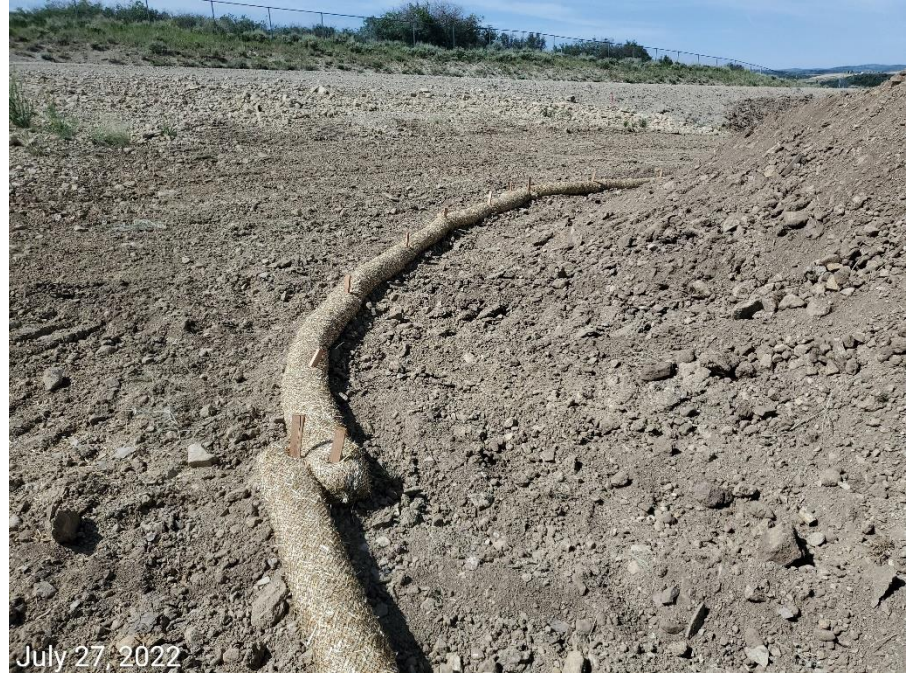
Photo 3: Topsoil stockpile. Straw wattle implemented at base of pile to minimize sediment transport. Topsoil pile is currently at risk to wind erosion- continue to maintain stockpile, ensure BMPs are implemented/maintained to ensure soils remain protected.

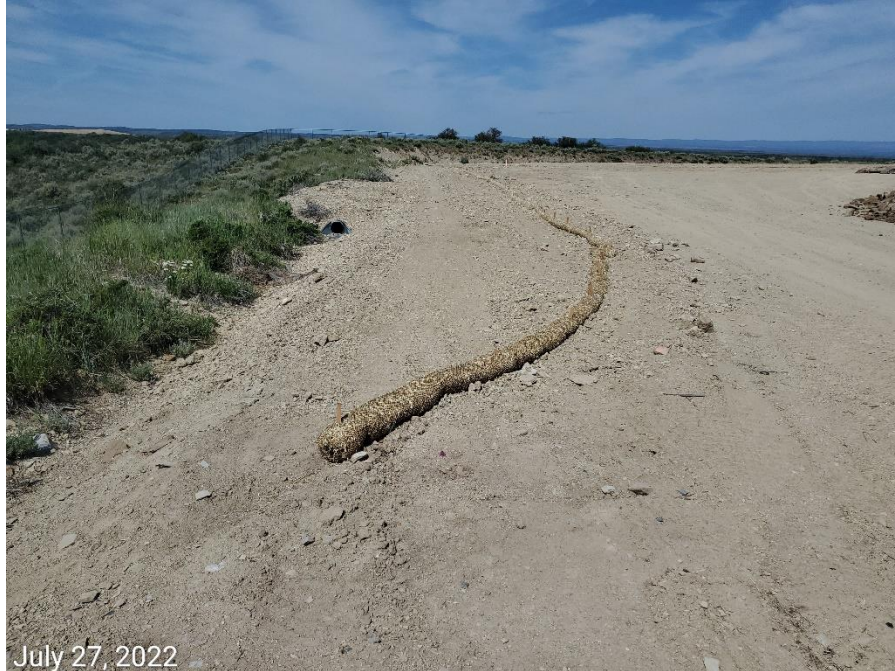
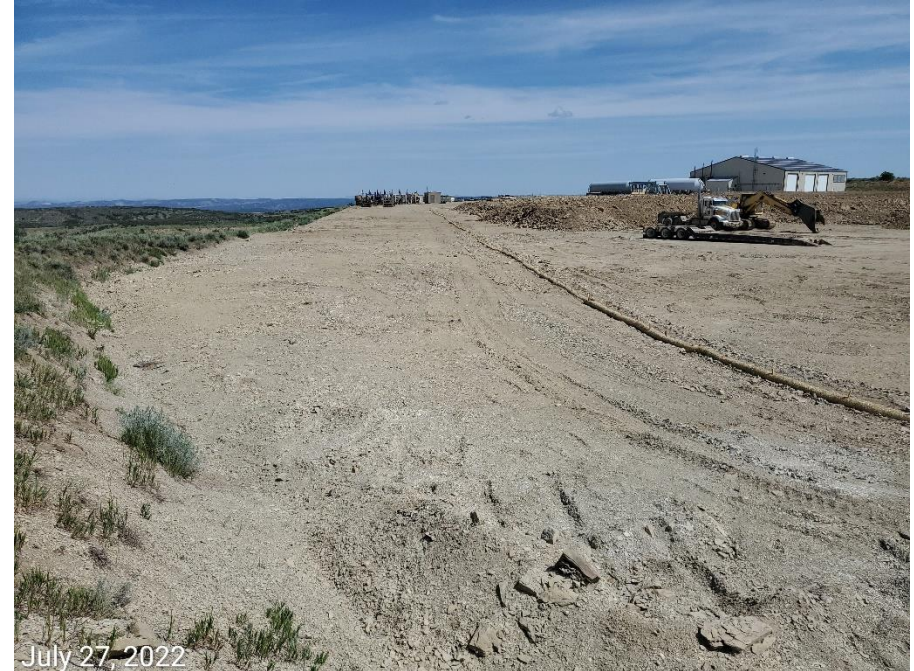
Photo 4: Wattles installed along current (construction) disturbance perimeter. Photo left also shows perimeter stormwater diversion ditch and culvert in place to divert runoff into sediment traps located on the south and west end of the Location.

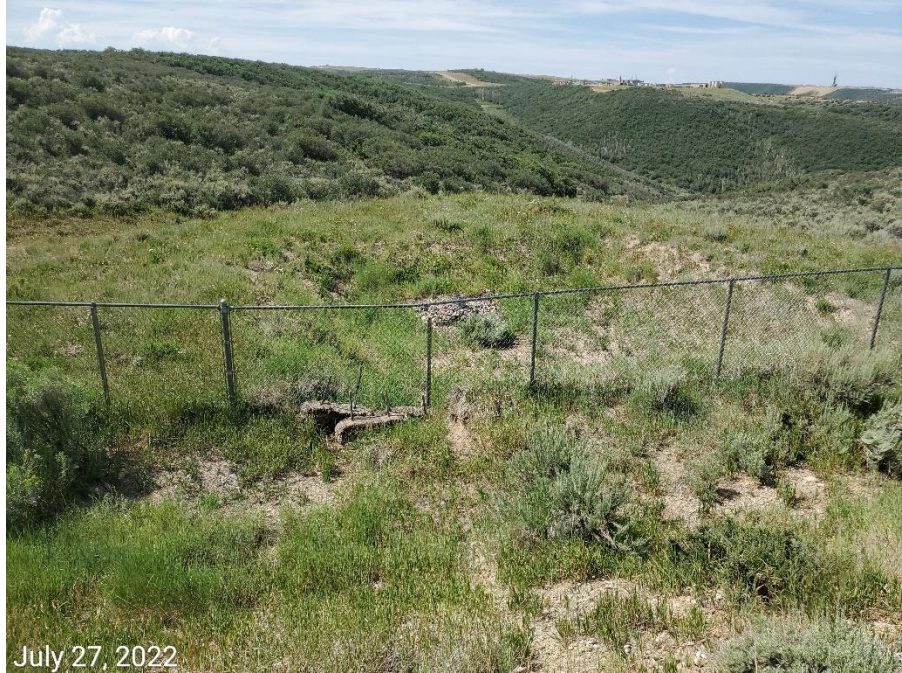
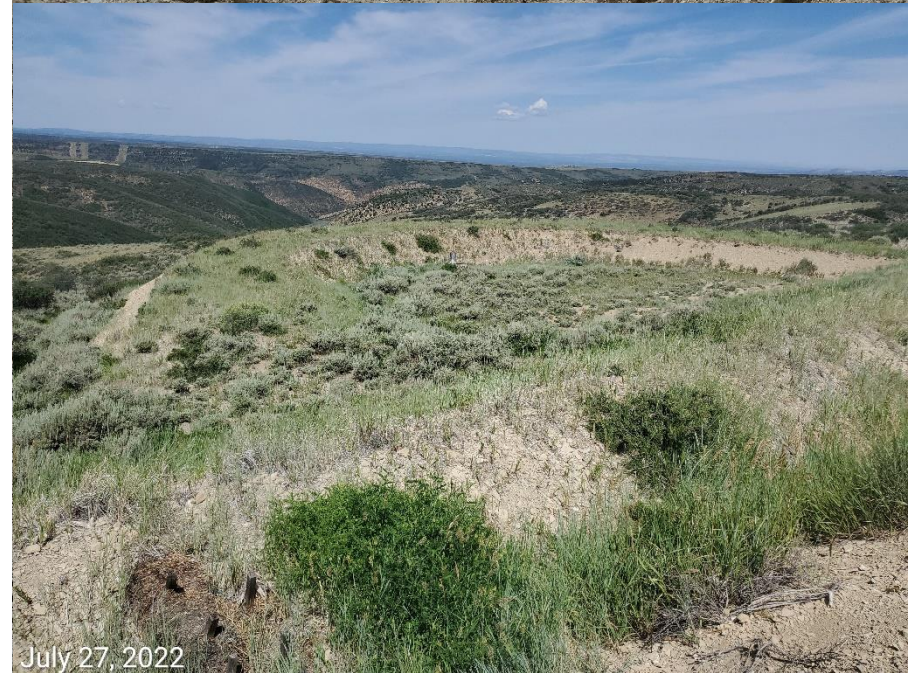
Photo 5: Sediment traps on south/west ends of the Location.

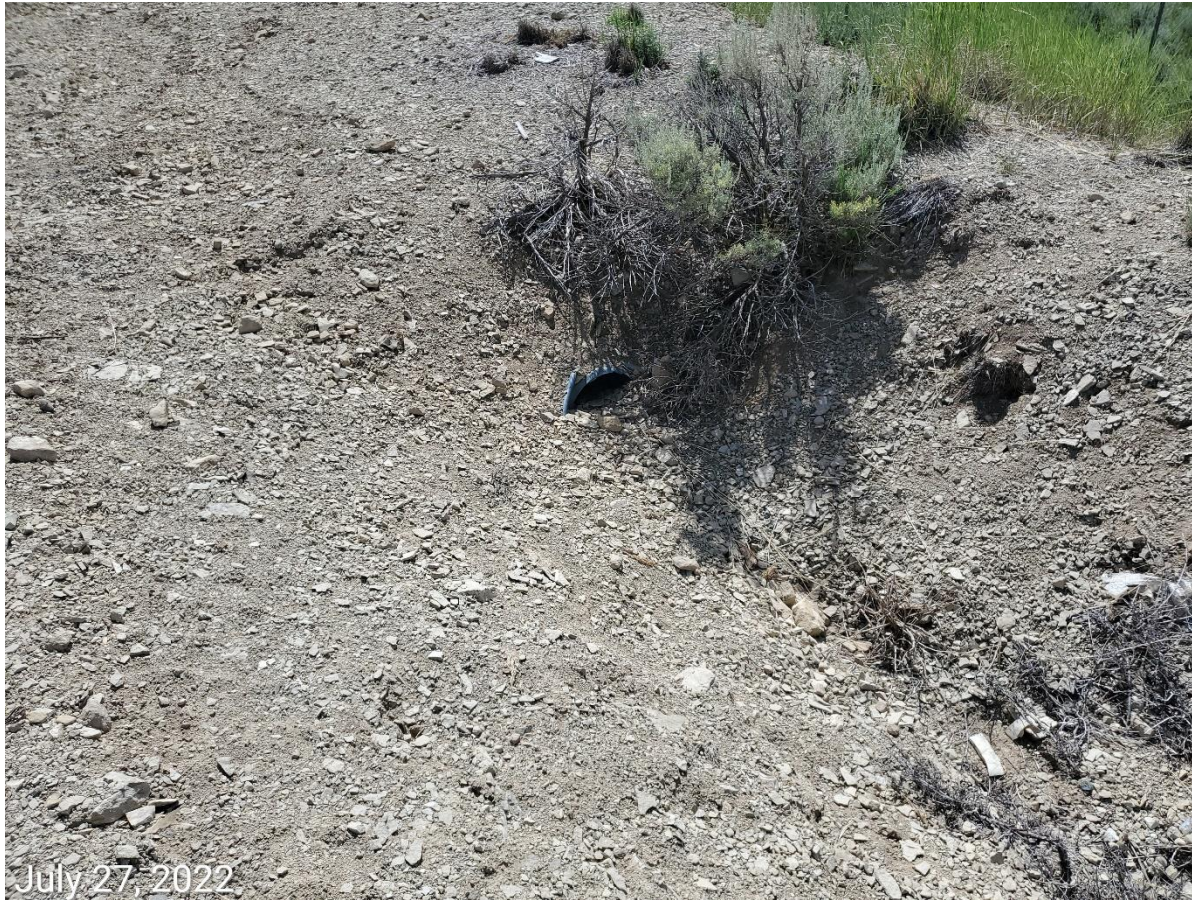
Photo 6: Culvert on south end of the Location filling with sediment.

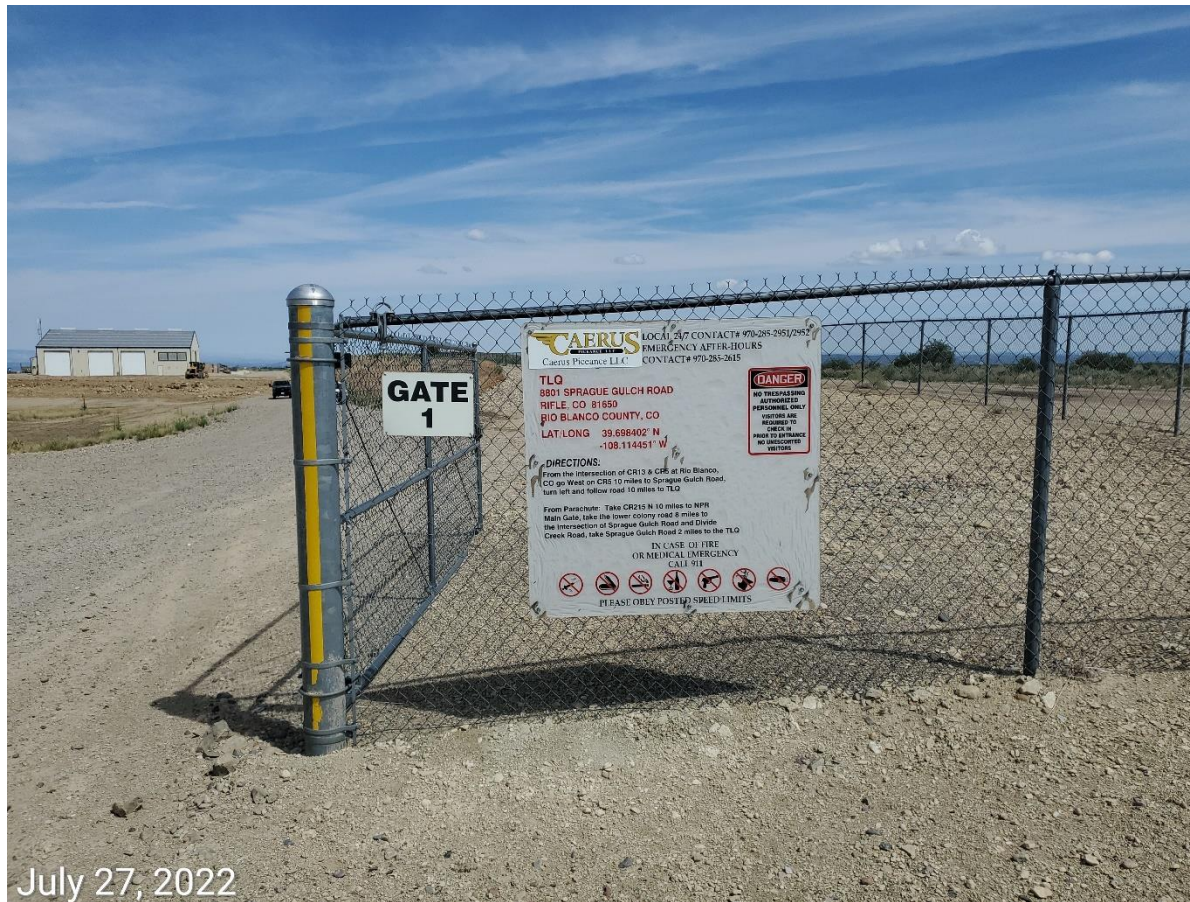
Photo 7: Only signage posted at the Location- Signage not associated with the ELU O13-496 Pad Location; Location signage per Rule 605.a missing. Form 2A information also not posted.
