# Construction and Stormwater Inspection

July 26, 2022

Operator: VERDAD RESOURCES LLC #10651

Location ID: 466345

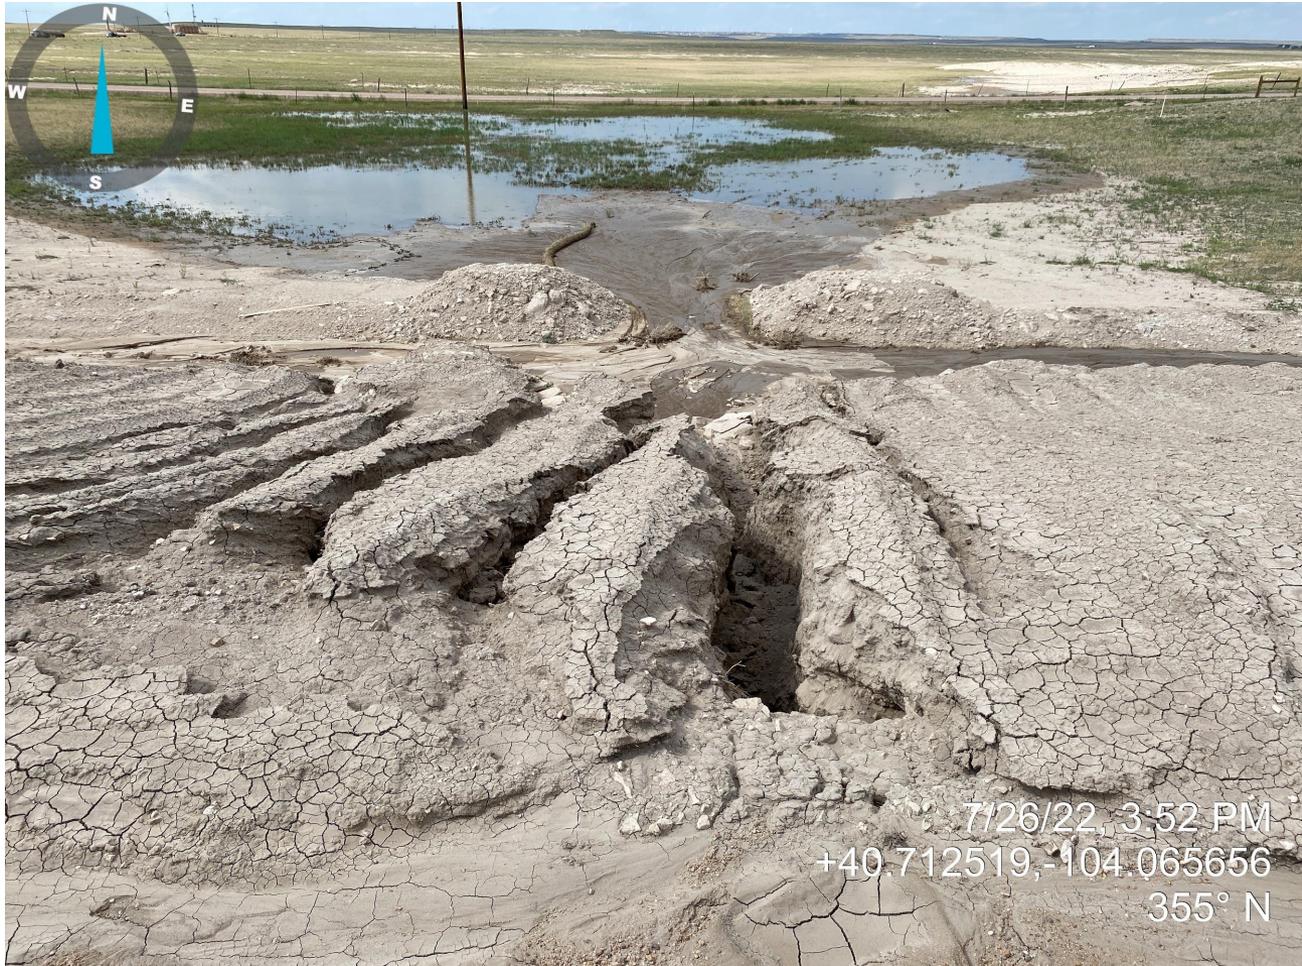
**Photo 1.** Photo taken from the northeastern location, facing North. Photo illustrates sediment discharge from location. Operator failed to install sufficient stormwater BMPs to comply with Rule 1002.f.

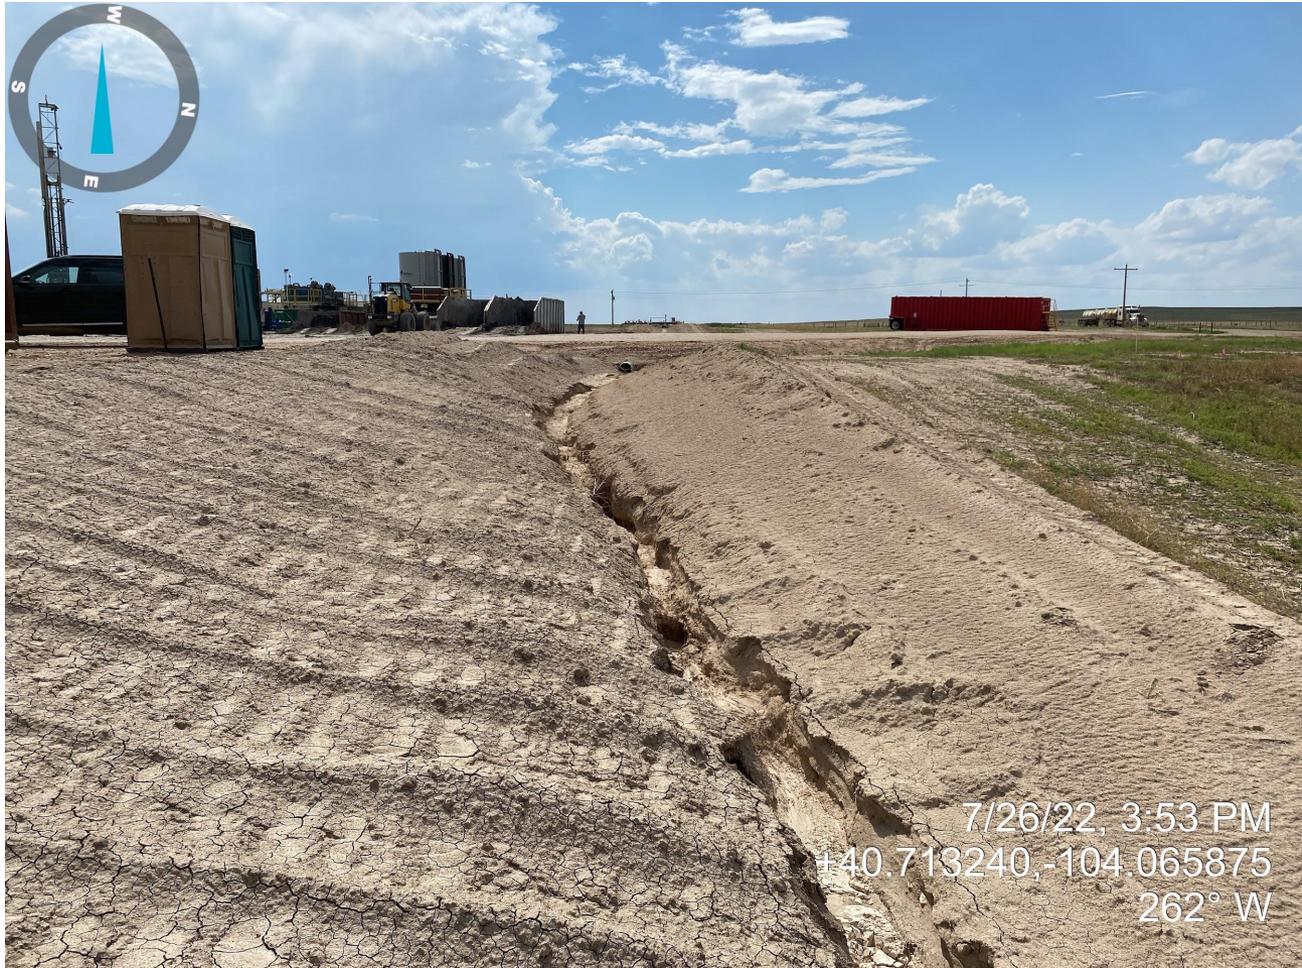
**Photo 2.** Photo taken from the northeastern location, facing West. Photo illustrates gully erosion along the ditch BMP. Operator has failed to properly stabilize the ditch BMP to prevent erosion. Also, the fill slope has only been temporarily stabilized with equipment tracking.

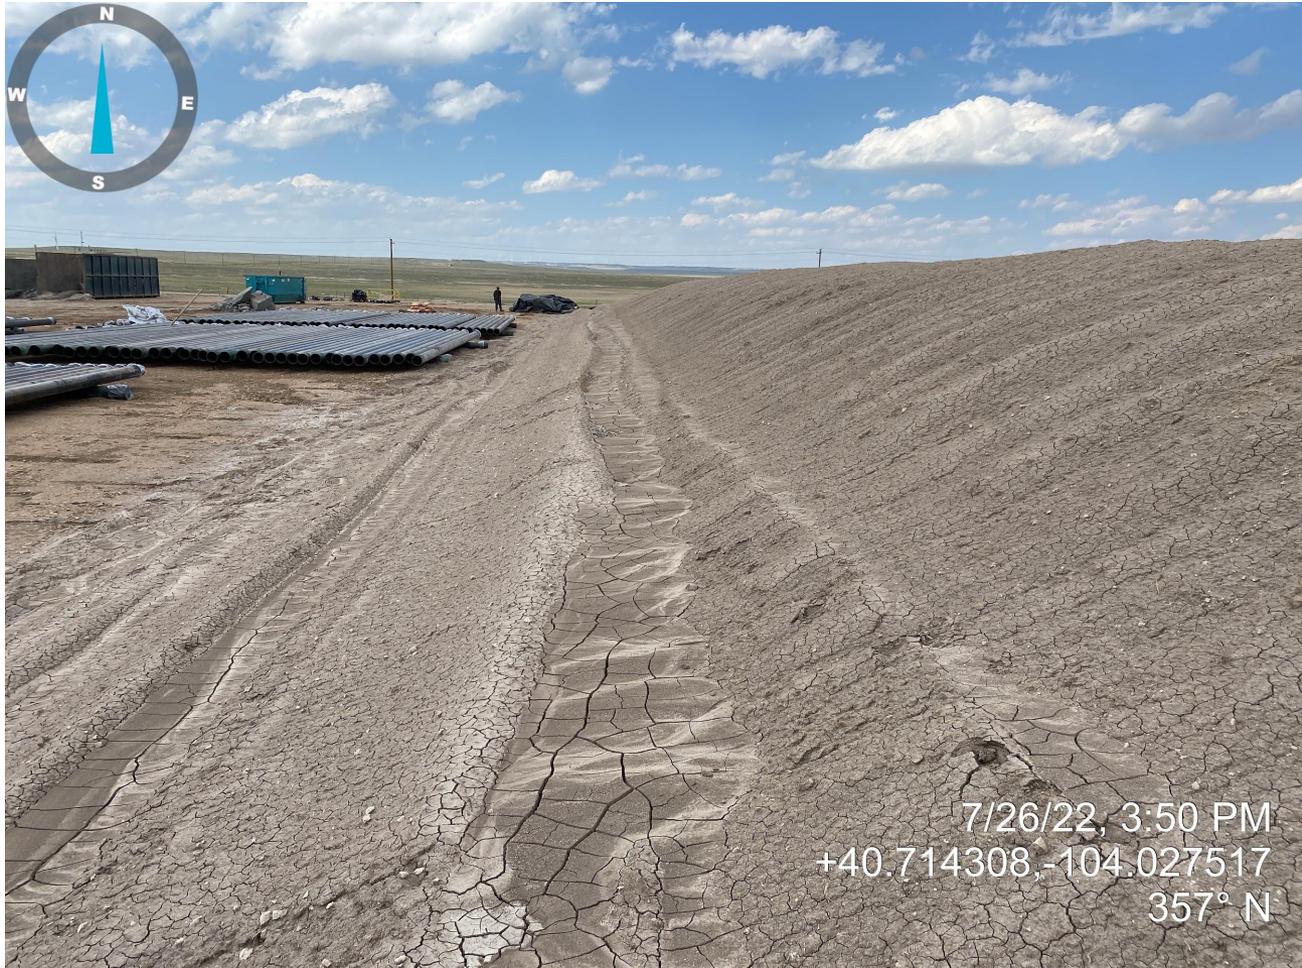
**Photo 3.** Photo taken from the western side of the topsoil stockpile, facing North. Photo illustrates the topsoil stockpile has only been temporarily stabilized with equipment tracking and erosion is starting to occur.

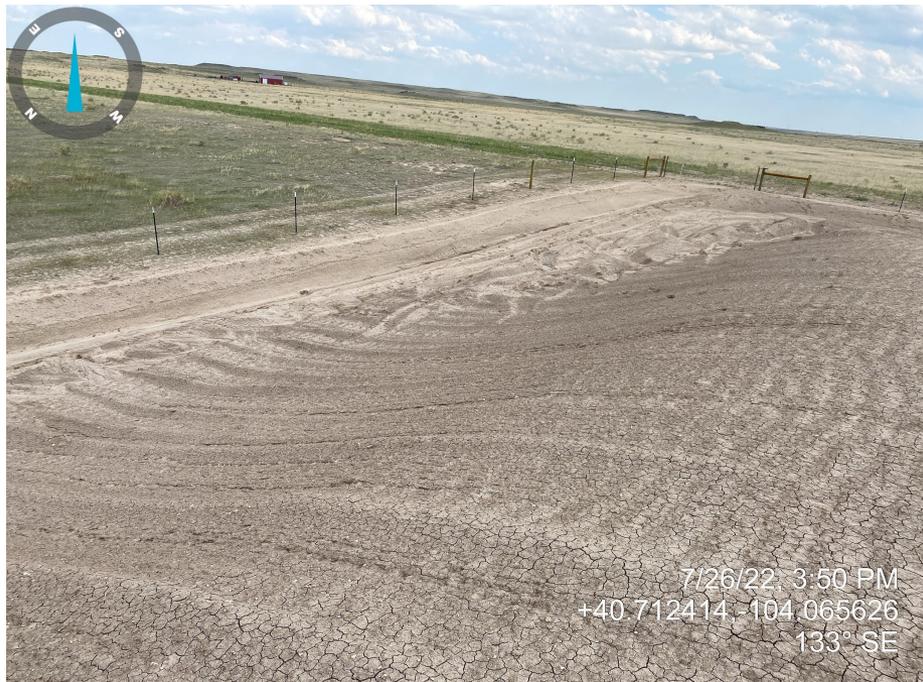
**Photo 4.** Photo taken from the southern topsoil stockpile, facing Southeast. See comments under Photo 3.

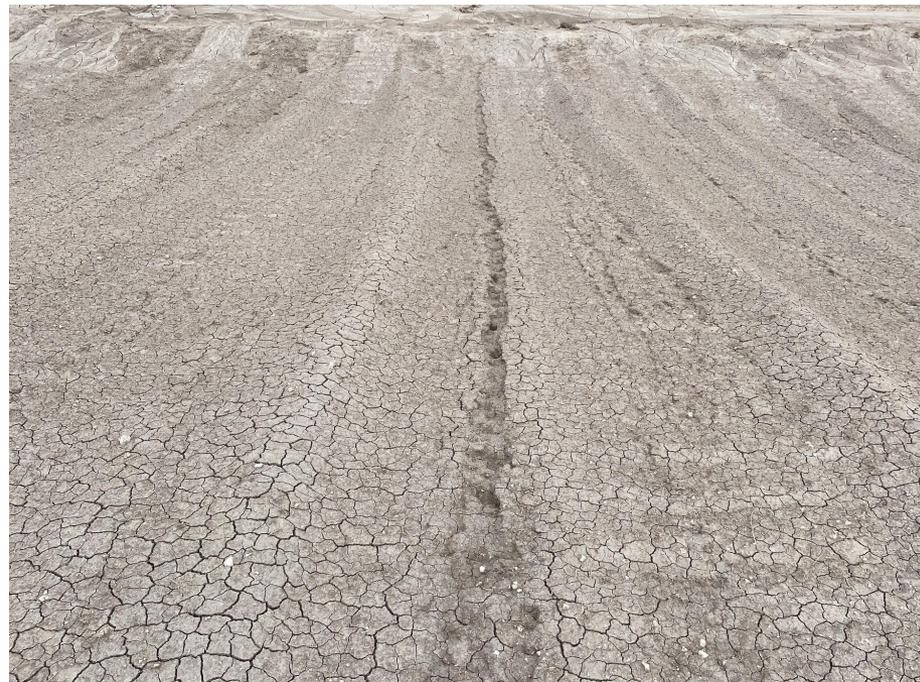
**Photo 5.** Photo taken from the southern topsoil stockpile, facing East. See comments under Photo 3.

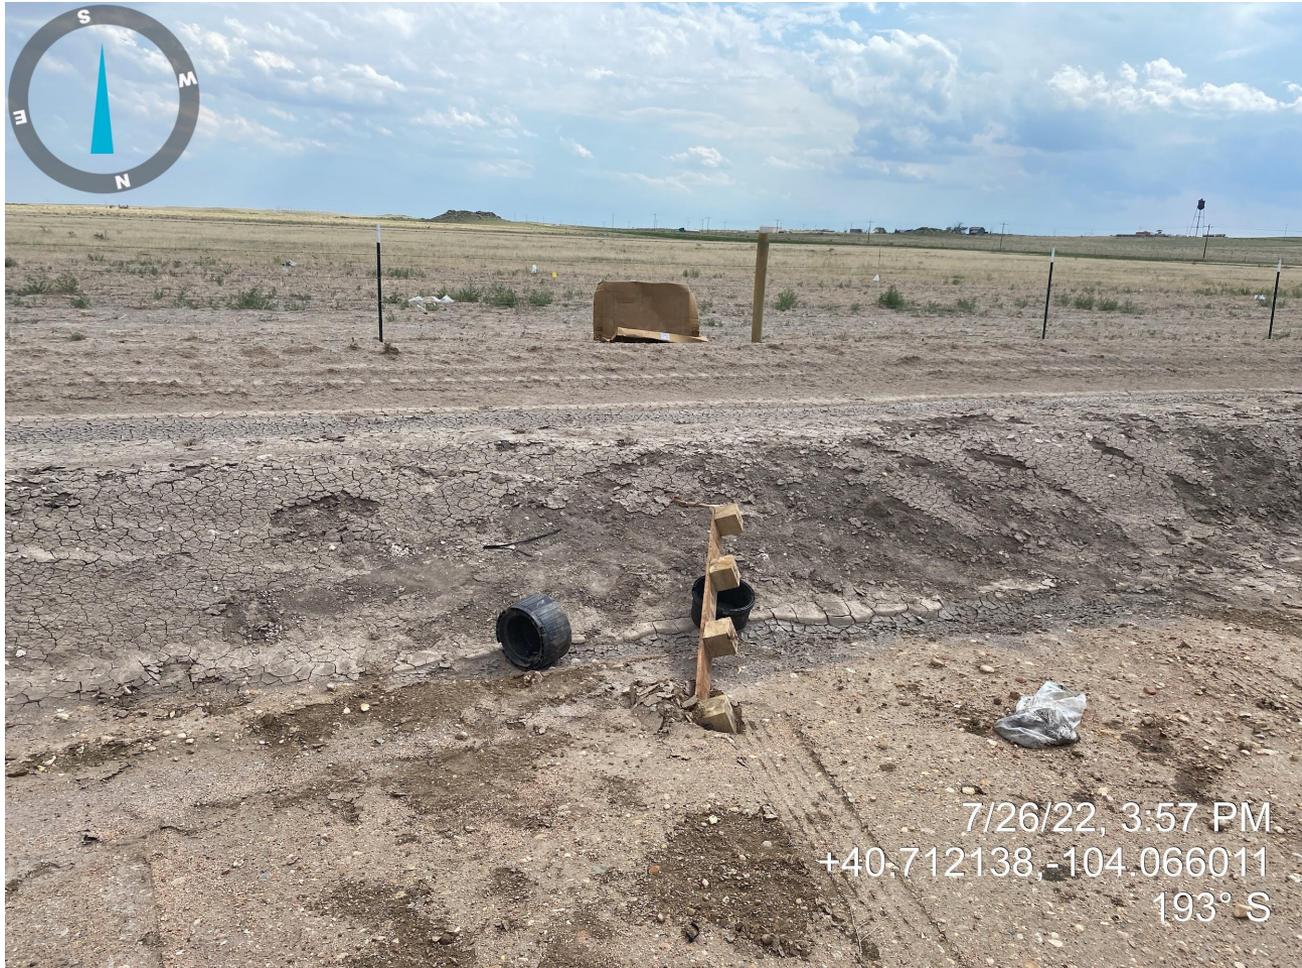
**Photo 6.** Photo taken from the southern location, facing Southwest. Photo illustrates trash and debris blowing off location. Operator shall collect all trash and debris that has blown off location.
