Reclamation Inspection

Operator: NOBLE ENERGY INC - #100322

Location ID: 287848

Location Name: CENTRALIZED LAND TREATMENT FACILITY

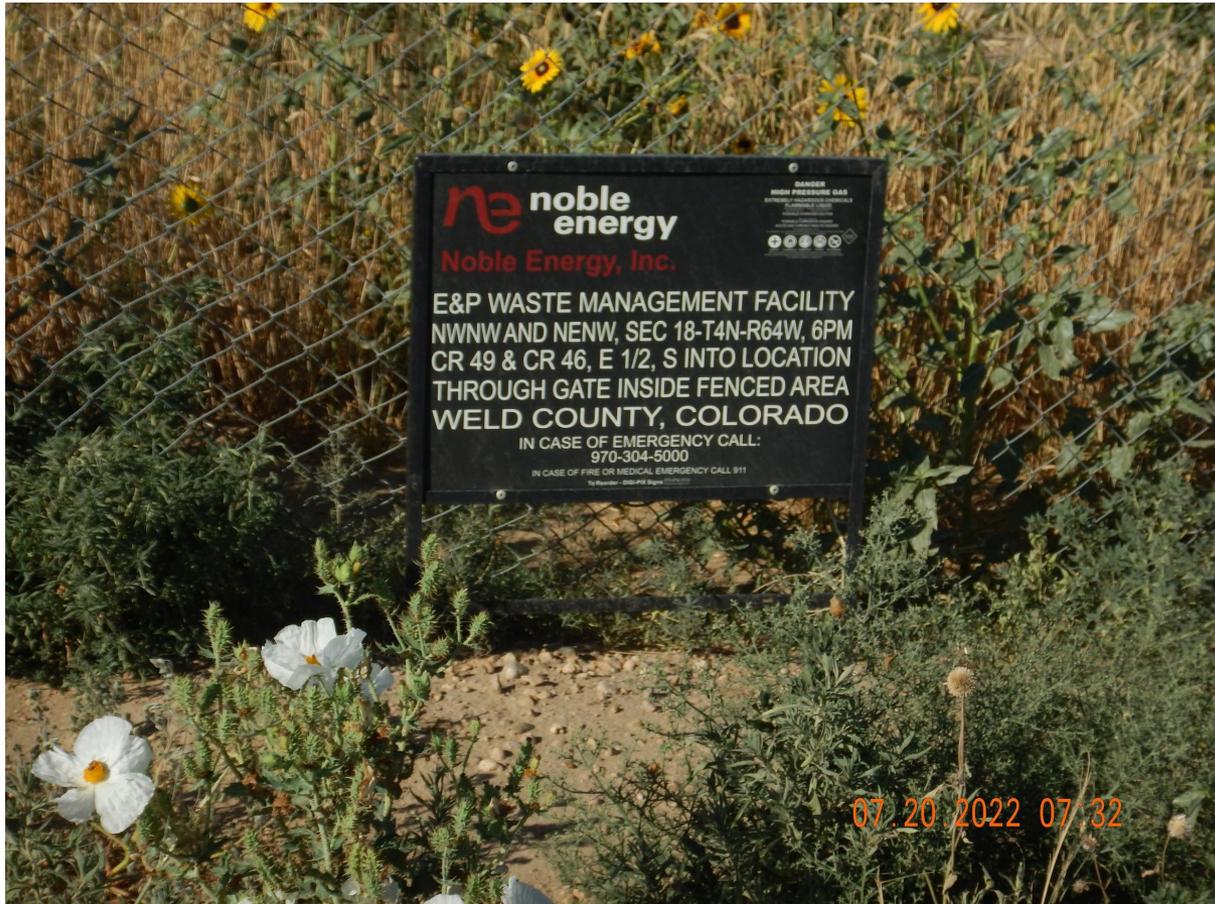
Photo 1. Photo taken from the entrance of the location. Photo illustrates the Operator sign which needs to be updated- the emergency phone number is not accurate and the title needs to be updated to state that NO E&P Waste is accepted.

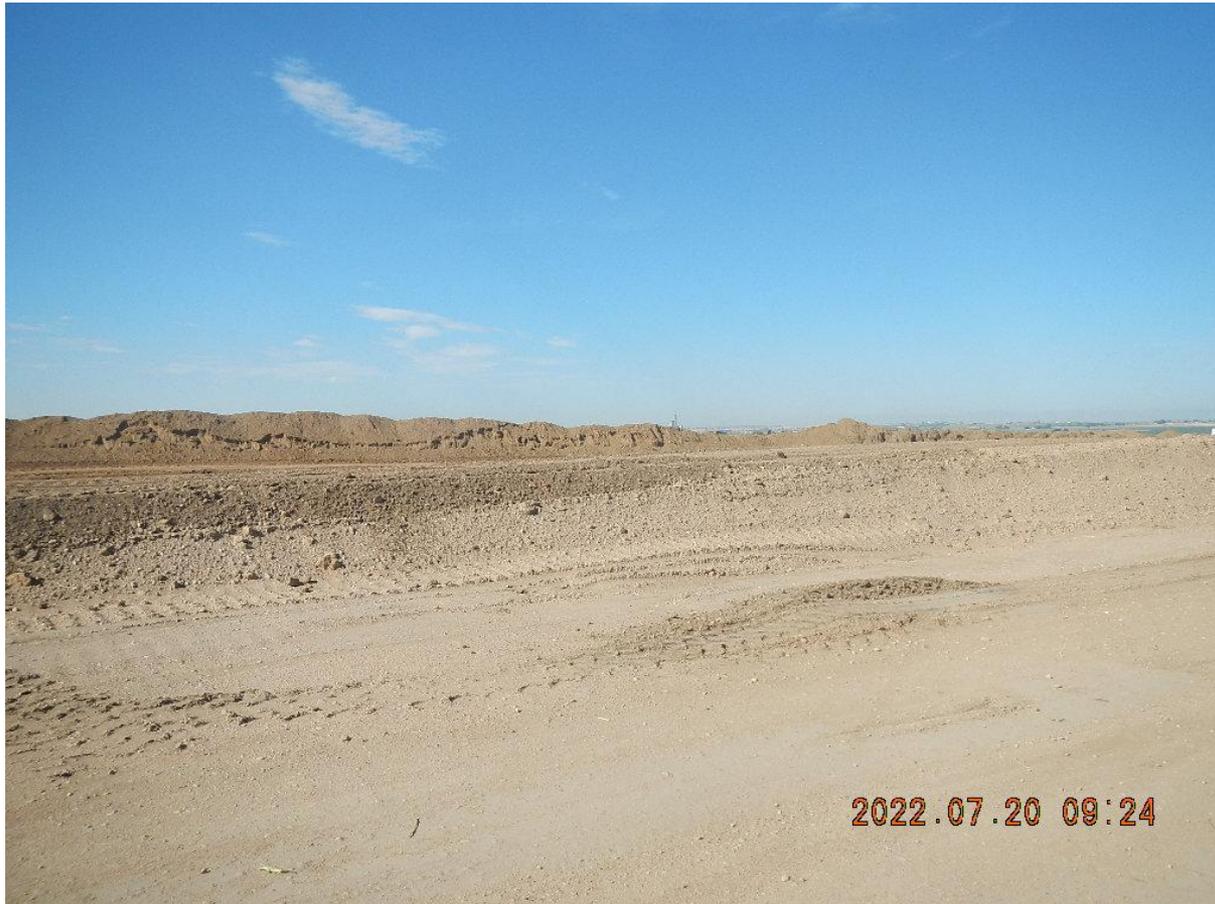
Photo 2. Photo taken from the northern location, facing Southwest. Photo illustrates one of the gravel (clean roadbase) stockpiles that is from interim and final reclamation locations being reused.

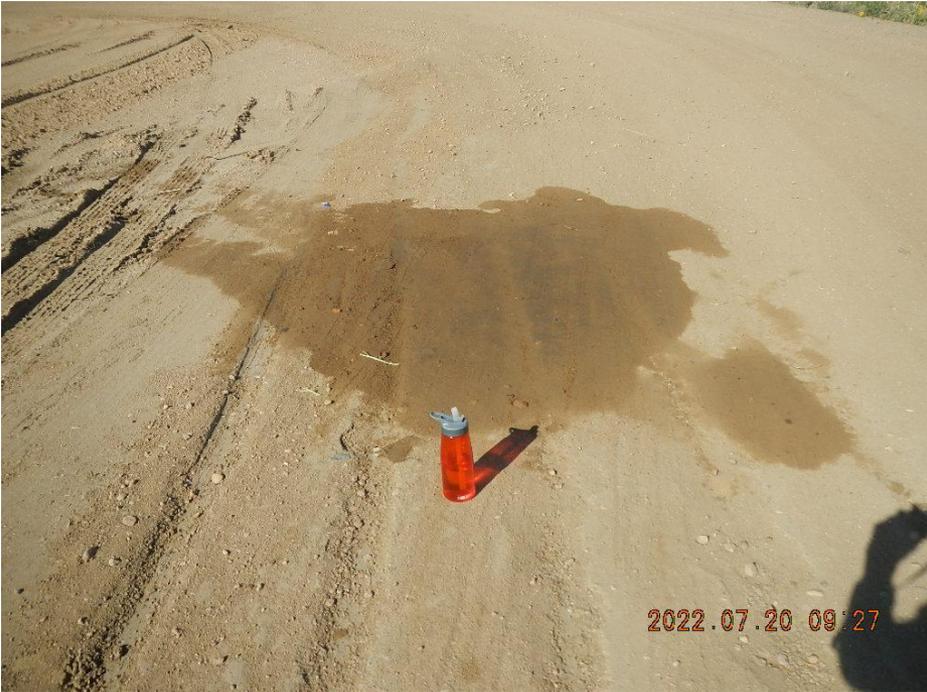
Photo 3. Photo taken from the north location, facing West. Photo illustrates an unknown spill.

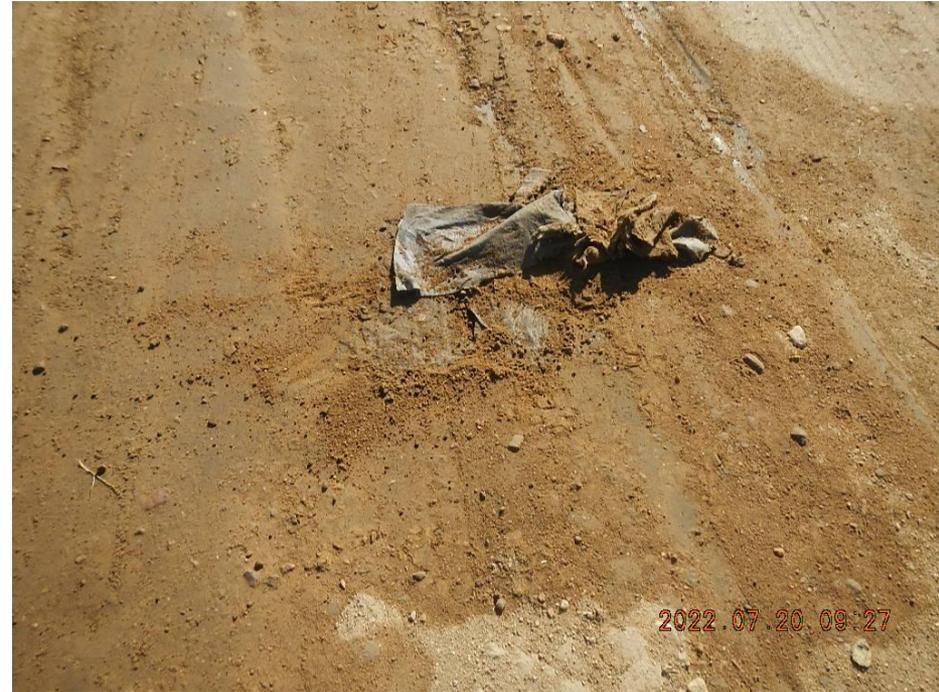
Photo 4. Photo taken from the previous photo. Photo illustrates trash within the spill area. Trash and debris were observed throughout other areas of the location.

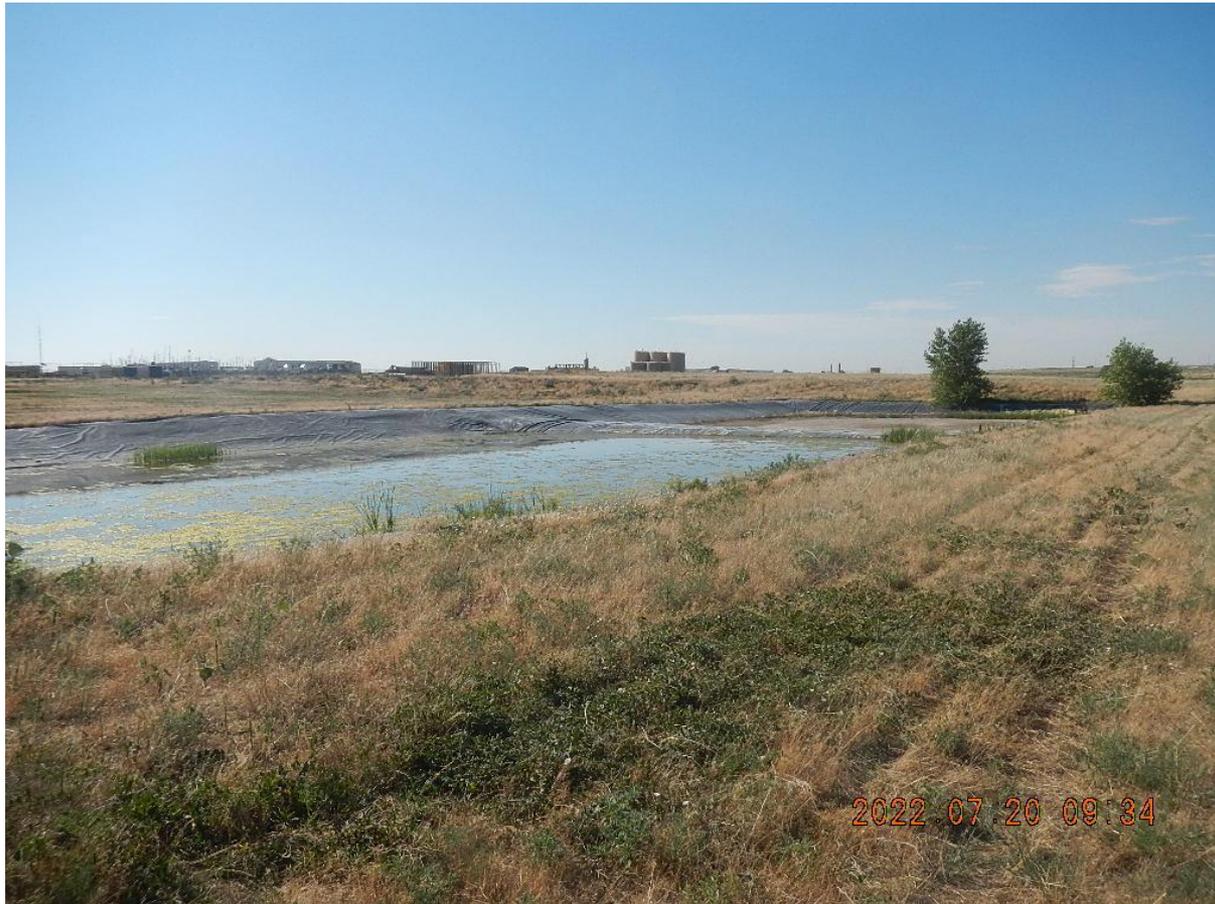
Photo 5. Photo taken from the western location, facing South. Photo illustrates stormwater retention ponds. Operator will need to perform sampling beneath the liner.

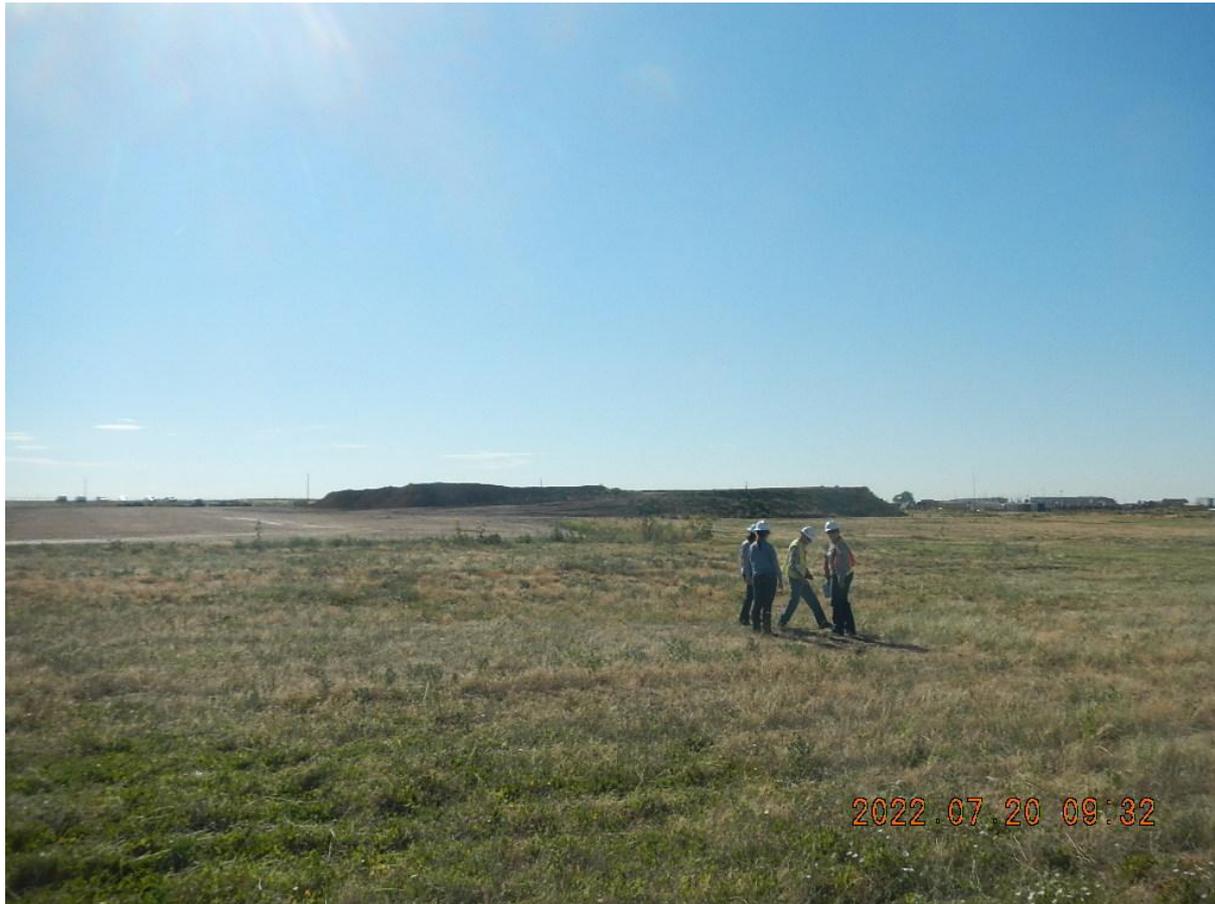
Photo 6. Photo taken from the western location, facing East. Photo illustrates the vegetated area that appears to be recently mowed, likely for performing weed control.
