Inspection Photos

Operator: Caerus Piceance LLC - #10456

Location Name: GL-67S93W /18SWSE

Inspection Document #: 702800555

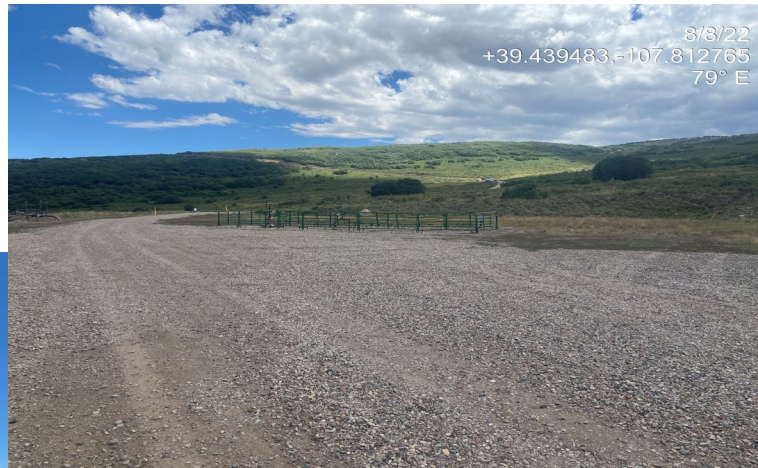
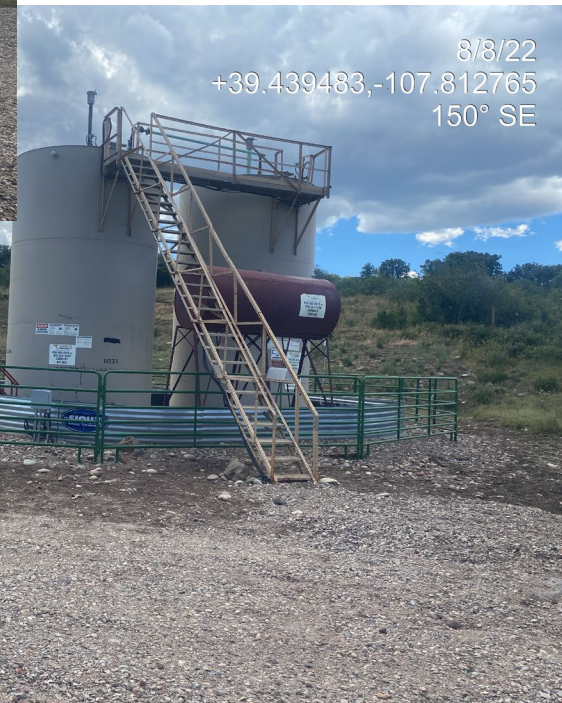
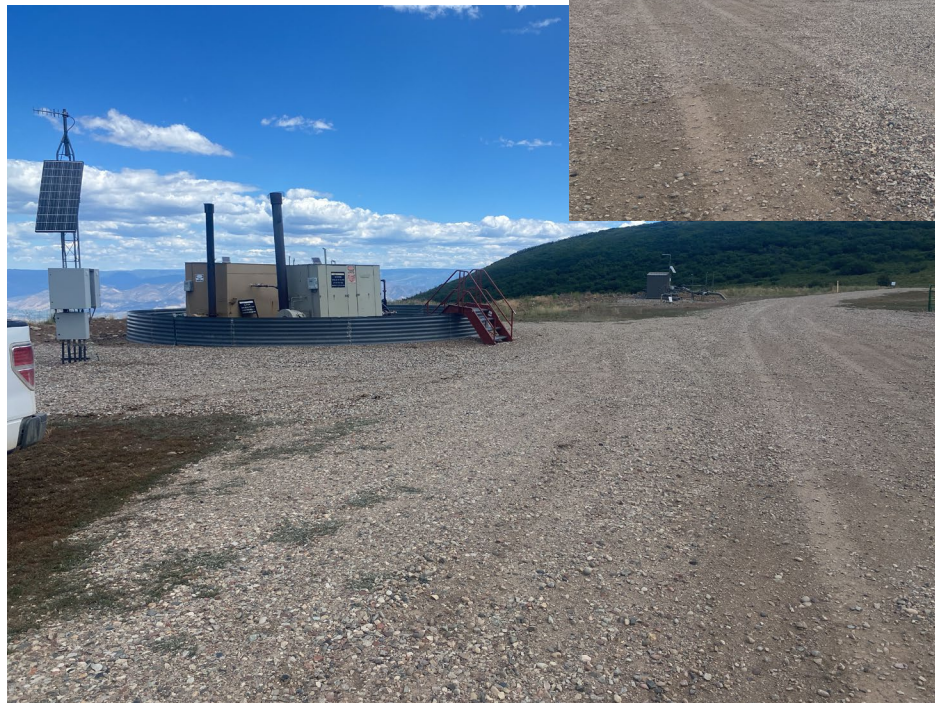
Photo 1. Photos taken from the Location entrance at the west show an overview of the production area. Photos show pad surface has been regraded and gravel applied.

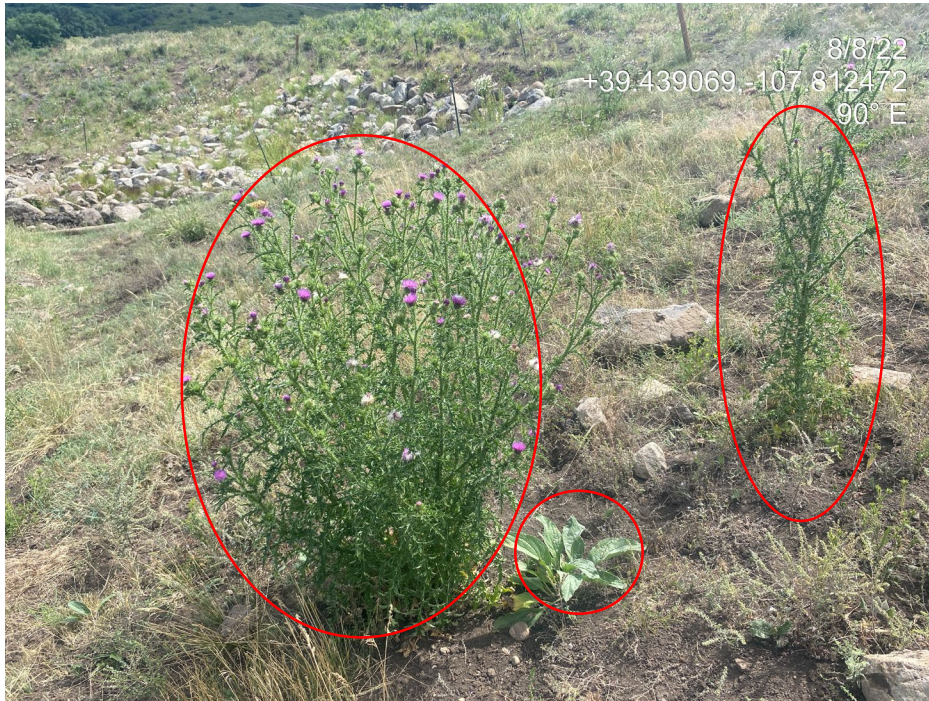
Photo 2. Photo taken from the south in the interim area shows plumeless thistle and houndstongue (CO List B Noxious Weeds).

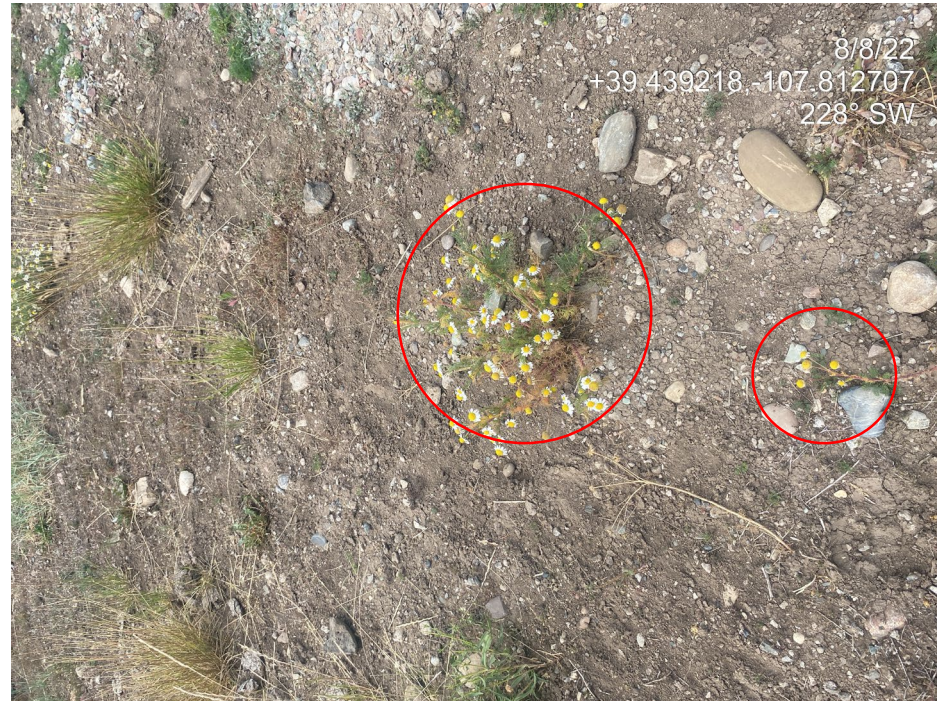
Photo 3. Photo taken from the south of the Location shows scentless chamomile (CO List B Noxious Weed).

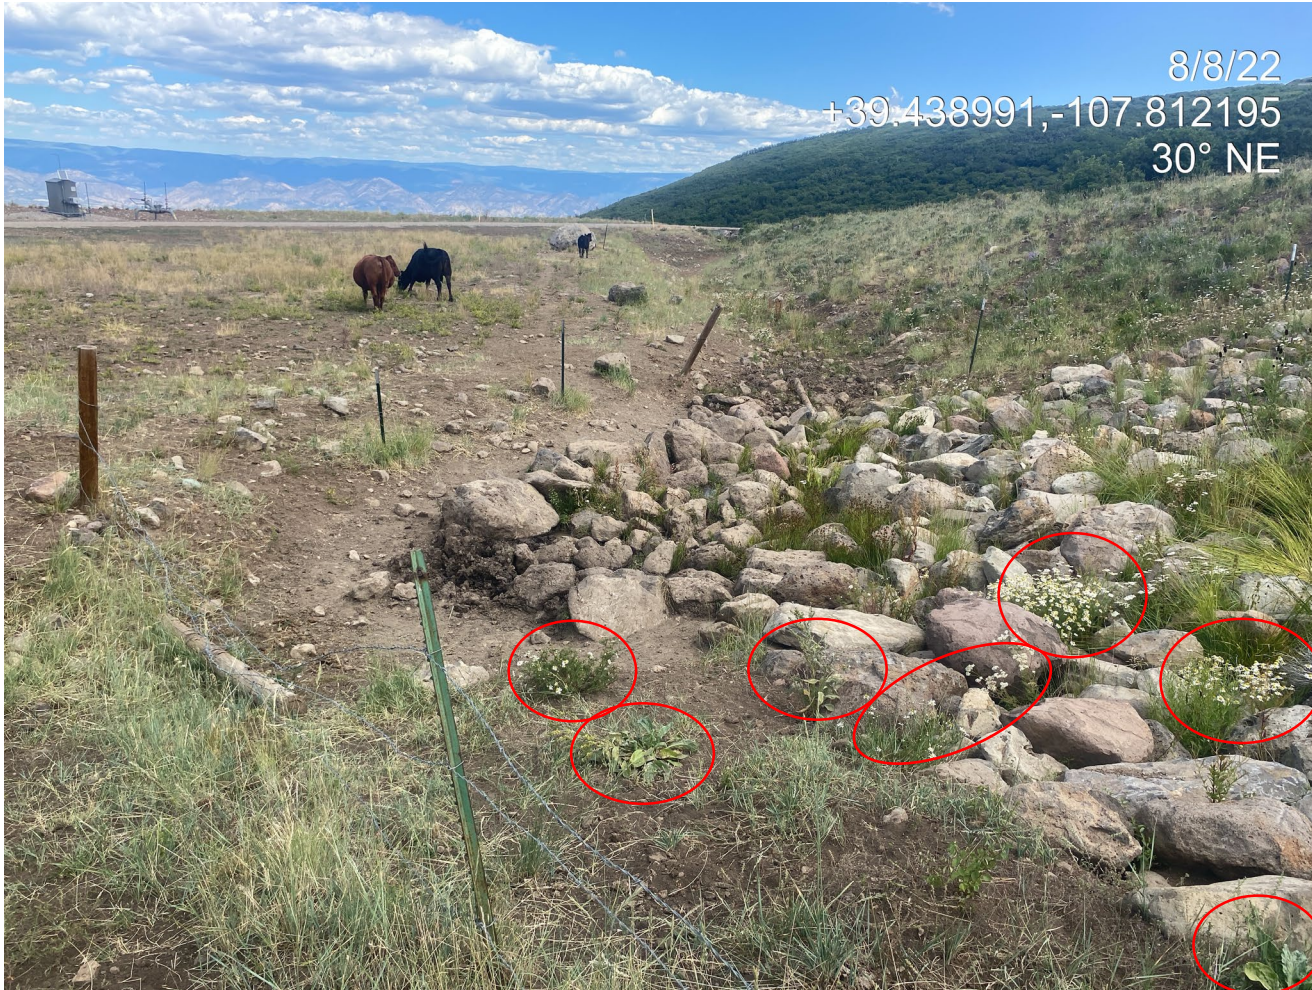
Photo 4. Photo taken from the south of the Location in the interim area shows the fence around the rock feature is in disrepair. Red circles indicate houndstongue and scentless chamomile.
