Inspection Photos and Issue Report

Operator: CAERUS PICEANCE LLC # 10456

Location #312380

Mesa County, CO

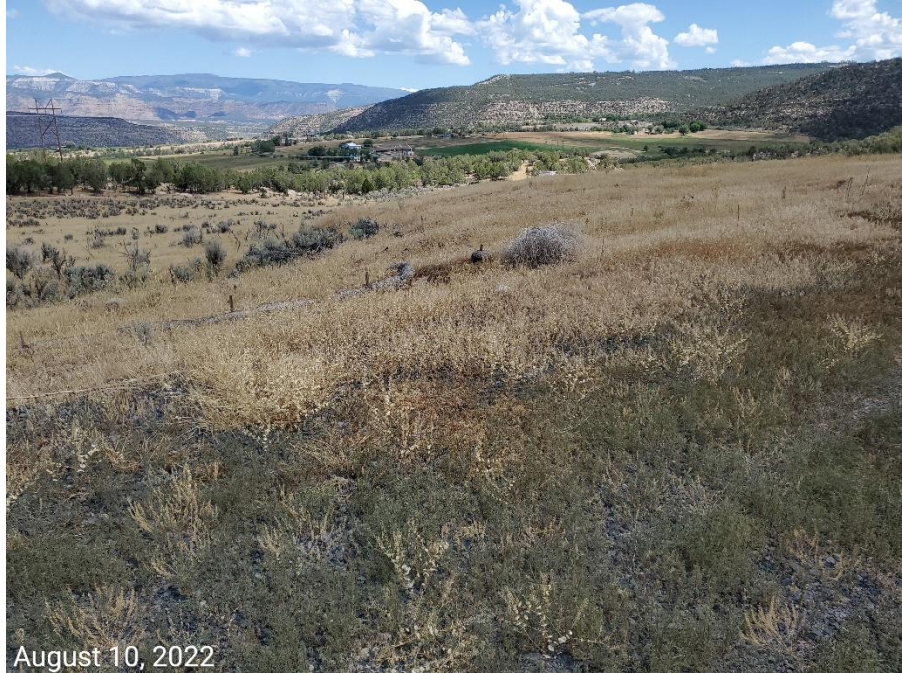
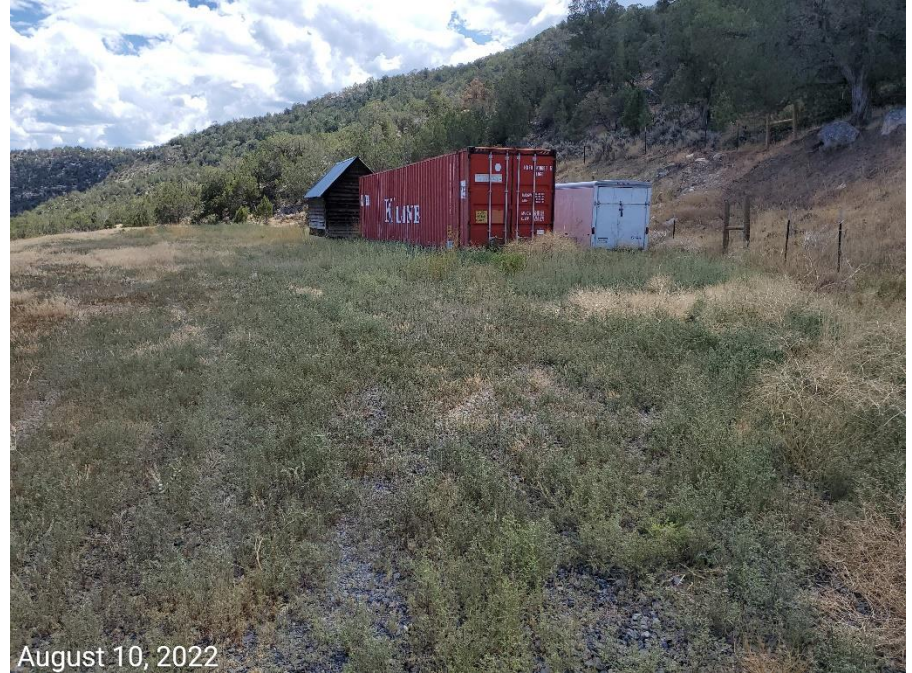
Photo 1: Photos taken from the east end of the Location, facing northeast, east. Photos examples showing Final reclamation (including removal of gravel, compaction alleviation, recontouring/regrading, and revegetating) has not been performed on the Location.

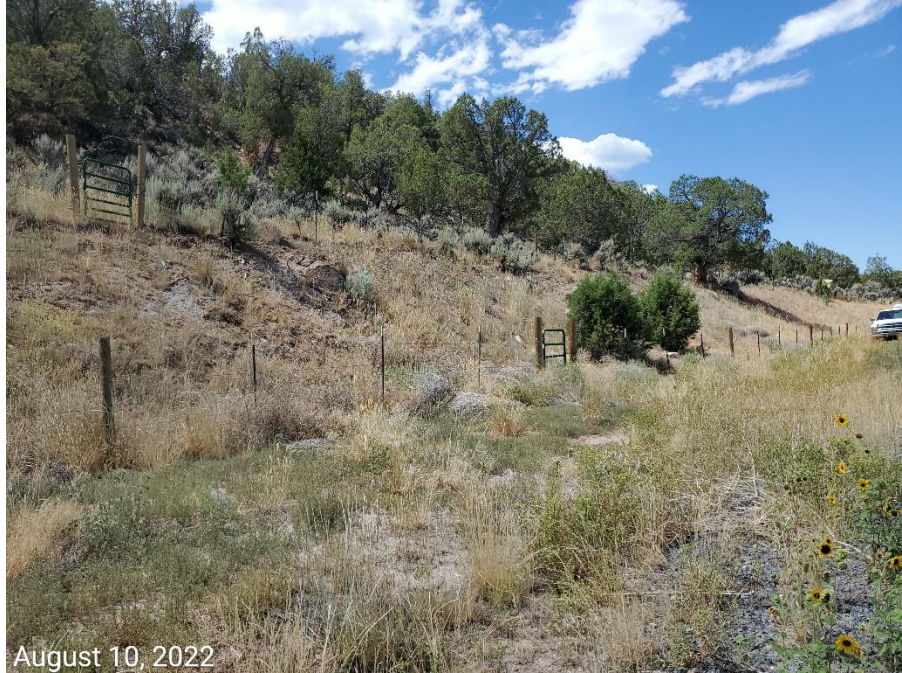
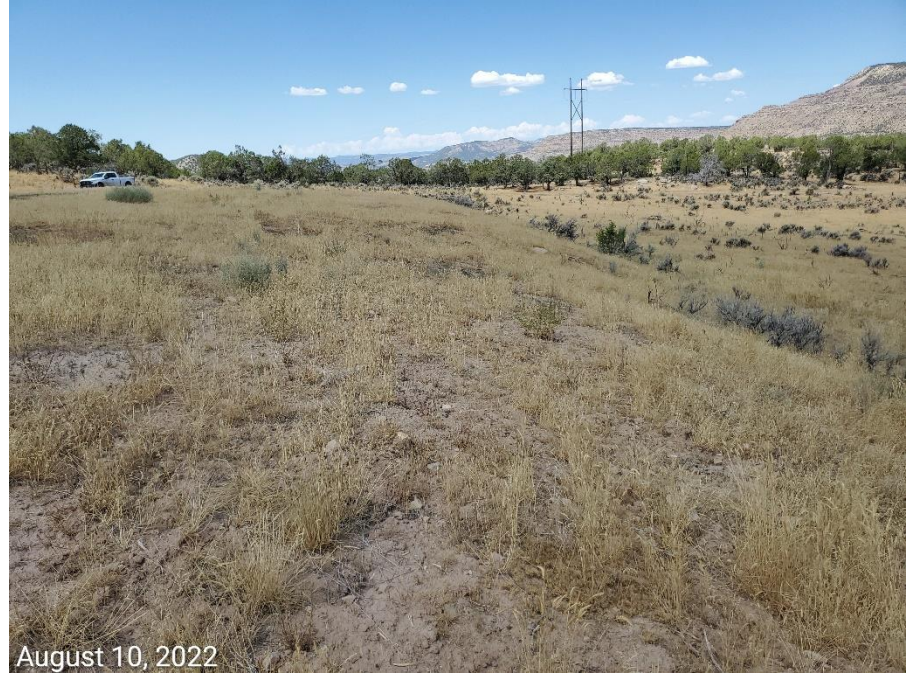
Photo 2: Photos show cut and fill slopes of the Location; location has not been recontoured/regraded.

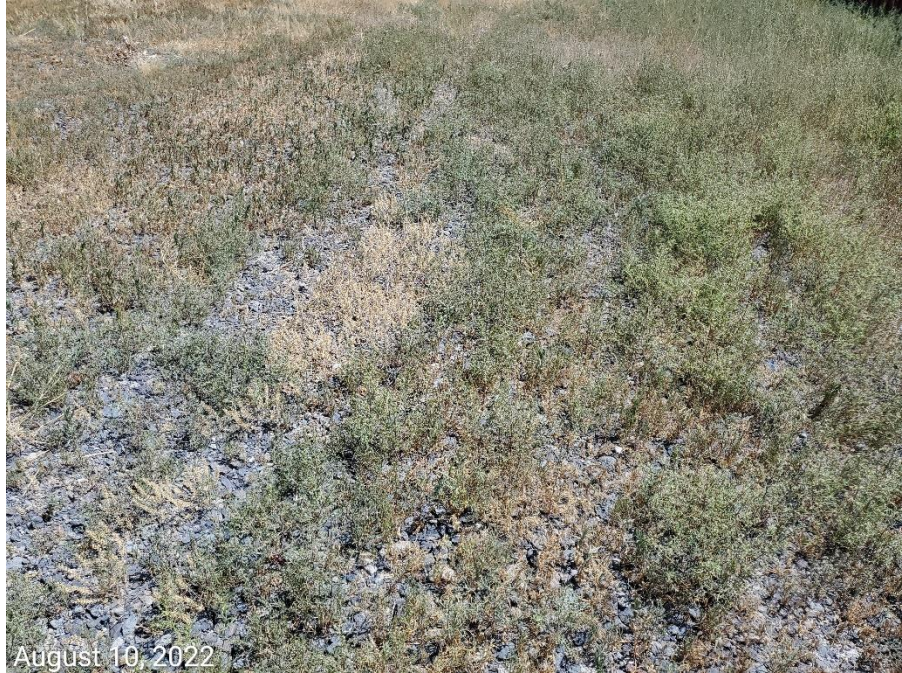
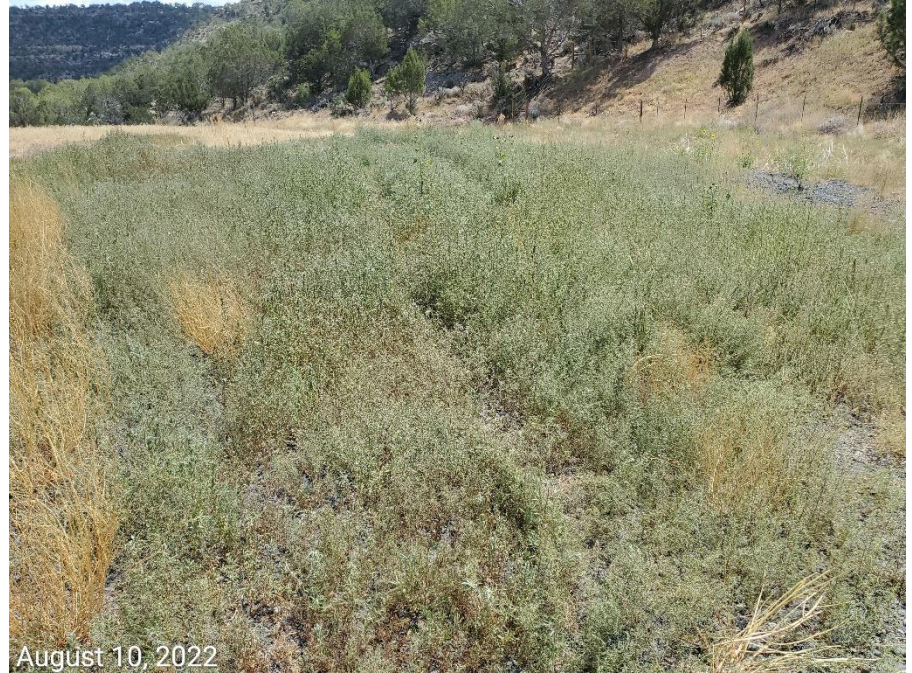
Photo 3: Photos taken from the Location. Photos examples showing gravel has not been removed, and Undesirable Plant establishment throughout the Location.

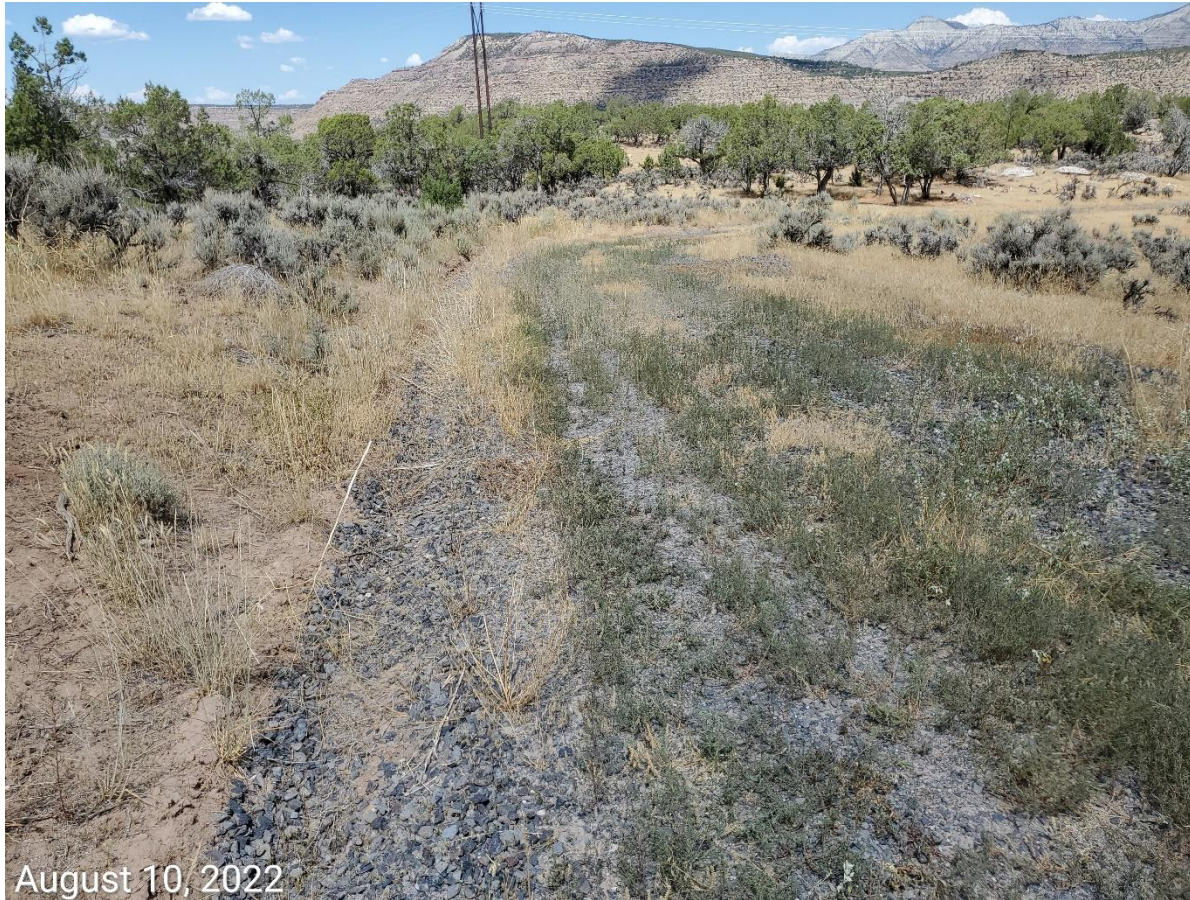
Photo 4: Photo example showing the O&G access road leading the Location has not been reclaimed.
