Inspection Photos and Issue Report

8/10/2022

Operator: CAERUS PICEANCE LLC # 10456

Location #312686

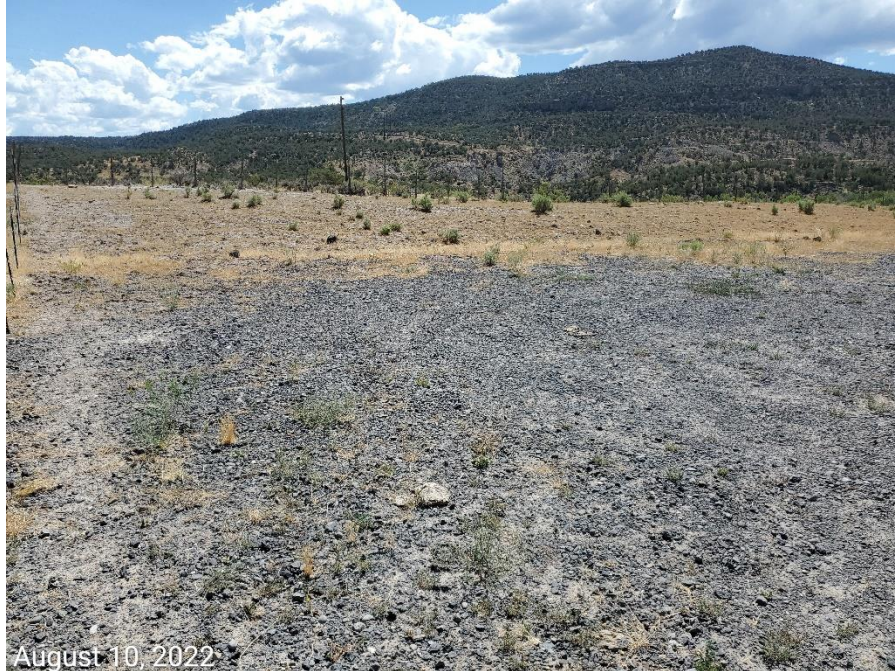
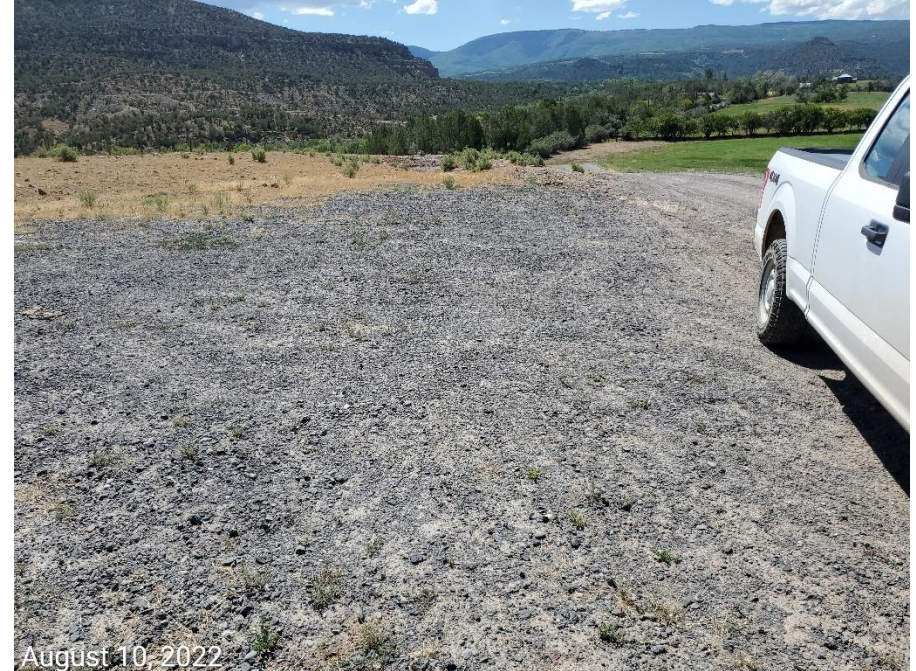
Photo 1: Photos show southern areas of the Location that have not been reclaimed in accordance with 1004 Rules; gravel has not been removed, and areas have not been decompacted, recontoured/regraded and revegetated.
