# Inspection Photos

Operator: TEP Rocky Mountain LLC - #96850

Location Name: Beaver Creek Ranch 08-13 Pad

Inspection Document #: 702800566

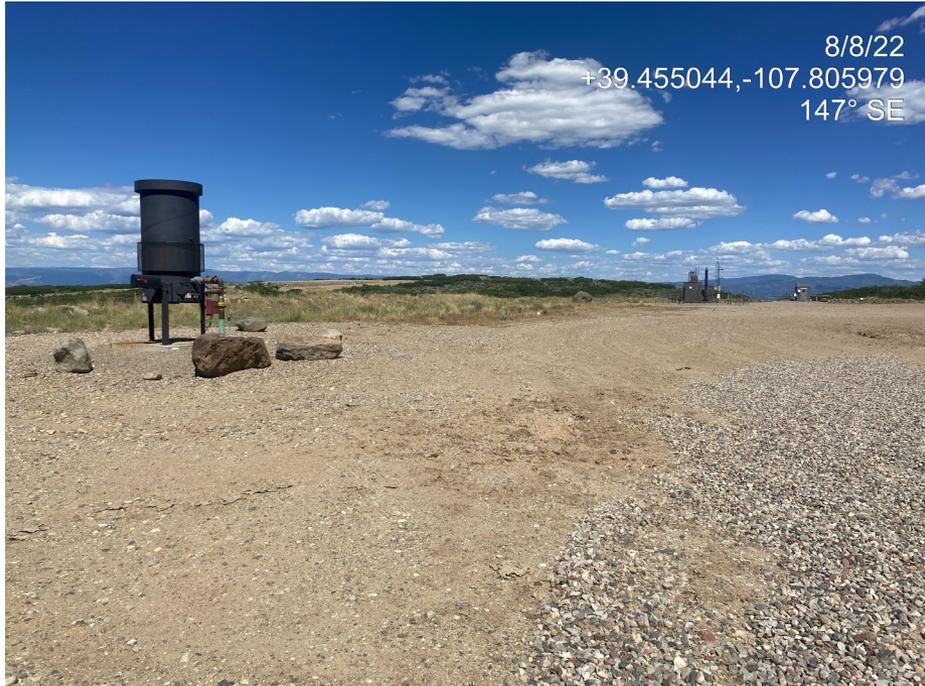
8/8/22  
+39.455044,-107.805979  
147° SE

**Photo 1.** Photo shows an overview of the production area. Photo also shows gravel has been added to the pad surface to the west.

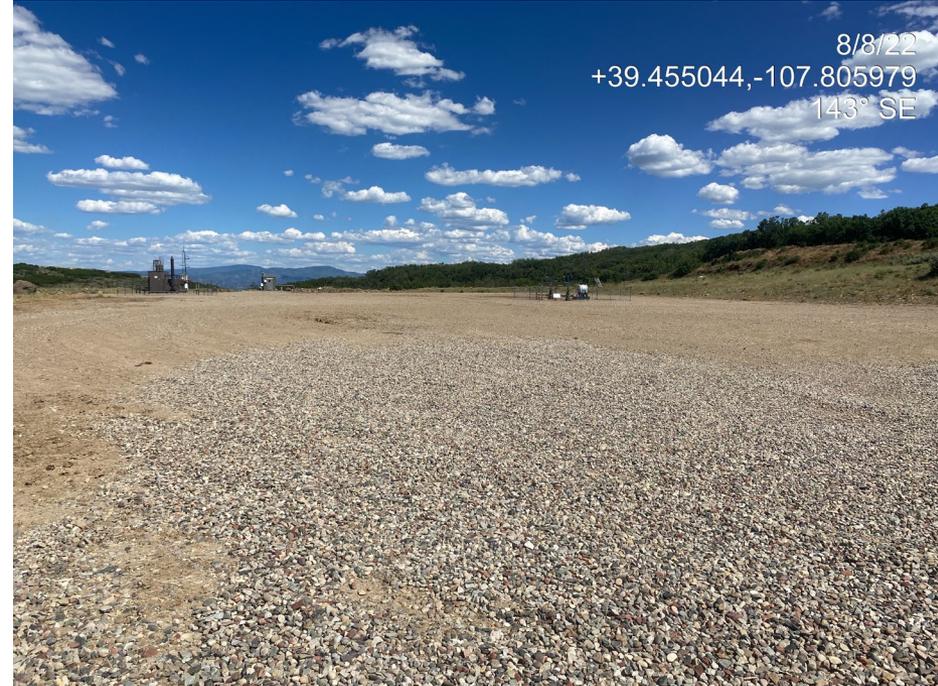
8/8/22  
+39.455044,-107.805979  
143° SE

**Photo 2.** Photo shows an overview of the production area. Photo also shows gravel has been added to the pad surface to the west.

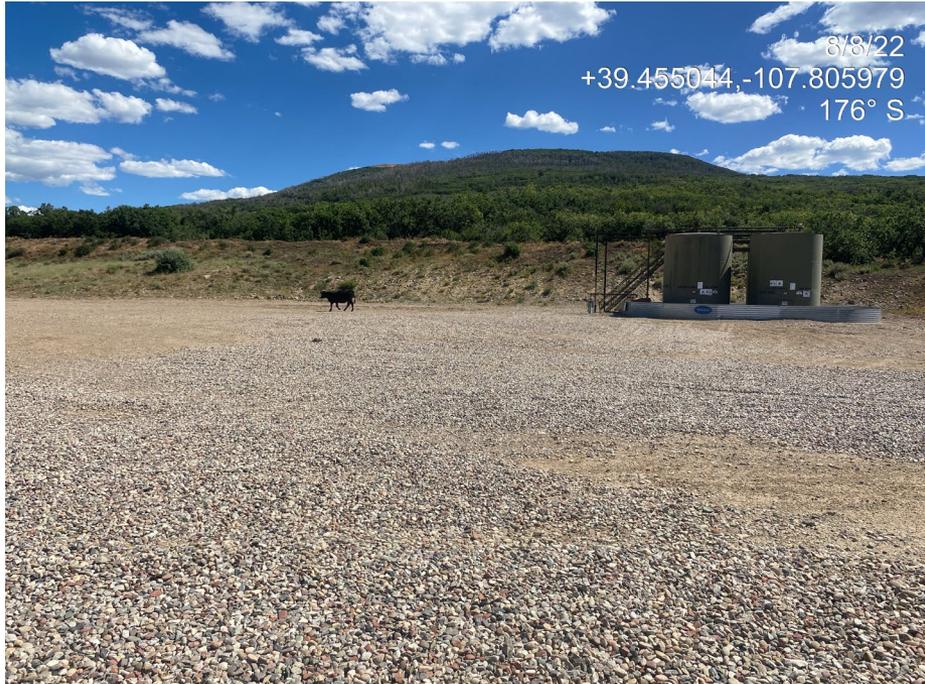
**Photo 3.** Photo shows an overview of the production area. Photo also shows gravel has been added to the pad surface to the west.

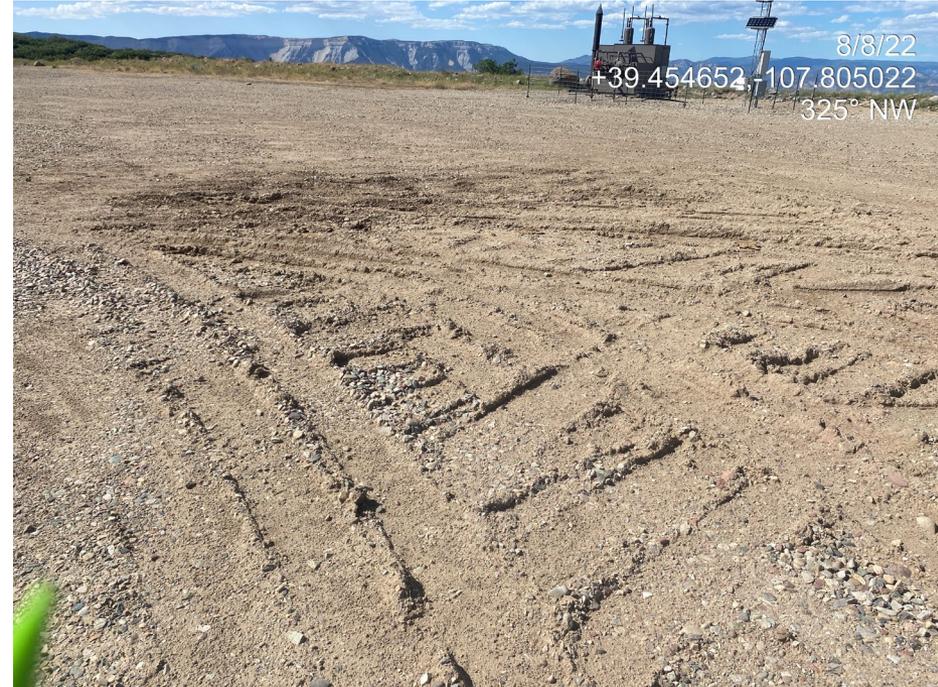
**Photo 4.** Photo shows control measures to protect and stabilize the production areas remain missing or insufficient at the east of the Location.

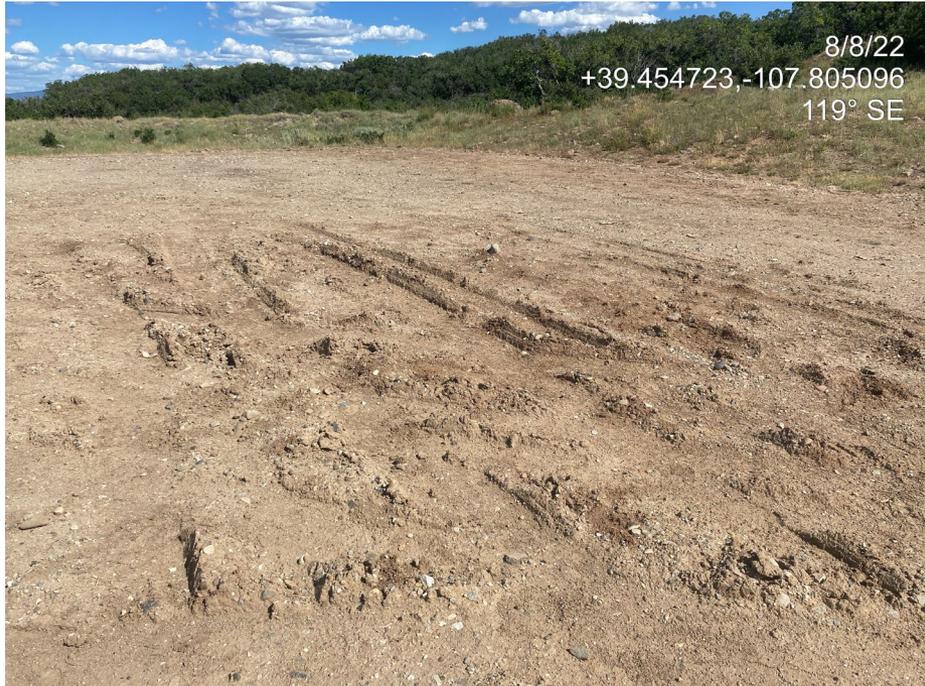
**Photo 5.** Photo shows control measures to protect and stabilize the production areas remain missing or insufficient at the east of the Location.

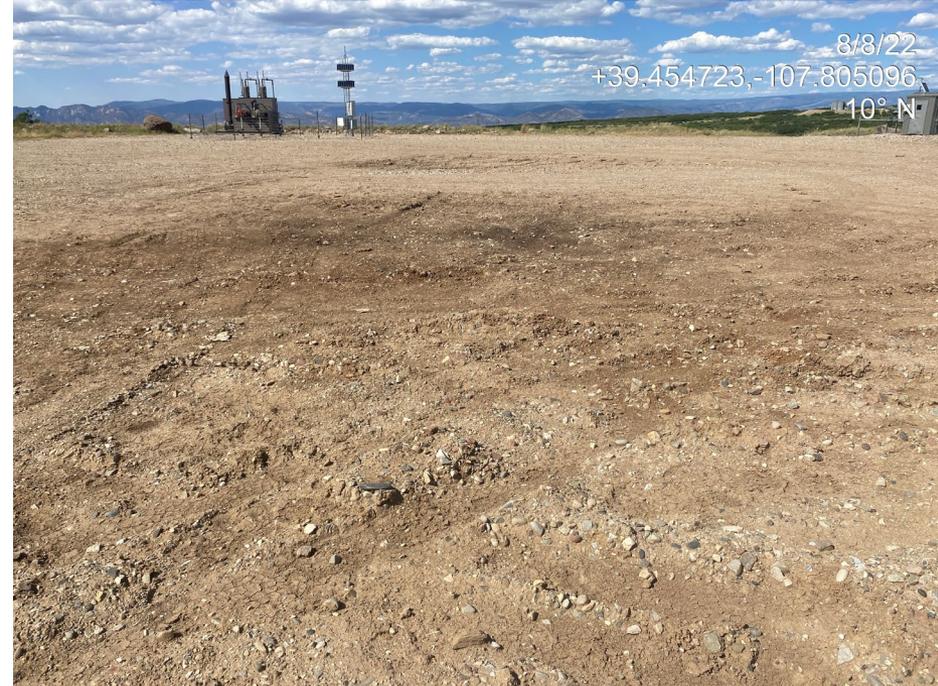
**Photo 6.** Photo shows control measures to protect and stabilize the production areas remain missing or insufficient at the east of the Location.

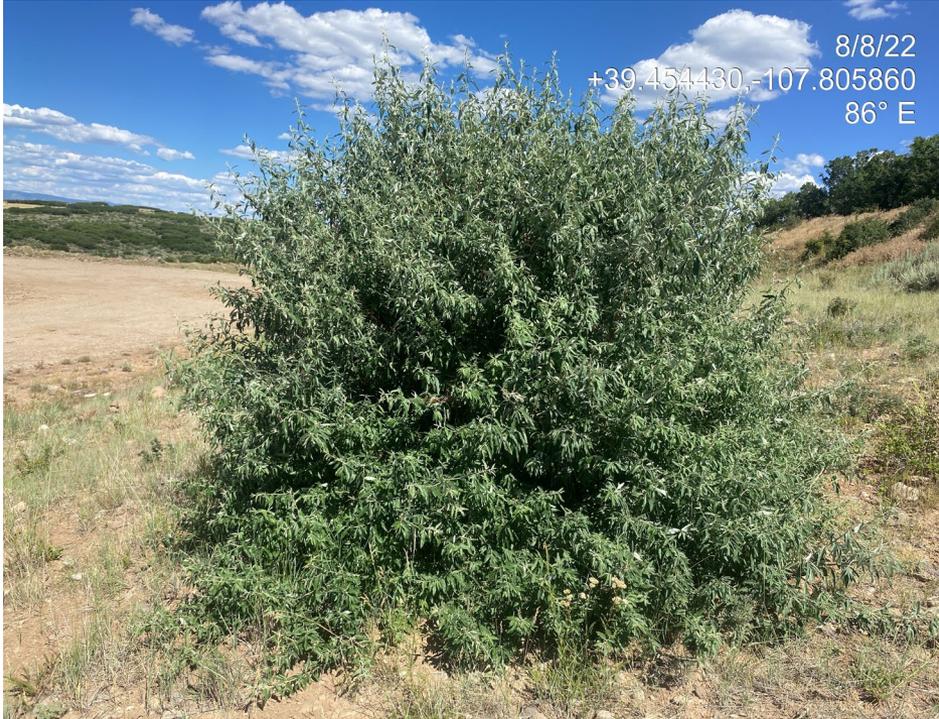
**Photo 7.** Photo taken from the southern interim area of the Location shows Russian olive, a CO List B Noxious Weed.

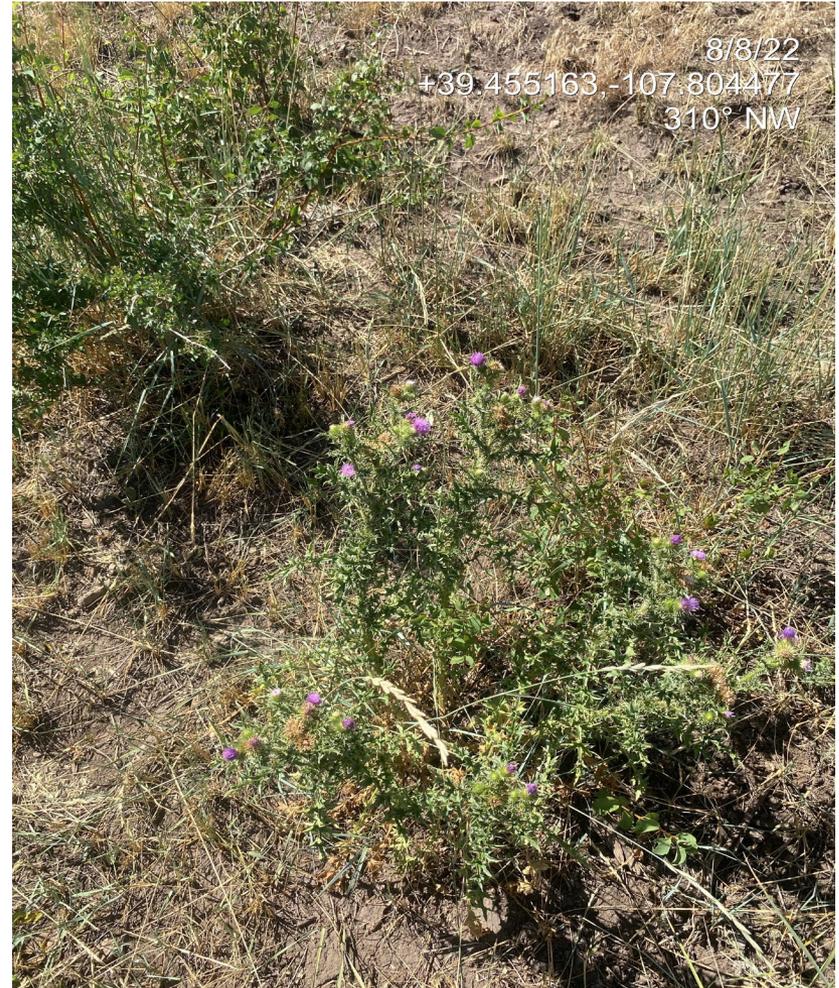
**Photo 8.** Photo taken from the north of the Location shows an example of plumeless thistle, a CO List B Noxious Weed found throughout the Location.

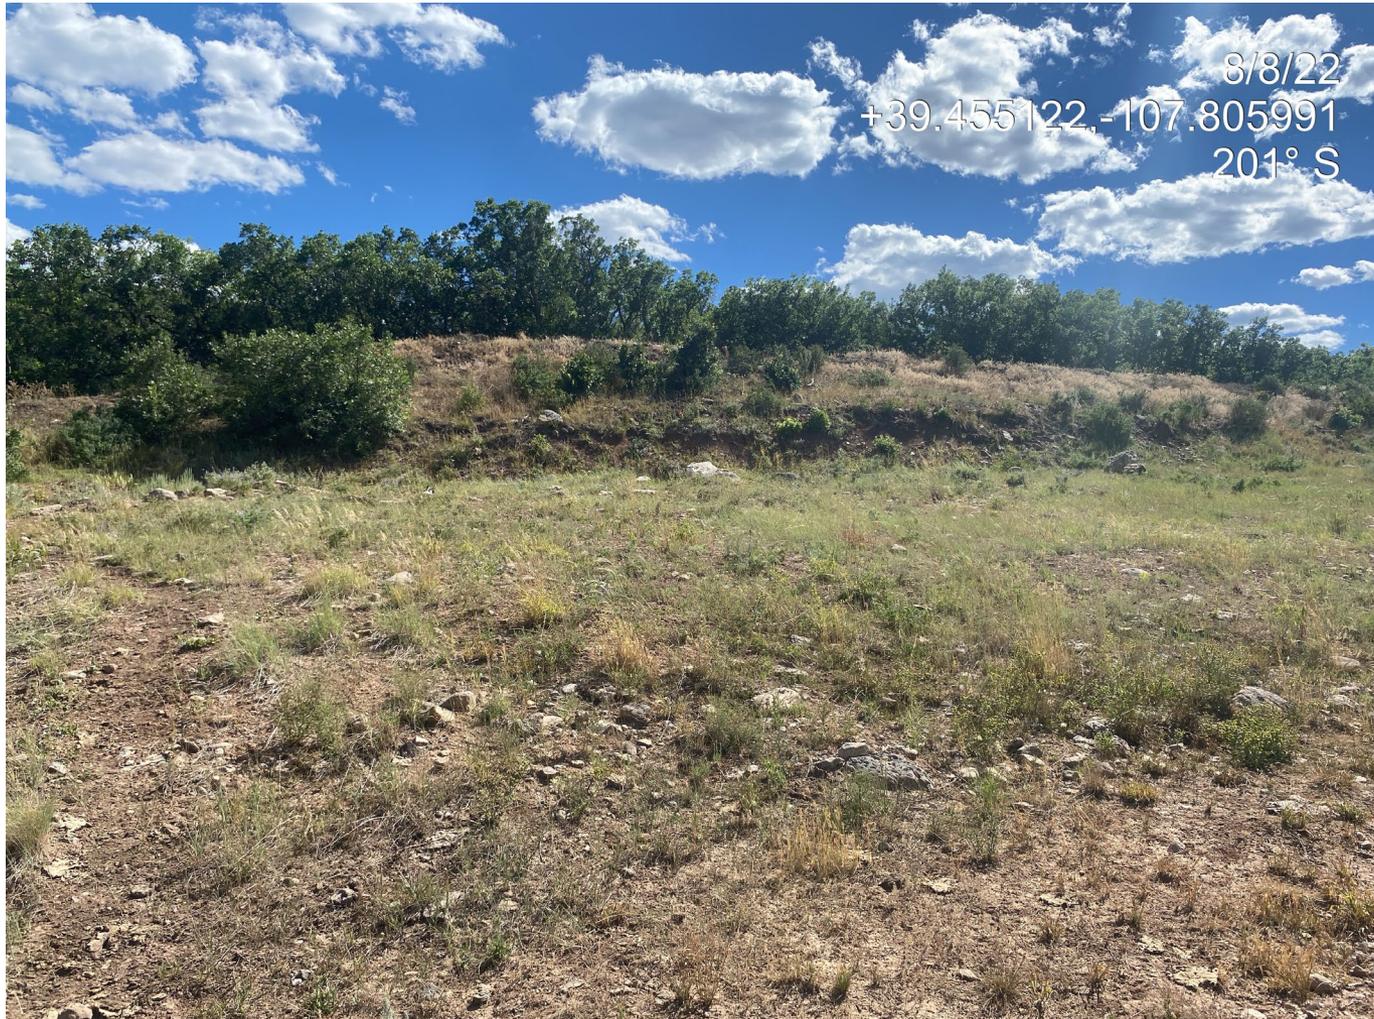
**Photo 9.** Photo taken from the south shows the original cut slope still present on Location.
