Final Reclamation Inspection

Operator: GREAT WESTERN OPERATING COMPANY LLC-10110

Location ID: 320352

Inspection Photos
Location Name: WIERMAN 43-7 (1)
Location ID: 320352

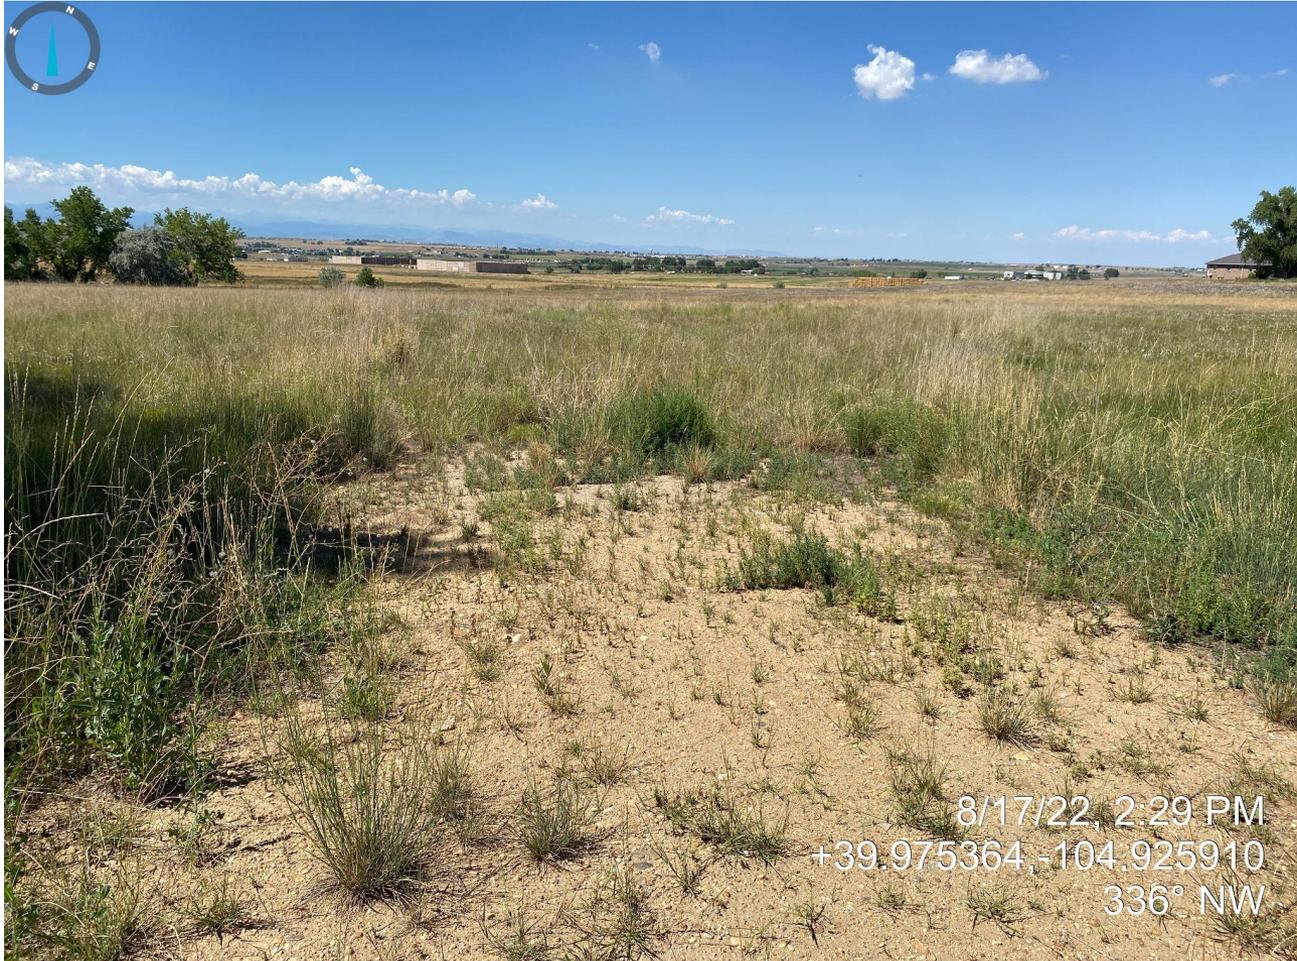
Photo 1. Location photo taken from southern portion, facing northwest. Photo illustrates gravel/road base observed on location; some desirable vegetation growth present.

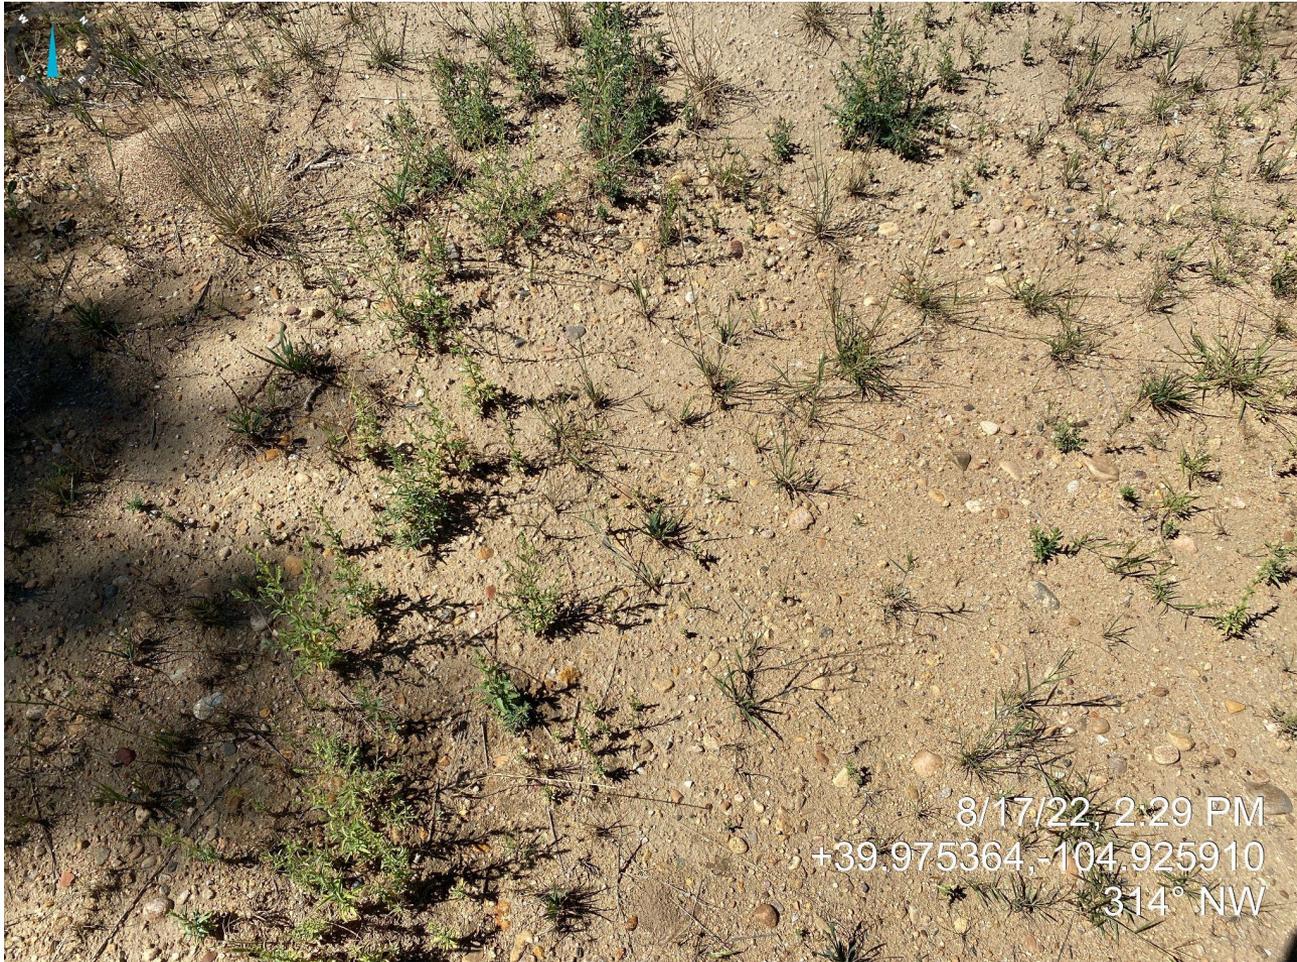
Photo 2. Location photo taken from southern portion, facing northwest. See comments in Photo 1.

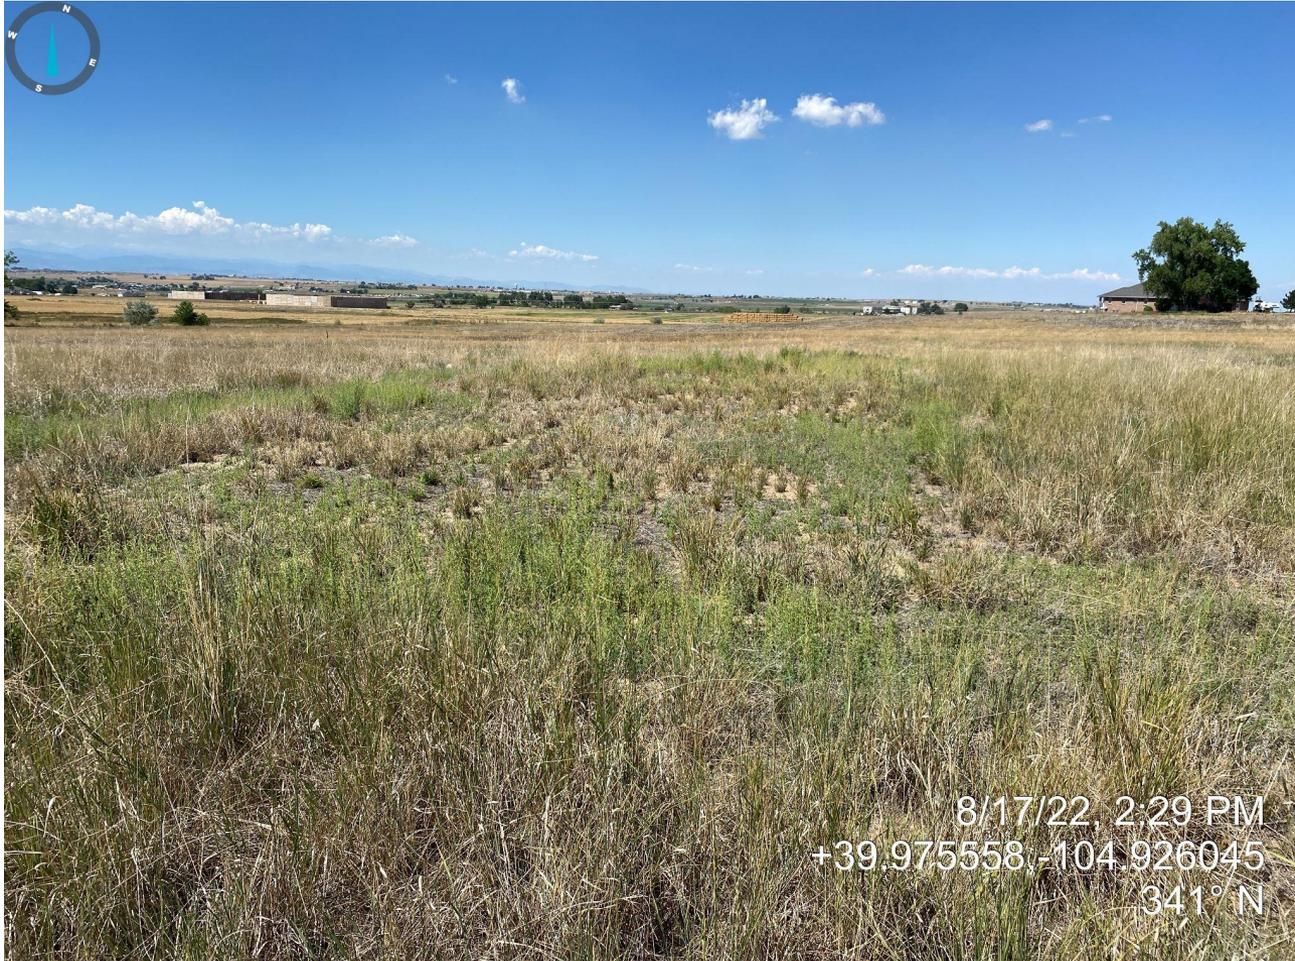
Photo 3. Location photo taken from southern portion, facing north. Photo illustrates some desirable perennial vegetation observed; annual weedy vegetation also observed (Russian thistle and Kochia) on reclamation area.

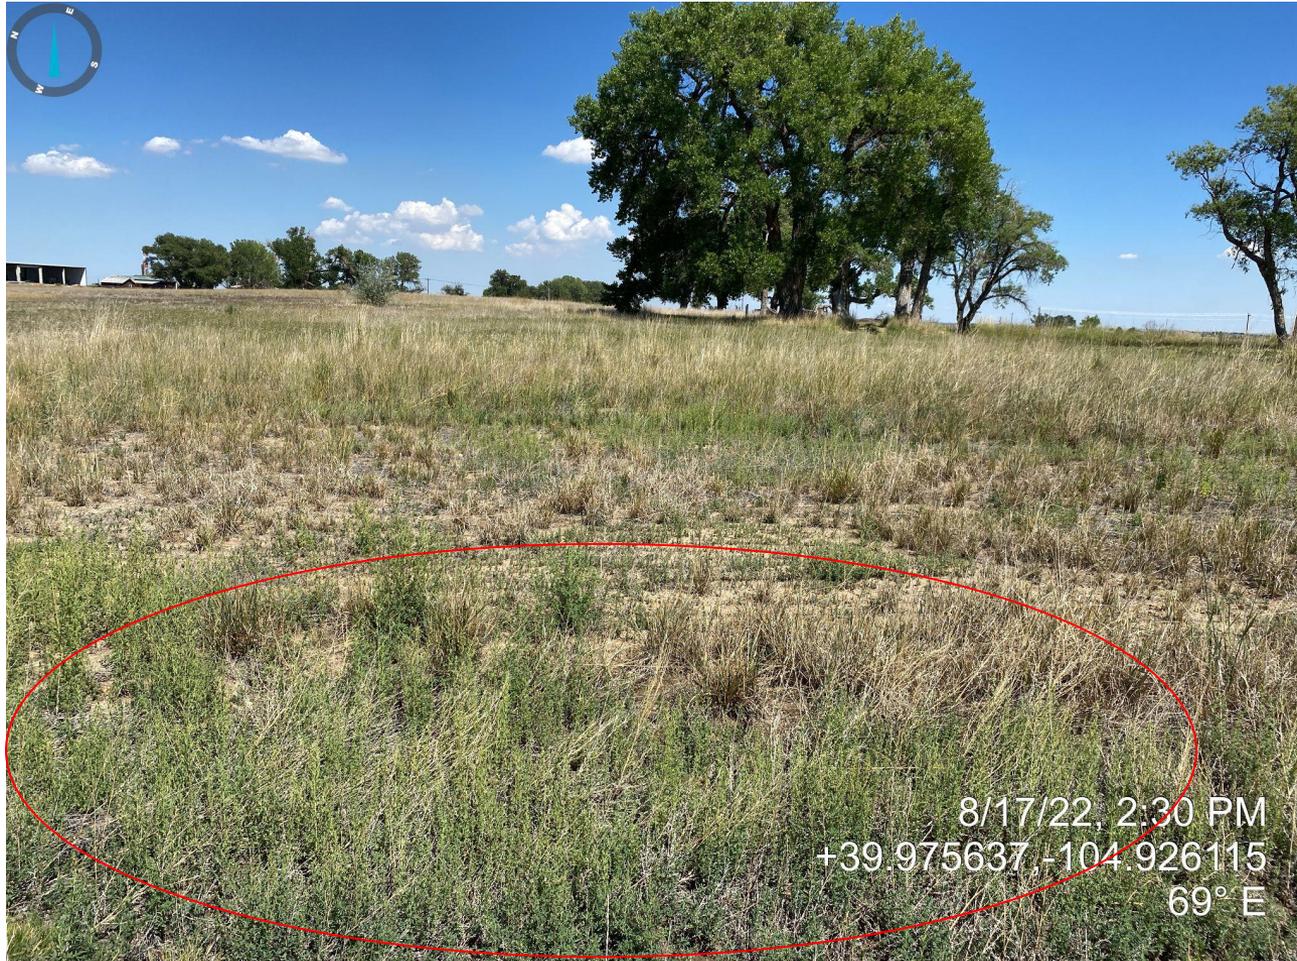
Photo 4. Location photo taken from center portion, facing east. Annual weedy vegetation observed on location (Russian Thistle highlighted in red).

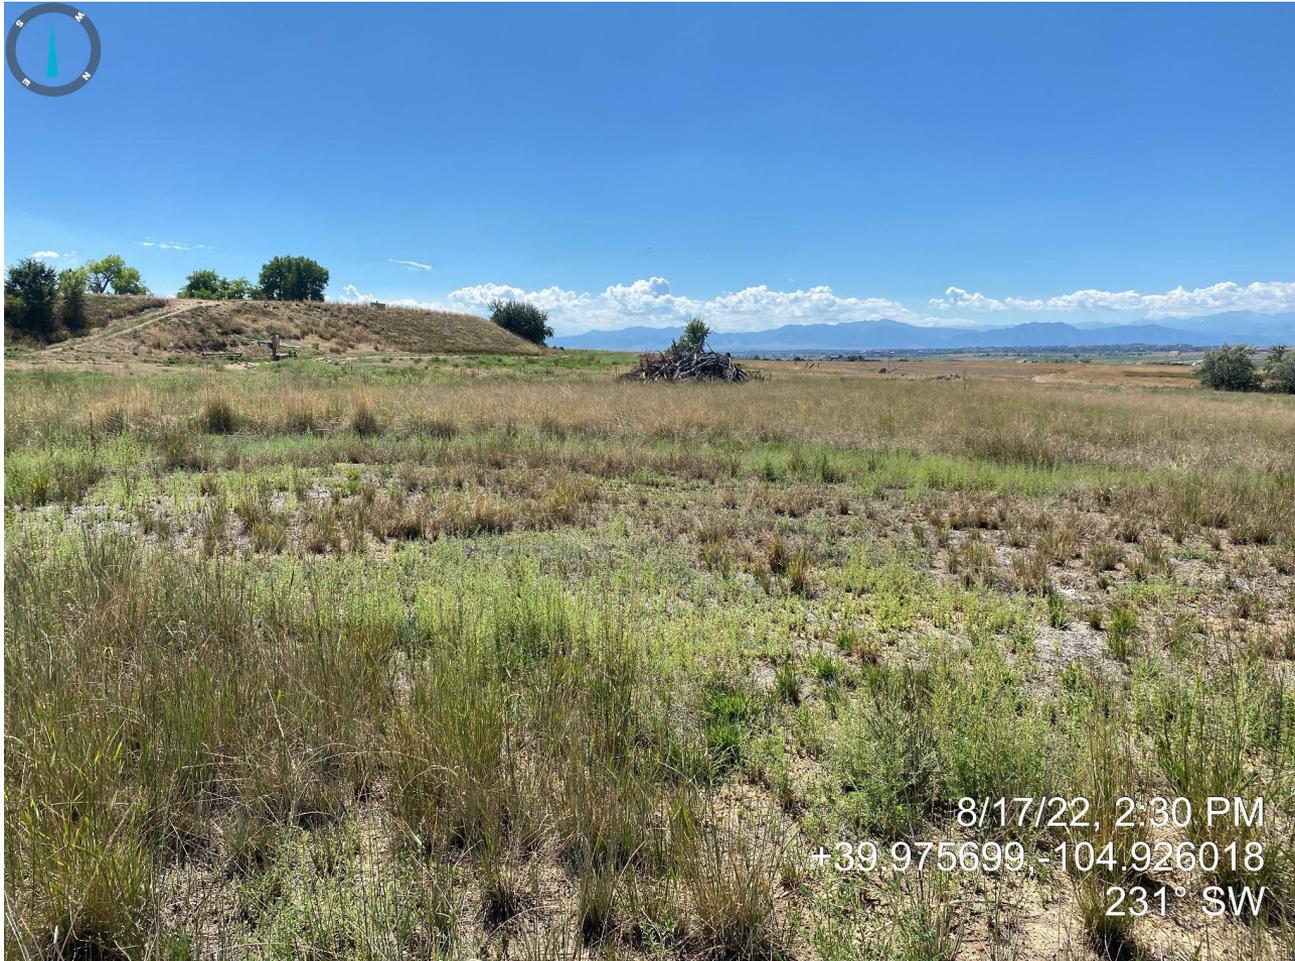
Photo 5. Location photo taken from center portion, facing southwest. Photo illustrates annual weedy vegetation, mainly Kochia and Russian Thistle. Some desirable perennial vegetation observed, e.g. Western Wheat.

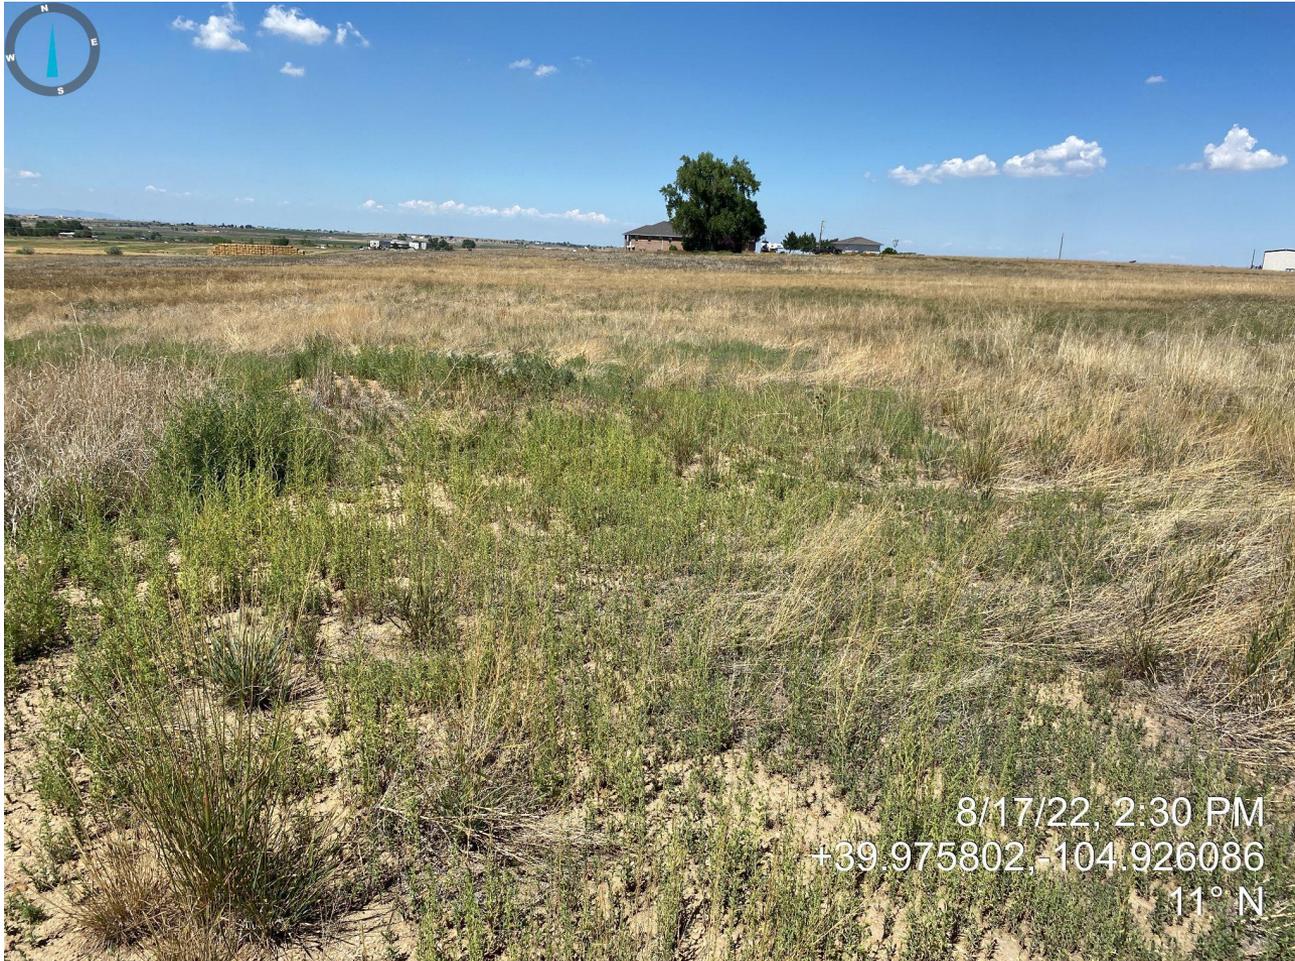
Photo 6. Location photo taken from center portion, facing north. See comments in Photo 5.

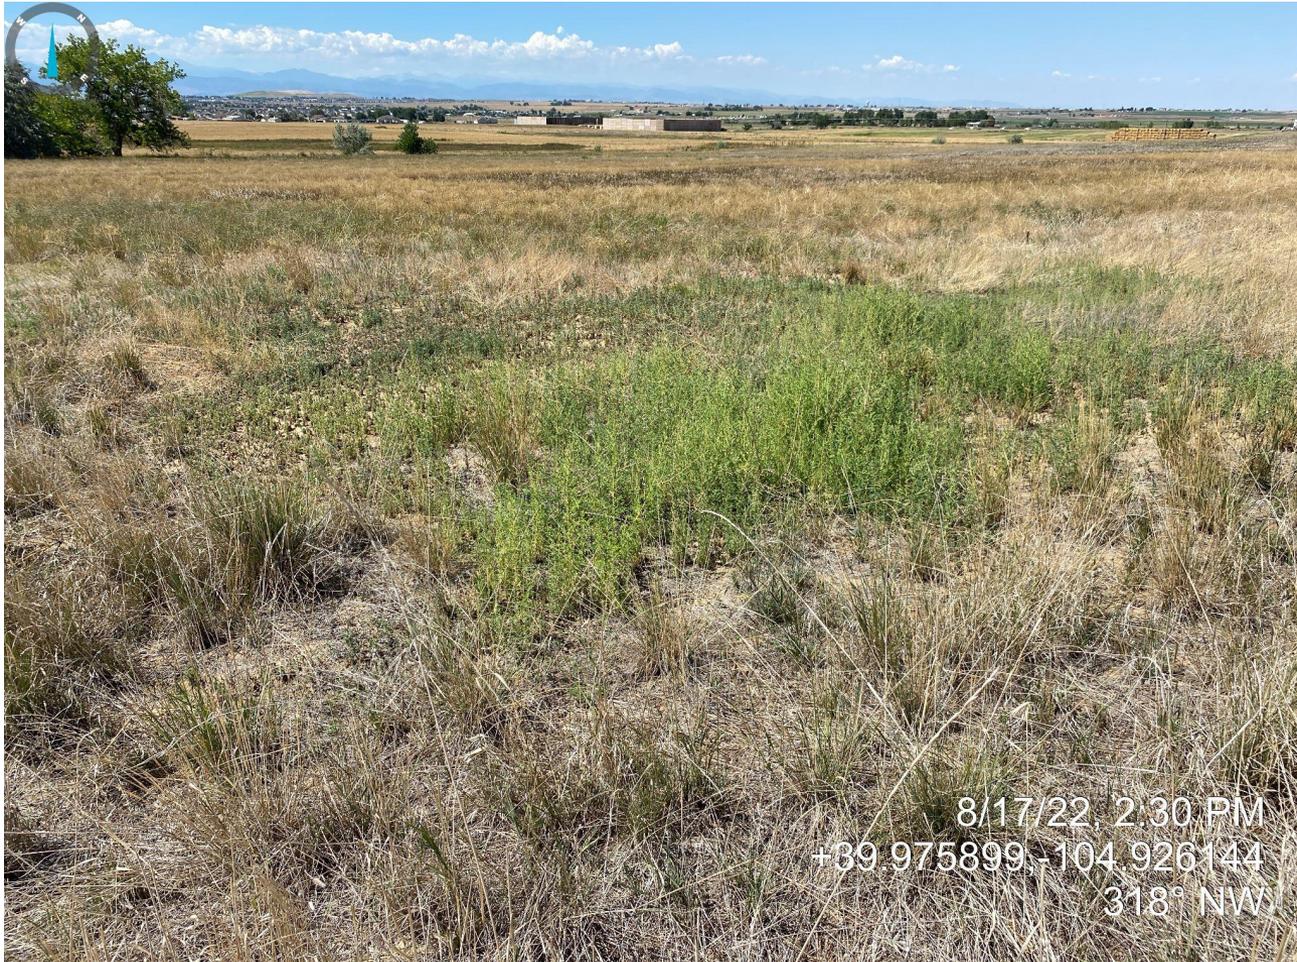
Photo 7. Location photo taken from northern portion, facing northwest. See comments in Photo 5.

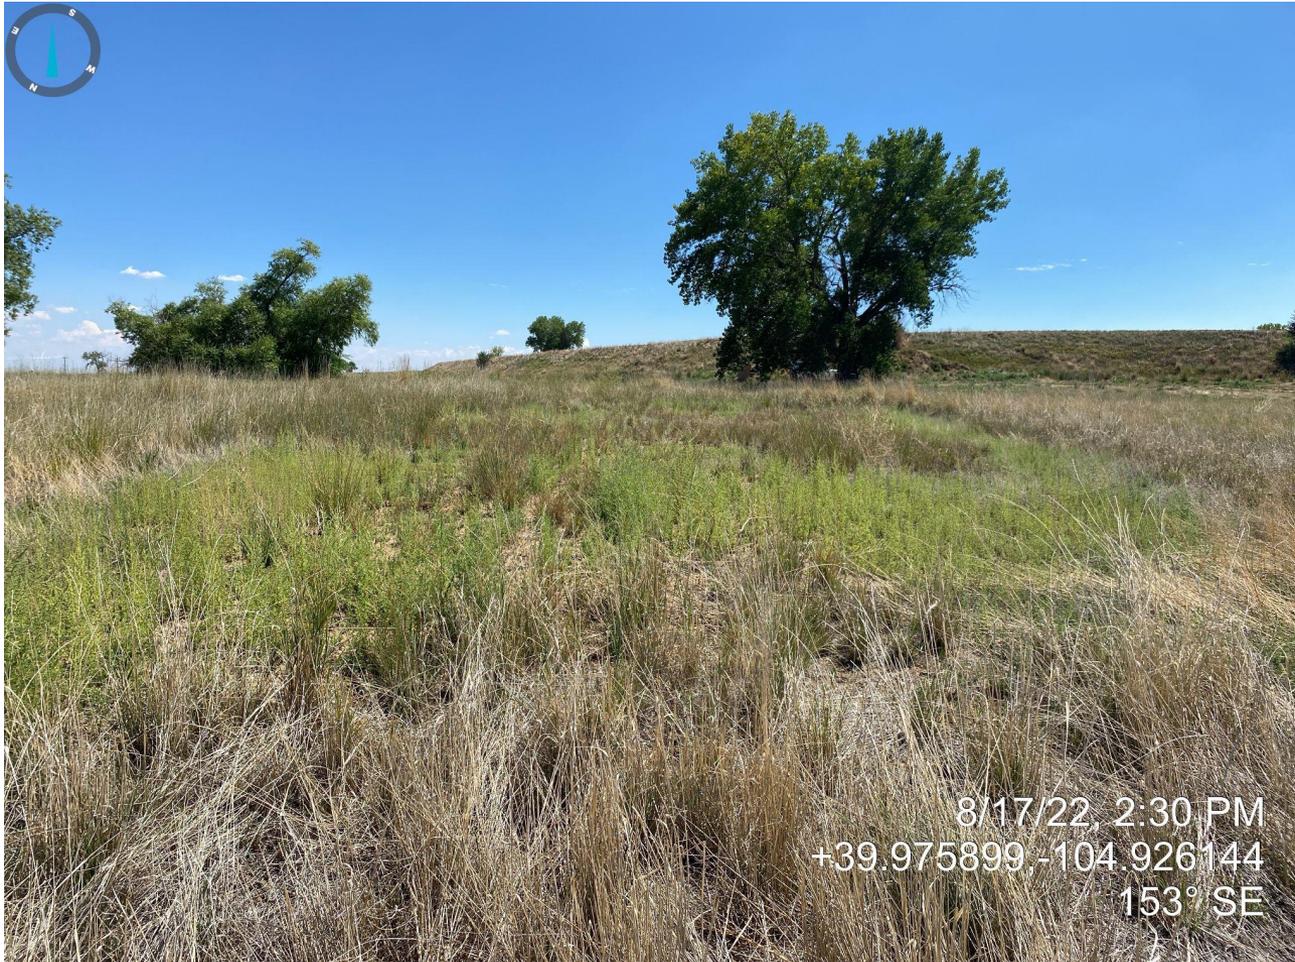
Photo 8. Location photo taken from northern portion, facing southeast. See comments in Photo 5.

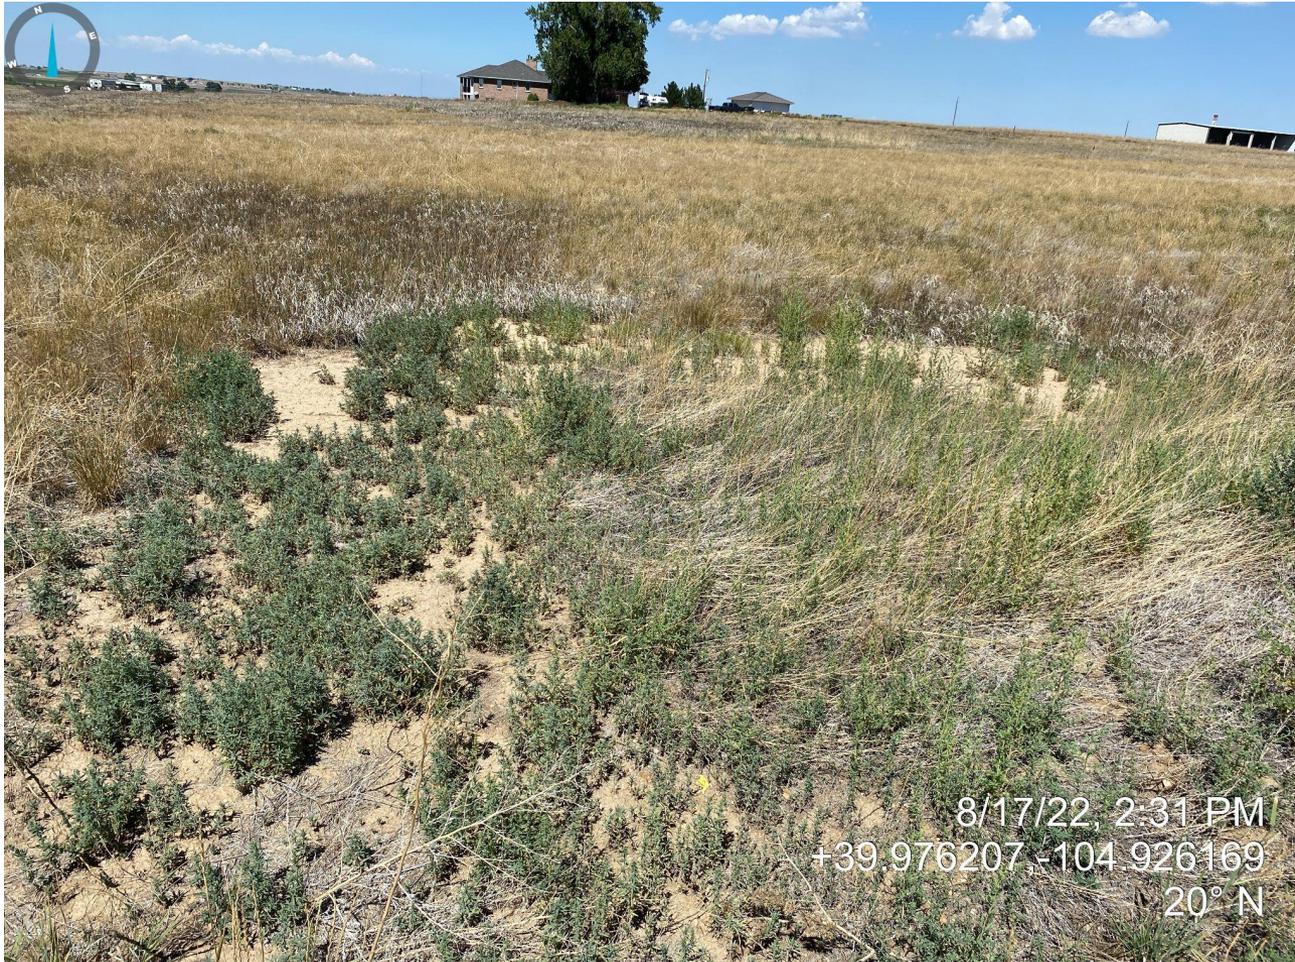
Photo 9. Location photo taken near old well location, facing north. Photo illustrates presence of annual weedy vegetation, Kochia.

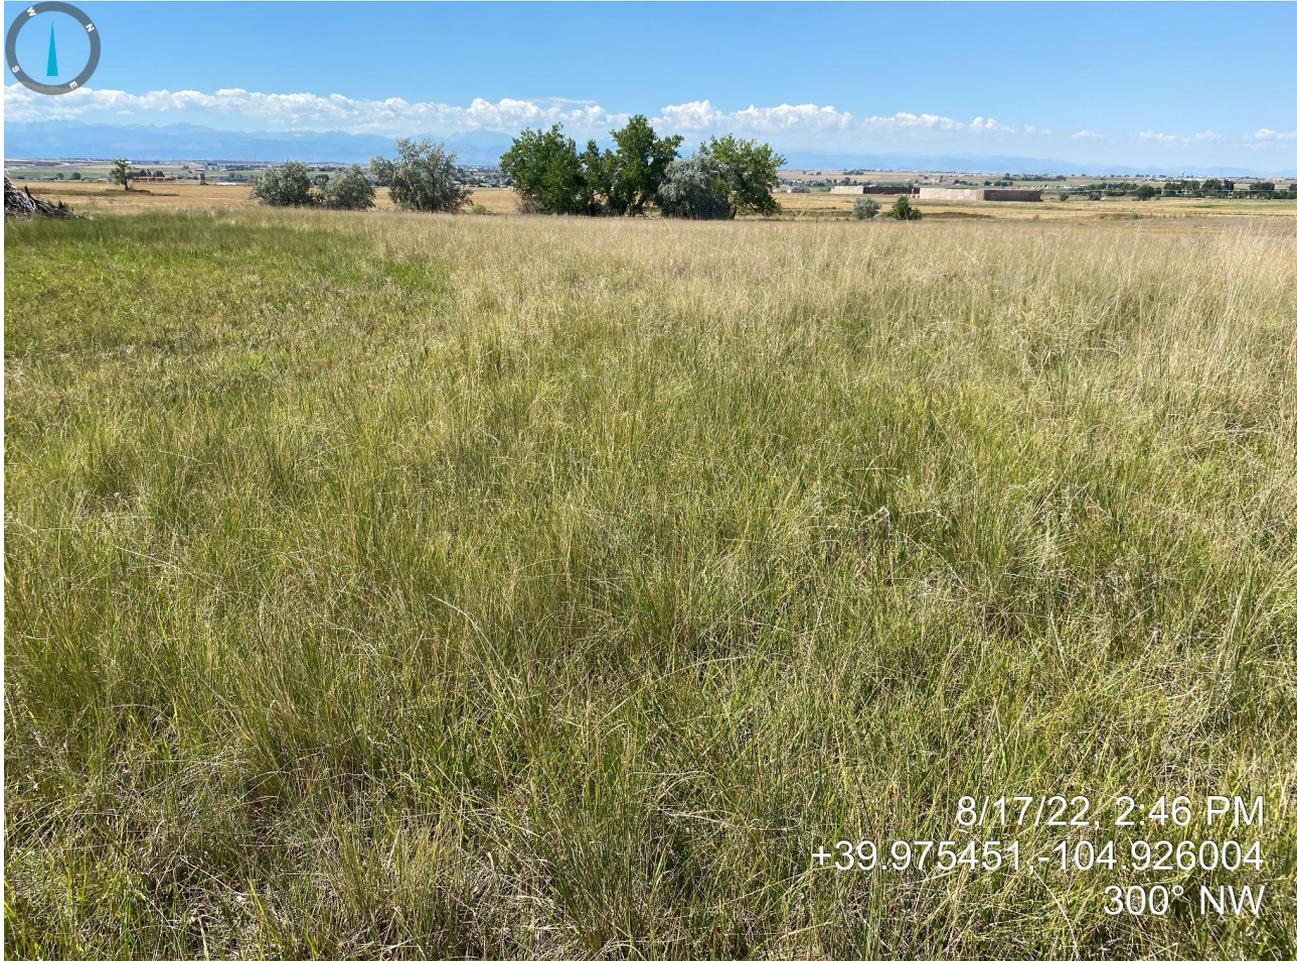
Photo 10. Reference area photo taken west of location, facing northwest.

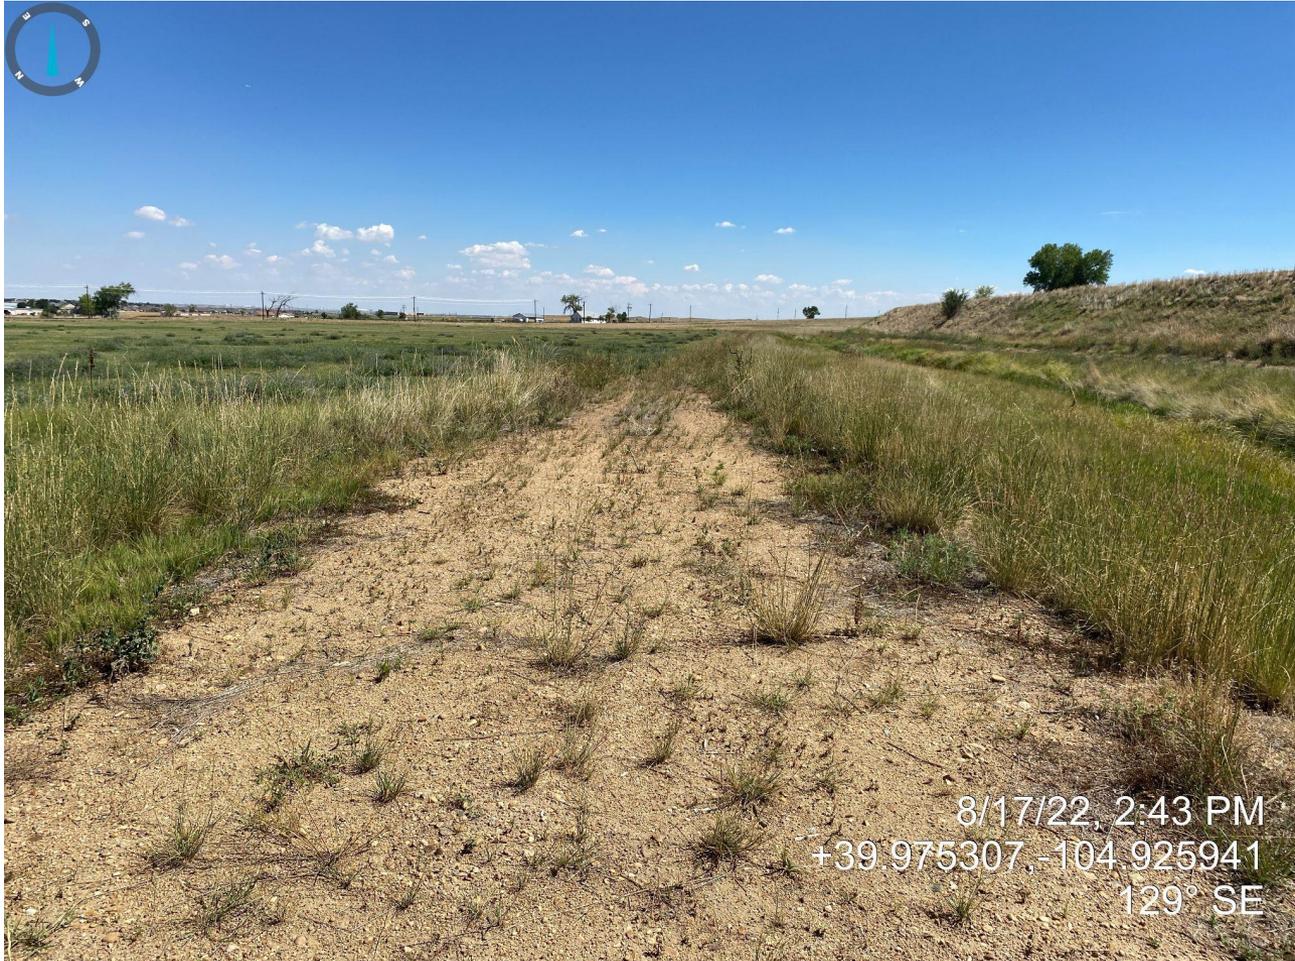
Photo 11. Access road photo taken south of location, facing southeast. Photo illustrates access road has not been reclaimed with presence of gravel/road base.

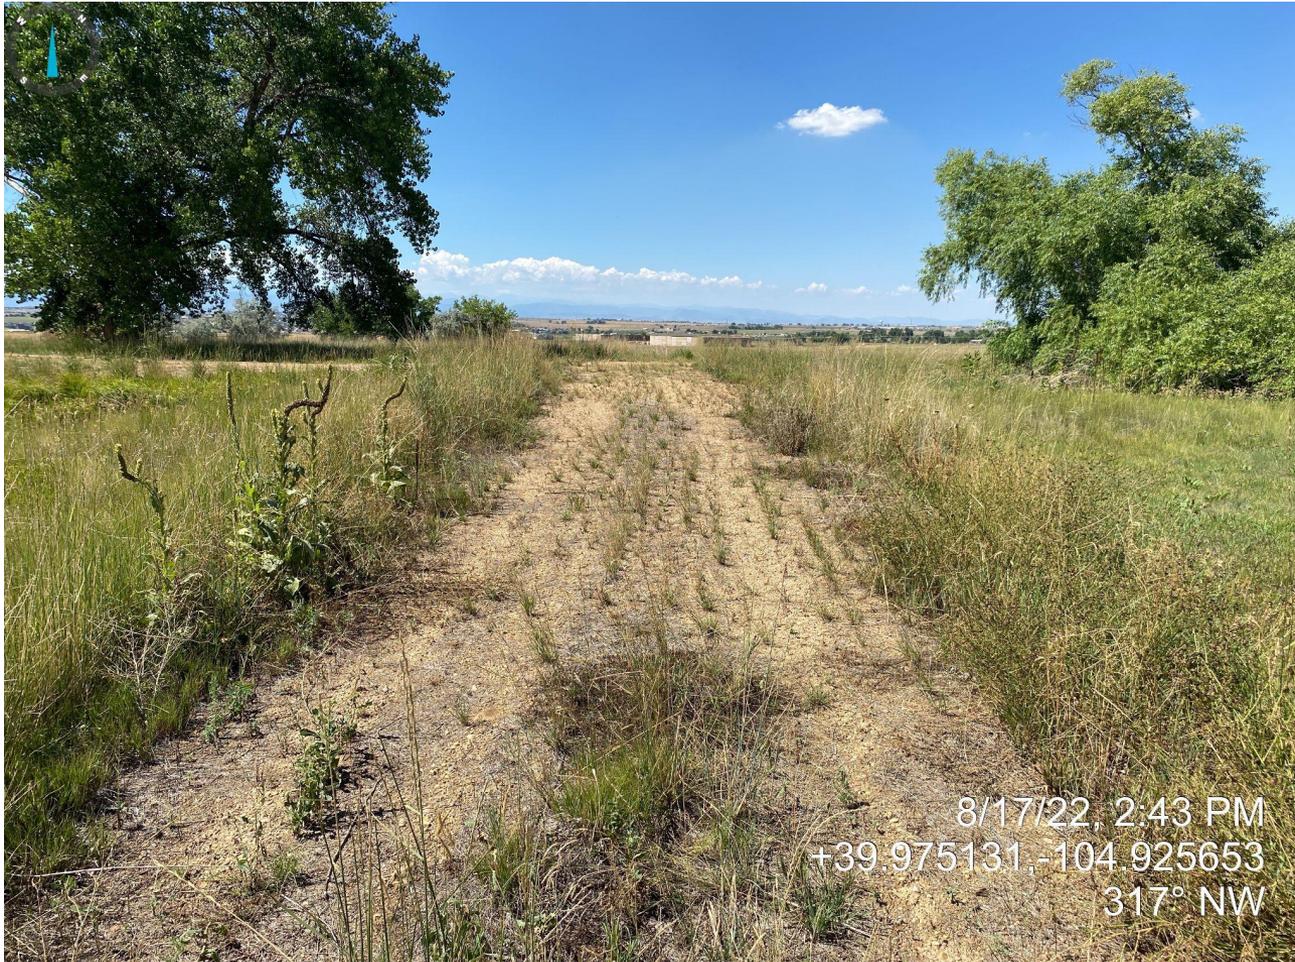
Photo 12. Access road photo taken south of location, facing northwest. See comments in Photo 11.

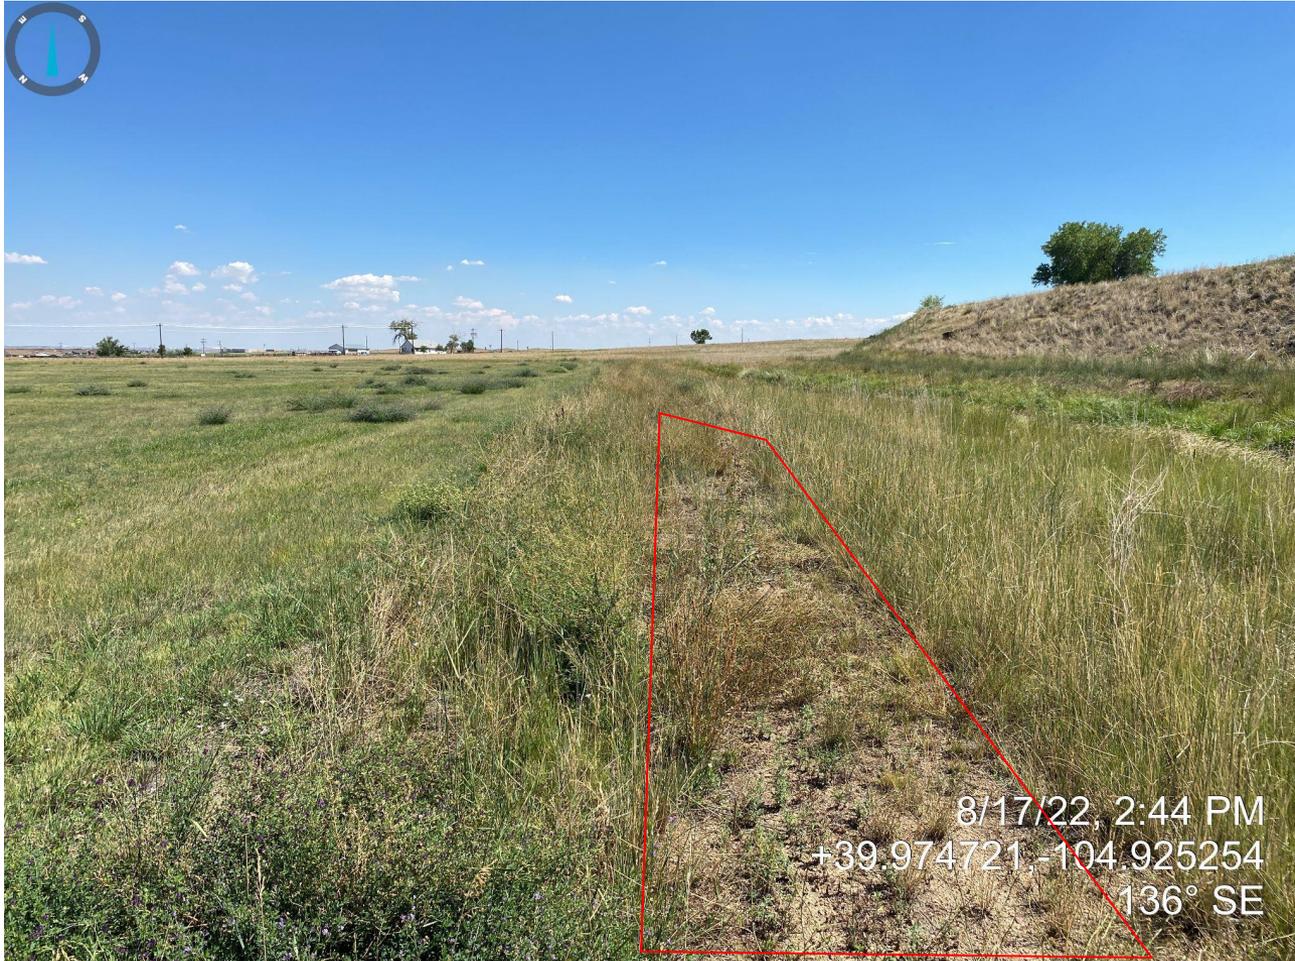
Photo 13. Access road photo taken south of location, facing southeast. Photo illustrates some desirable vegetation along portions of the access road; gravel/road base observed within new growth (highlighted in red).

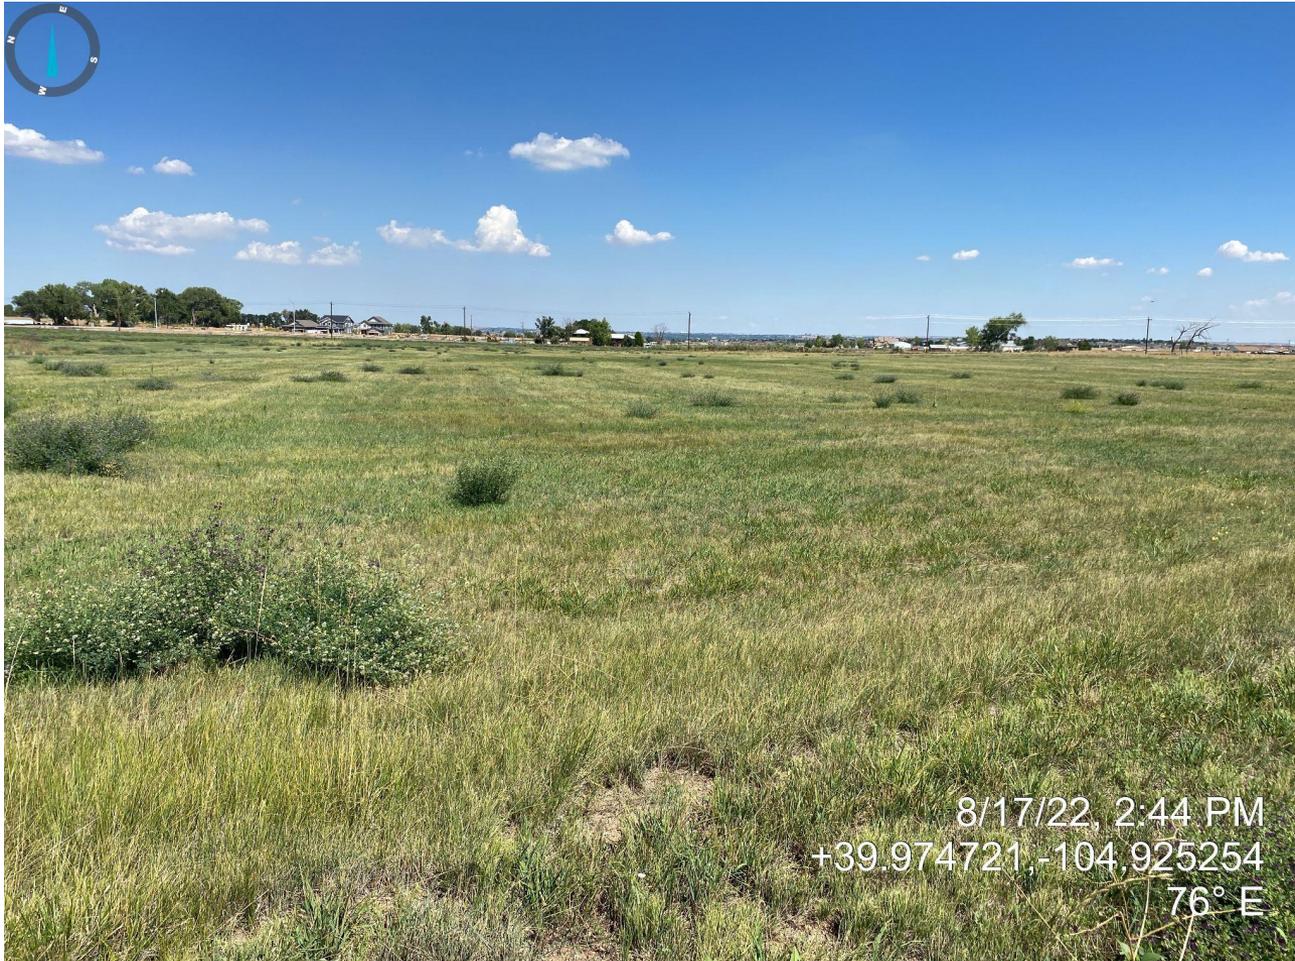
Photo 14. Reference area photo taken east of access road, facing east.
