Inspection Photos

API: 071-07711

Operator: EVERGREEN NATURAL RESOURCES

Inspection Date: 8/23/2022

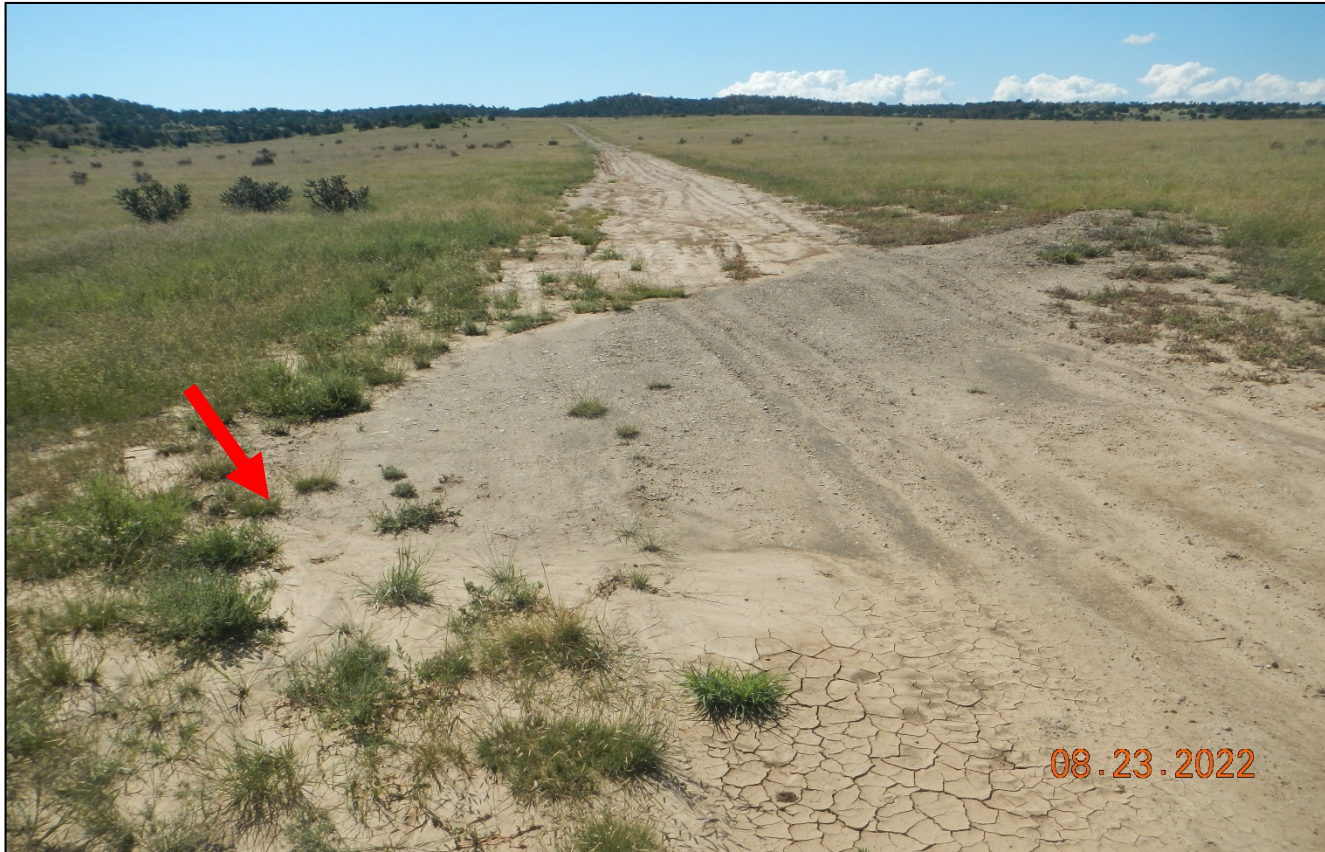
Photo 1. Facing southeast at the beginning of the access road. The water bars installed along the road need maintenance. Stormwater is being directed back onto the road shown at red arrow.

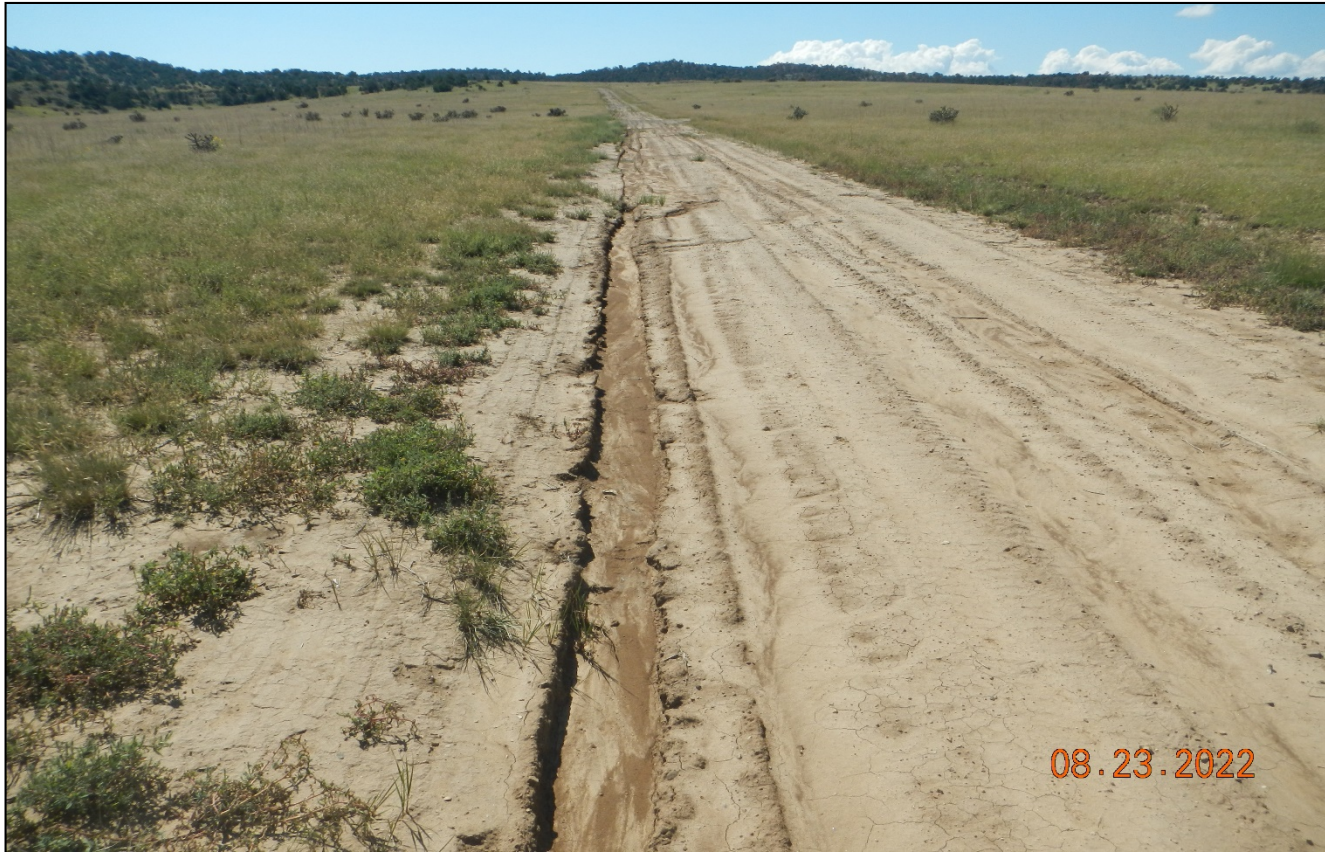
Photo 2. Facing southeast along the access road. There is erosion occurring along the road due to issue shown in previous photo.

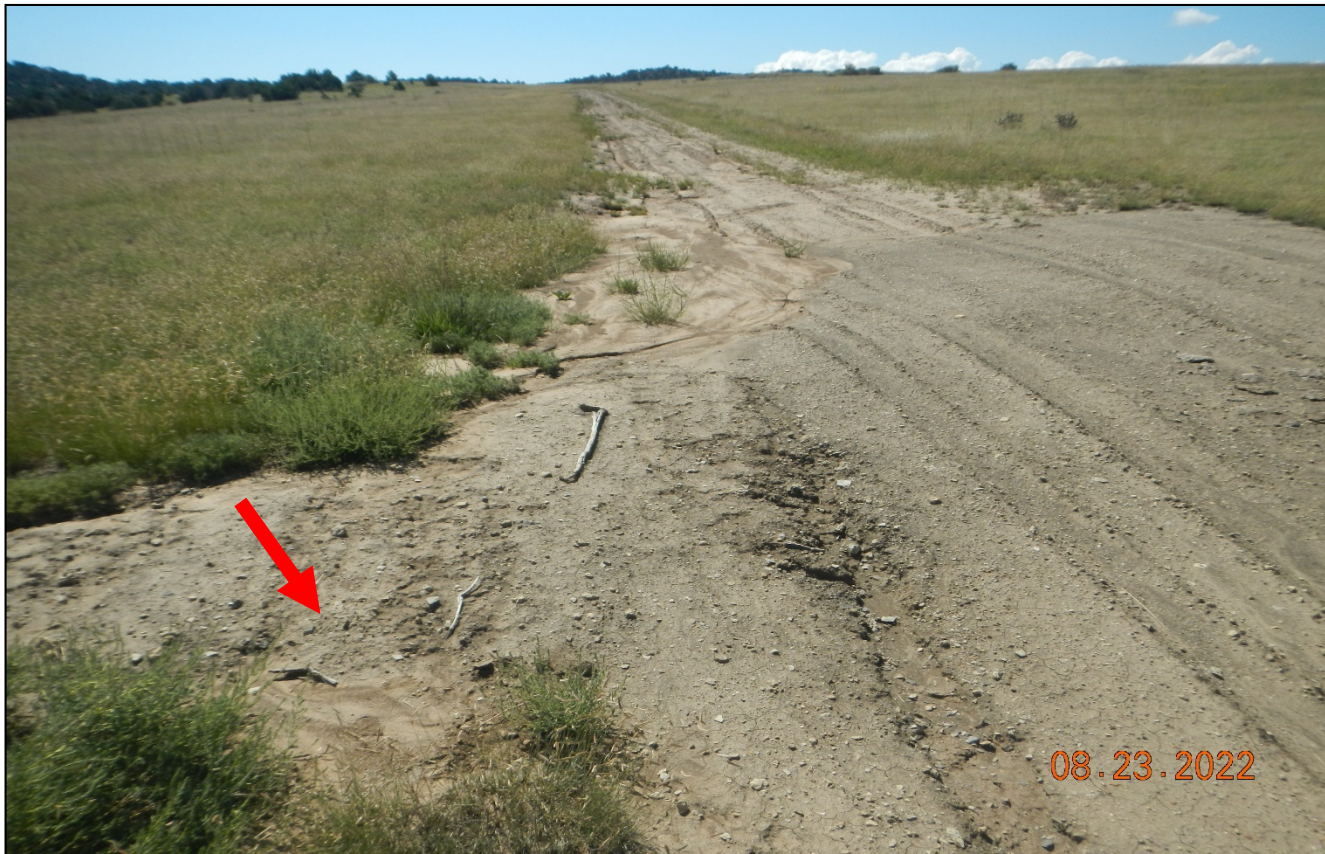
Photo 3. Facing southeast further along the access road. The water bars installed along the road need maintenance. Stormwater is being directed back onto the road shown at red arrow.

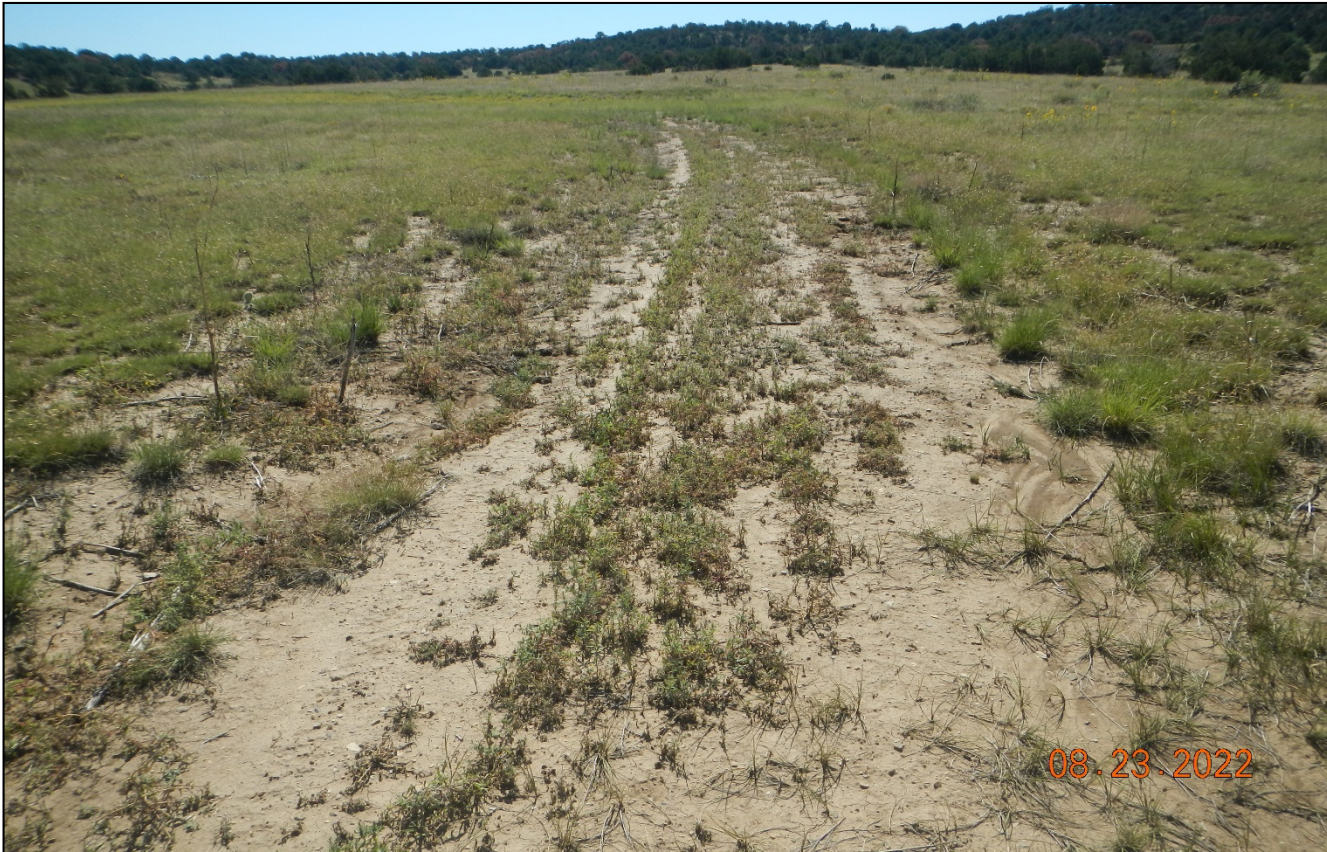
Photo 4. Facing southeast at the access road toward the location.

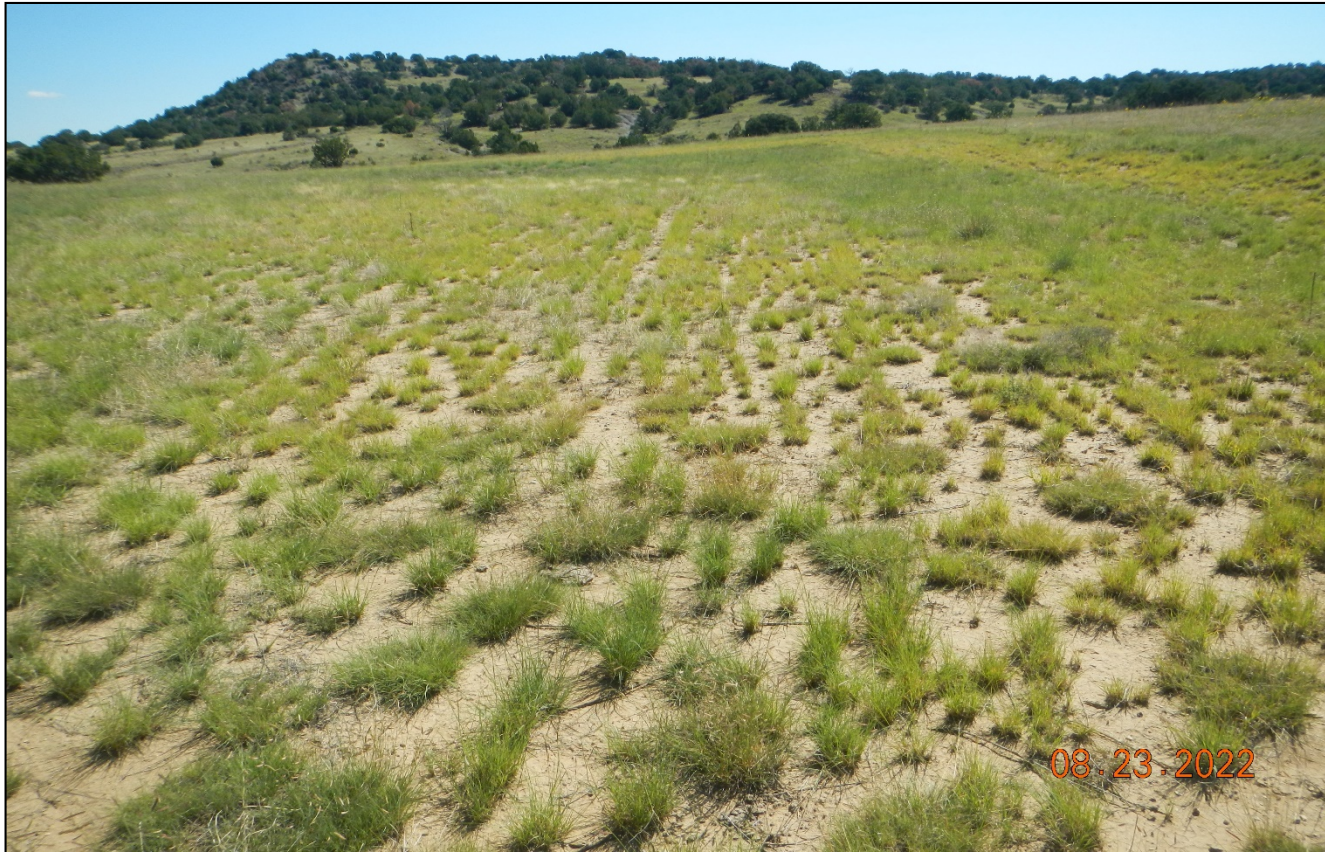
Photo 5. Facing east toward the location. Desirable vegetation is progressing well throughout most areas of the location.

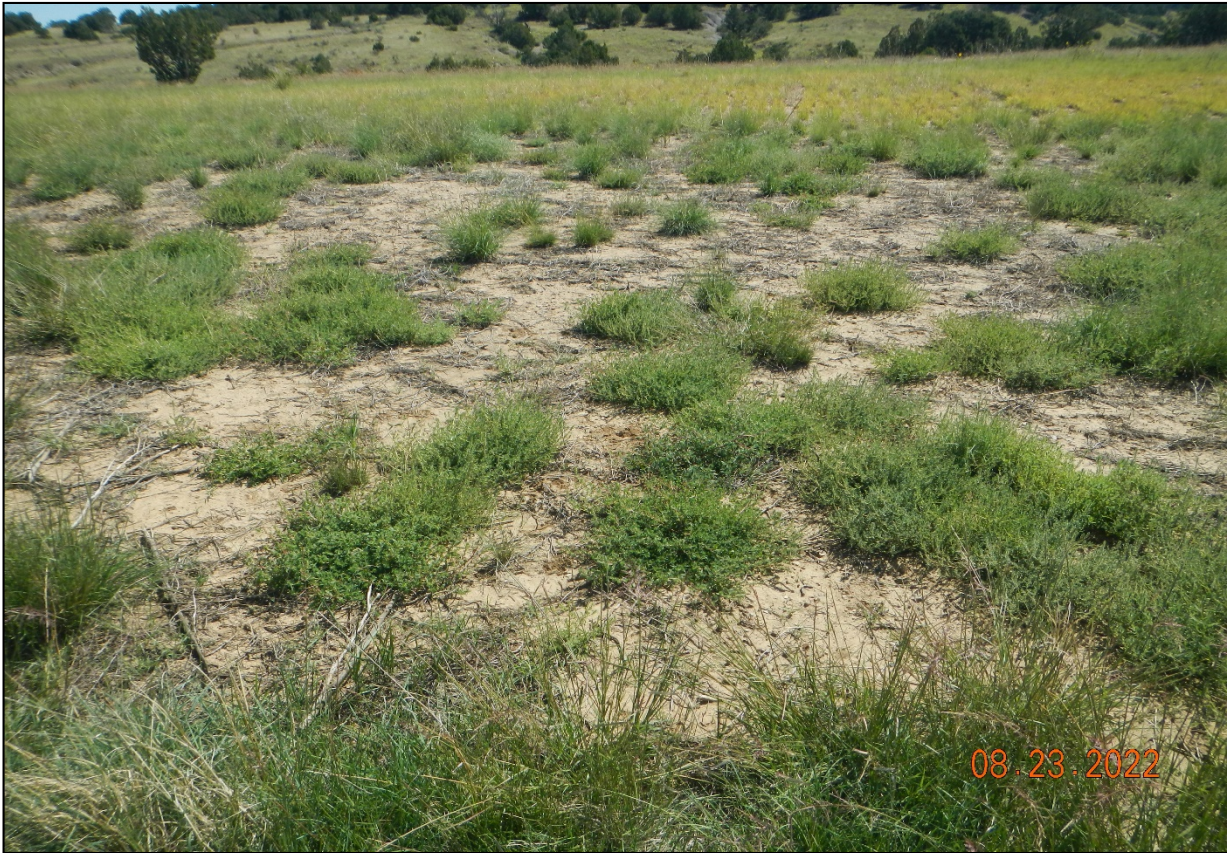
Photo 6. This area at the east side of the location approximately 50'x50' which has not established desirable vegetation . This area should be reseeded.

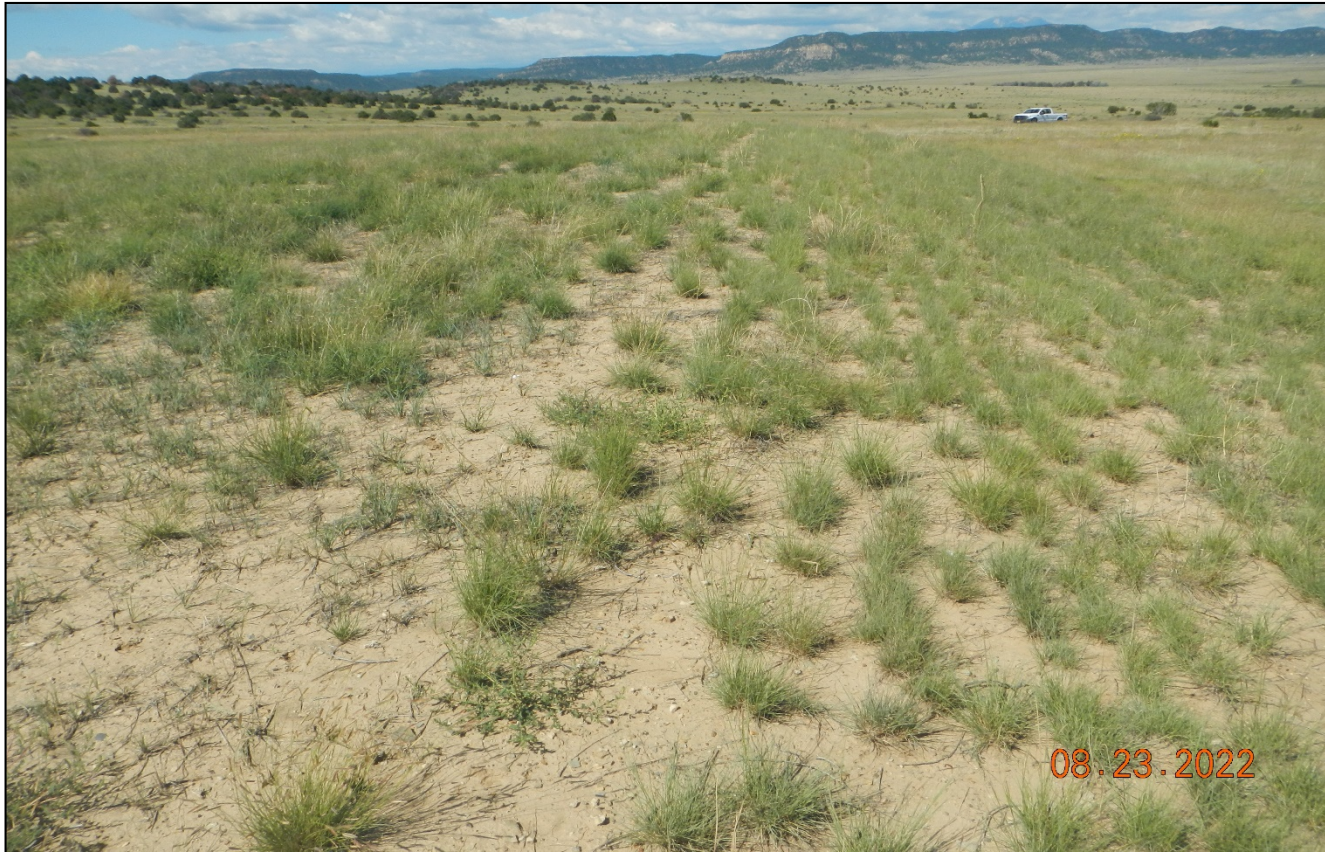
Photo 7. Facing west along the fill slope of the location.

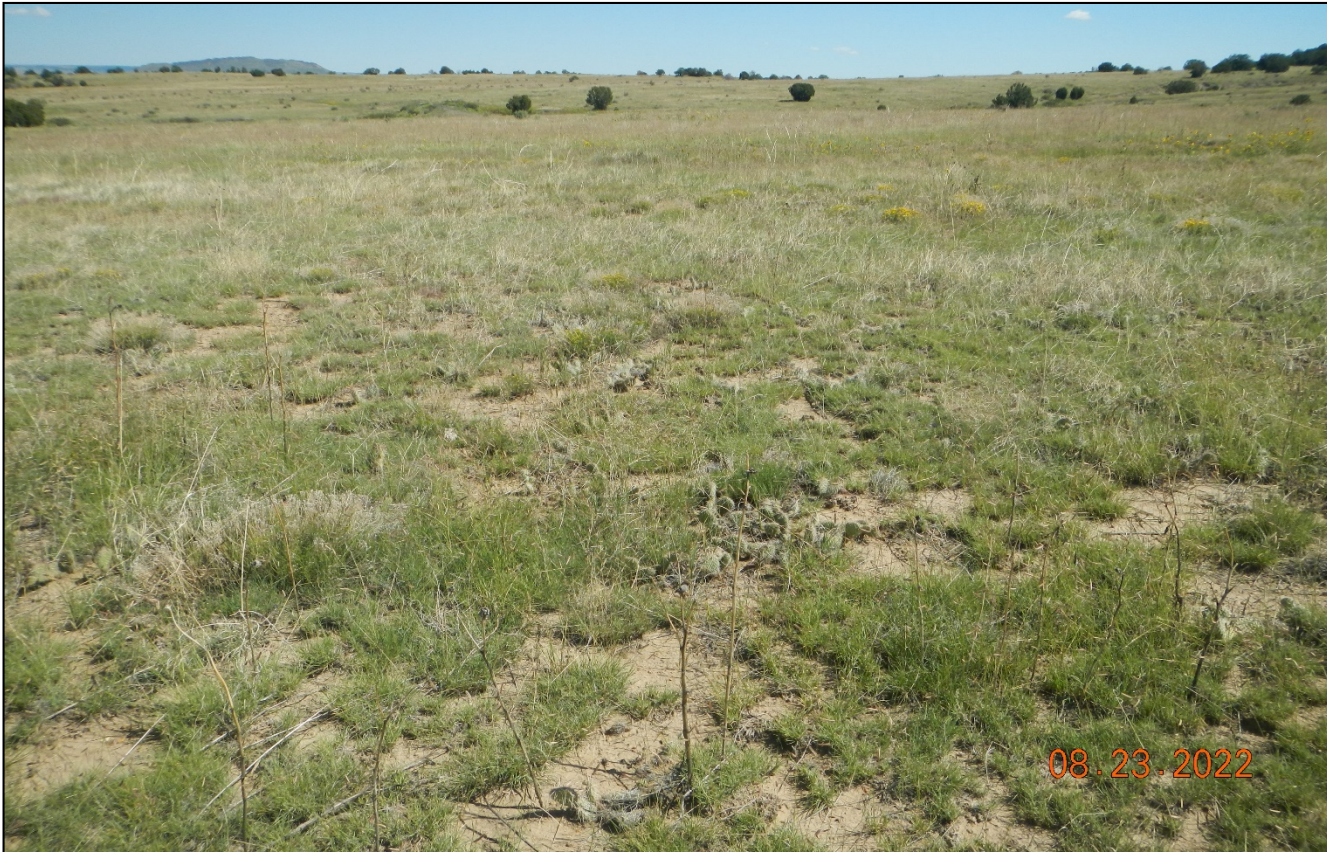
Photo 8. Facing northeast toward the surrounding undisturbed reference area vegetation cover which consists of Blue grama, Sand dropseed, Prairie threeawn, among other species.
