Inspection Photos

Location Name: Woodward-64S94W /22SESW

Inspection Document #: 702800570

Anna O'Malley
Reclamation Specialist, COGCC

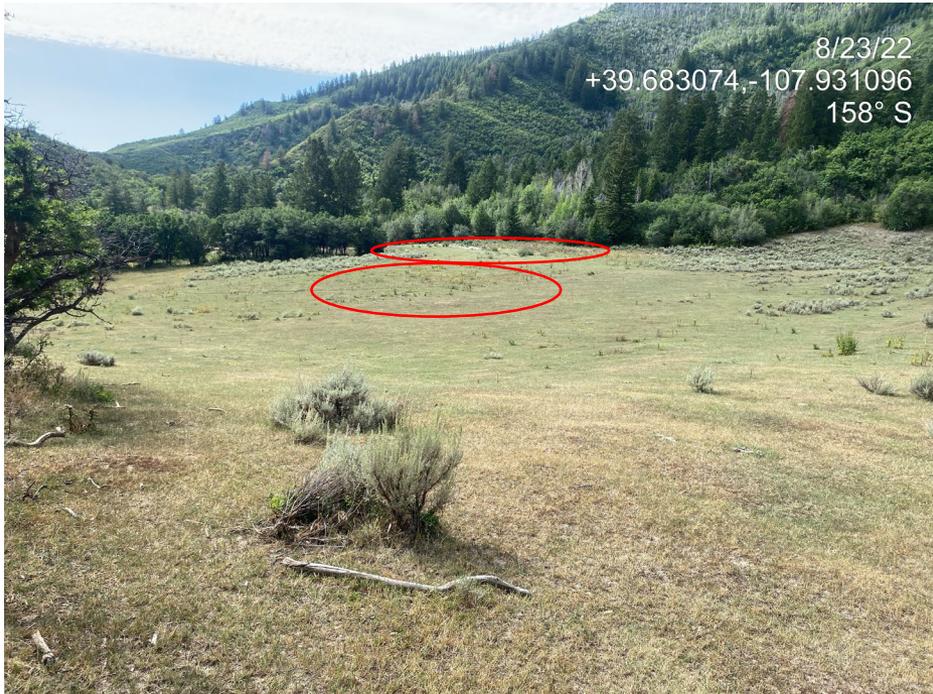
Photo 1. Photo taken from the northwest shows an overview of the Location. Approximate areas of failed reclamation are indicated by red circles. Refer also to Photos 3-6.

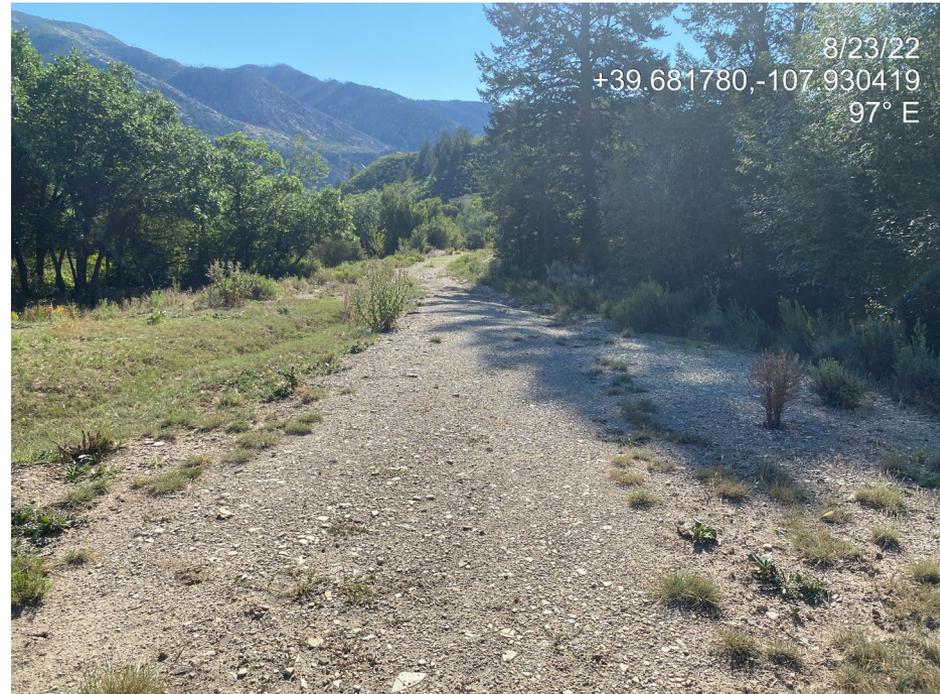
Photo 2. Photo taken from the southeast at the Location entrance shows the unreclaimed access road.

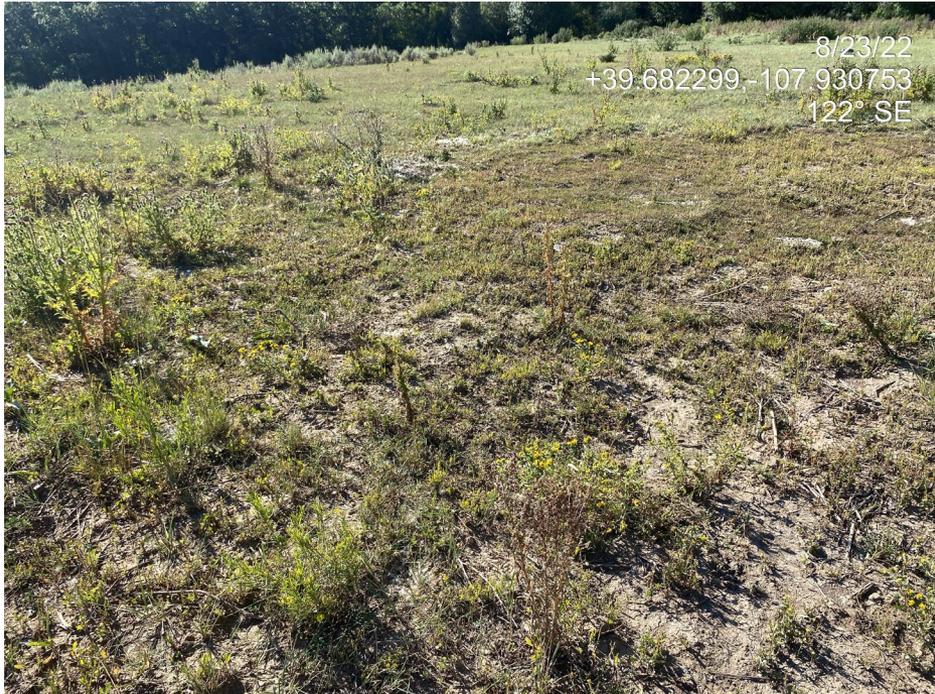
Photo 3. Photo taken from the center of the Location shows the general area around the former site of the wellhead. The plant covering much of the ground surface is prostrate knotweed, an annual, introduced, undesirable species. The taller plants throughout the photo are noxious weeds.

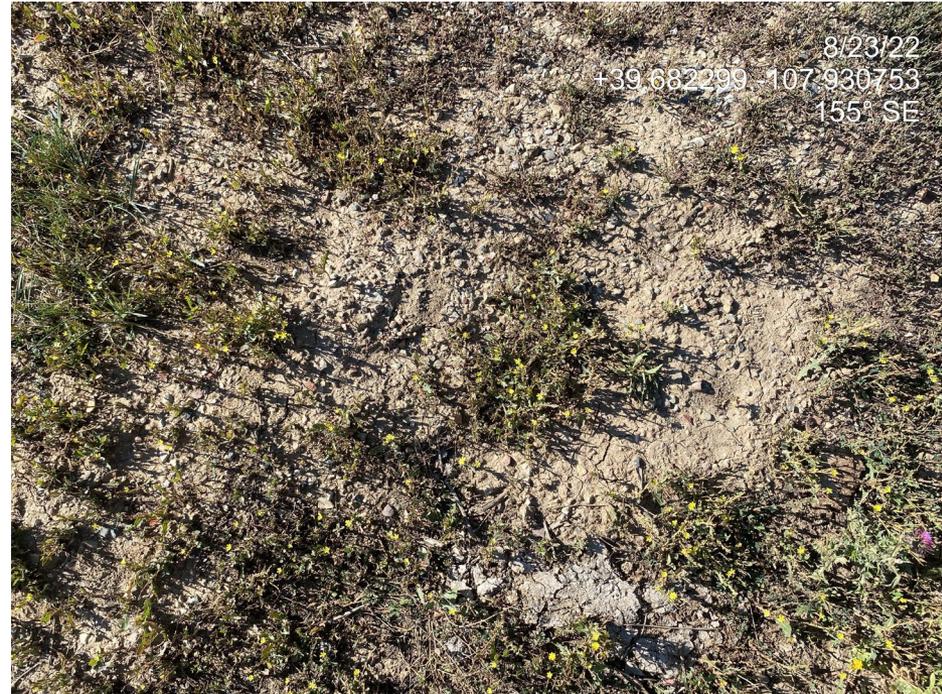
Photo 4. Photo shows a close-up of the ground surface of the area shown in Photo 3.

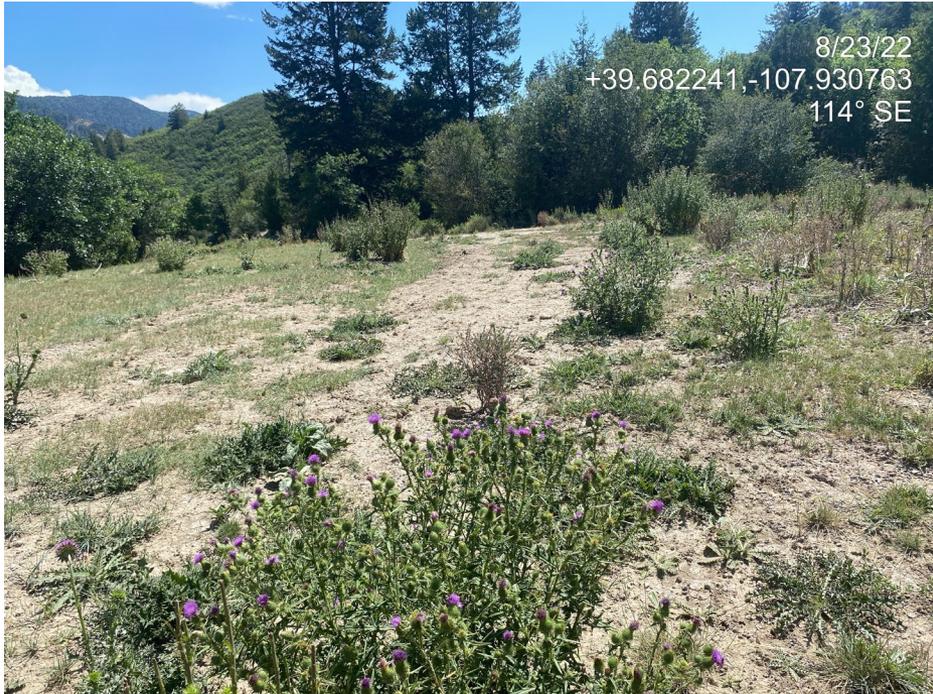
8/23/22
+39.682241,-107.930763
114° SE

Photo 5. Photo taken from the south of the Location shows where revegetation has failed. Areas of failed revegetation in photo include the general area around the Location entrance and the former site of the tank battery and other equipment. Photo also shows the area is dominated by noxious weeds.

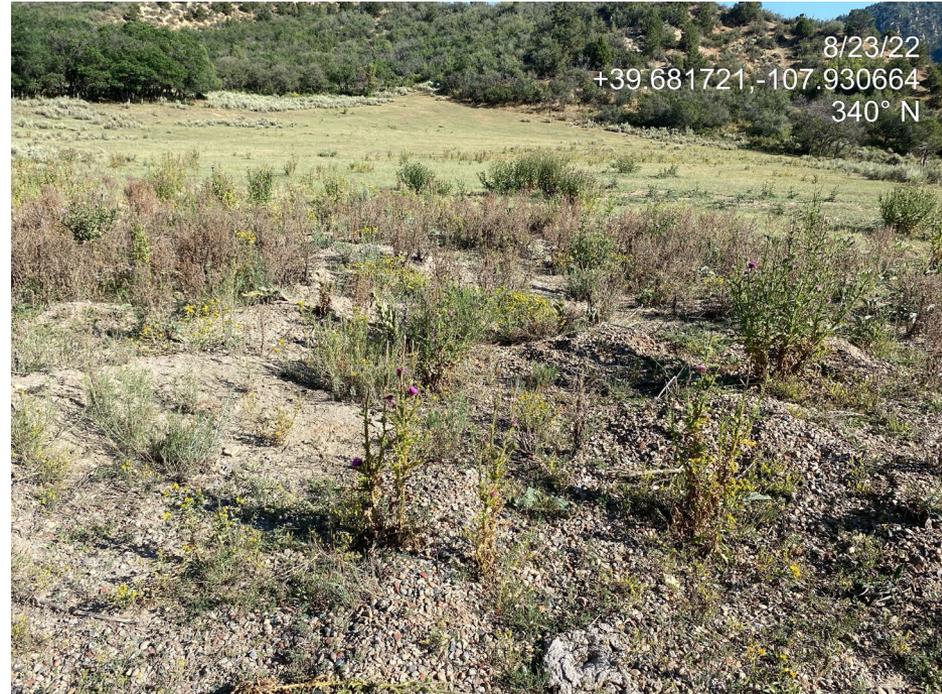
8/23/22
+39.681721,-107.930664
340° N

Photo 6. Photo taken from the south of the Location shows where revegetation has failed at the former site of the tank battery and other equipment. Photo also shows the area is dominated by noxious weeds.

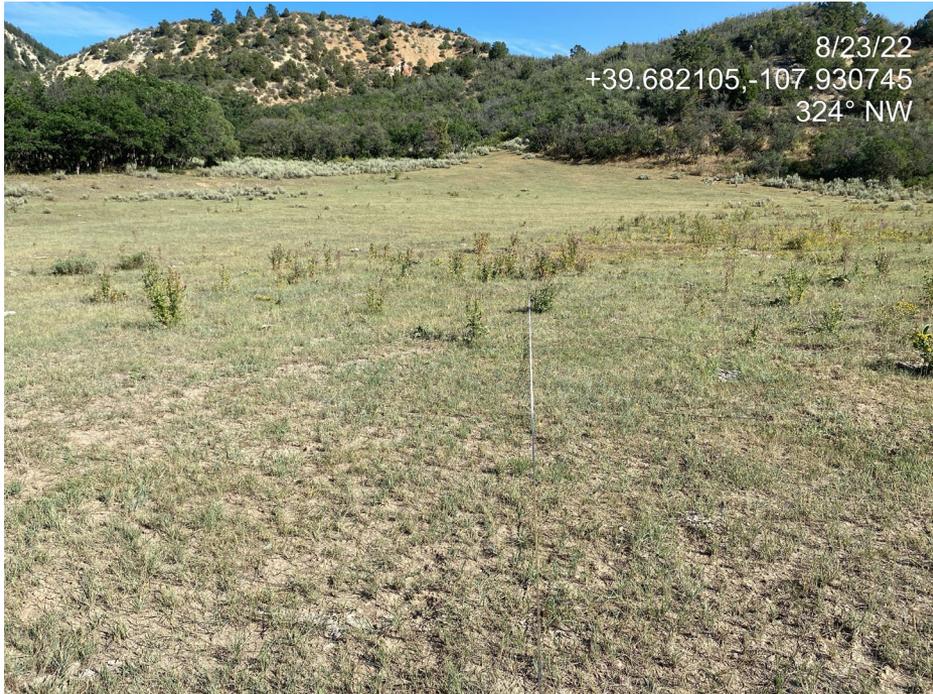
Photo 7. Photo taken from the center of the Location shows the start of the disturbed area vegetation monitoring transect. The taller plants throughout the photo are noxious weeds.

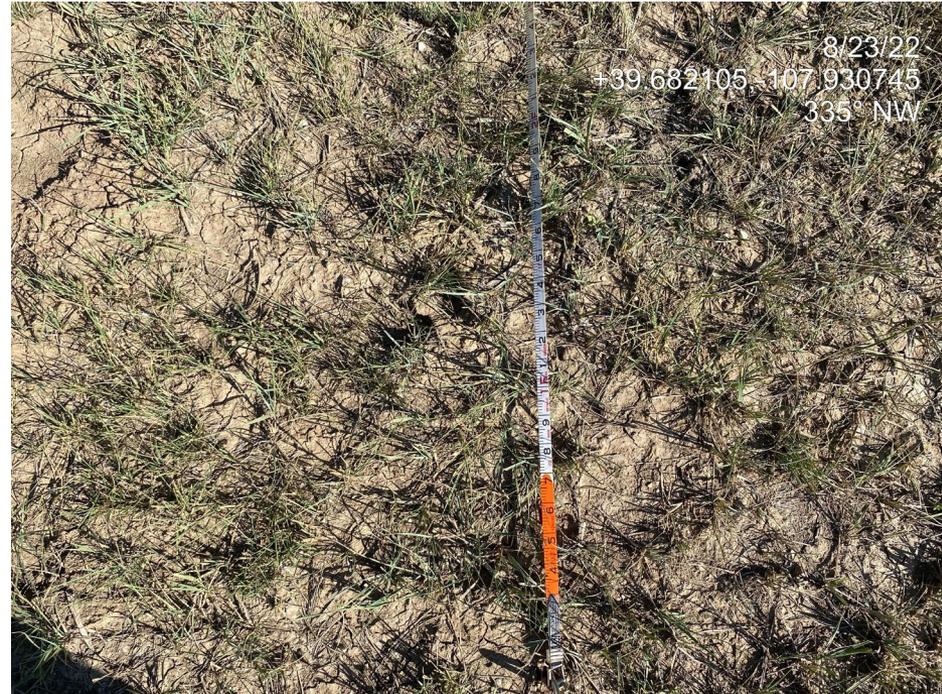
Photo 8. Photo taken from the center of the Location shows the ground surface at the start of the disturbed area vegetation monitoring transect.

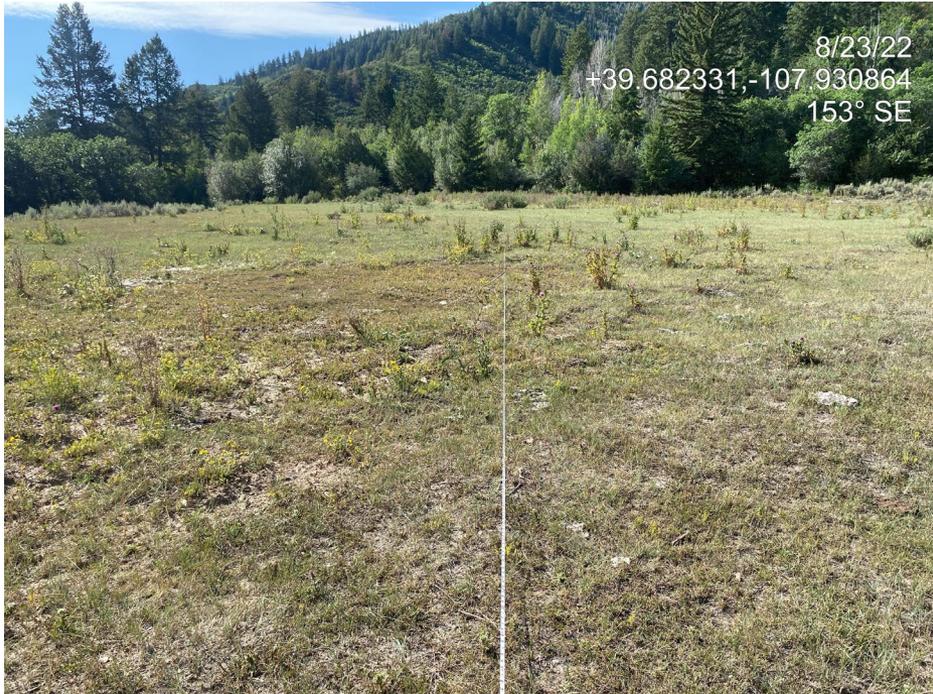
Photo 9. Photo taken from the center of the Location shows the end of the disturbed area vegetation monitoring transect. The taller plants throughout the photo are noxious weeds.

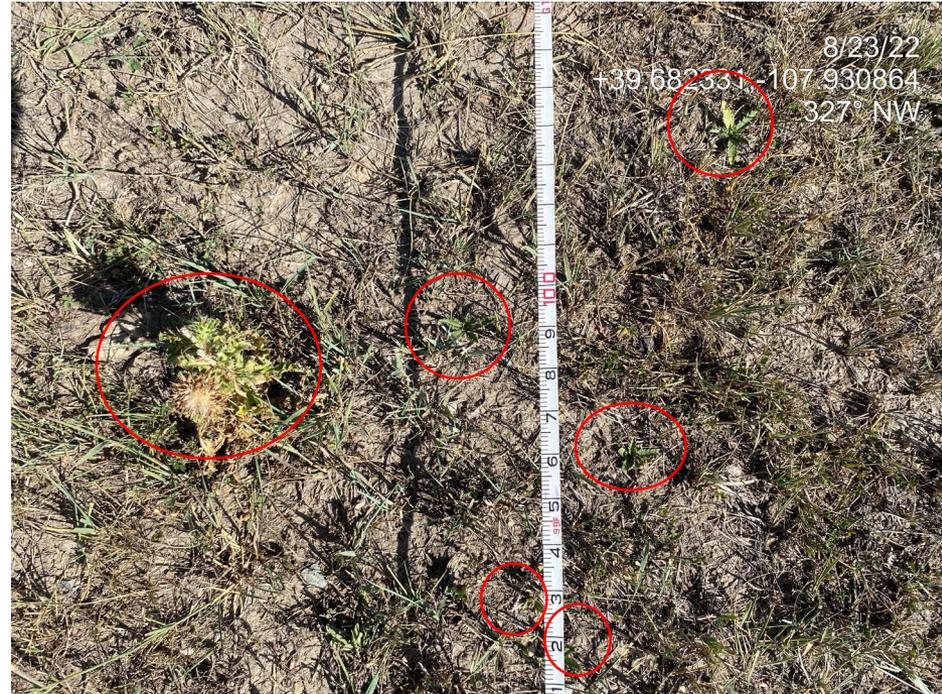
Photo 10. Photo taken from the center of the Location shows the ground surface at the end of the disturbed area vegetation monitoring transect. Red circles indicates musk thistle, a noxious weed.

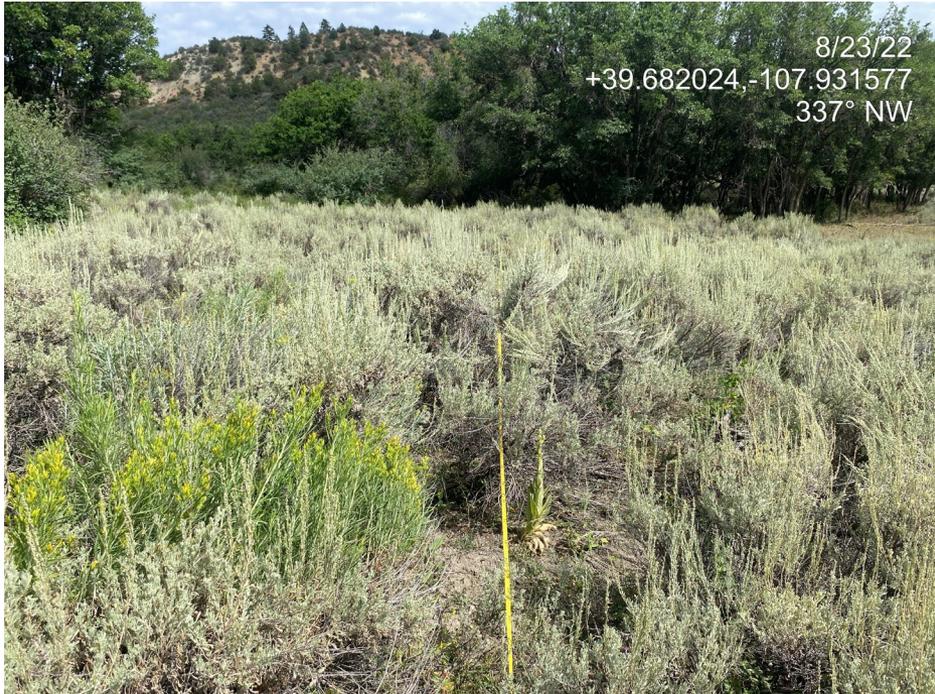
Photo 11. Photo taken to the west of the Location shows the start of the reference area vegetation monitoring transect.

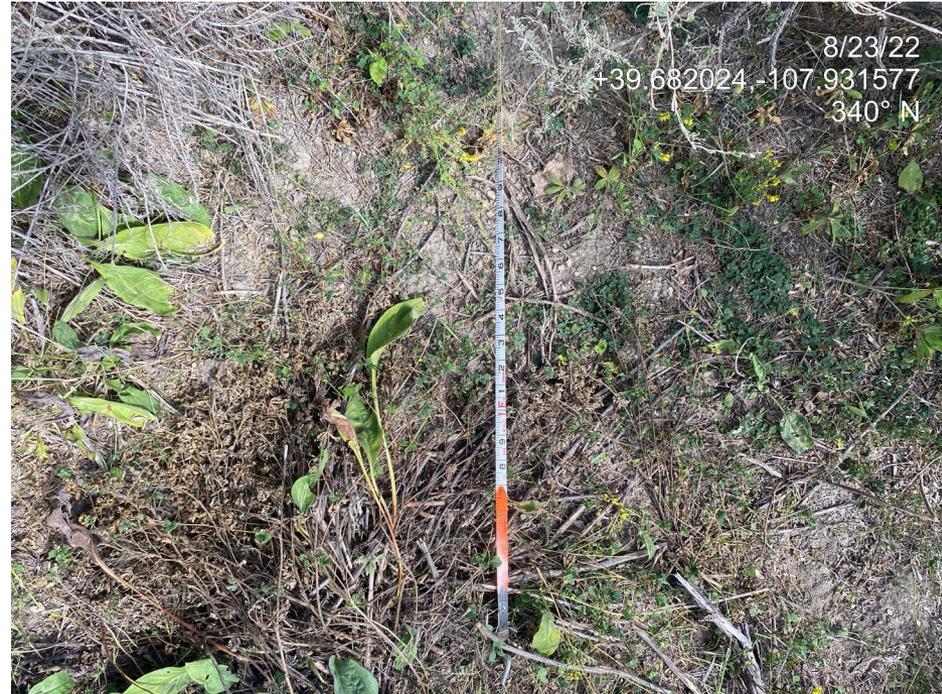
Photo 12. Photo taken to the west of the Location shows the ground surface at the start of the reference area vegetation monitoring transect.

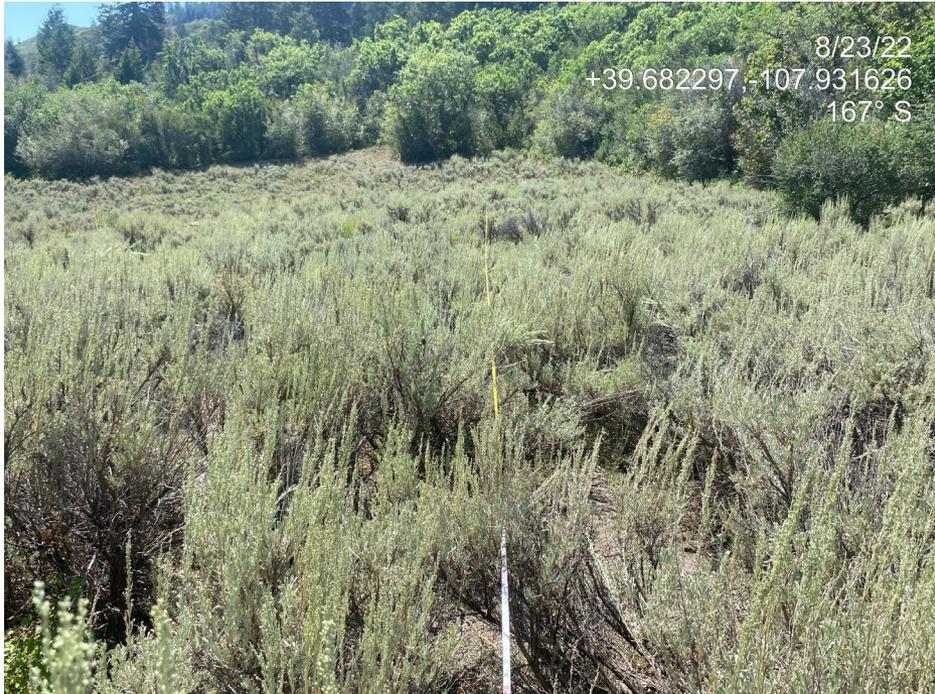
Photo 13. Photo taken to the west of the Location shows the end of the reference area vegetation monitoring transect.

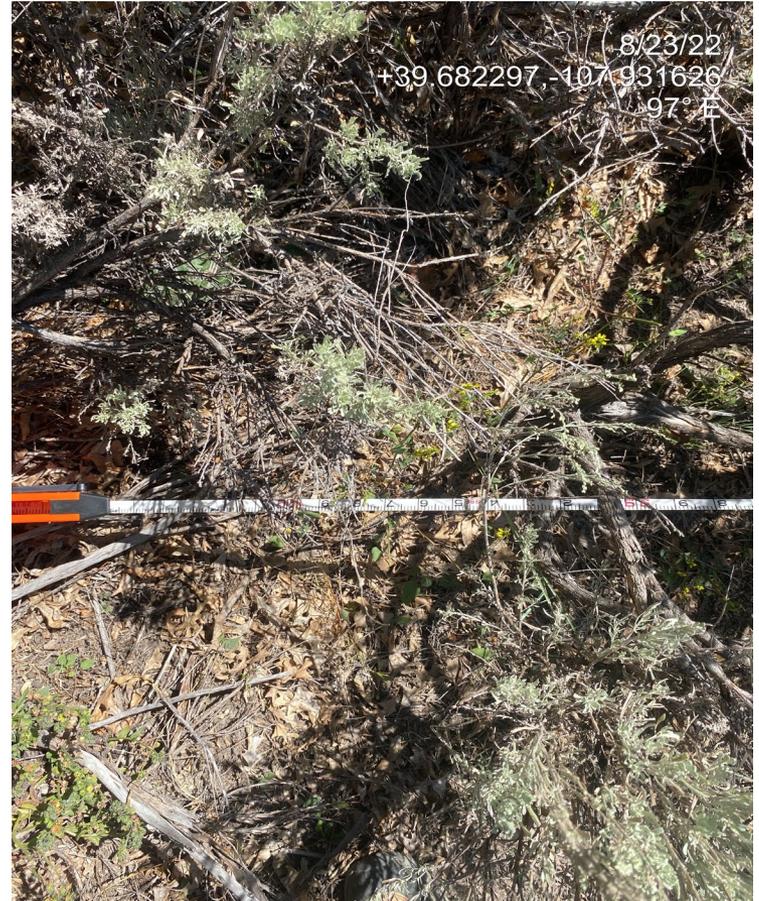
Photo 14. Photo taken to the west of the Location shows the ground surface at the end of the reference area vegetation monitoring transect.
