Inspection Photos

Location ID: 334282

Location Name: GMU-66S93W /35NWSW

Inspection Document #: 702800571

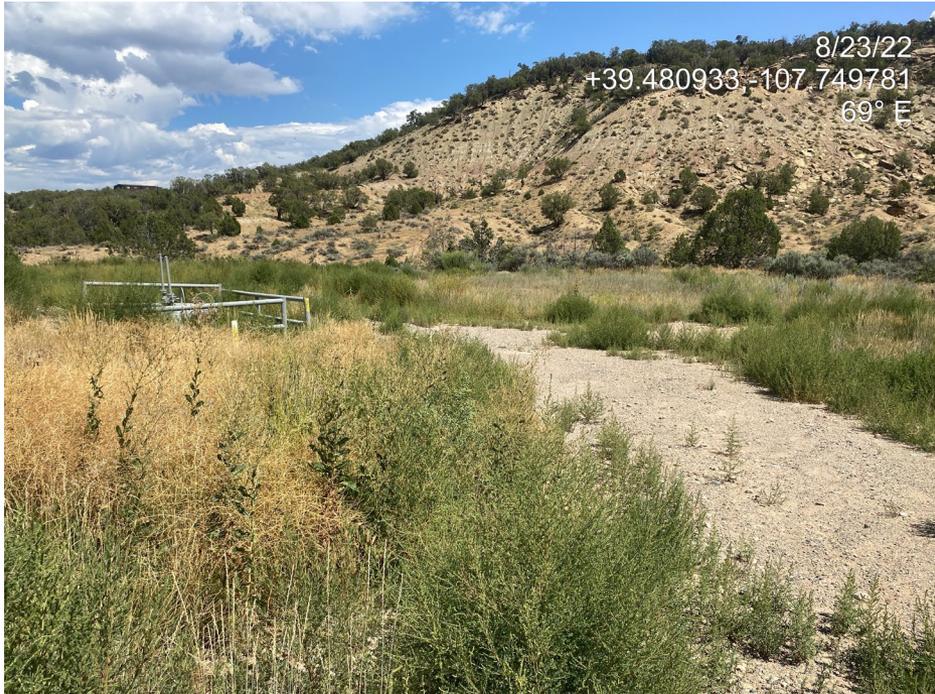
Photo 1. Photo taken from the southeast of the Location shows a pig launcher/receiver and associated road remaining on Location.

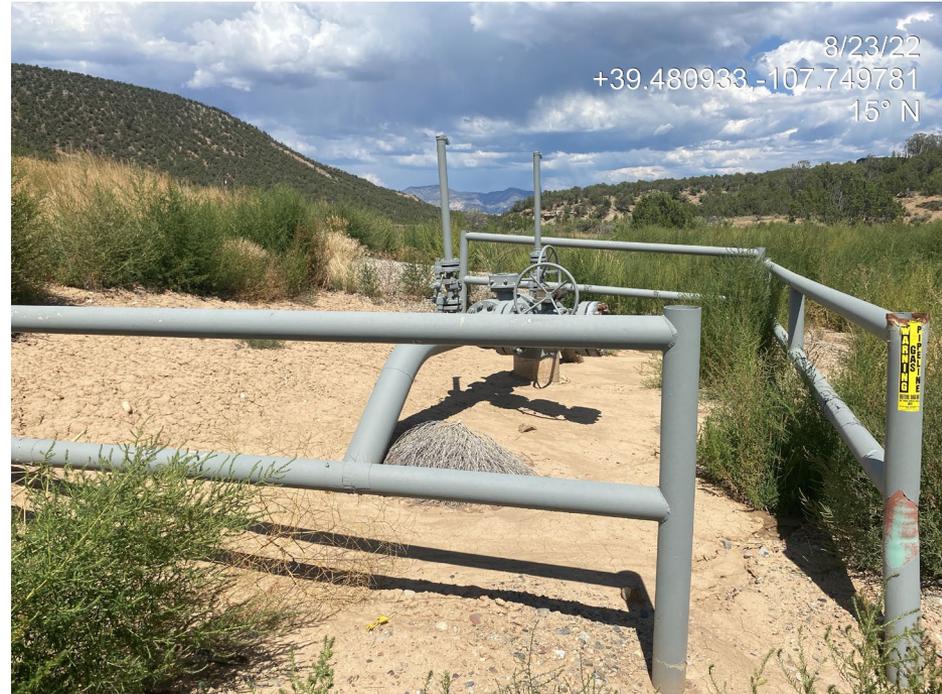
Photo 2. Photo taken from the southeast of the Location shows a pig launcher/receiver remaining on Location.

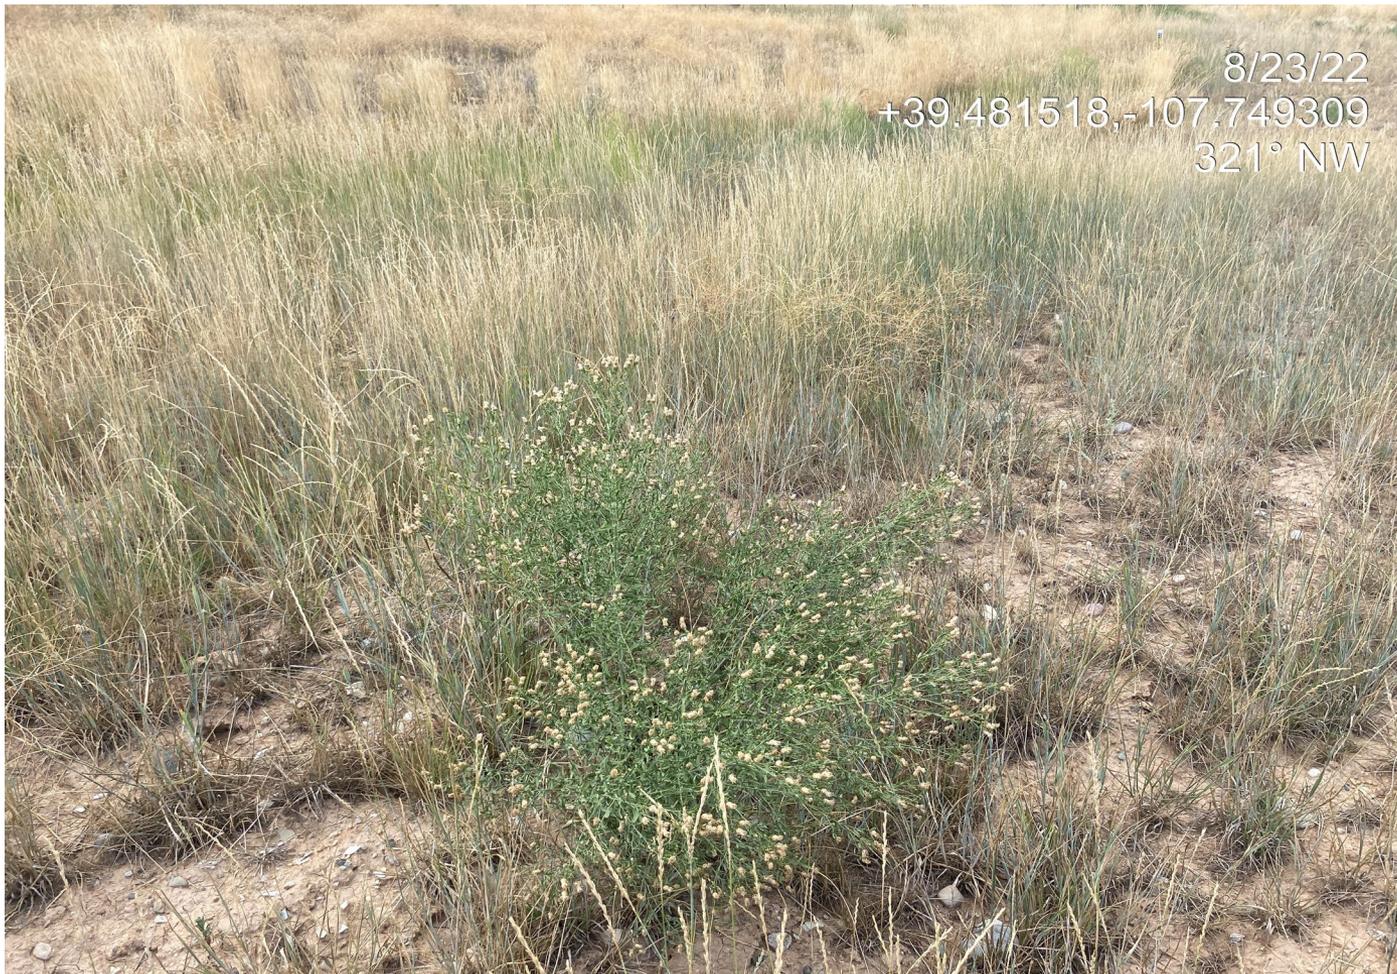
Photo 3. Photo taken from the northeast of the Location shows Russian knapweed, a CO List B Noxious Weed.

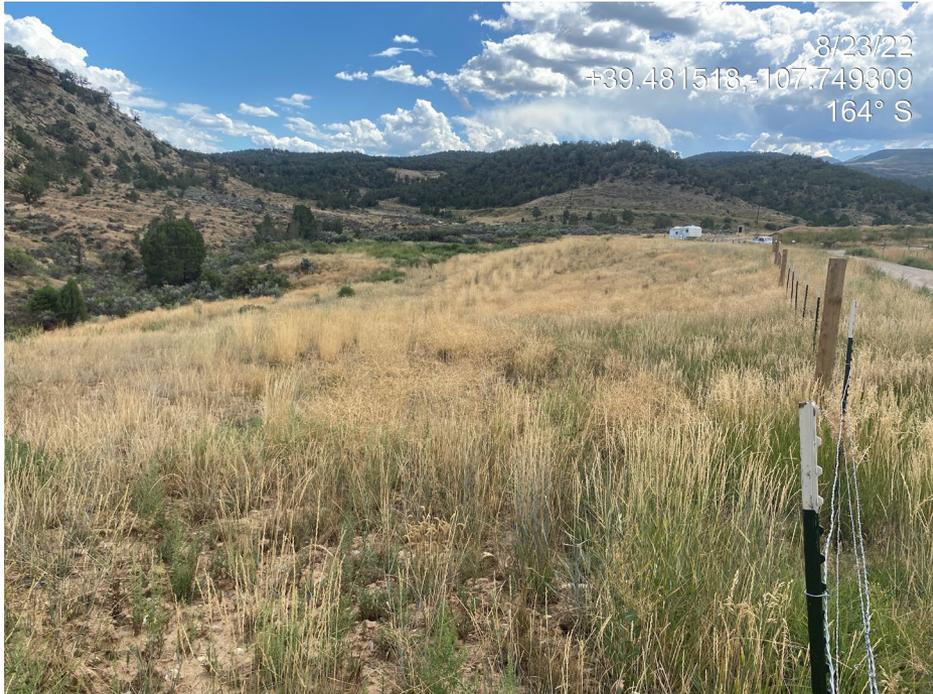
Photo 4. Photo taken from the north shows an overview of the lower/eastern portion of the reclaimed Location. The area is dominated by perennial grasses. A residential road/driveway bisects the Location.

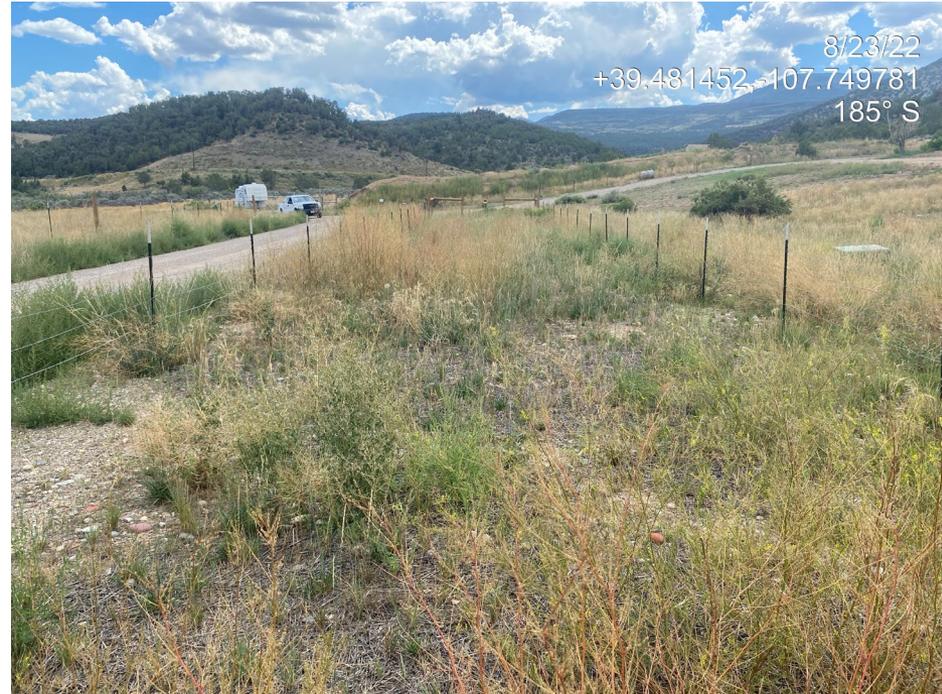
Photo 5. Photo taken from the north shows an overview of the upper/western portion of the reclaimed Location at the former site of the wellheads. The area is dominated by perennial grasses.

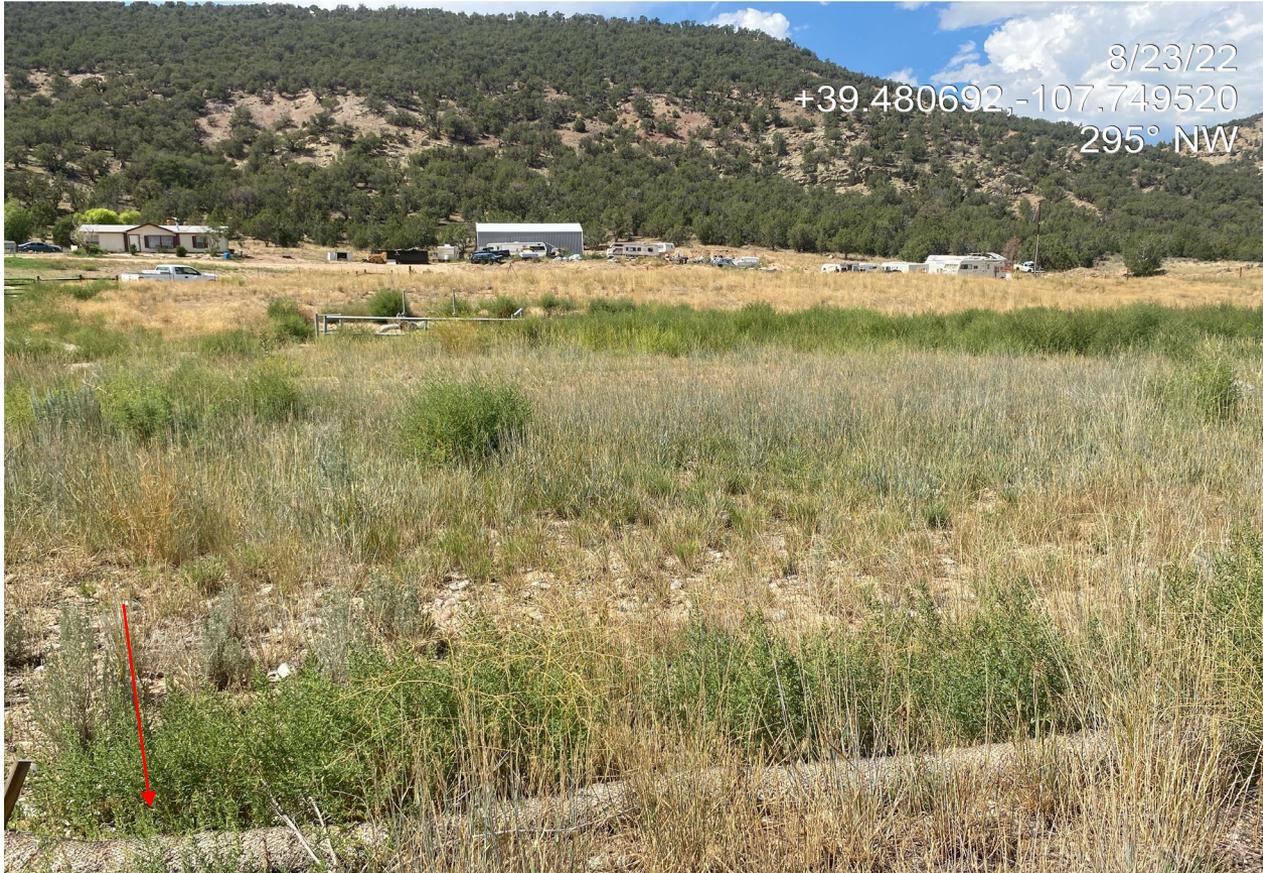
Photo 6. Photo taken from the east shows the lower/southeastern portion of the reclaimed Location at the former site of the tank battery. The area is dominated by perennial grasses. Note the straw wattle, which must be removed for the site to receive a passing final reclamation inspection.

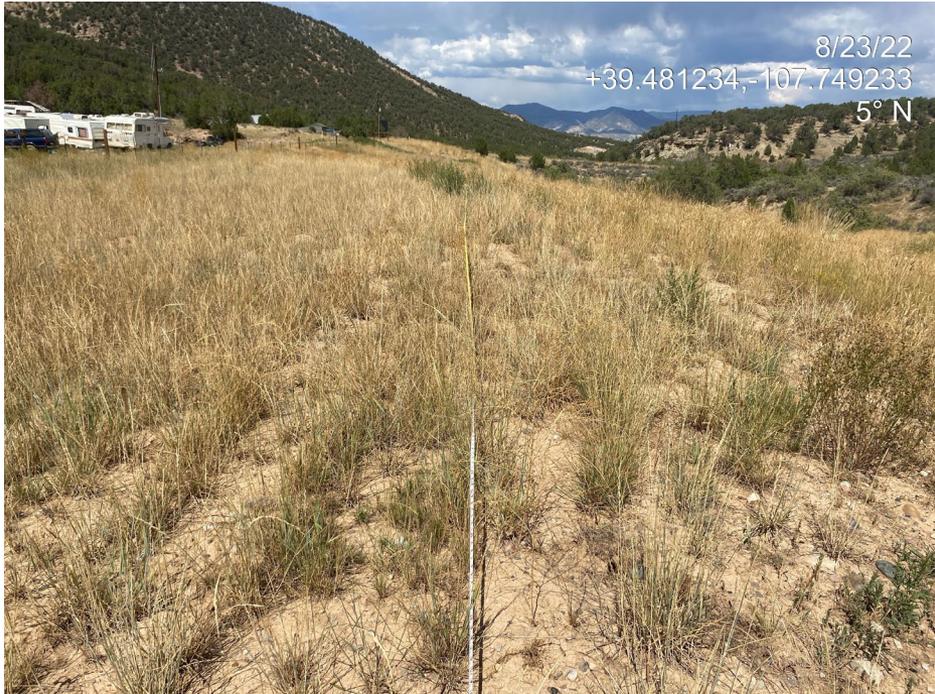
Photo 7. Photo taken from the center of the Location shows the start of the disturbed area vegetation monitoring transect.

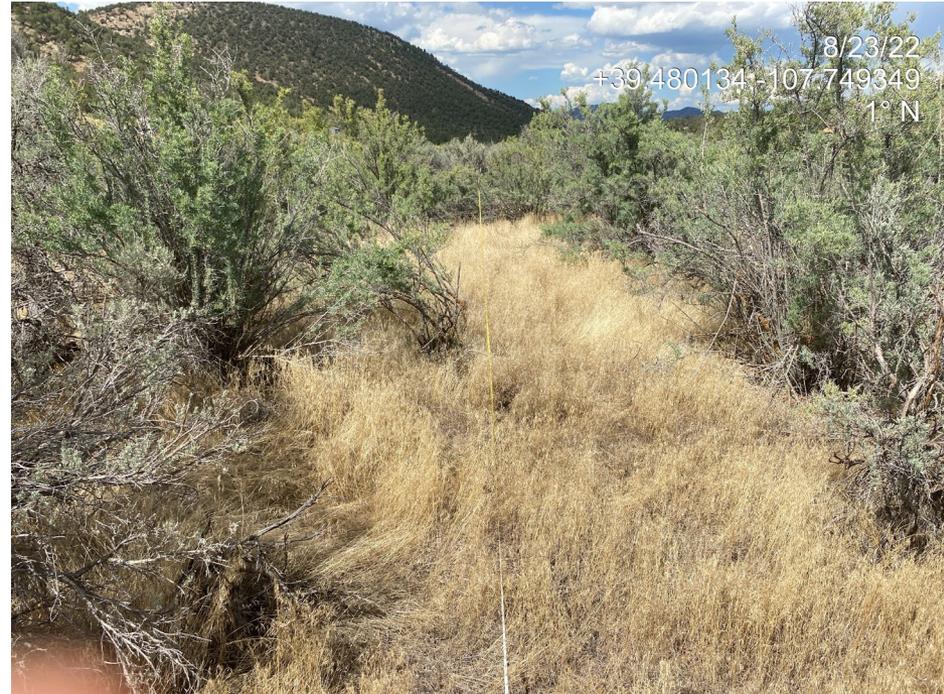
Photo 8. Photo taken to the south of the Location shows the start of the reference area vegetation monitoring transect.
