# Inspection Photos and Issue Report

8/25/2022

Operator: D & G ROUSTABOUT SERVICE -  
22370CORP - 10539  
Location #322318  
Garfield County, CO

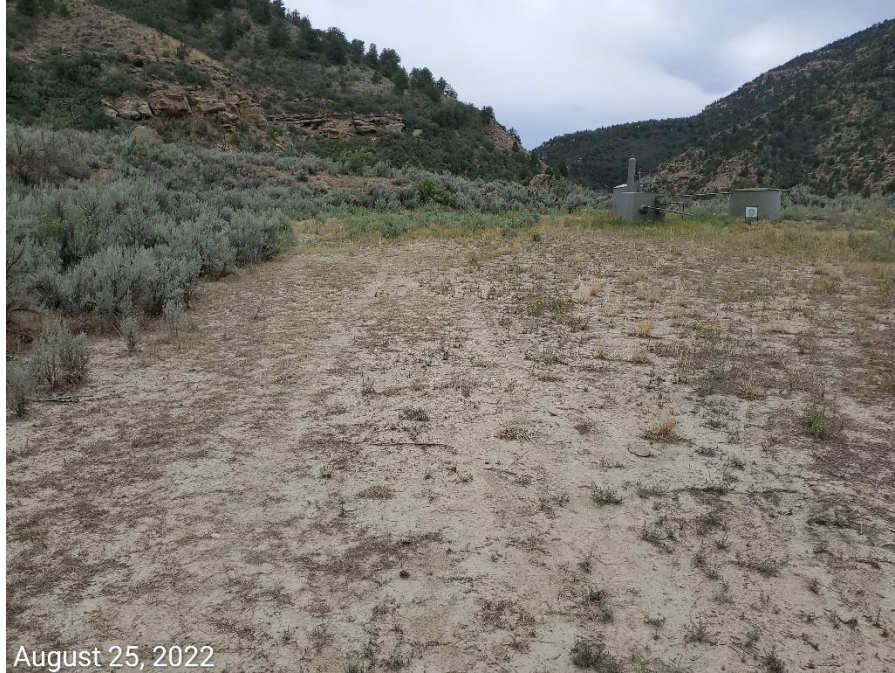
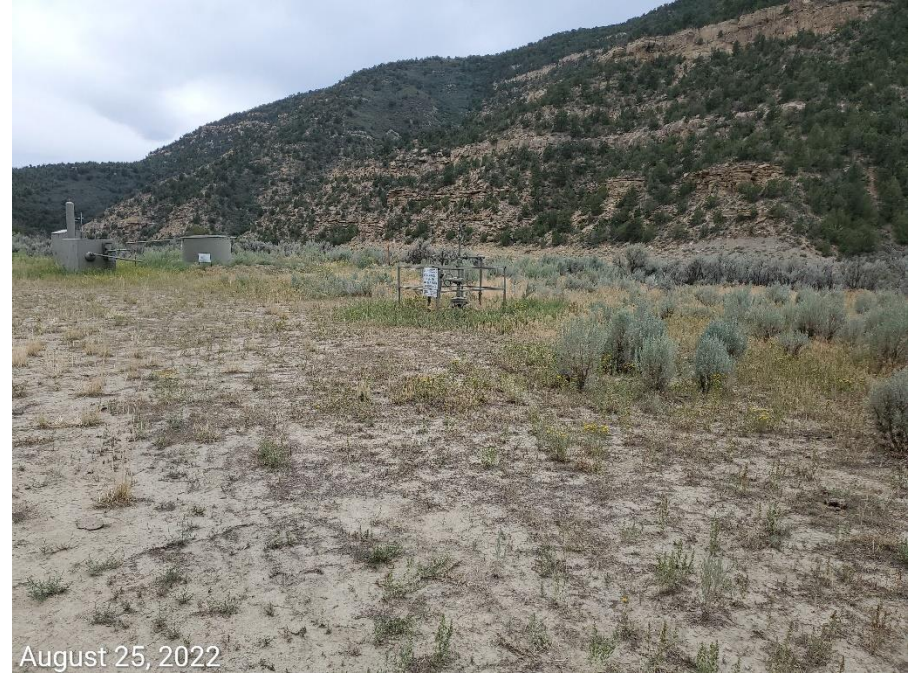
**Photo 1:** Photos provide overview of the Location. Vegetation observed on the working pad is predominantly undesirable and noxious plant species.

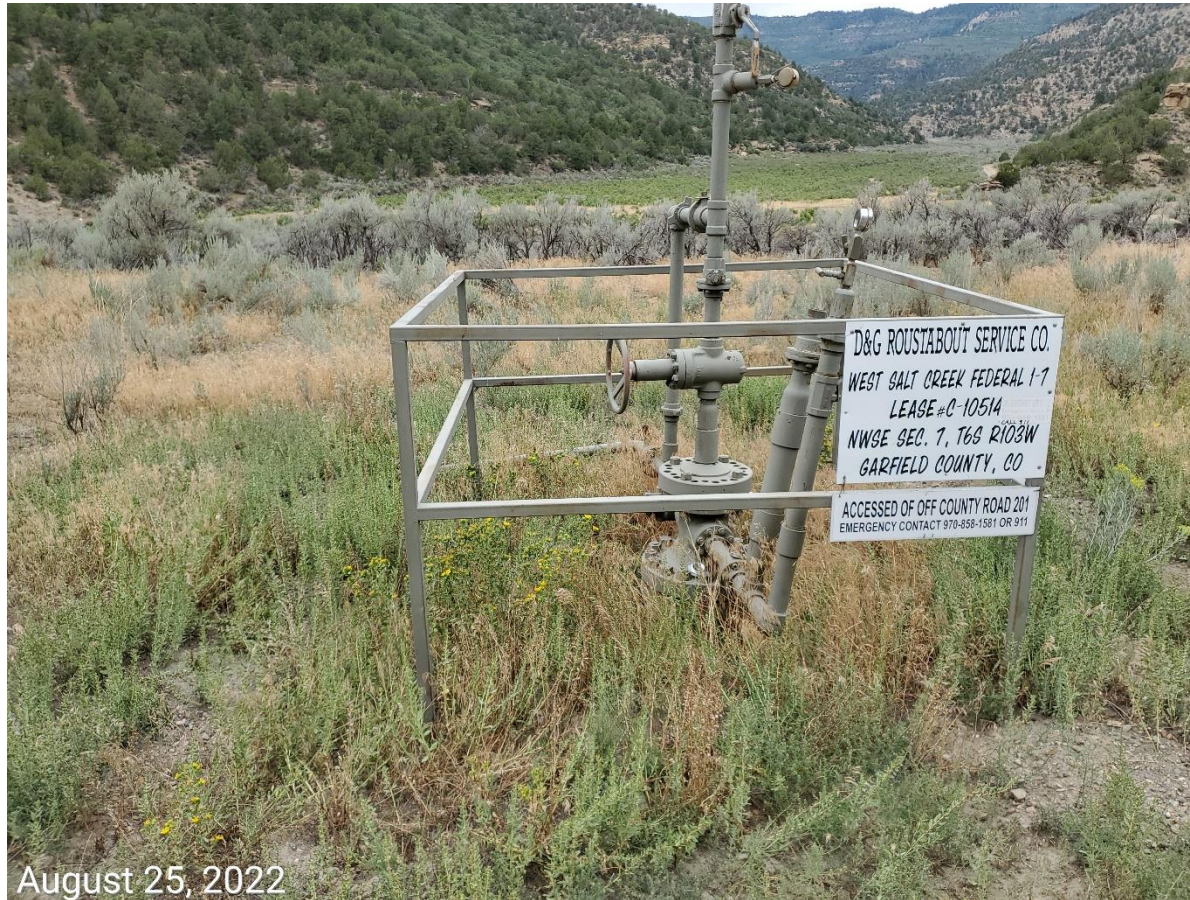
**Photo 2:** Photo shows weeds have re-established at and around production equipment on the Location; this is a fire hazard

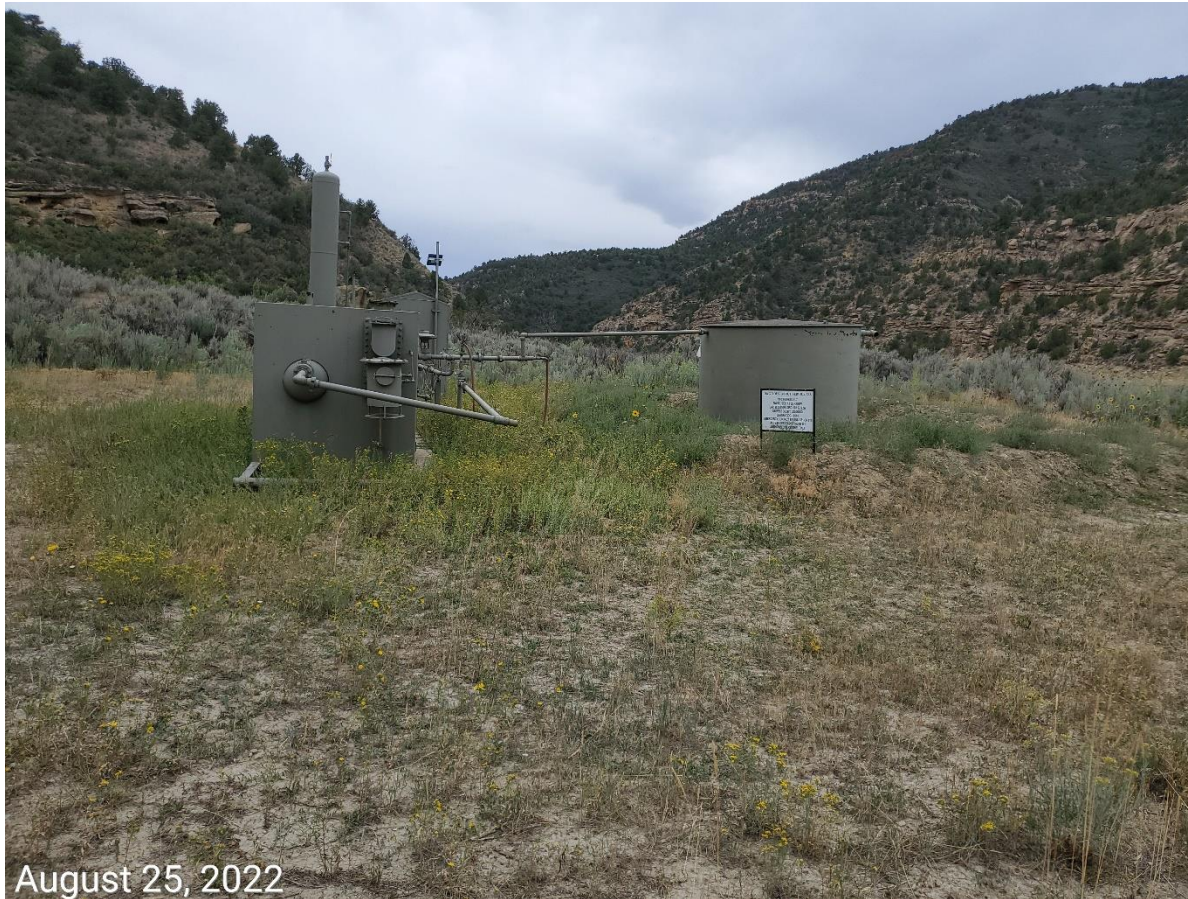
**Photo 3:** Photo shows weeds have re-established at and around production equipment on the Location; this is a fire hazard

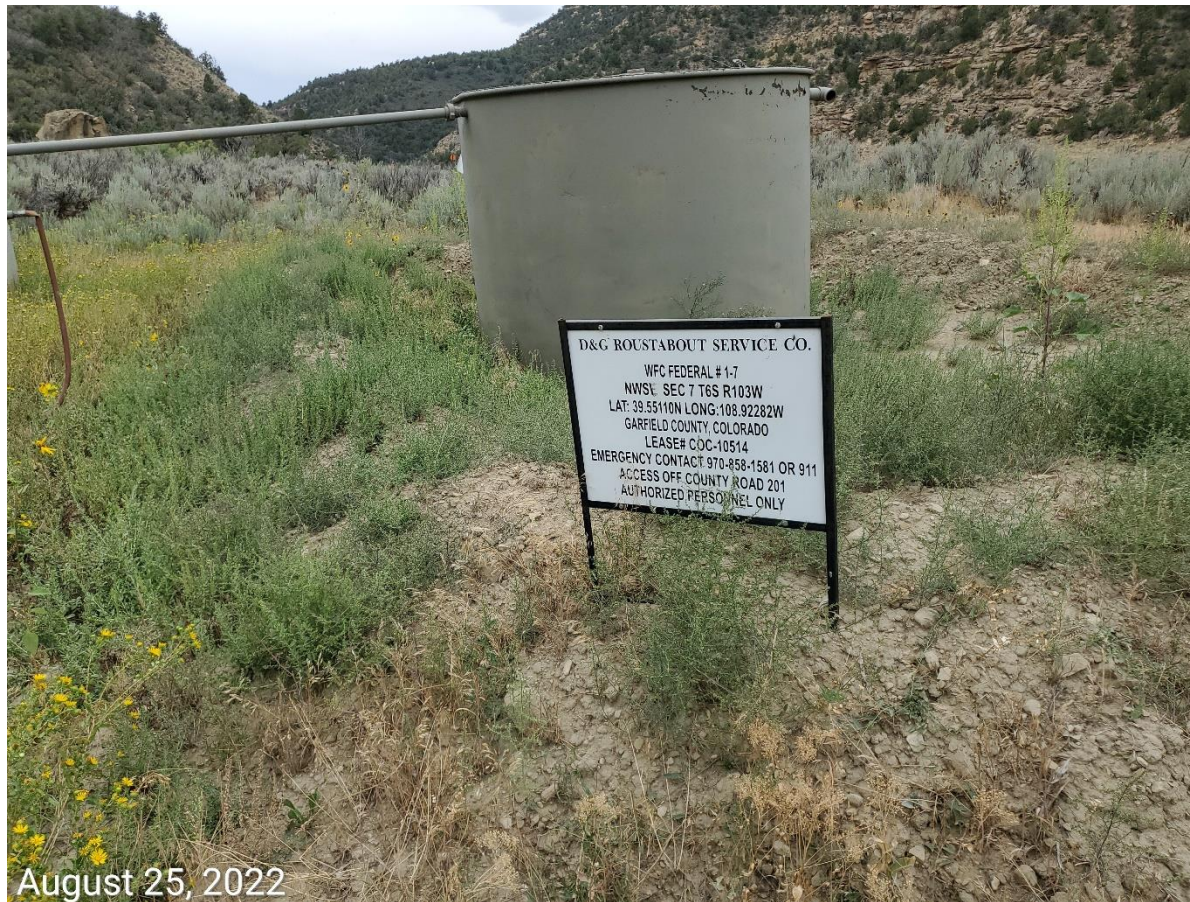
**Photo 3:** Photo shows produced water tank, and earthen berm (secondary containment). Photo shows integrity of the BMP has not been maintained; vegetation has re-established around the production equipment, and on/within the containment BMP- BMP is compromised.

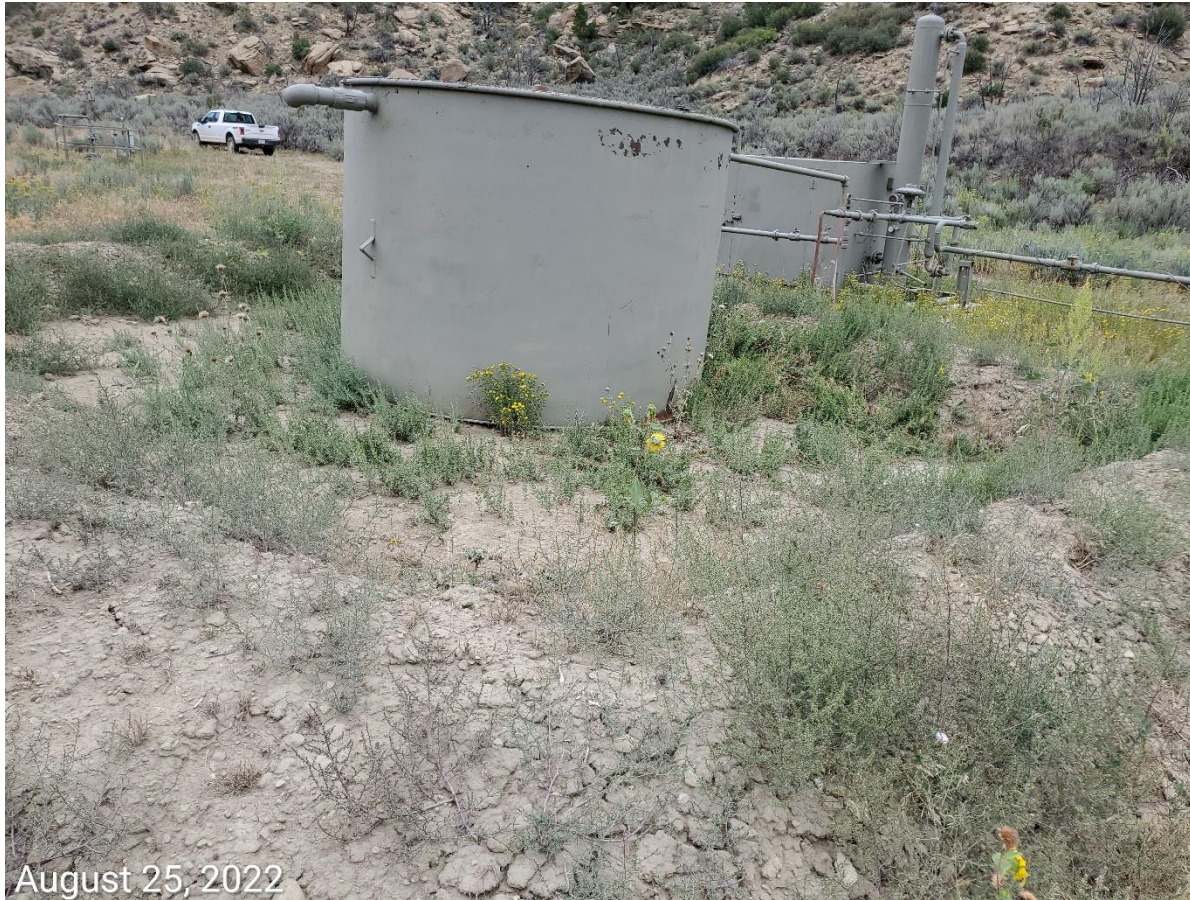
**Photo 5:** Photo shows produced water tank, and earthen berm (secondary containment). Photo shows integrity of the BMP has not been maintained; vegetation has re-established around the production equipment, and on/within the containment BMP- BMP is compromised.

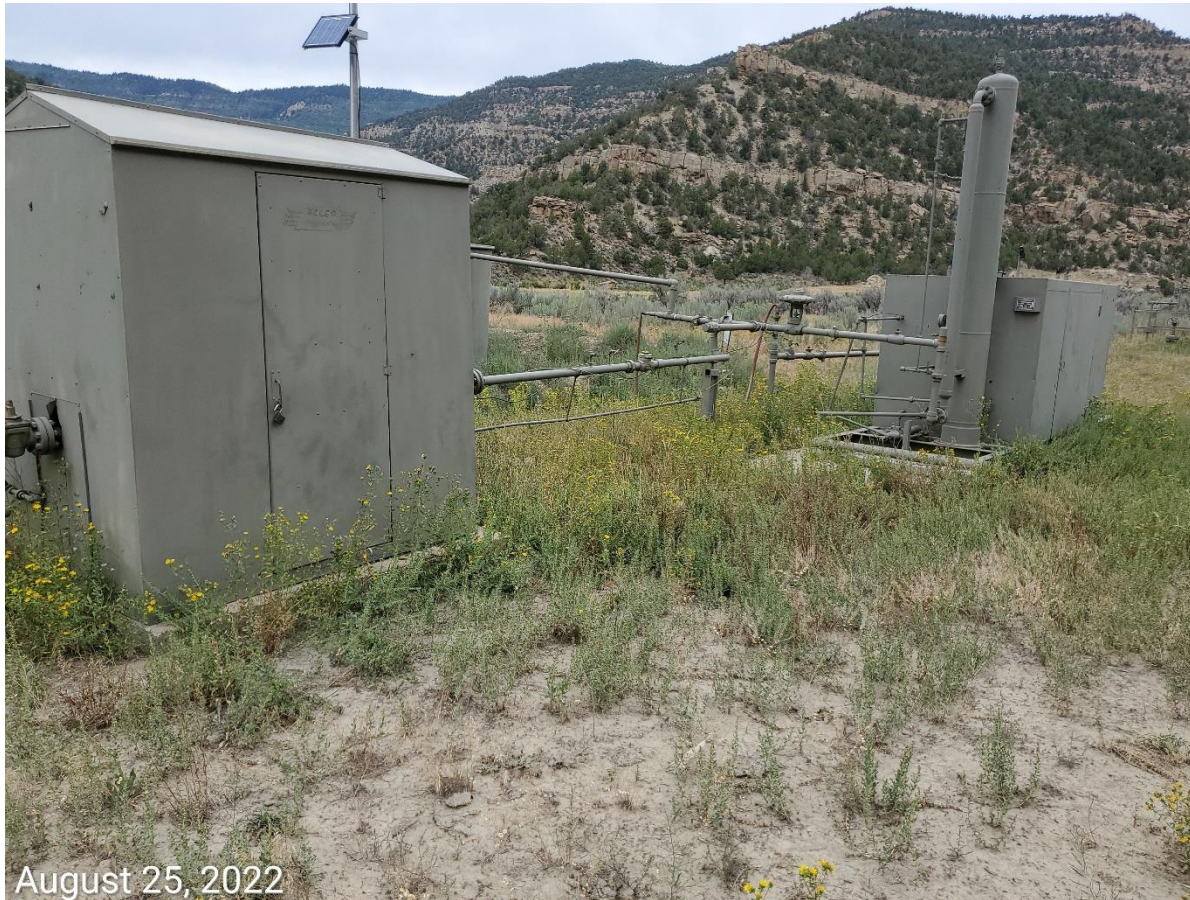
**Photo 6:** Photo shows weeds have re-established at and around production equipment on the Location; this is a fire hazard
