Inspection Photos and Issue Report

Operator: LOCIN OIL CORPORATION - 51130

Location #322320

Garfield County, CO

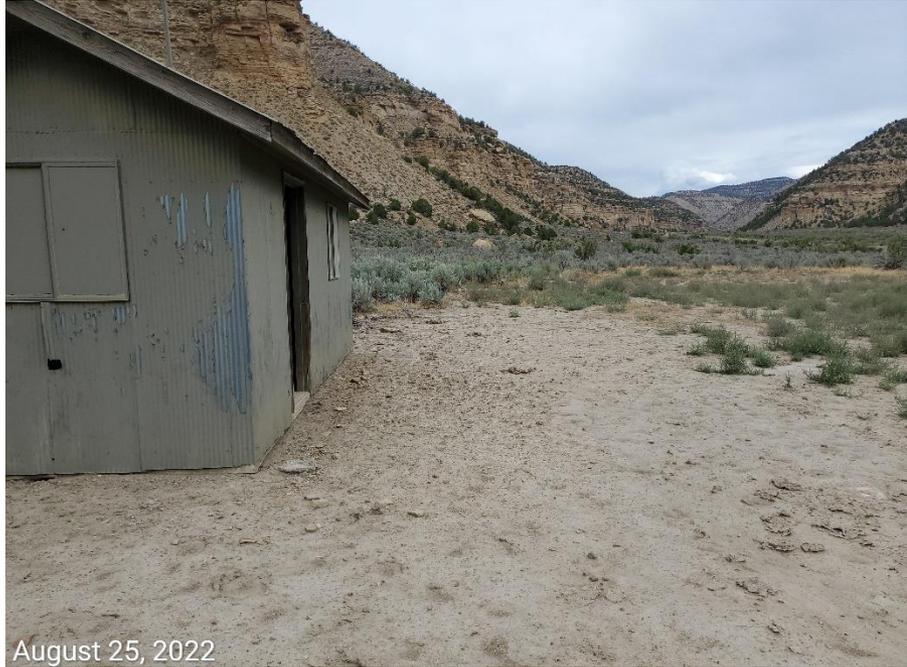
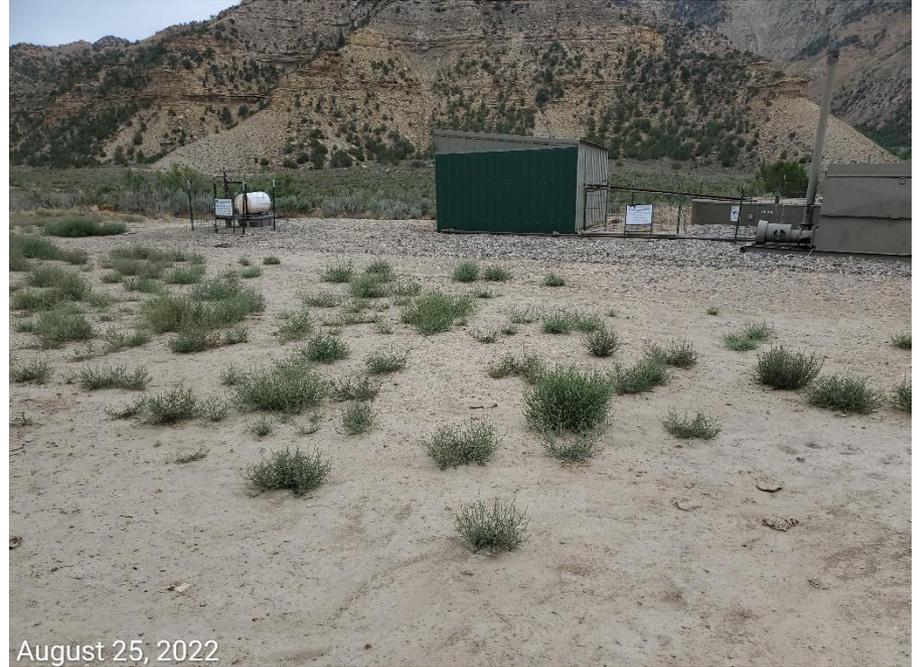
Photo 1: Photos 1-2 provide an overview of the Location from north, northeast, southeast to south. Photos also show Undesirable Plant Species established on the Location- weed management required.

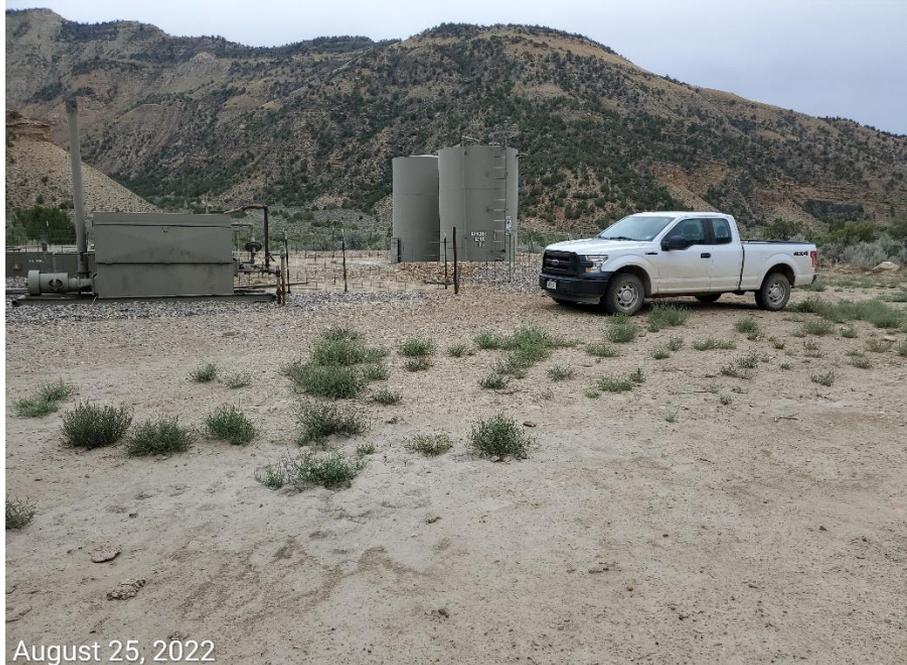
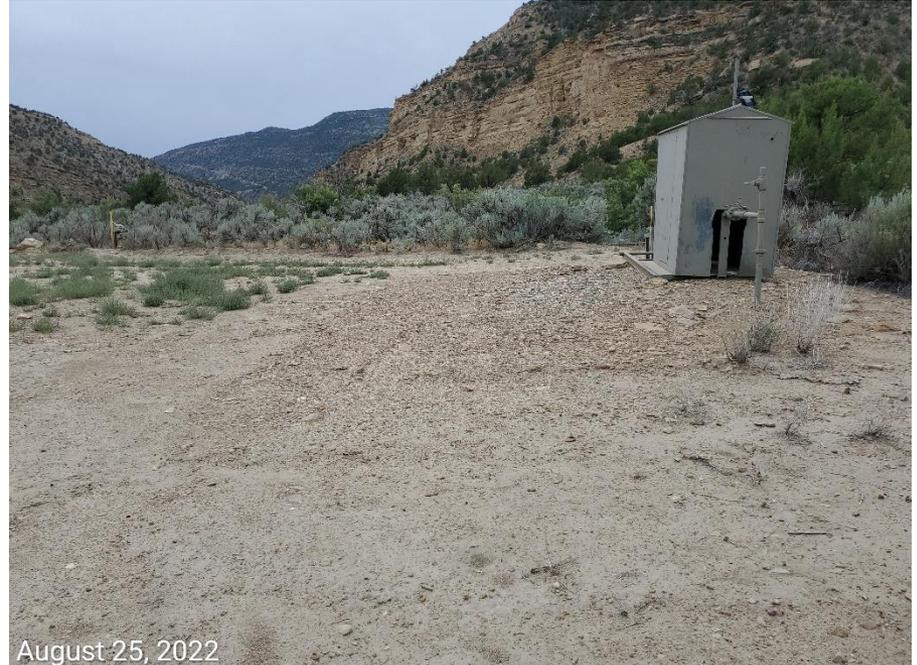
Photo 2: See comments under photo 1.

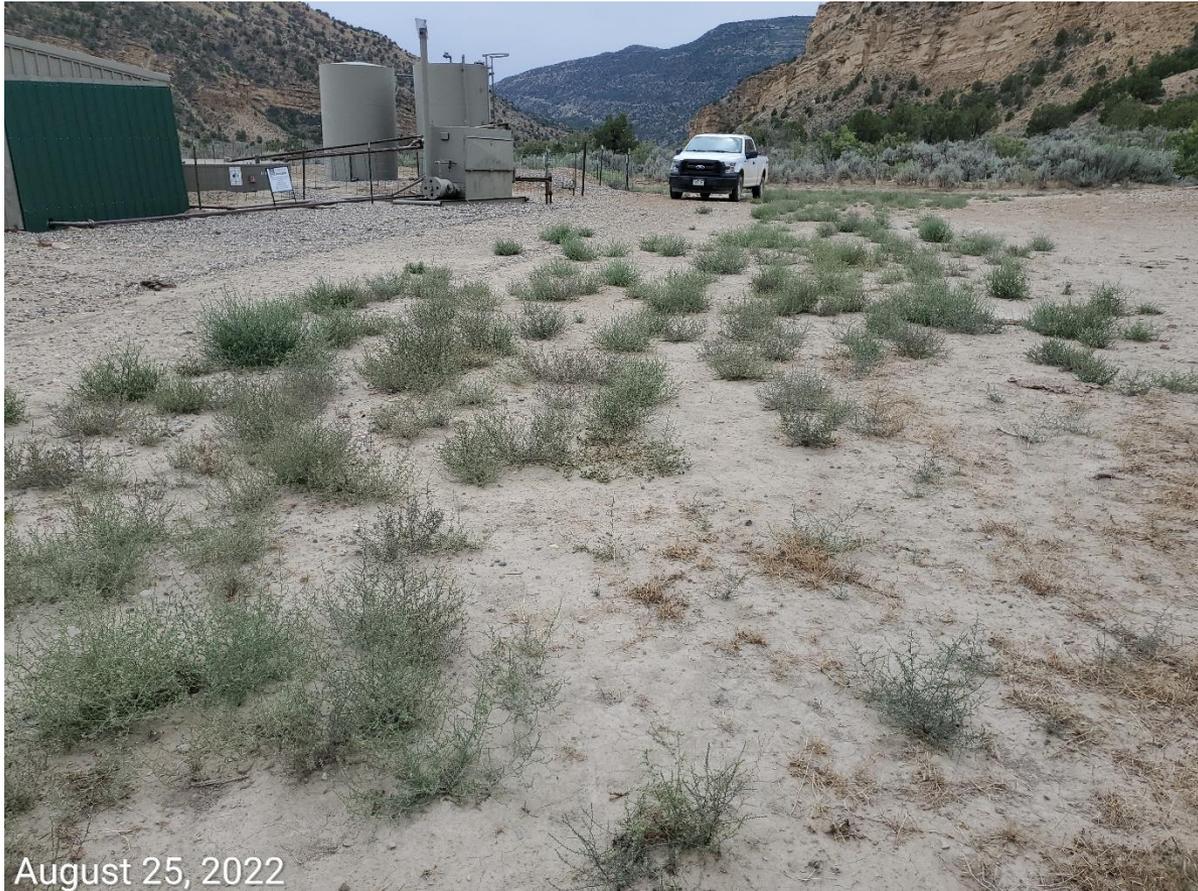
Photo 3: Photo example showing weed establishment on the Location.

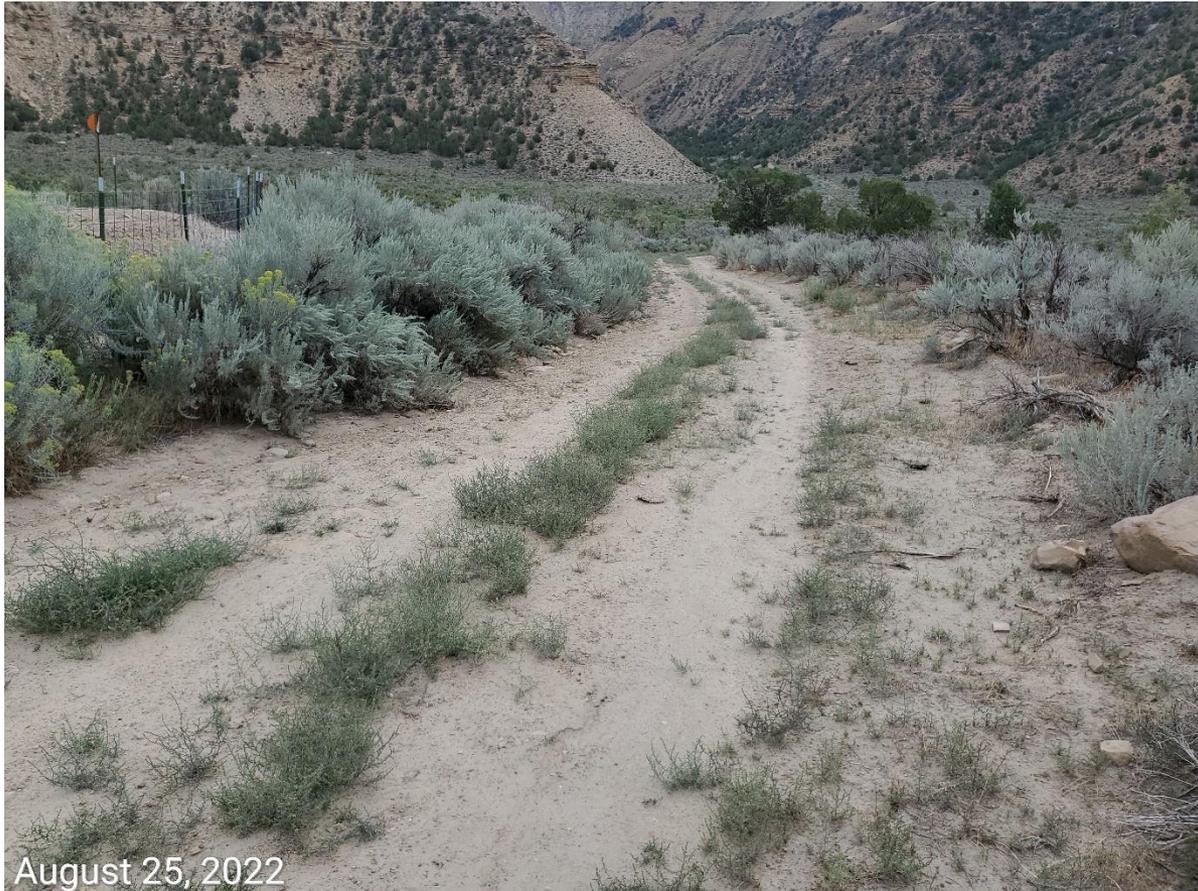
Photo 4: Photo example showing weed establishment on access road.

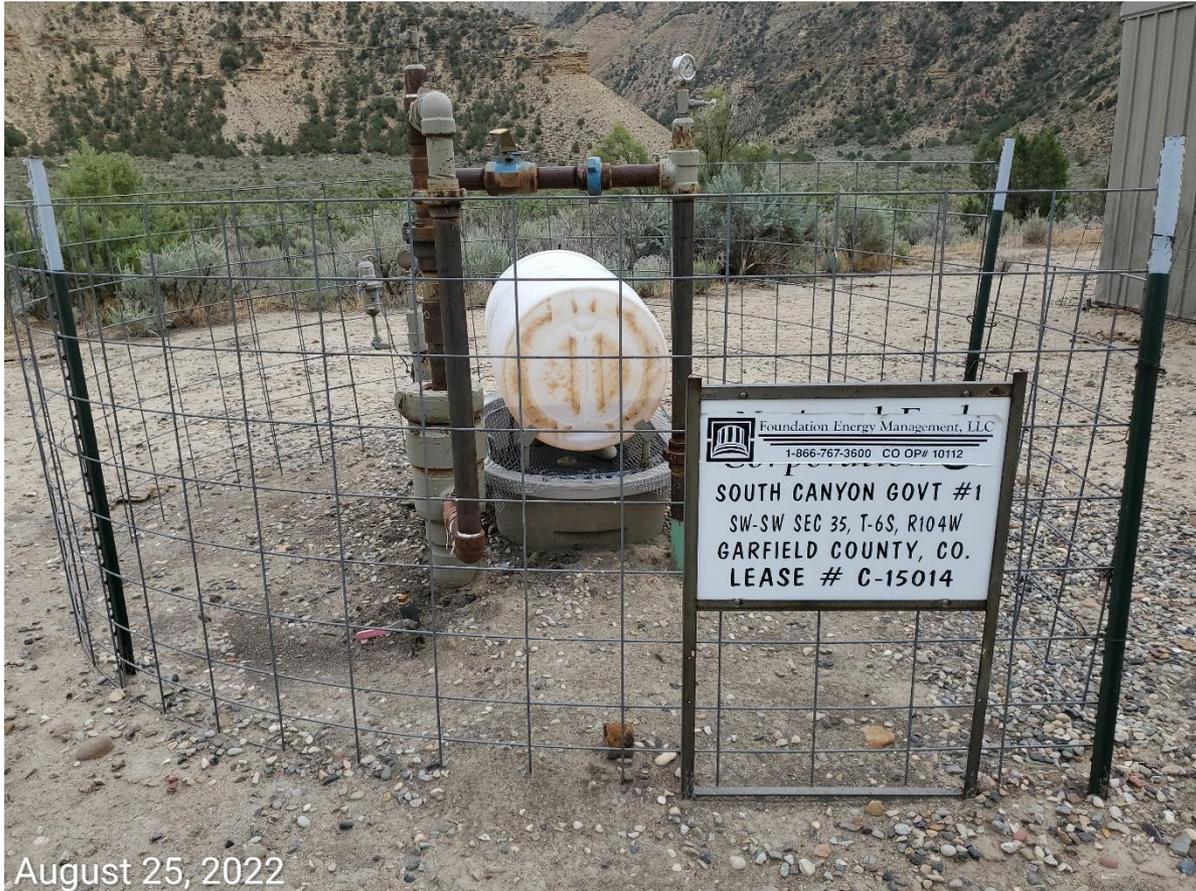
Photo 5: Signage at well head shows Foundation Energy Management. Records shows Locin Oil Corp as Operator, effective 3/1/2022 .

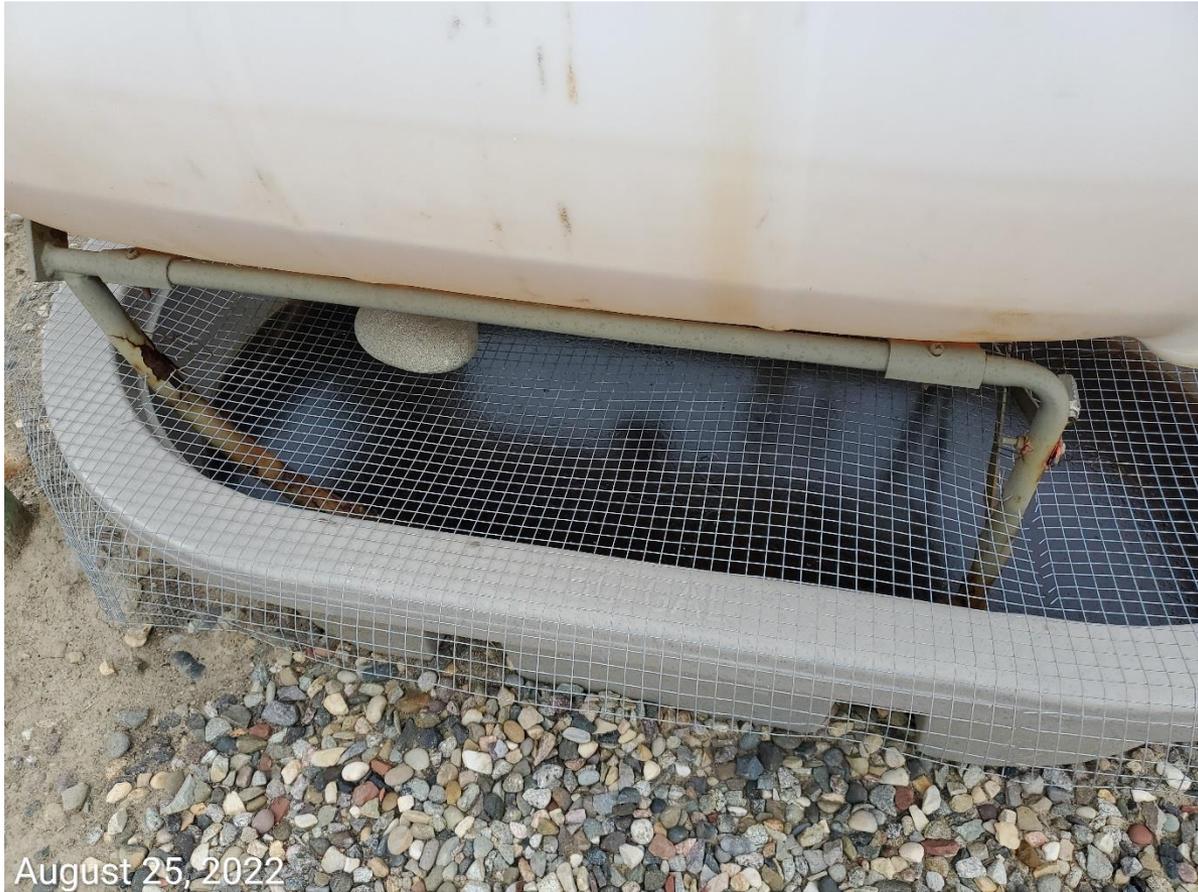
Photo 6: Continue from photo 5. Photo show fluids within the secondary containment of the methanol tank.

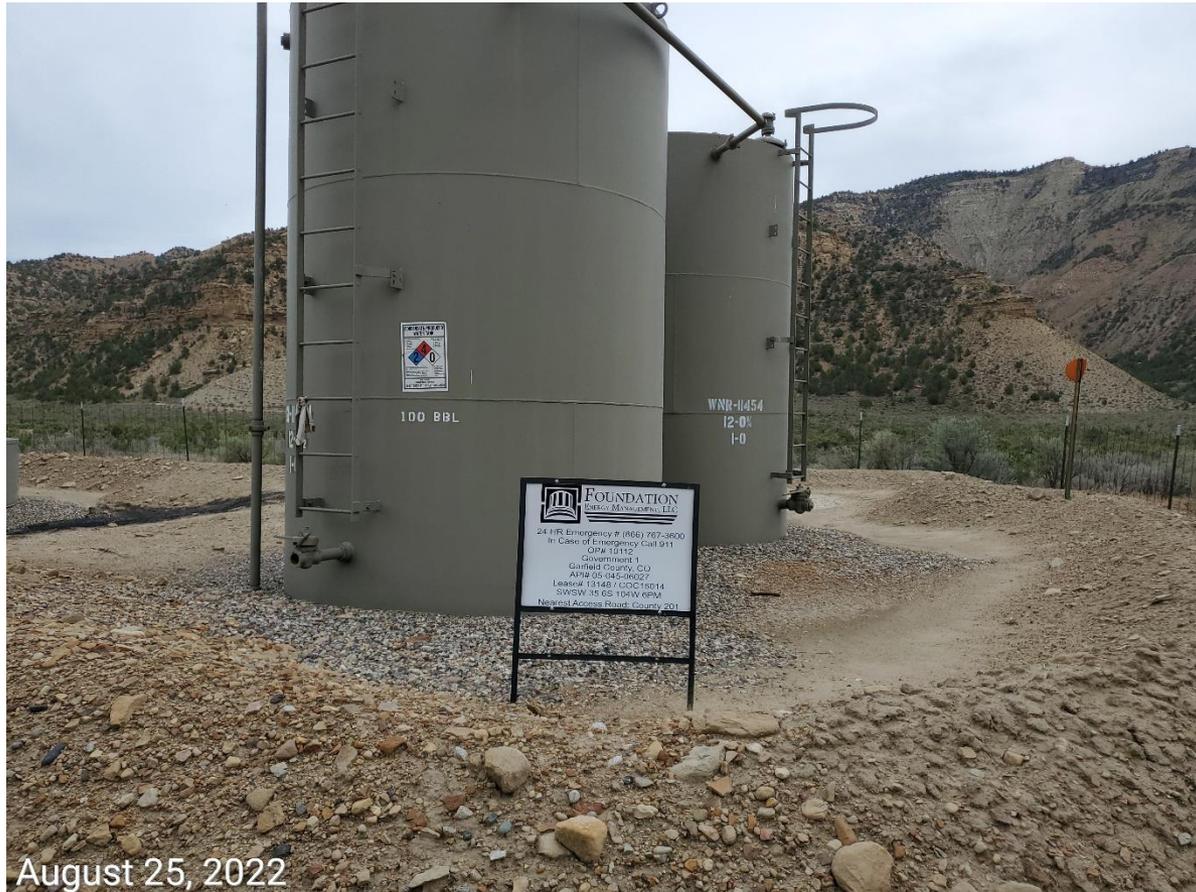
Photo 7: Photo example showing signage at battery posted as Foundation Energy Management. Records shows Locin Oil Corp as Operator, effective 3/1/2022. Labels on tanks also missing required information per 605.h.

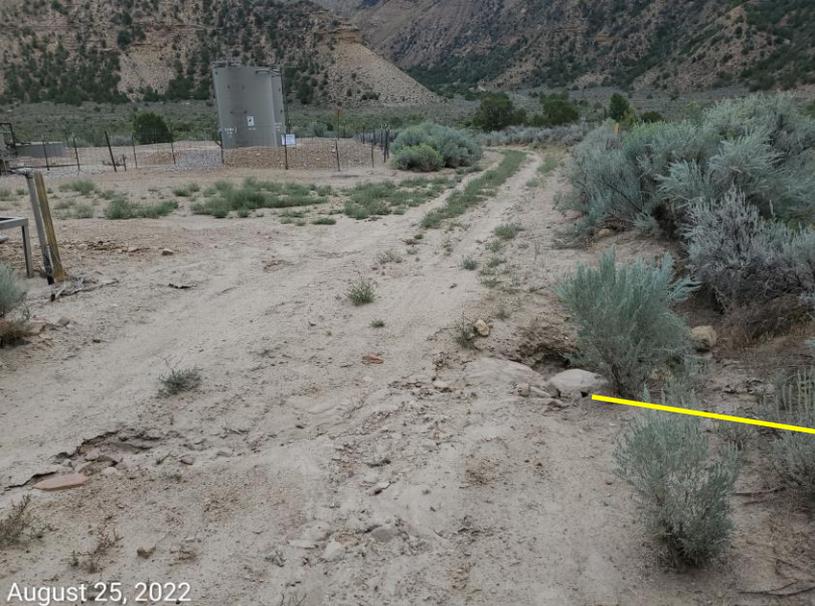
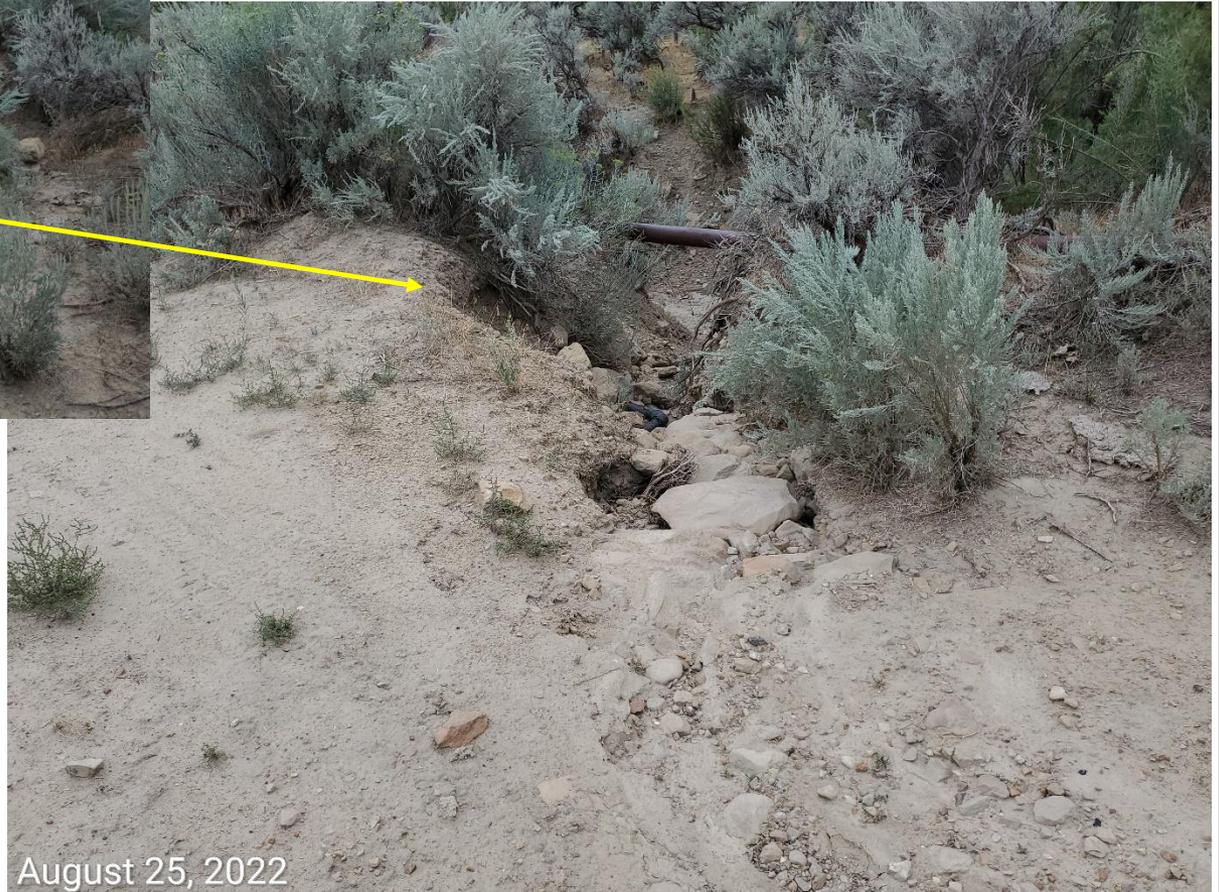
Photo 8: Photo taken from the access road. Photo shows erosion control and stabilization BMPs are missing or insufficient along entire access road- erosion degradation and sediment transport evident.

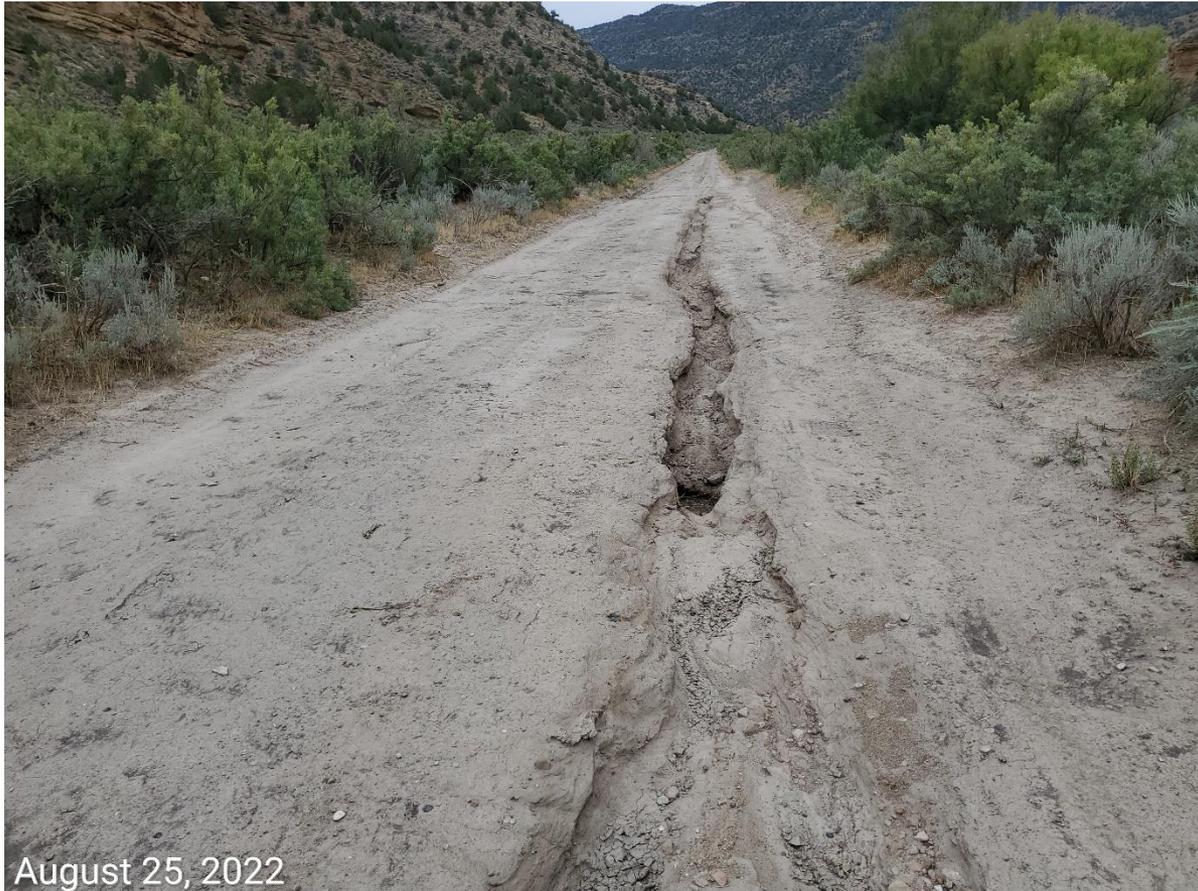
Photo 10: Photo taken from the access road south of Utah Gas Corp's Federal-Carbonera 1-2; access road is shared between the two Operators. Photo shows erosion control and stabilization BMPs are missing or insufficient along entire access road- erosion degradation and sediment transport evident.
