Inspection Photos and Issue Report

Operator: CAERUS PICEANCE LLC

Location #448472

Garfield County, CO

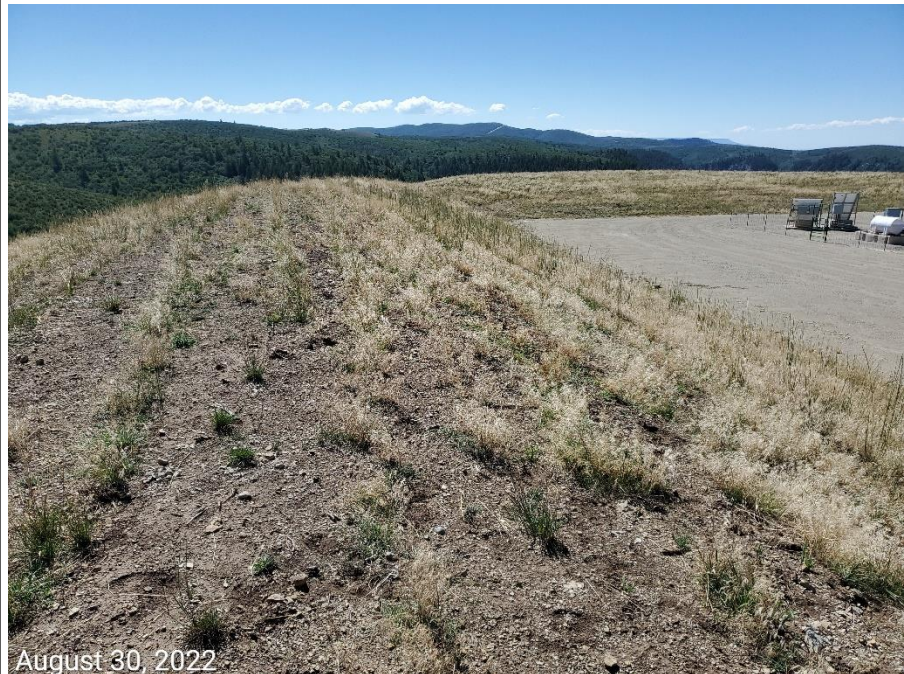
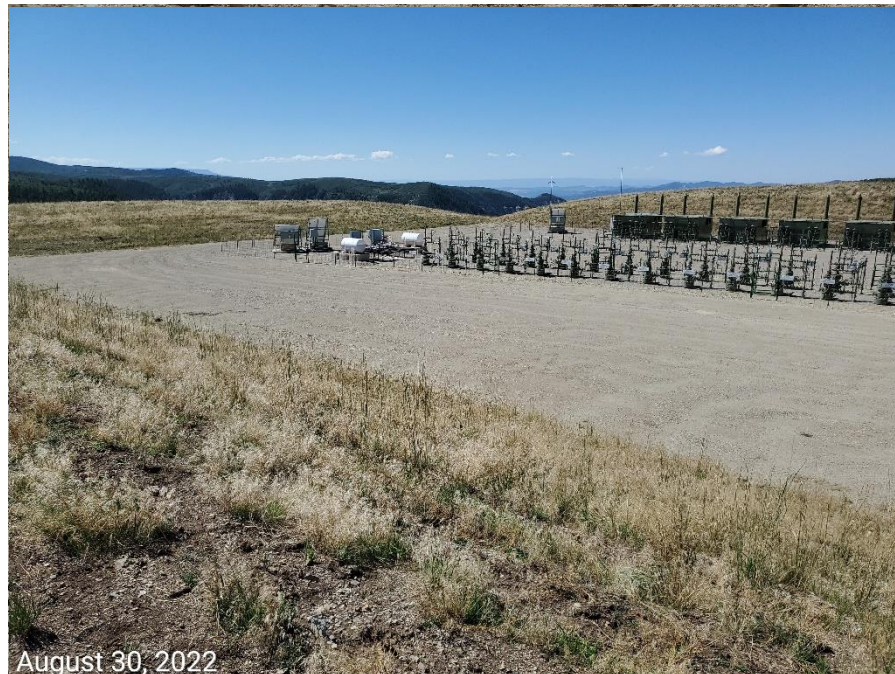
Photo 1: Photos taken from the interim areas on the east end of the Location. Photos 1-2 provide an overview of the Location from south, southwest, northwest to north.

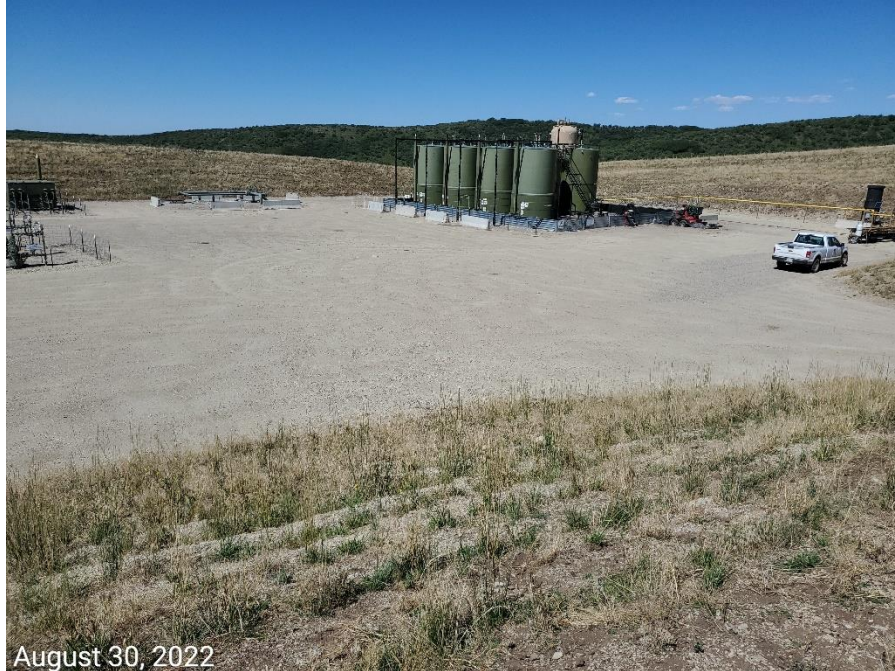
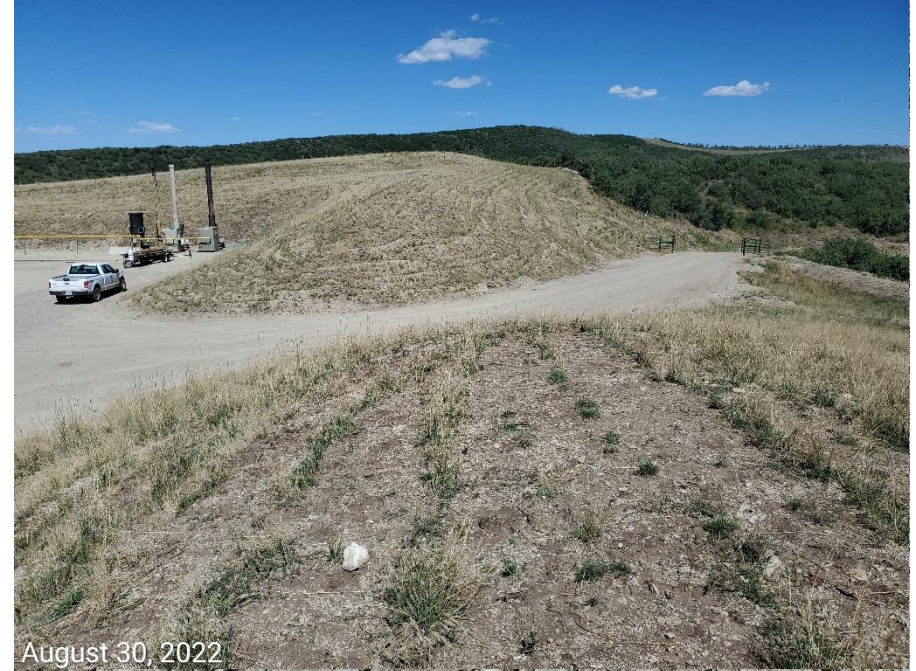
Photo 2: See comments under photo 1.

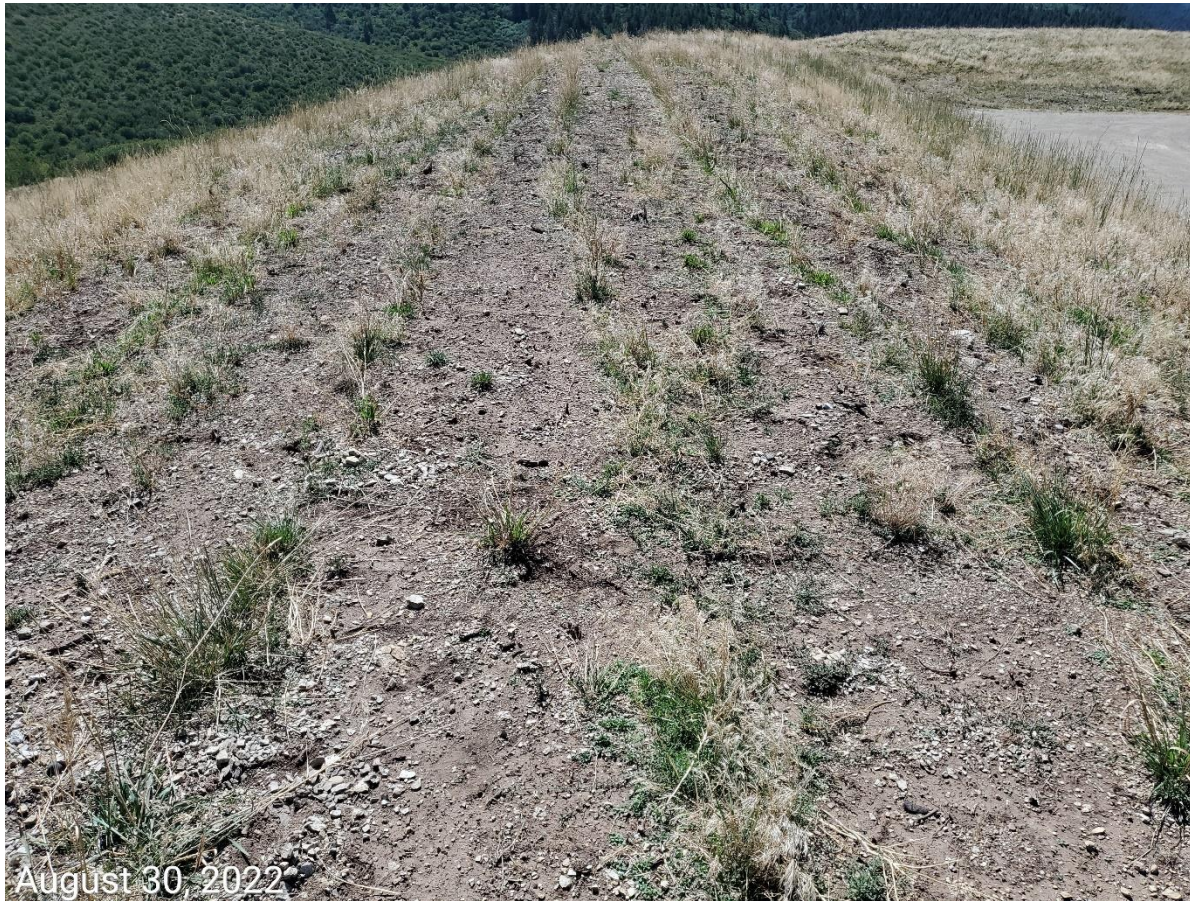
Photo 3: Photo example showing vegetation on the interim areas; areas appear to be progressing towards COGCC uniform revegetative standards.

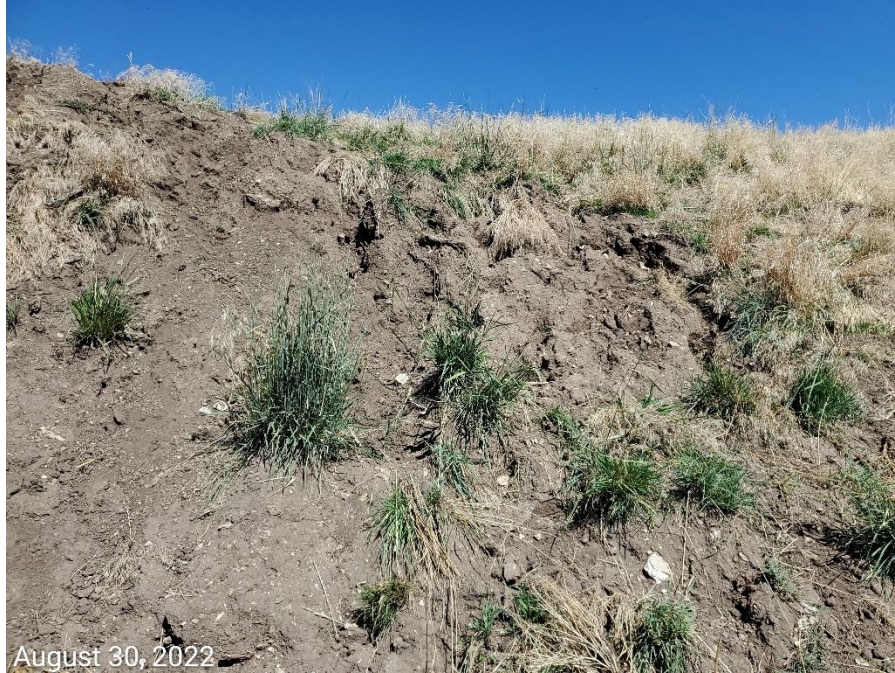
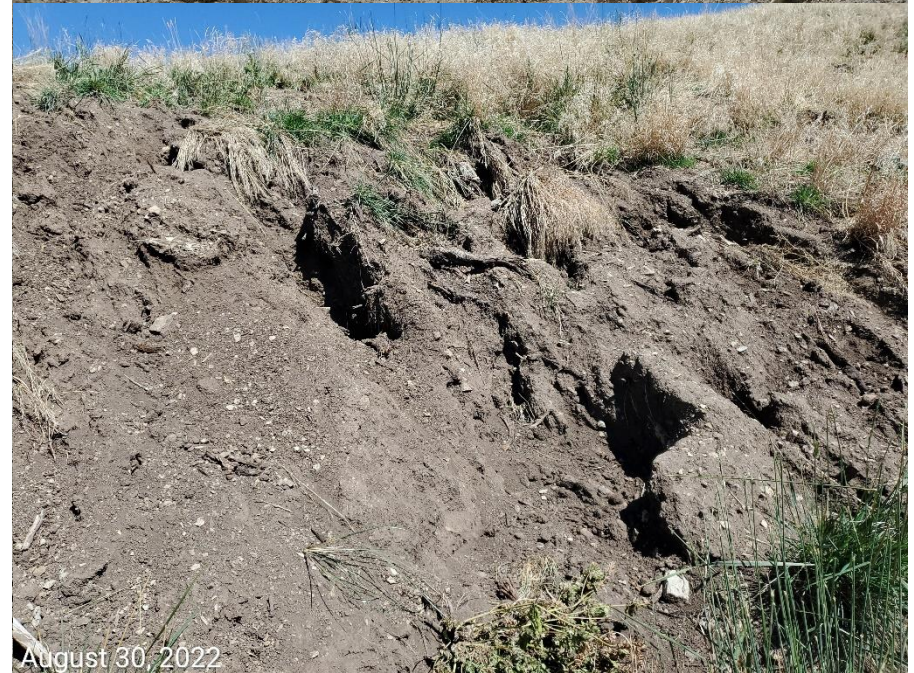
Photo 4: Photo taken from the sediment trap on the southwest end of the Location; photo shows erosion degradation observed on the south facing slopes.

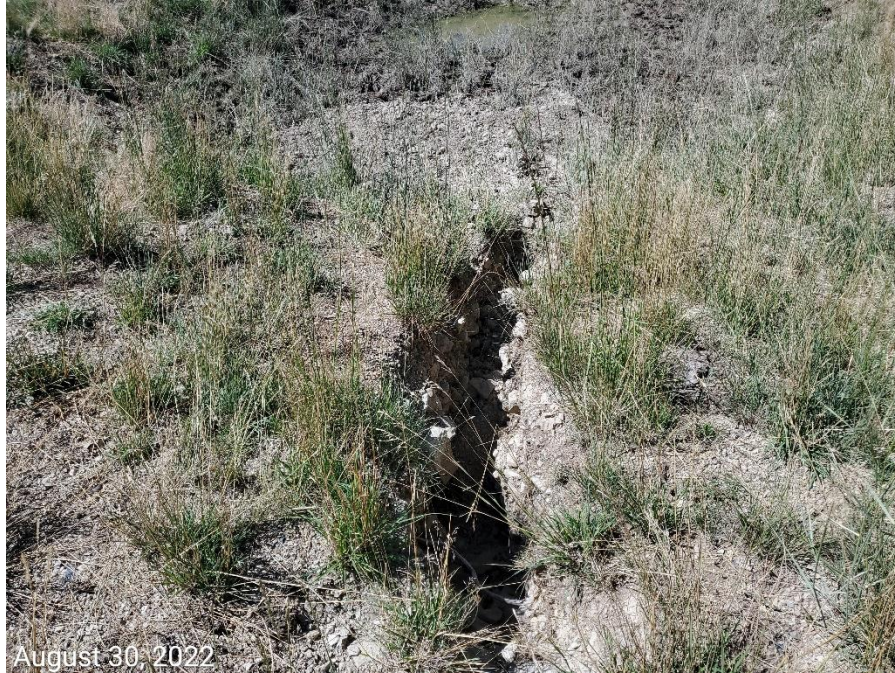
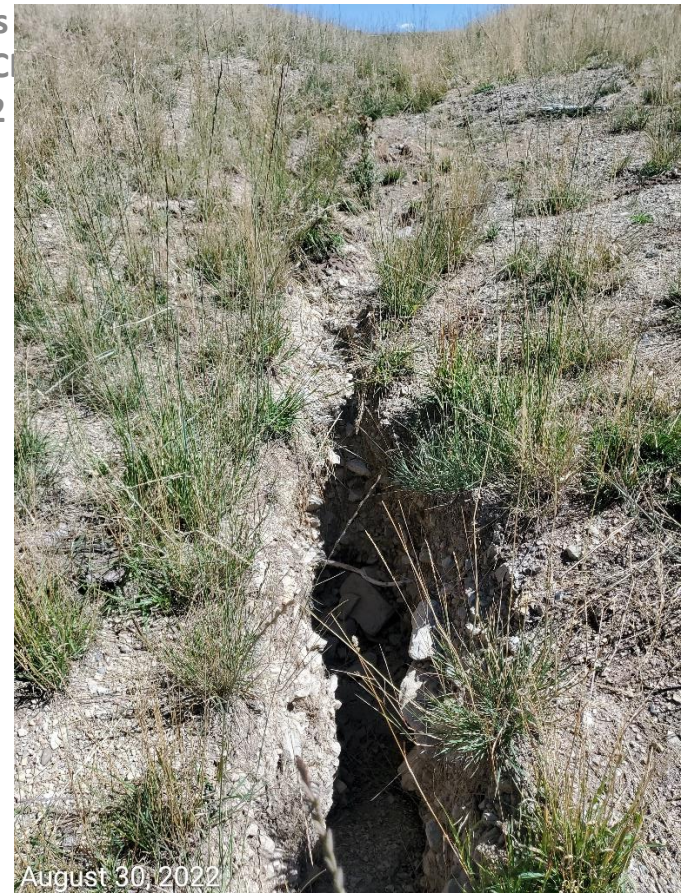
Photo 5: Photos taken from the sediment trap on the southwest end of the Location. Photo shows gulley erosion at inlet of the trap.

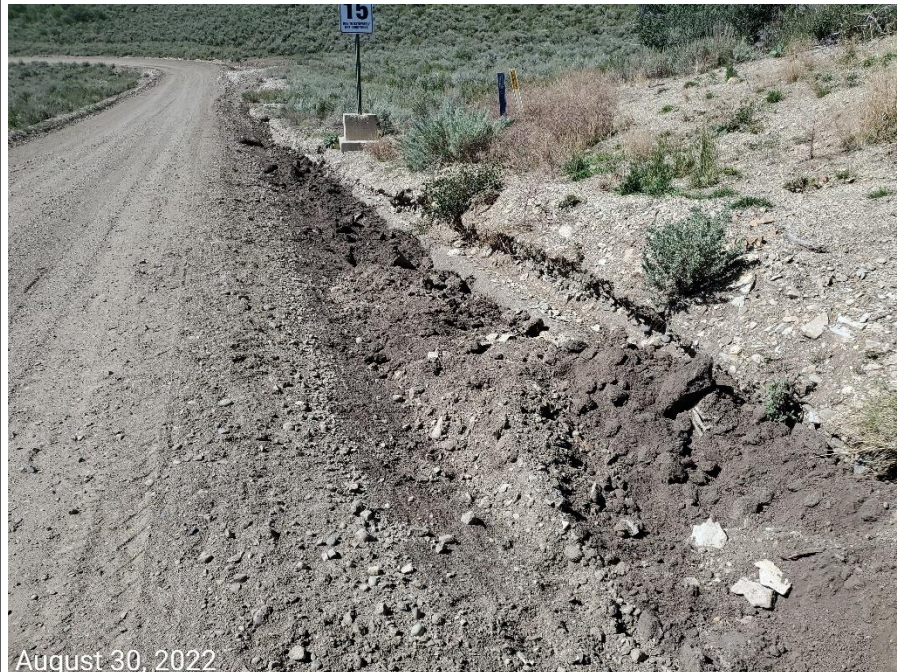
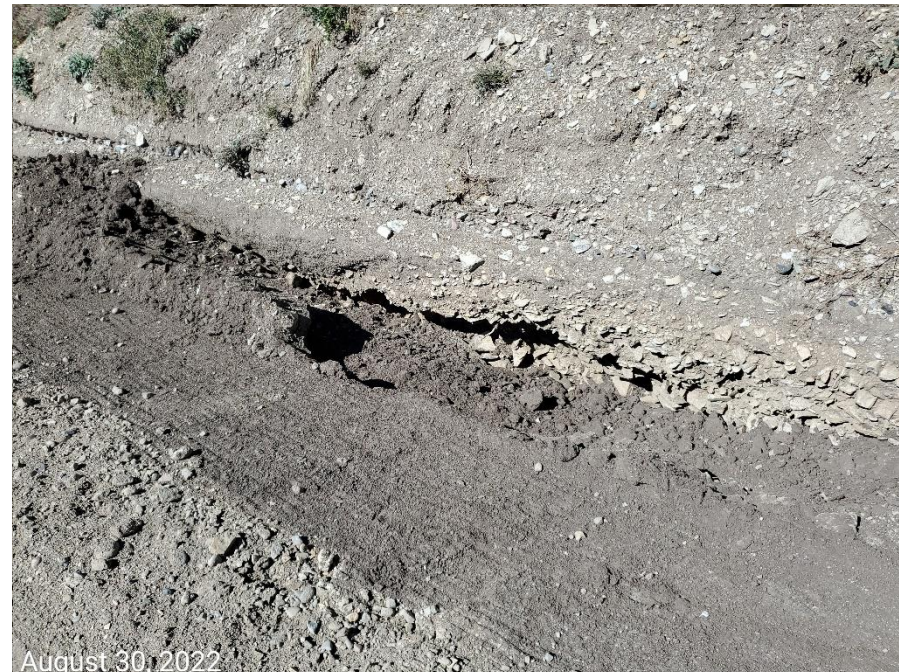
Photo 6: Photos taken from the access road. Photos examples showing erosion degradation evident at the stormwater diversion ditch; additional unconsolidated soils also appear to have been put into the ditch; this will contribute to sediment-laden stormwater discharge.
