Inspection Photos and Issue Report

Operator: CAERUS PICEANCE LLC

Location #445862

Garfield County, CO

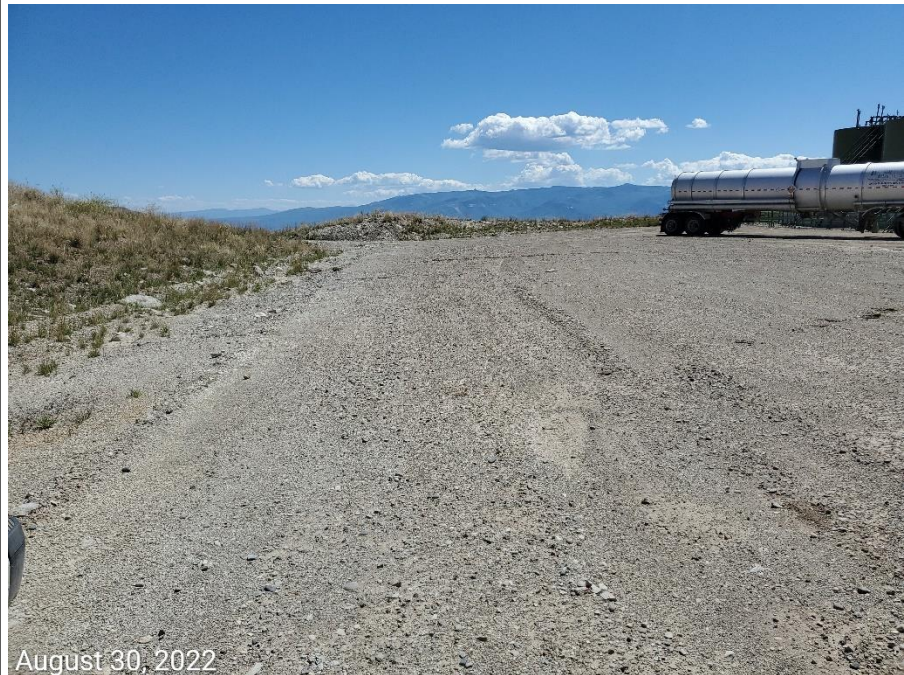
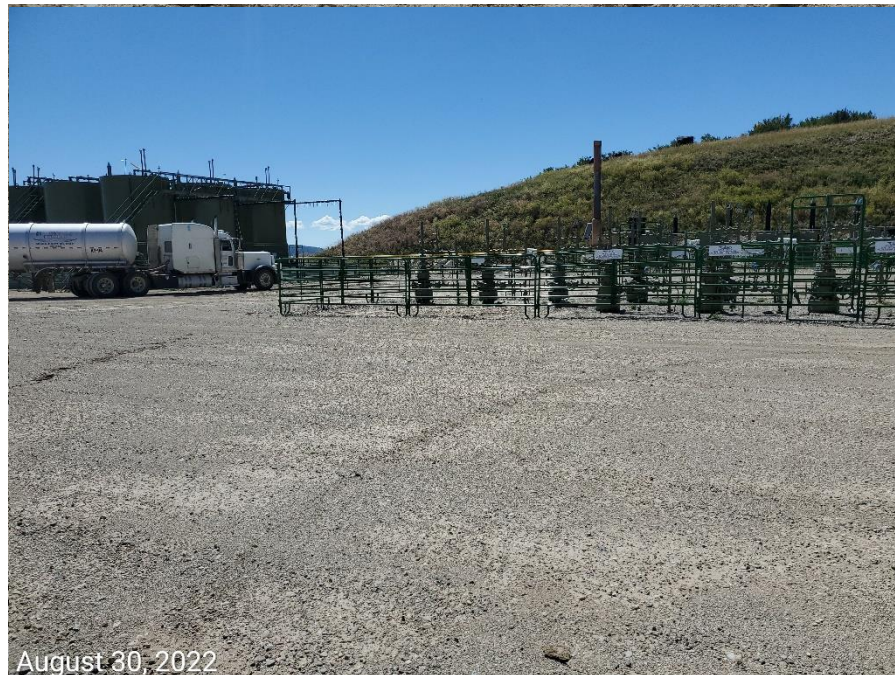
Photo 1: Photos taken from the north end of the Location. Photos 1-2 provide an overview of the Location from east, southeast, southwest to west.

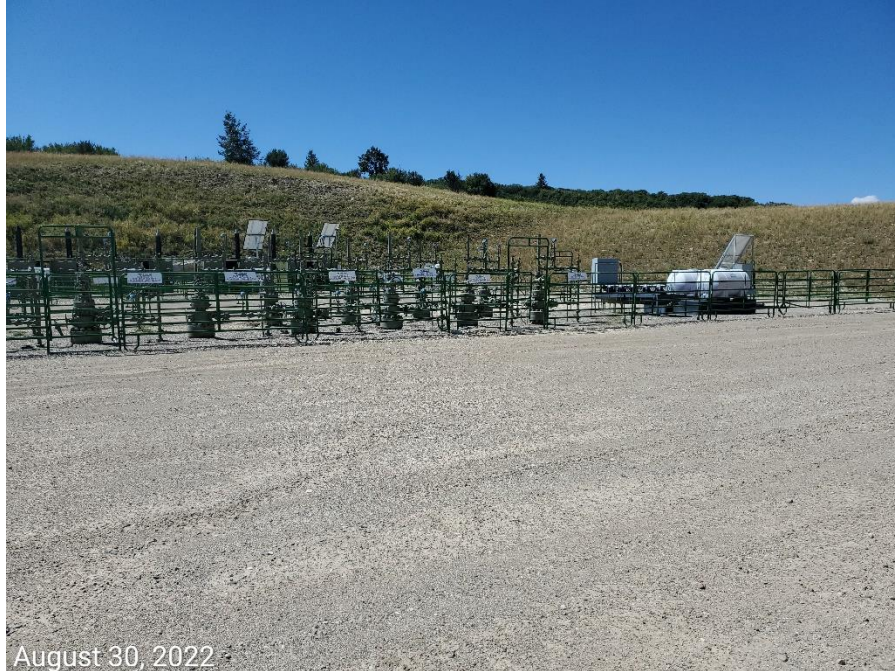
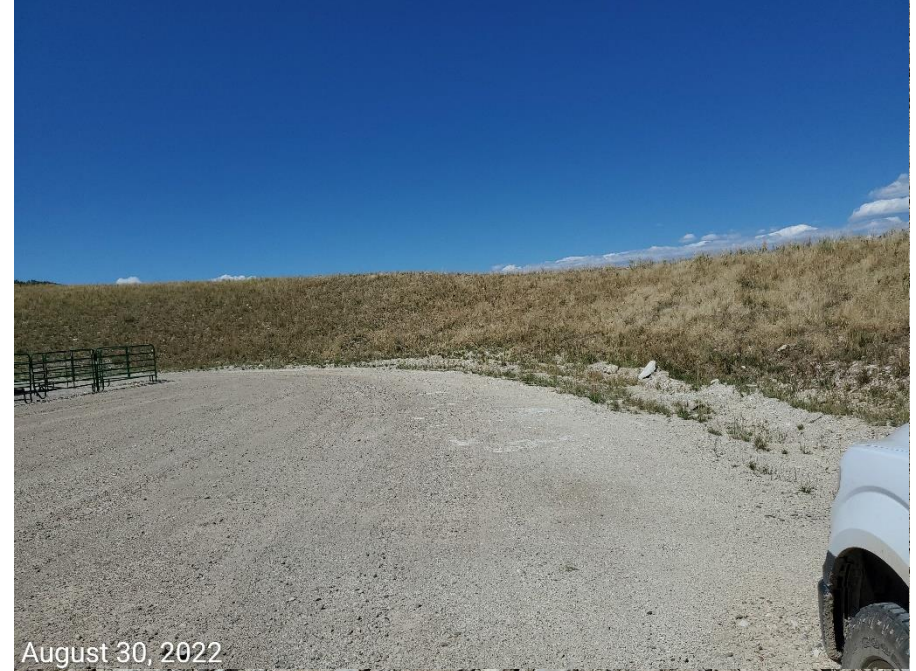
Photo 2: See comments under photo 1.

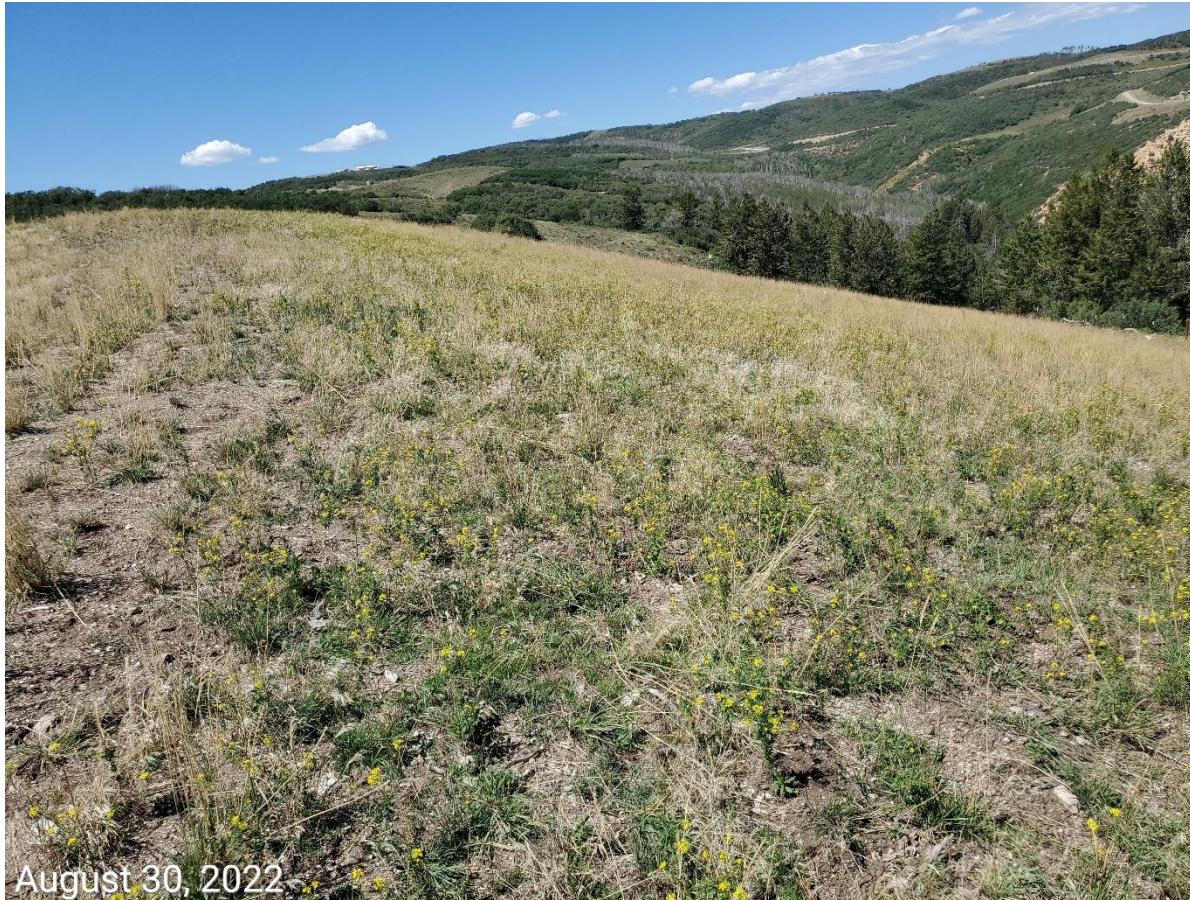
Photo 3: Photo example showing vegetation on the interim areas; areas appear to be progressing towards COGCC uniform revegetative standards.

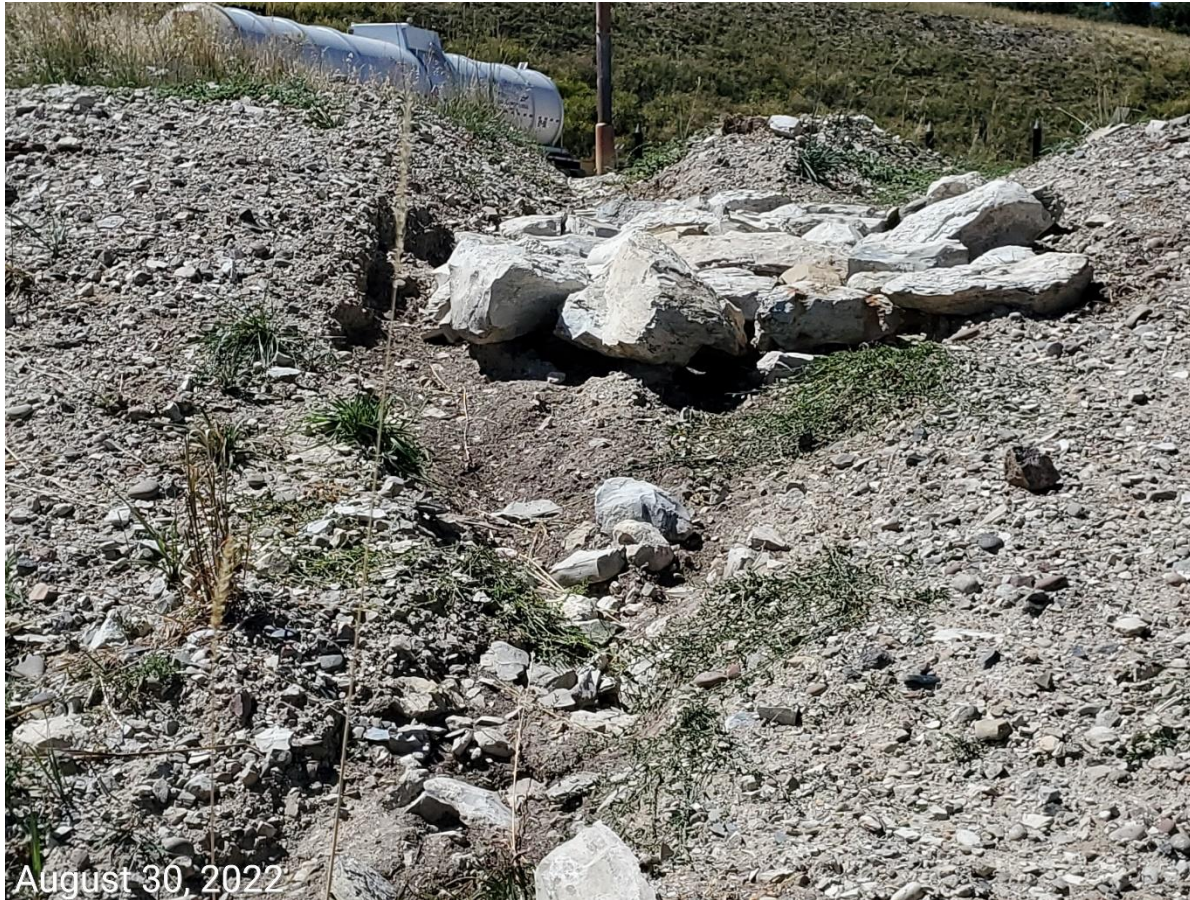
Photo 4: Photo taken from the inlet of the sediment trap on the north end of the Location. erosion degradation evident at sediment trap on the north end of the Location; inlet does not appear to have been constructed with a geotextile lining in conjunction with rip-rap armoring per good engineering practices, resulting in erosion degradation beneath the rock material; degradation also observed below the armored section of the inlet leading into the sediment trap.

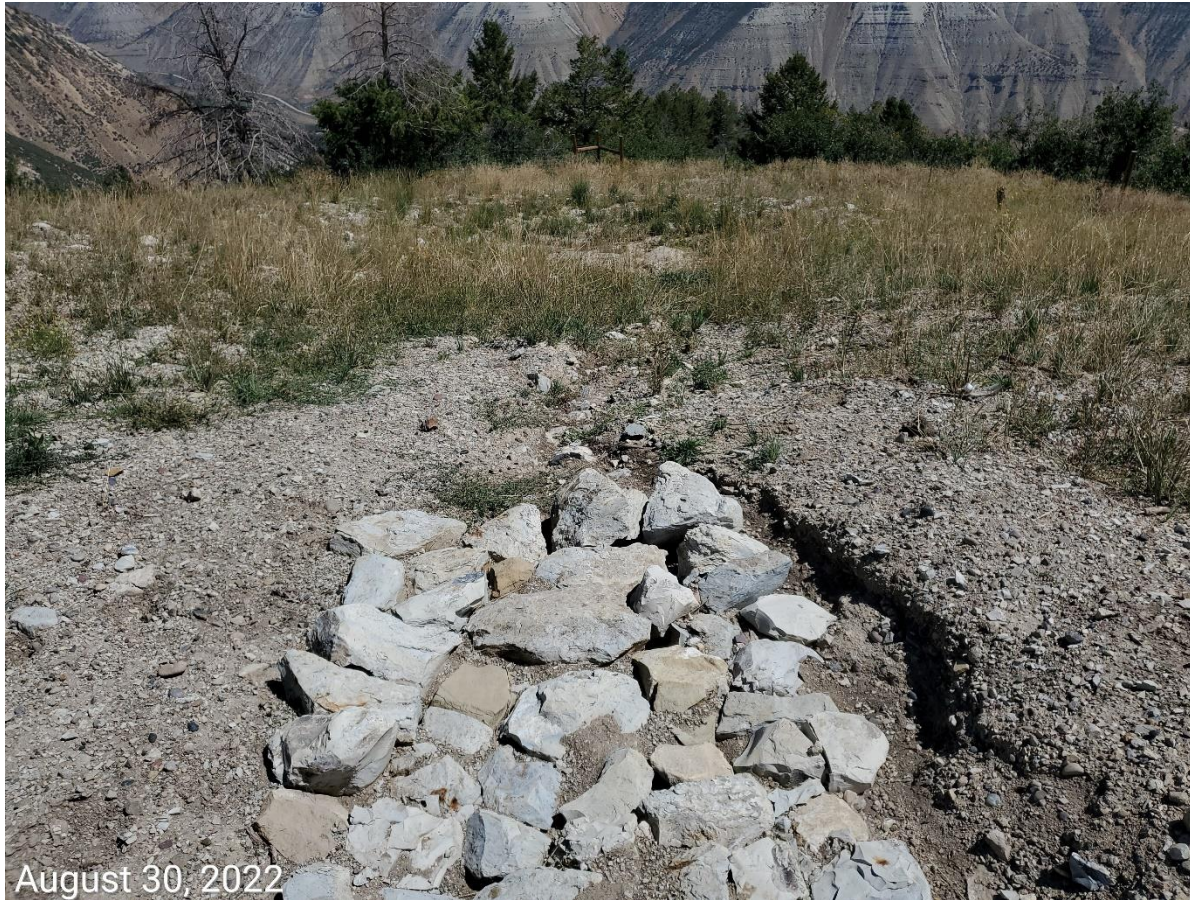
Photo 5: Photo taken from the inlet of the sediment trap on the north end of the Location; erosion degradation evident at sediment trap; inlet does not appear to have been constructed with a geotextile lining in conjunction with rip-rap armoring per good engineering practices, resulting in erosion degradation beneath the rock material; degradation also observed below the armored section of the inlet leading into the sediment trap.

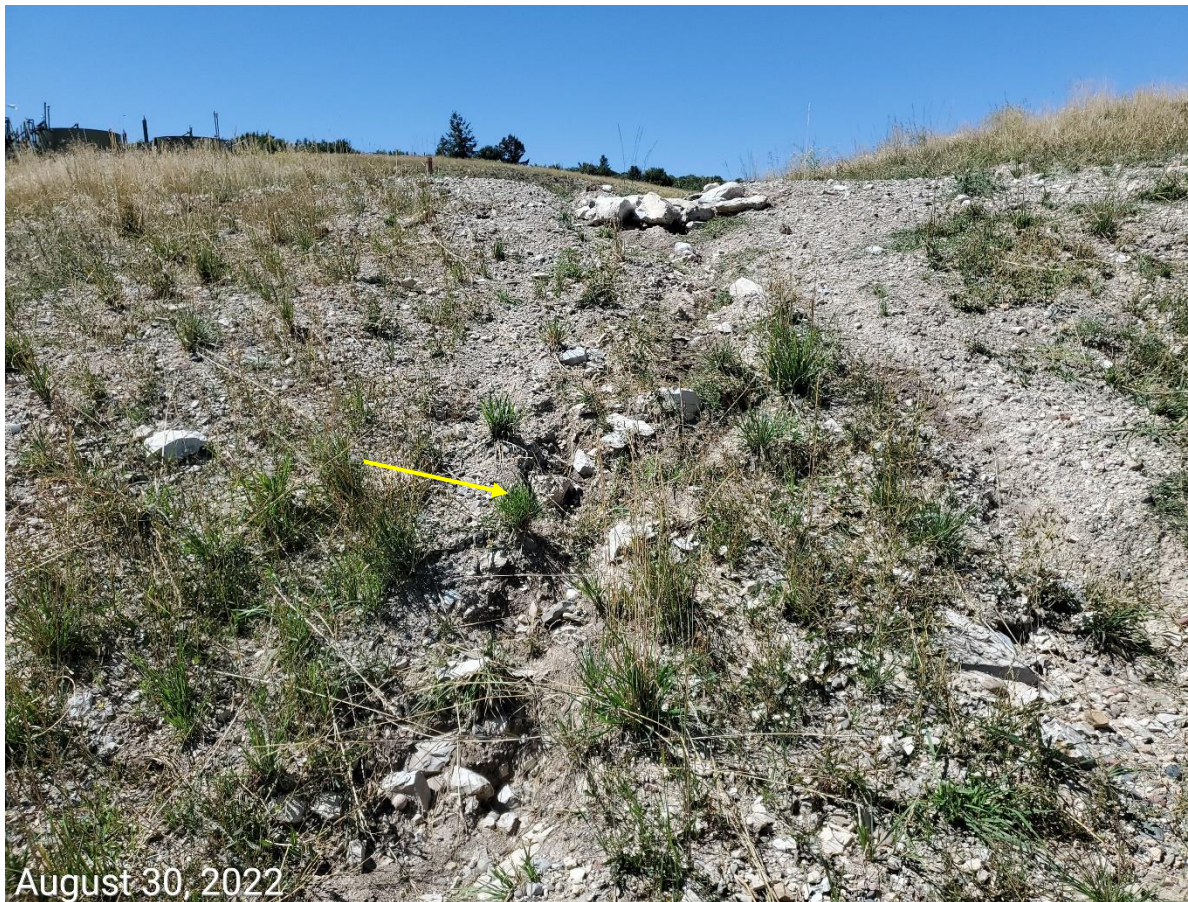
Photo 6: Photo taken from the sediment trap on the north end of the Location. Photo shows degradation observed below the armored section of the inlet leading into the sediment trap.

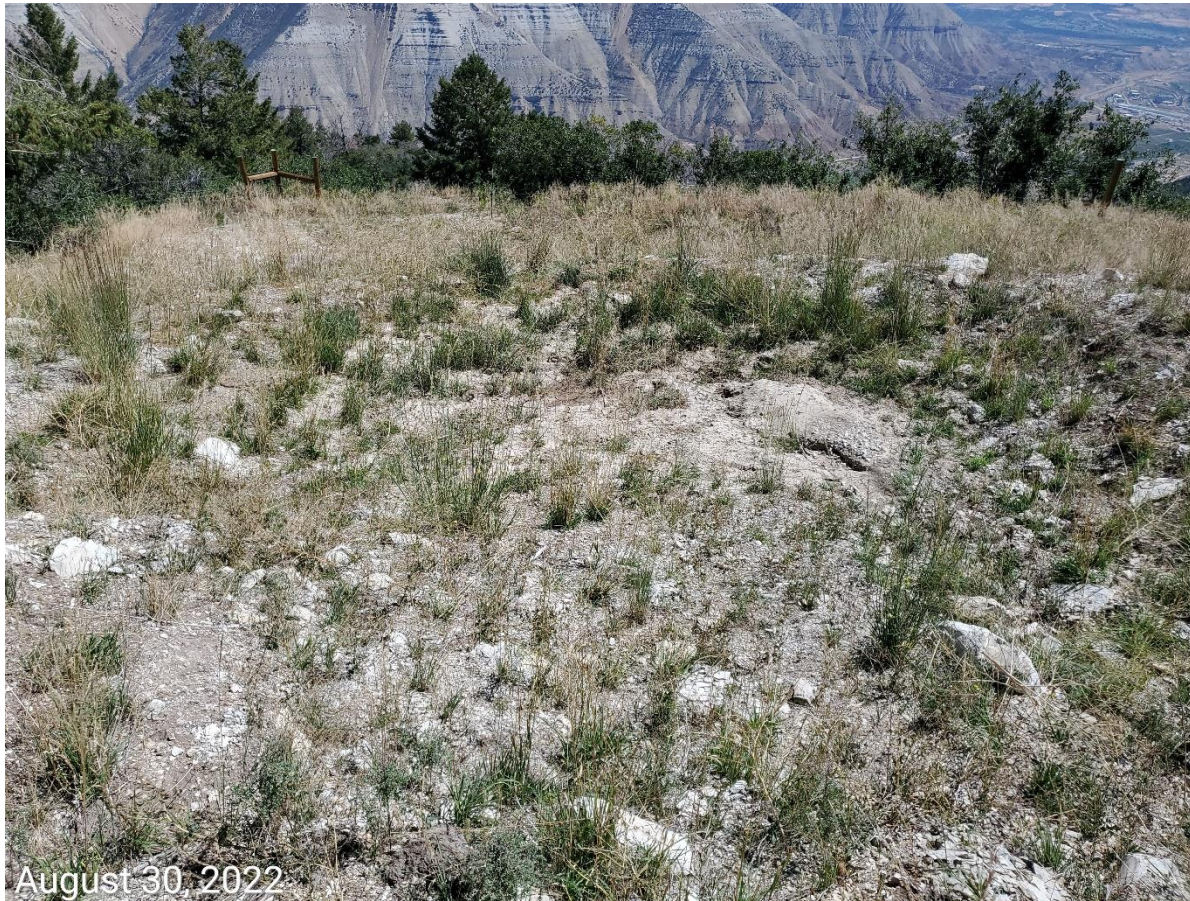
Photo 7: Photo shows sediment trap on north end of the Location. BMP does not appear to have been constructed with an engineered outlet. BMP filling with sediment- maintenance advised.
