Inspection Photos

Loc: 307032

Operator: SIMCOE LLC

Inspection Date: 8/30/2022

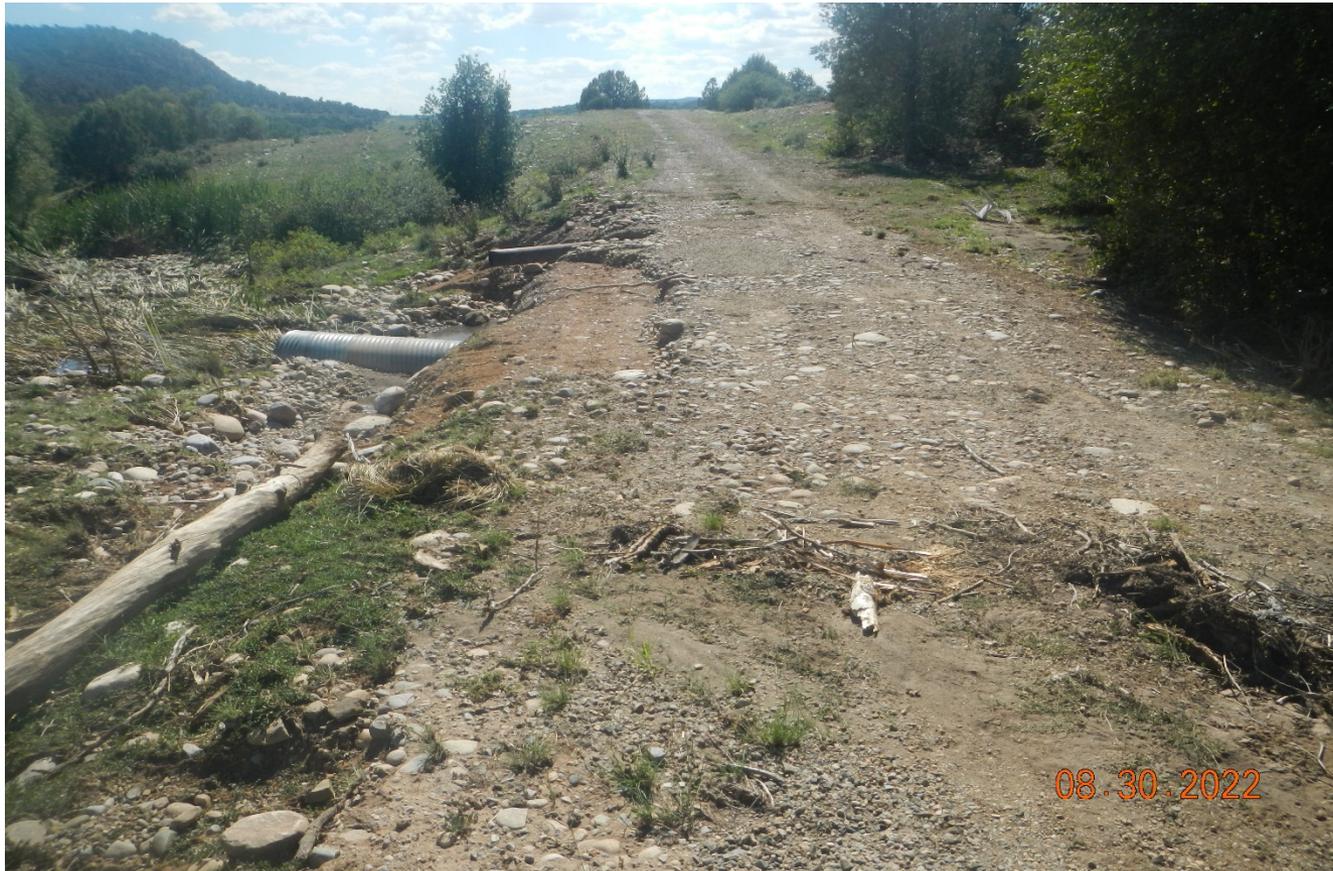
Photo 1. Facing west along the access road. The road has been washed out in this area and will need to be repaired and stabilized.

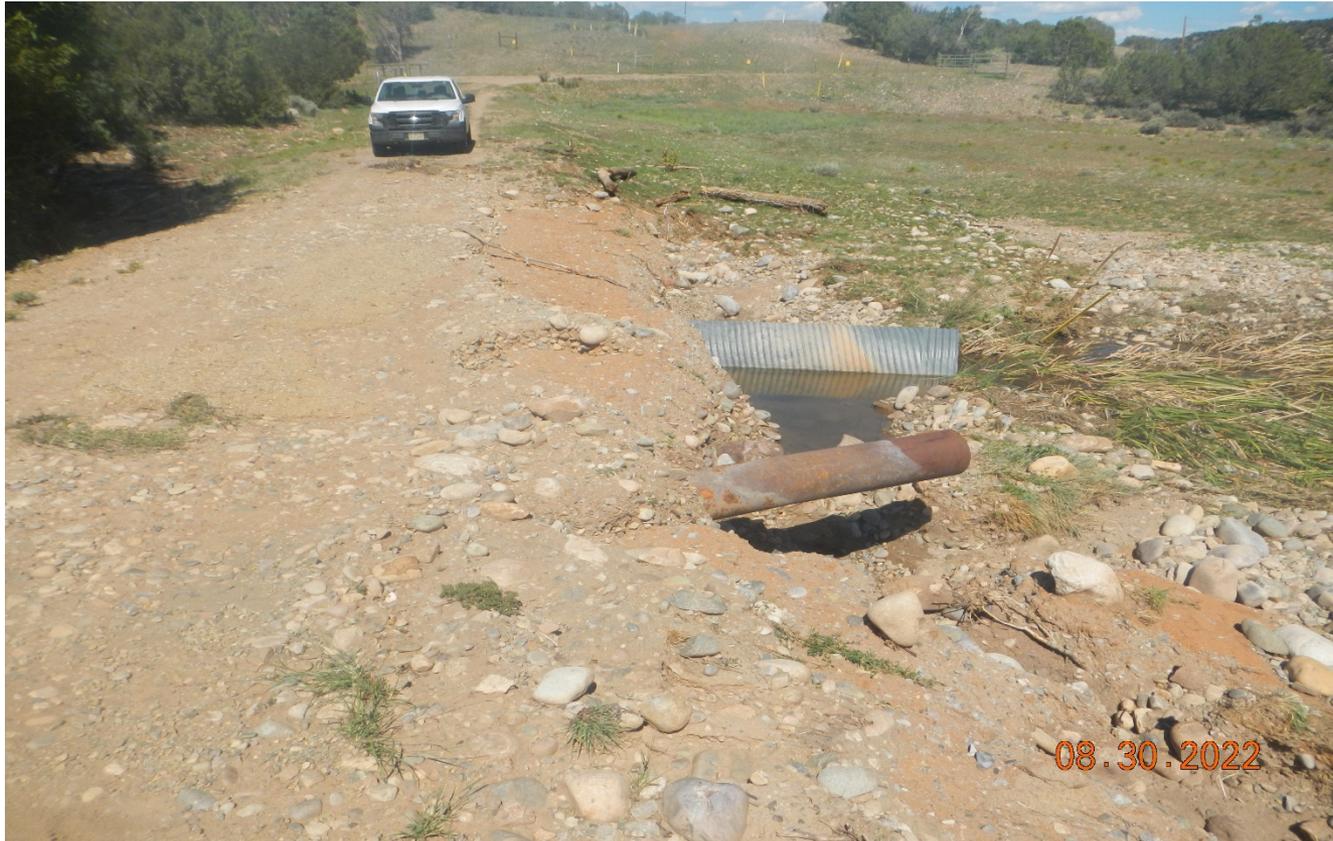
Photo 2. Facing back east along the access road. The road has been washed out in this area and will need to be repaired and stabilized.

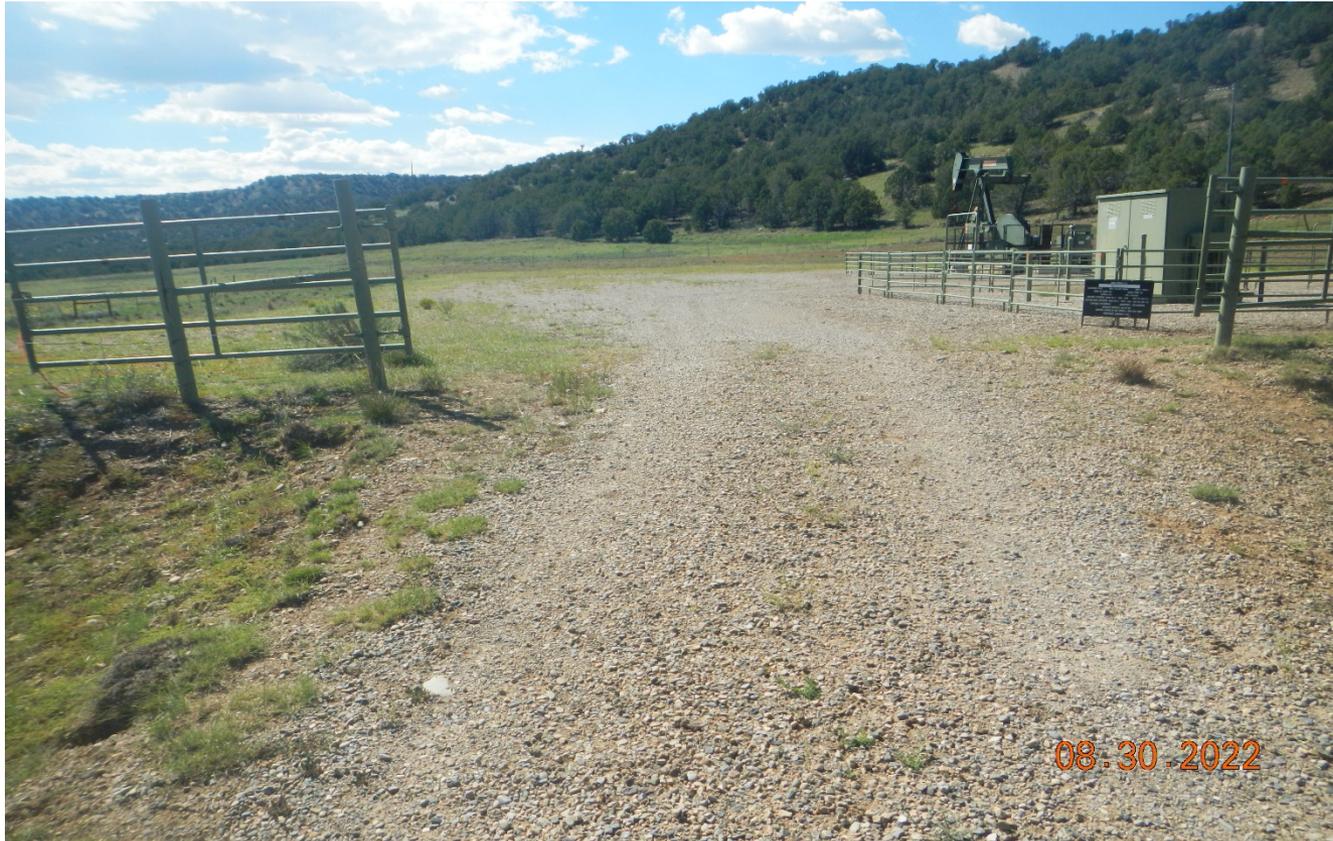
Photo 3. Facing west toward the location which is fenced. The gate is left open and should remain closed to prevent livestock entry.

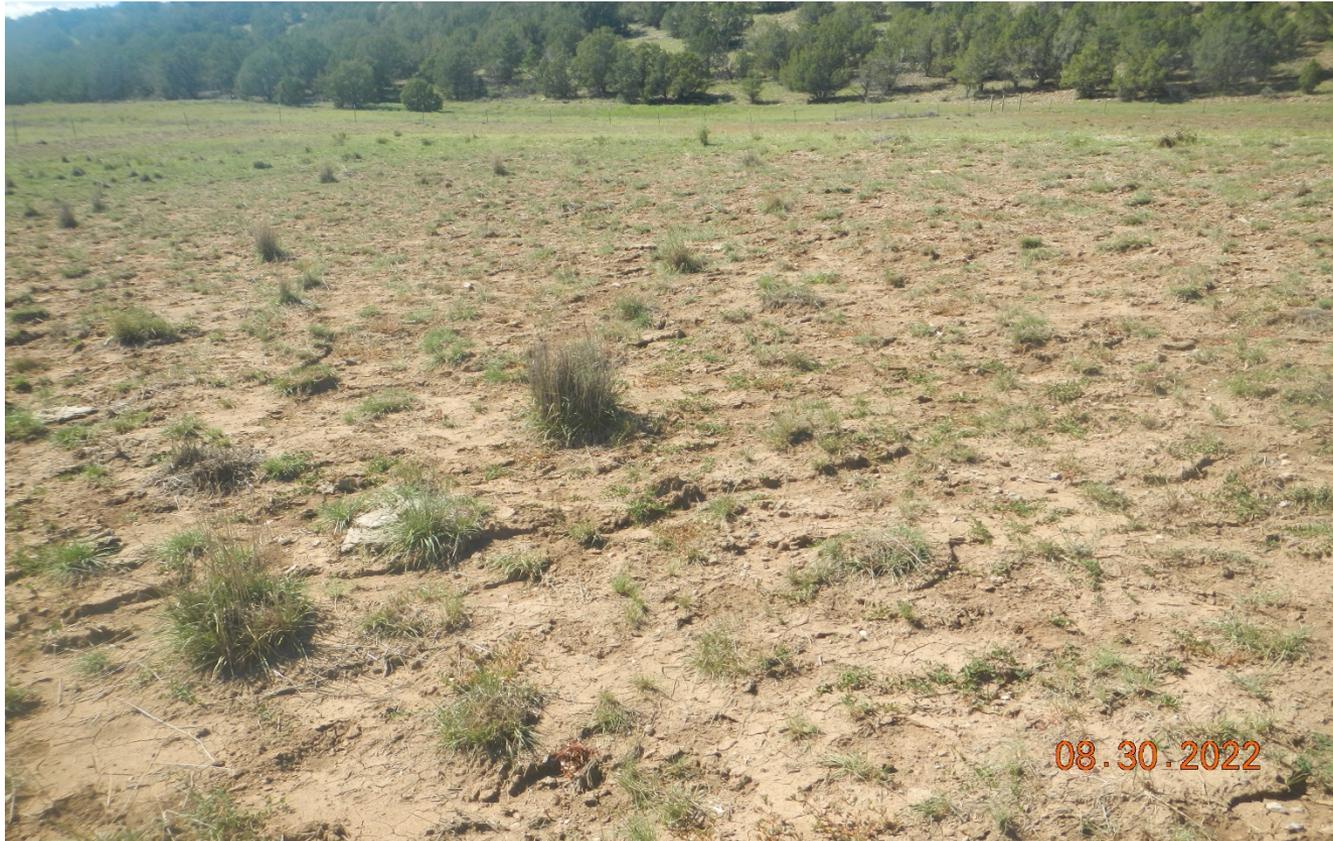
Photo 4. The fill slope of the location has sparse vegetation and looks to be heavily grazed down. The gate to the location should remain closed and additional seeding is needed in this area.
