ENVIRONMENTAL DAILY FIELD REPORT

PROJECT NAME: RA11 Flowline Investigation

DATE: 8/23/2022

SITE LOCATION: RA11 Pad

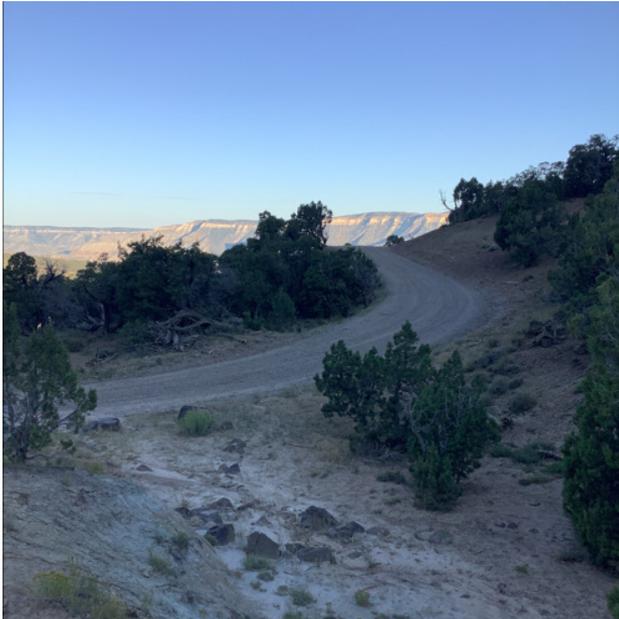
Fig. 1: General background sample area - North.

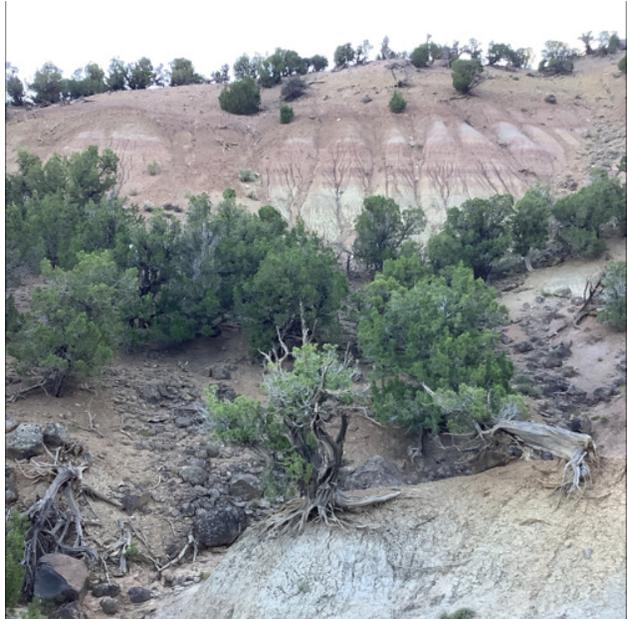
Fig. 2: General background sample area - East

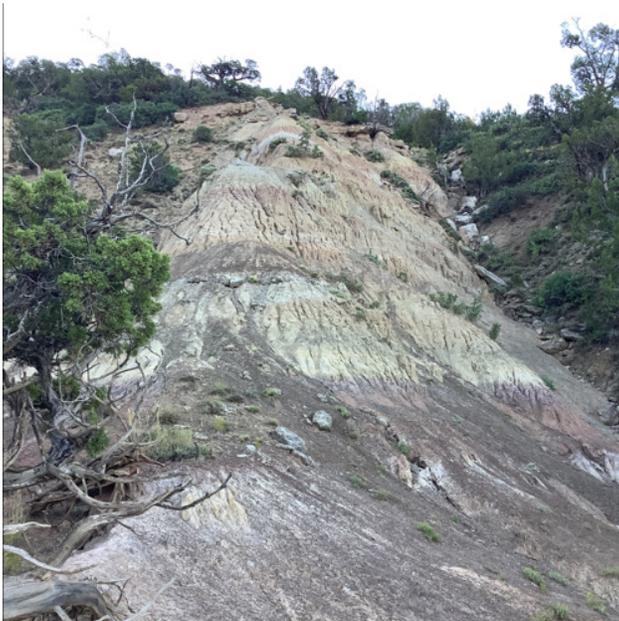
Fig. 3: General background sample area - South

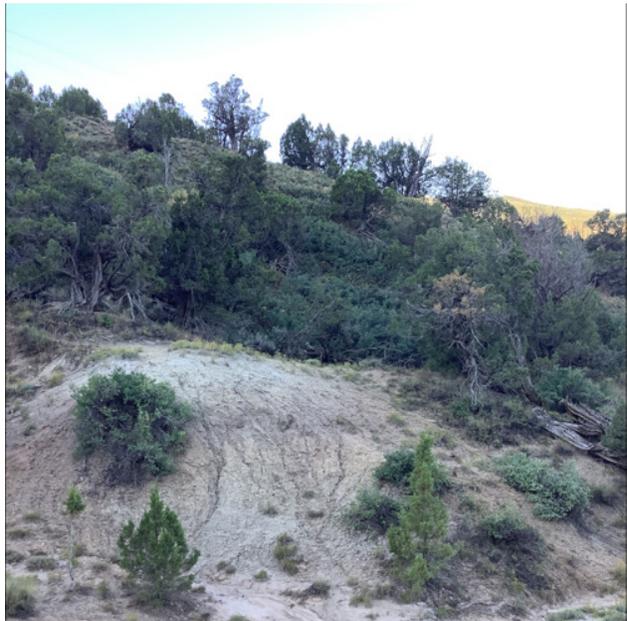
Fig. 4: General background sample area - West

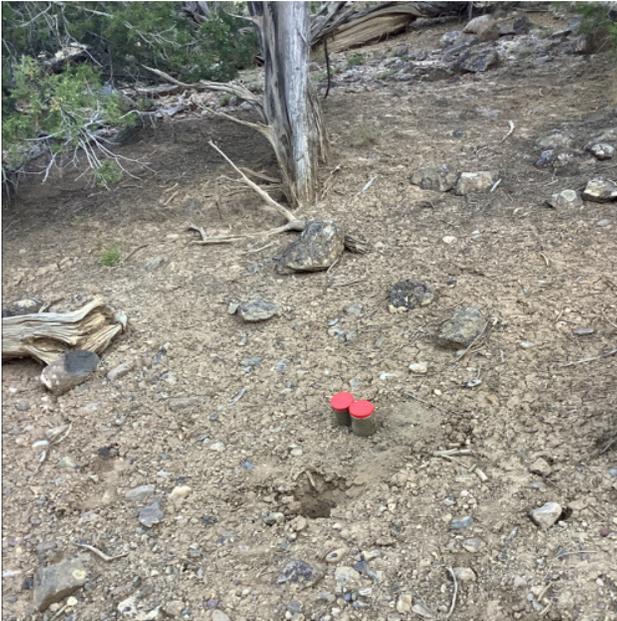
Fig. 5: 20220823_RA 11_BG03@1ft

Sample ID	Sample Type	Date	Time	Depth	PID (ppmv)	Odor	Staining	Comments
20220823_RA 11_BG03@1ft	Background	08/23/2022	07:15 AM	1 to 1	0	N	N	Soil is light tan in color.
20220823_RA 11_BG04@1ft	Background	08/23/2022	07:20 AM	1 to 1	0	N	N	Soil is light tan/light red in color.
20220823_RA 11_BG08@3ft	Background	08/23/2022	07:45 AM	3 to 3	0	N	N	
20220823_RA 11_BG08@5ft	Background	08/23/2022	07:55 AM	5 to 5	0	N	N	
20220823_RA 11_BG09@3ft	Background	08/23/2022	08:20 AM	3 to 3	0	N	N	Rocky soil.
20220823_RA 11_PW01	Other	08/23/2022	08:45 AM	0 to 0	0	Y	N	PID measurement not collected.
20220823_RA 11_BG10@5ft	Background	08/23/2022	08:50 AM	5 to 5	0	N	N	
20220823_RA 11_BG10@7ft	Background	08/23/2022	09:20 AM	7 to 7	0	N	N	
20220823_RA 11_BG10@9ft	Background	08/23/2022	09:50 AM	9 to 9	0	N	N	
20220823_RA 11_BG10@11ft	Background	08/23/2022	10:15 AM	11 to 11	0	N	N	
20220823_RA 11_BG10@13ft	Background	08/23/2022	10:45 AM	13 to 13	0	N	N

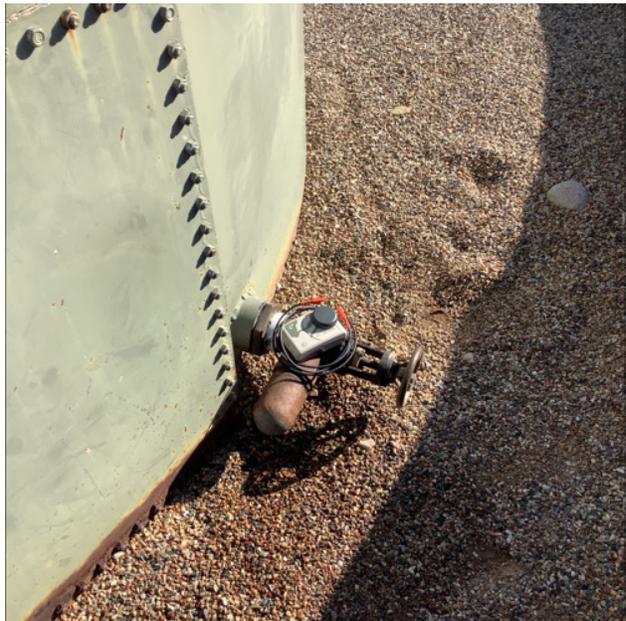
Fig. 11: 20220823_RA 11_PW01

A Caerus pumper (Marco) arrived at approximately 8:45 AM to assist with the collection of a produced water sample. The sample was collected directly from the tank loadout valve into a 1-liter unpreserved polyethylene collection bottle.

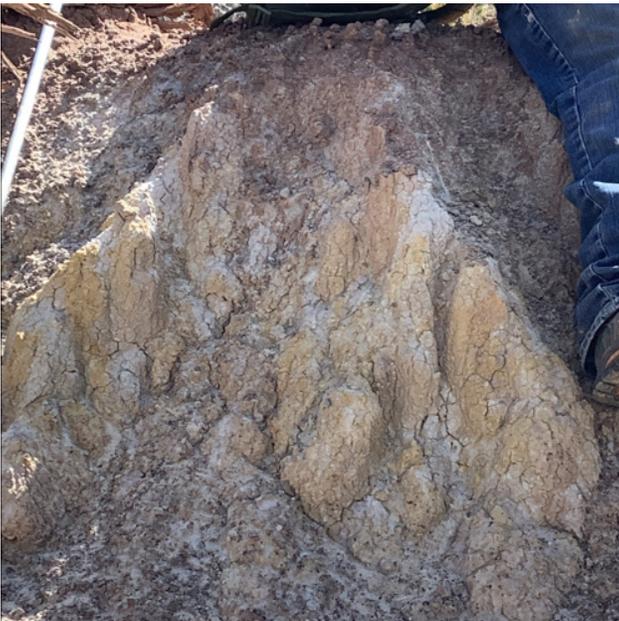
Fig. 17: 20220823_RA 11_BG05@1ft

20220823_RA 11_BG05@1ft	Background	08/23/2022	11:00 AM	1 to 1	0	N	N	Soil is white/yellow in color.
20220823_RA 11_BG06@1ft	Background	08/23/2022	11:10 AM	1 to 1	0	N	N	Soil is white/yellow in color.
20220823_RA 11_BG07@1ft	Background	08/23/2022	11:20 AM	1 to 1	0	N	N	In drainage gully.

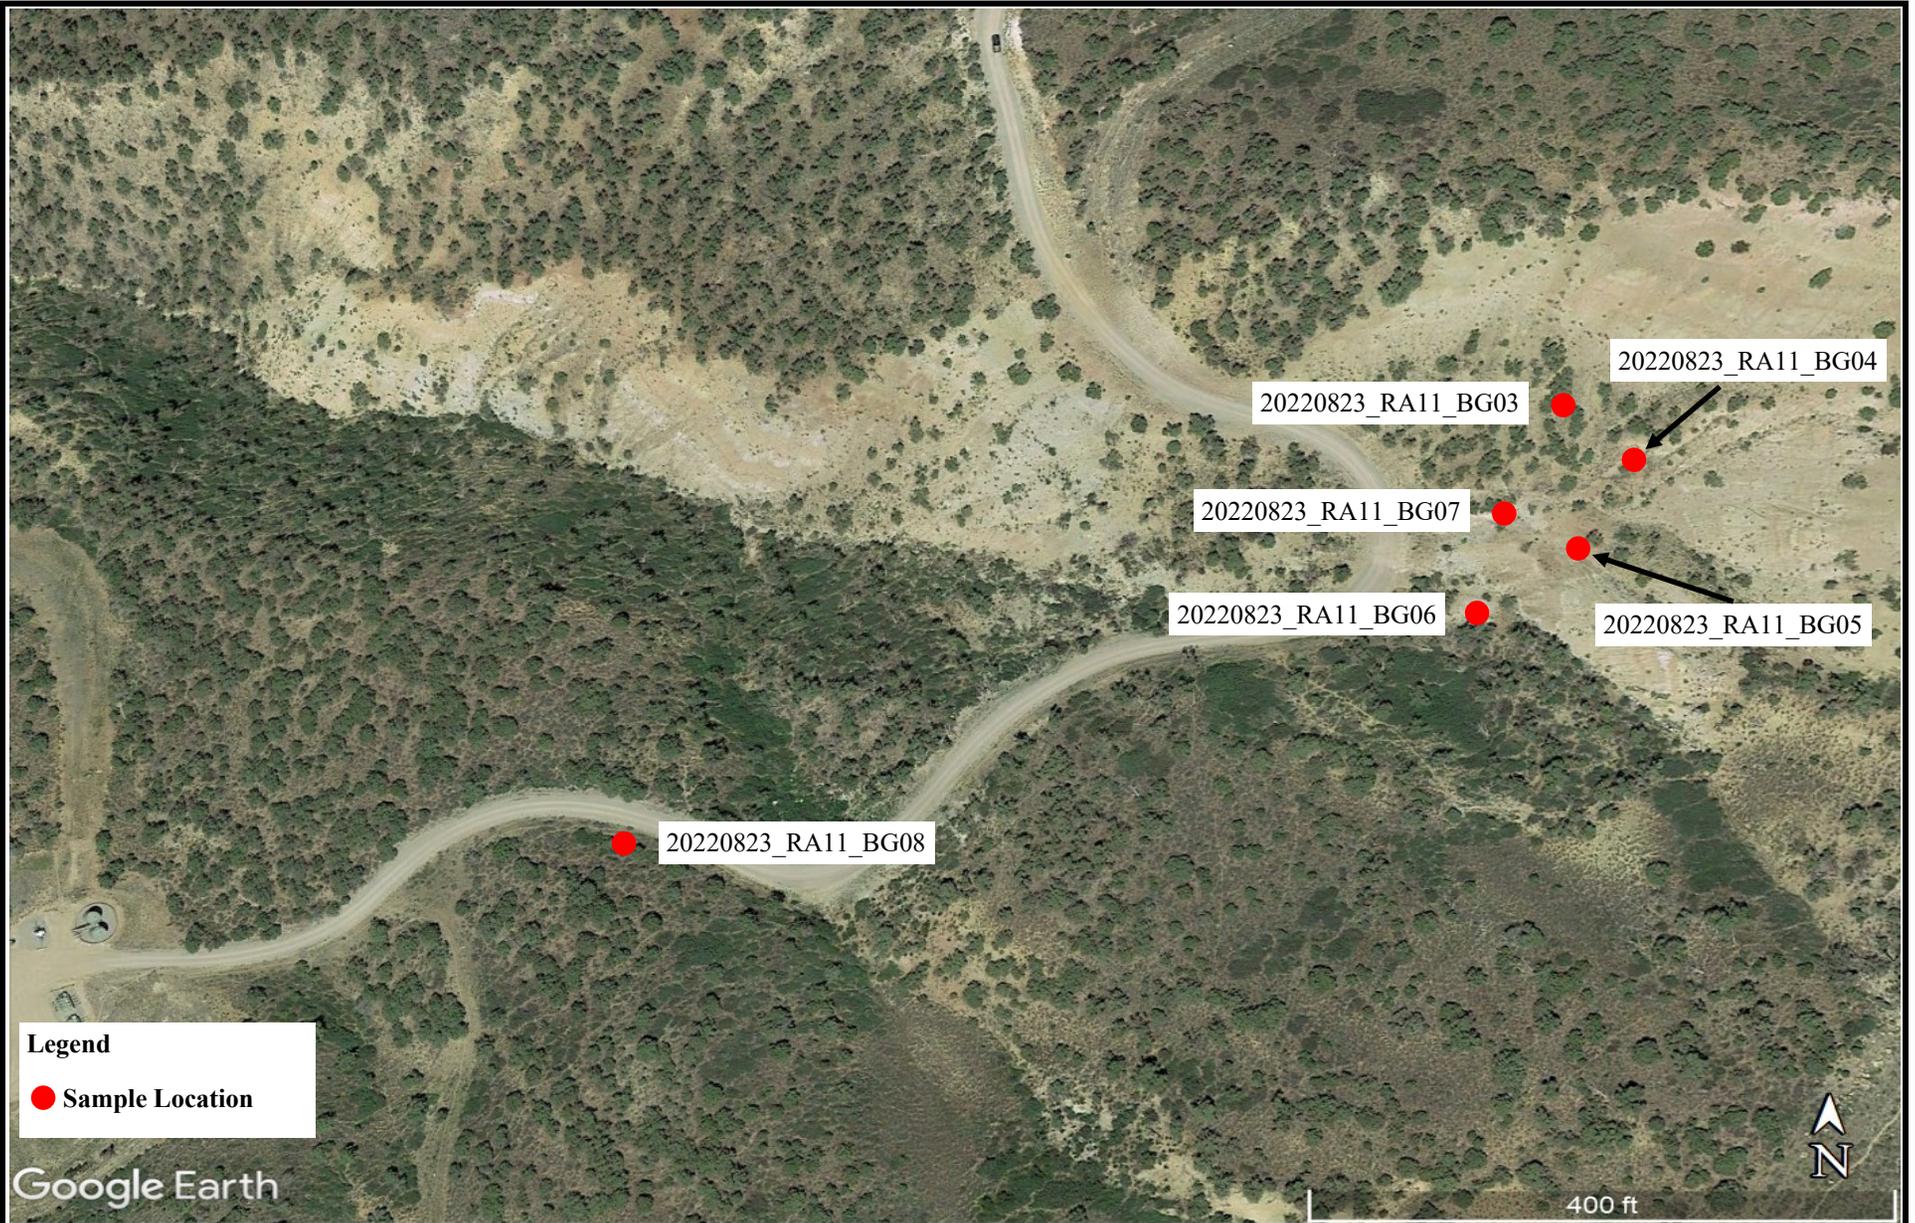
Figure

Five locations were identified in a gully located approximately 0.25 miles east of the RA11 facility as background soil sample locations. The gully was identified as a sampling area by Caerus during a site walk on 8/11/2022. Sample locations were chosen to reflect the variety of soil types encountered in the area. One soil sample was collected from each of the five locations at 1-foot bgs using a stainless-steel hand auger.

RA11 Flowline Investigation
 East Background Samples
 Caerus Piceance, LLC
 NENE Sec. 11 T7S R94W
 Garfield County, Colorado

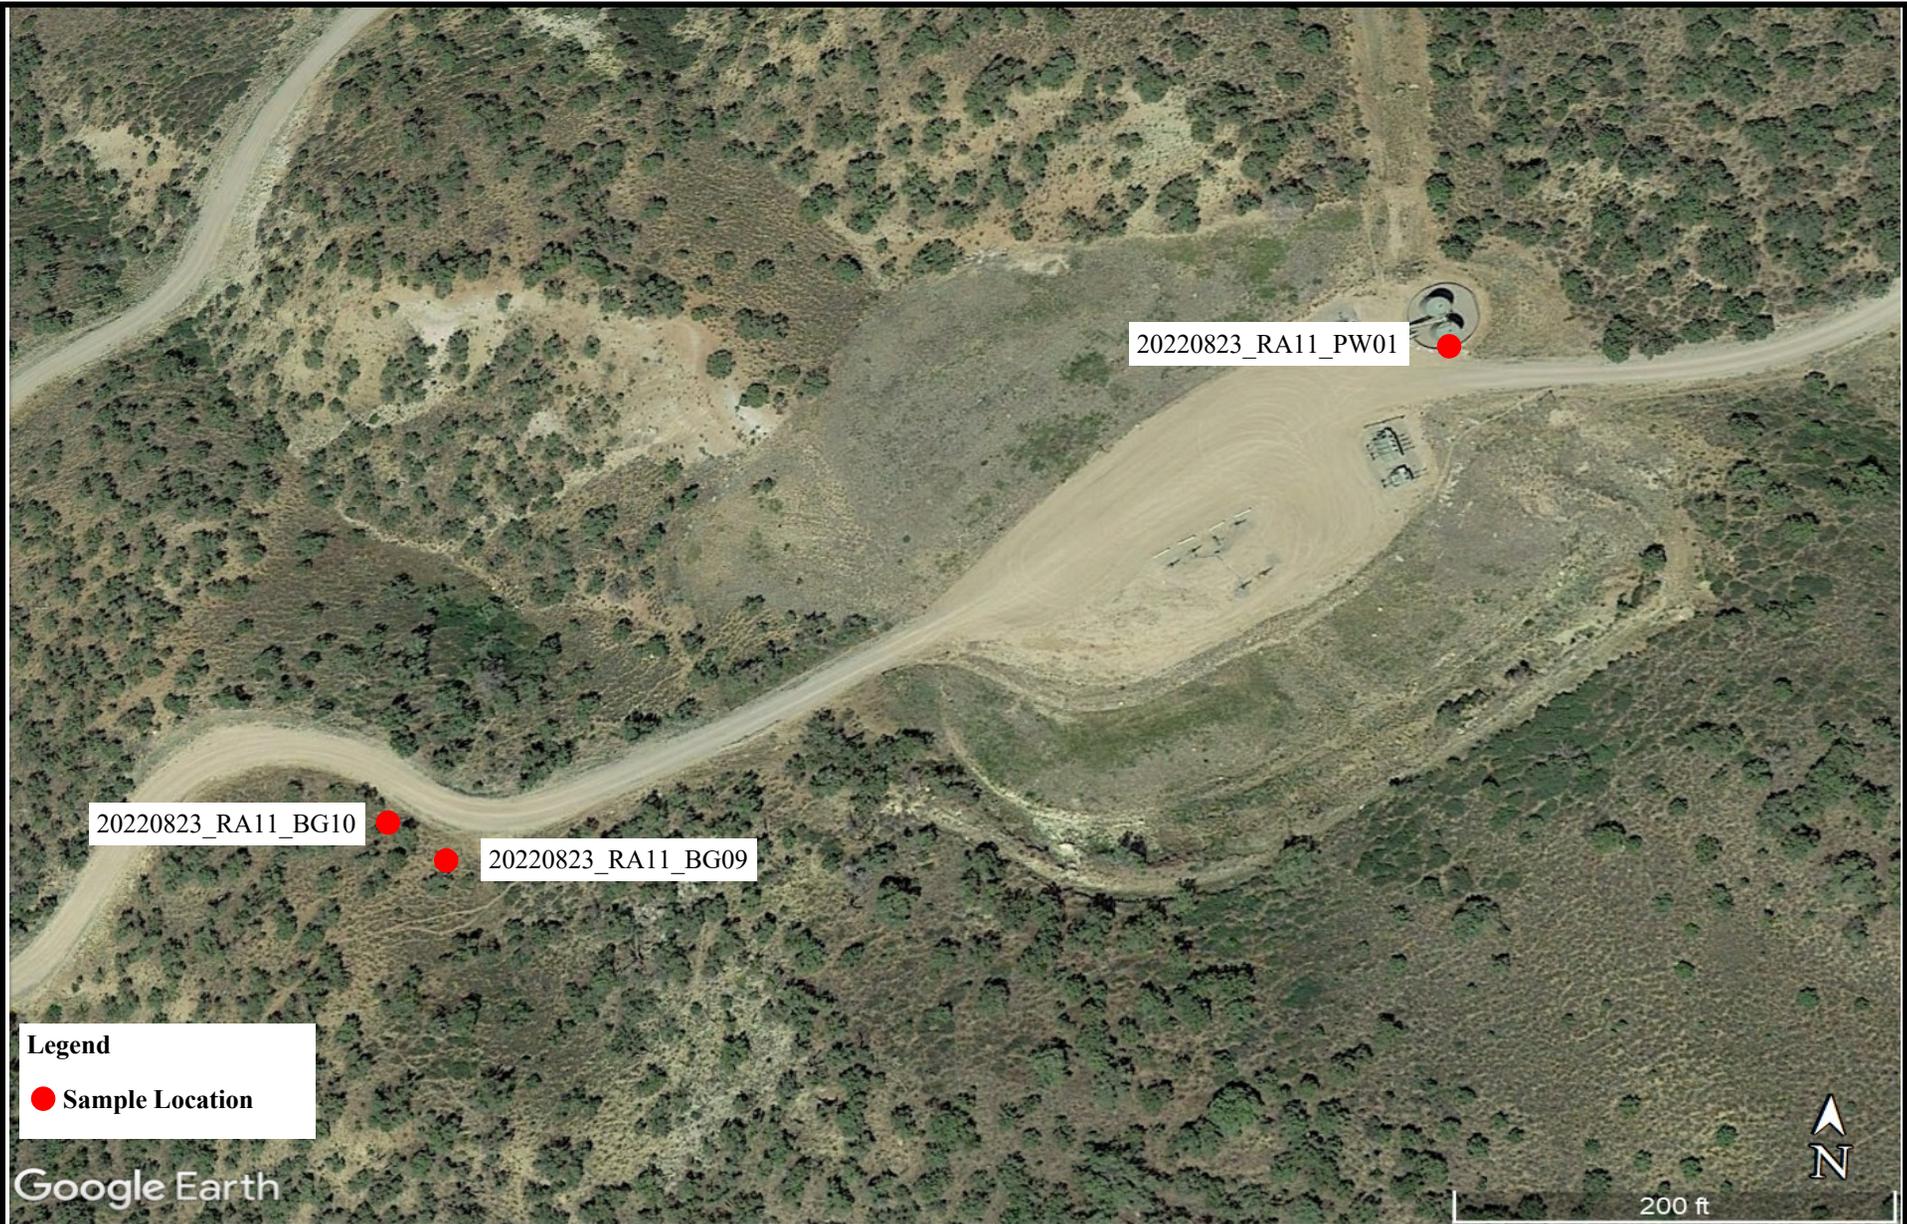
Figure

A second suitable pothole location was identified approximately 0.05 miles west of the RA11 facility. The pothole location was identified by Caerus on 8/11/2022 based on its proximity to the RA11 and the ability for a hydrovac to be able to operate. WCO was tasked to hydrovac to a depth of 15 feet bgs, however WCO encountered a layer of what

RA11 Flowline Investigation
 West Background and Produced Water Samples
 Caerus Piceance, LLC
 NENE Sec. 11 T7S R94W
 Garfield County, Colorado
