Inspection Photos

Operator: EOG Resources Inc - #27742

Location Name: Kaline Unit-612N94W /23NESW

Inspection Document #: 702800685

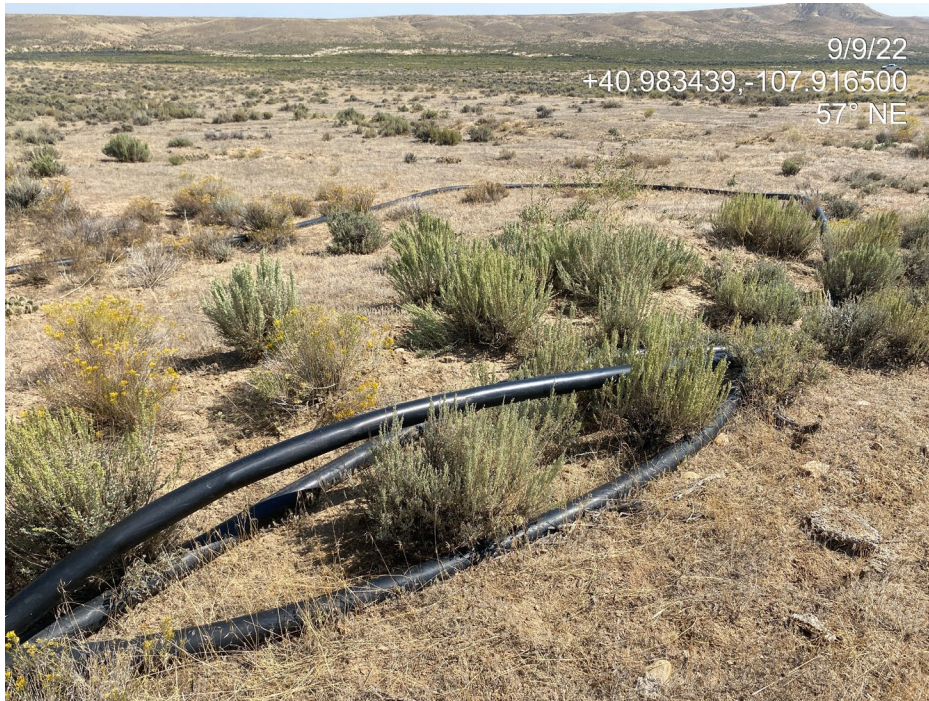
Photo 1. Photo taken to the east, on the access road shows debris from a locator wire is present. All debris and equipment must be removed per Rule 1004.a.

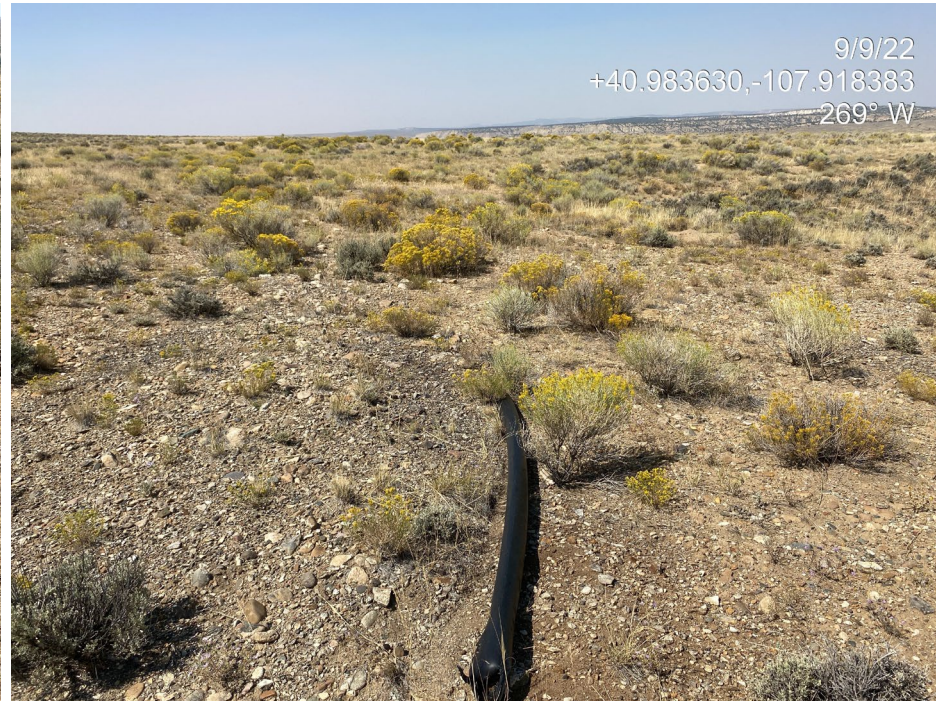
Photo 2. Photo taken at the south of the Location shows debris from a locator wire is present. All debris and equipment must be removed per Rule 1004.a.

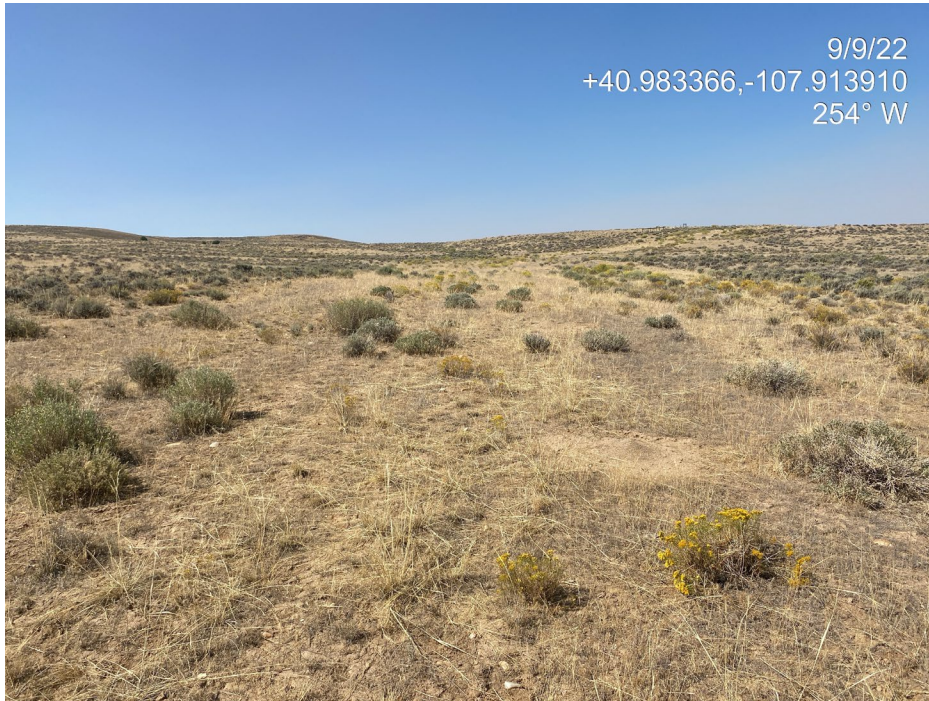
Photo 3. Photo taken to the east of the Location shows the access road has been reclaimed.

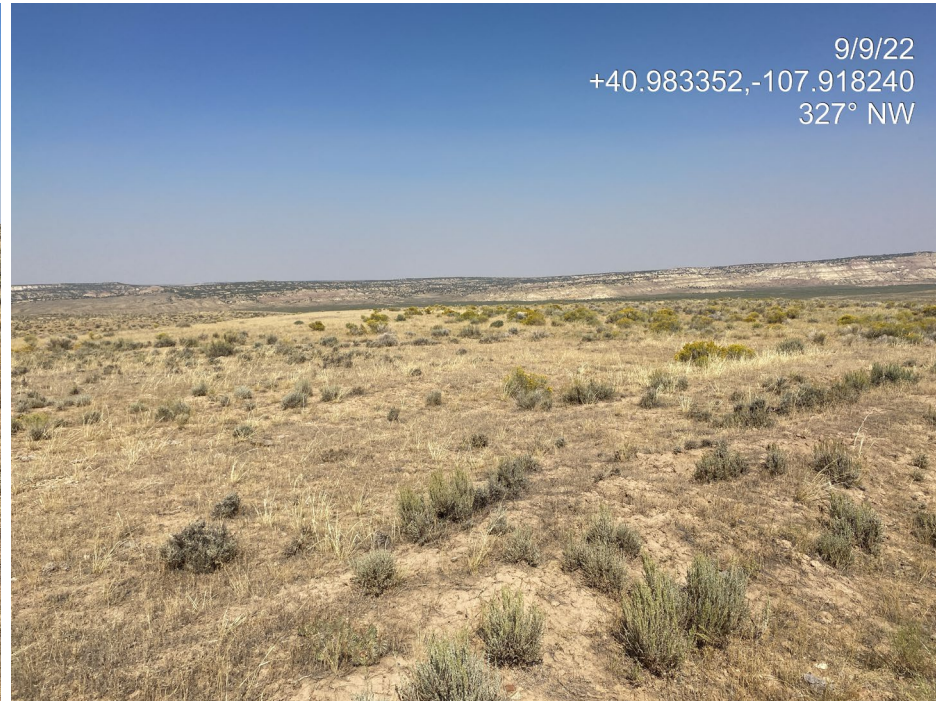
Photo 4. Photo taken to the south shows an overview of the reclaimed Location.

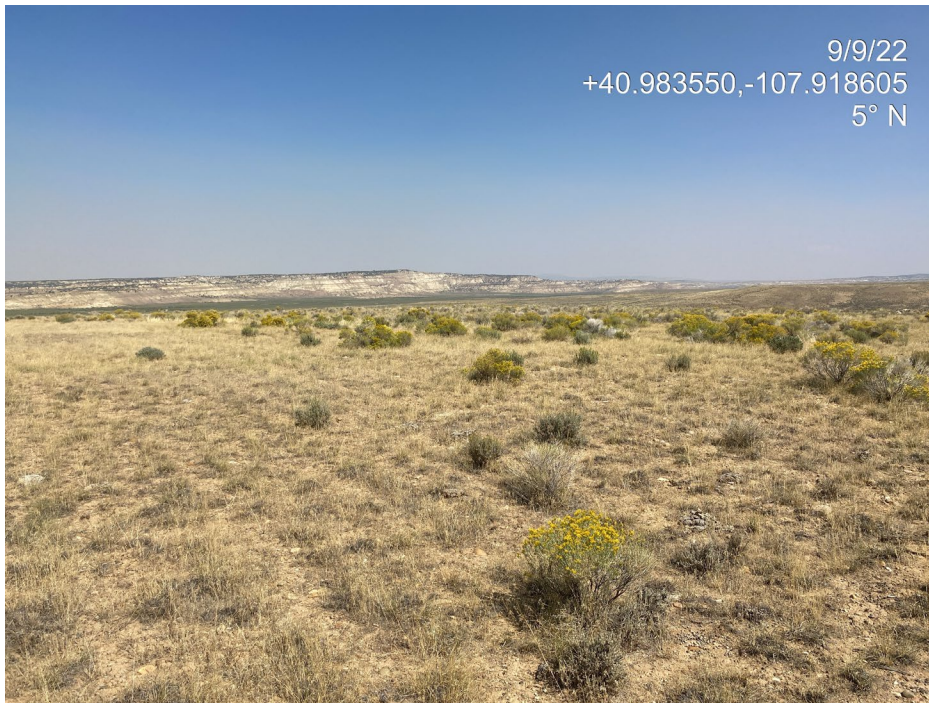
Photo 5. Photo taken from the south of the Location shows the vegetation community of the reclaimed Location is dominated by native perennial grasses and occasional native shrubs.

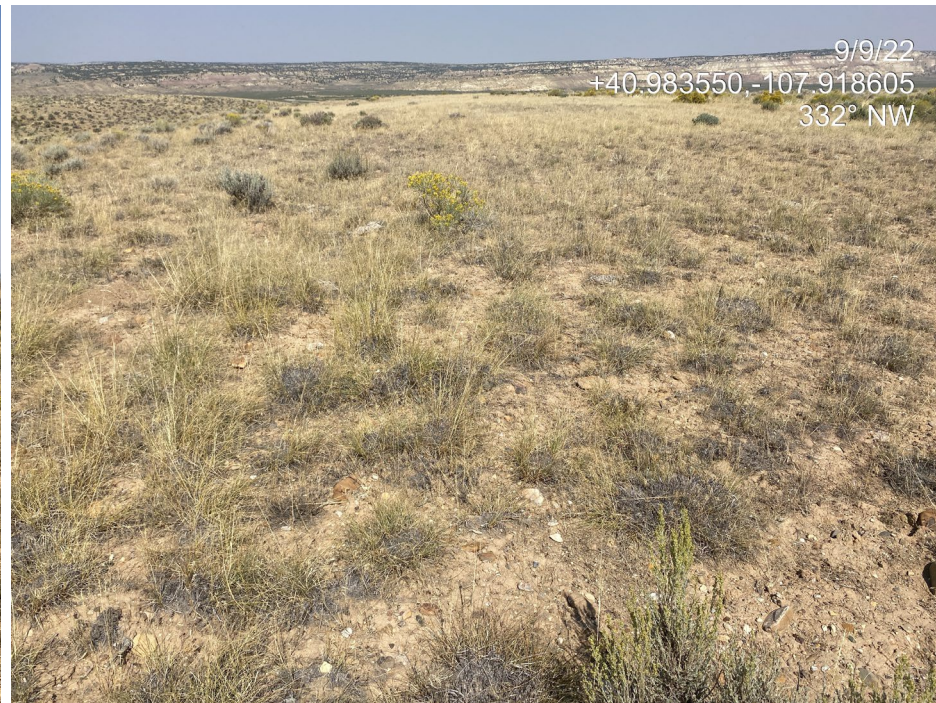
Photo 6. Refer to Photo 5 comment.

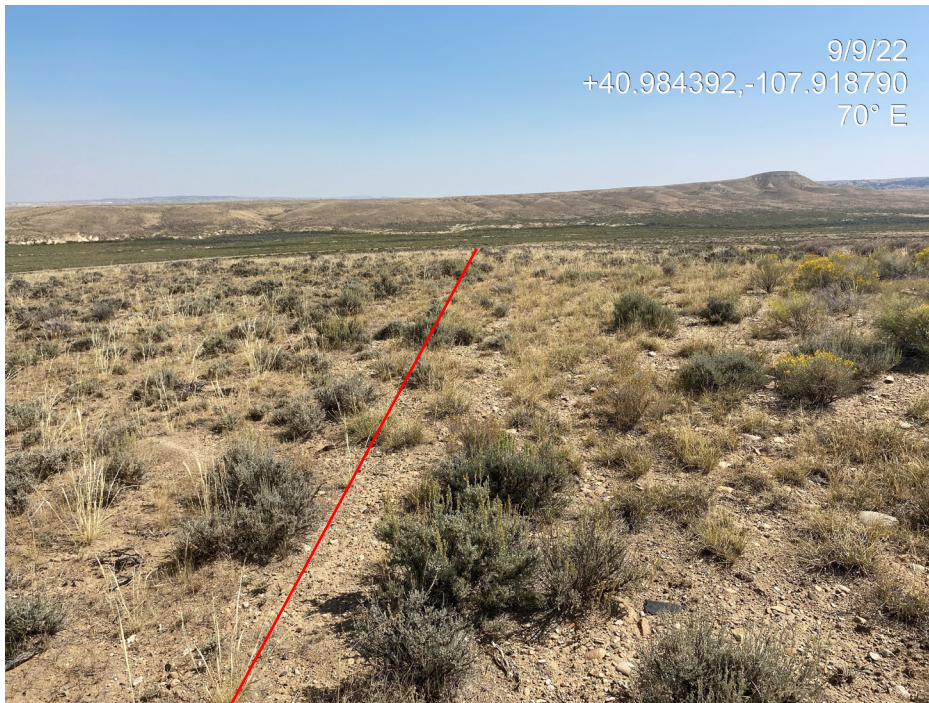
Photo 7. Photo taken from the north of the Location shows the vegetation community on the reclaimed Location (right) and off Location in the reference area (left).

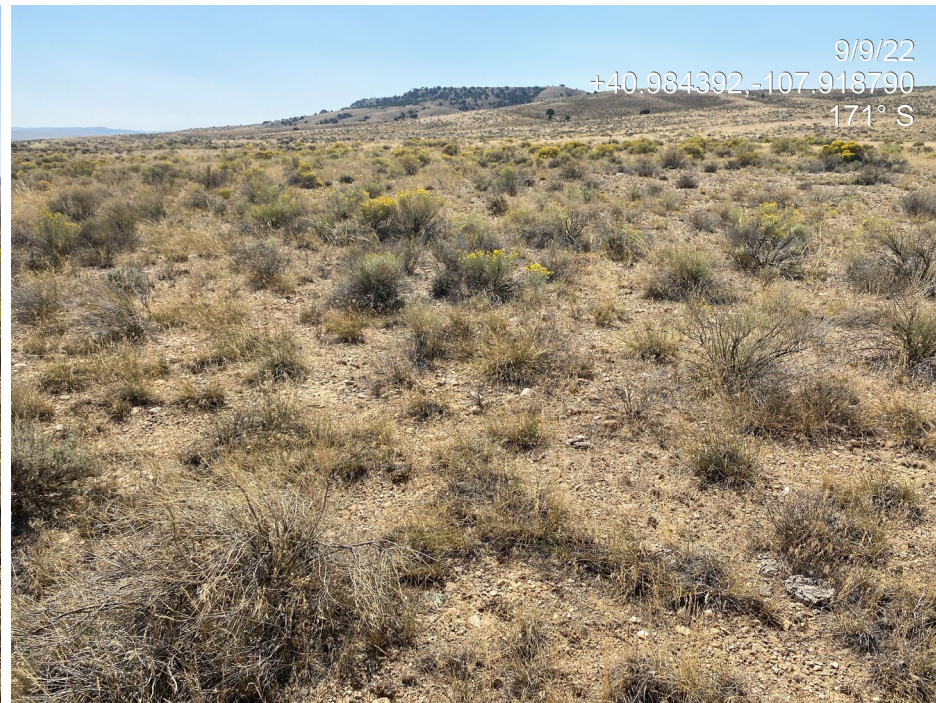
Photo 8. Photo taken from the north of the Location shows the vegetation community of the reclaimed Location is dominated by native perennial grasses and occasional native shrubs.

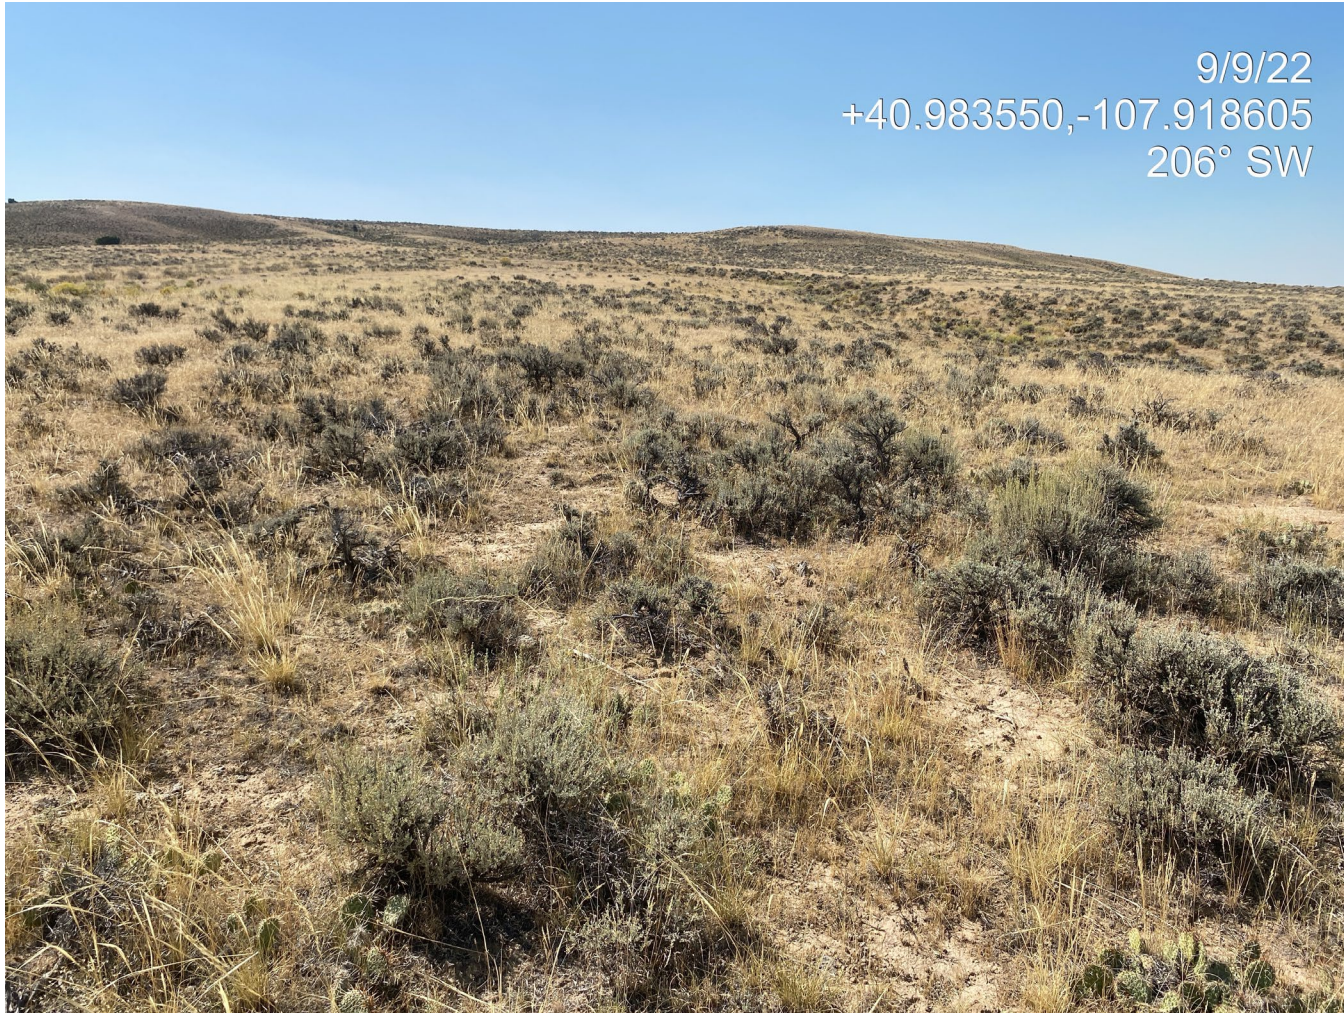
Photo 9. Photo shows reference area vegetation to the south of the Location.
