# Site Inspection Report

**Site: COSSLET A 9 FLOWLINE**  
09/08/2022

SITE/LOCATION	DATE	TIME	INSPECTOR
COSSLET A 9 FLOWLINE	09/08/2022	02:13 PM	Alexander Ahmadian
Comments			
Work Activity Notes			
Changes since previous inspection?	No	Drive by inspection	No
Actively being worked?	No		
Fieldwork Oversight Performed?	No	Oversite Type	
Were Oversight Samples Collected?	No	Sample Details

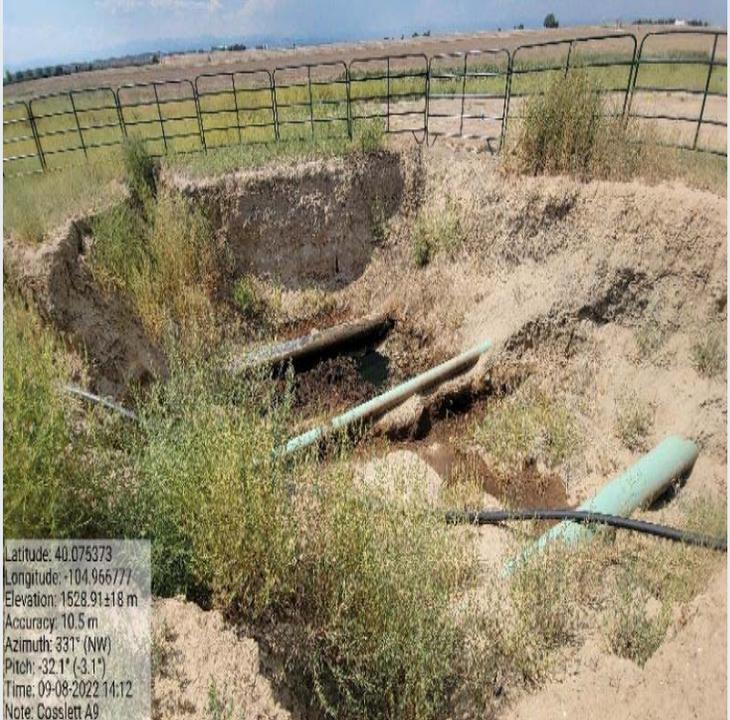
Photo
<p><b>Question:</b> Open excavation(s)? Note: Approximate size(s) (Length x Width x Depth, ft)</p> <p><b>Response:</b> Yes</p> <p><b>Notes:</b></p>

<p>Latitude: 40.075373                  Longitude: -104.966777                  Elevation: 1528.91±18 m                  Accuracy: 10.5 m                  Azimuth: 331° (NW)                  Pitch: -32.1° (-3.1°)                  Time: 09-08-2022 14:12                  Note: Cosslett A9</p>

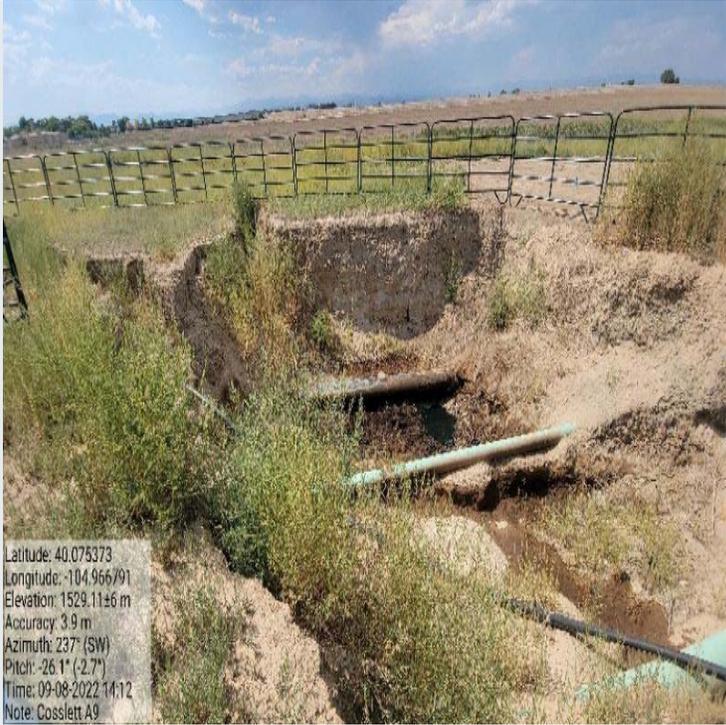
Photo
<p><b>Question:</b> Open excavation(s)? Note: Approximate size(s) (Length x Width x Depth, ft)  <b>Response:</b> Yes  <b>Notes:</b></p>

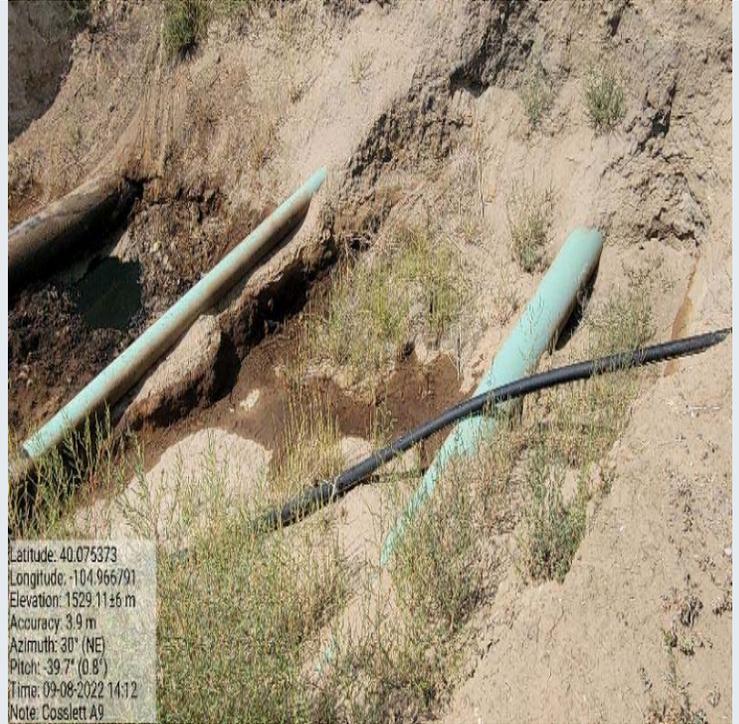
**Question:** Ground surface appears clean (no evidence of new equipment leaks, oil leaks, spills, or releases)?

**Response:** No

**Notes:** Product pooling within the excavation

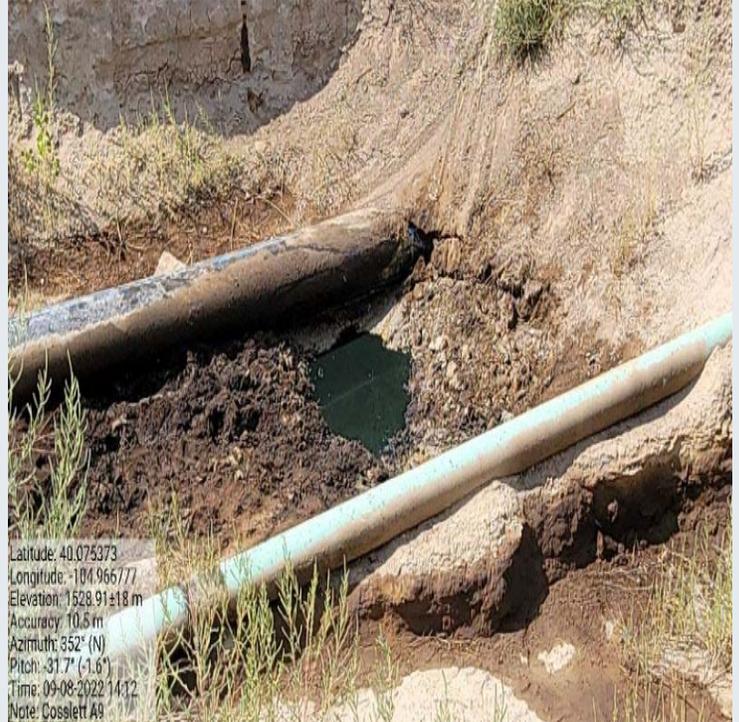
**Question:** Ground surface appears clean (no evidence of new equipment leaks, oil leaks, spills, or releases)?

**Response:** No

**Notes:** Product pooling within the excavation

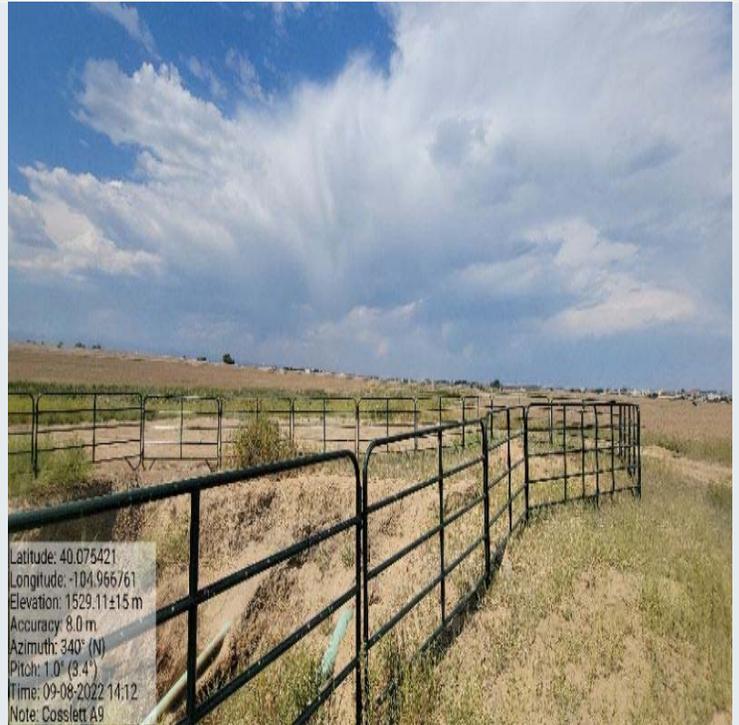
**Question:** Open excavation properly fenced/covered (in accordance with Rule 913.b.(5)B.i.)?

**Response:** Yes

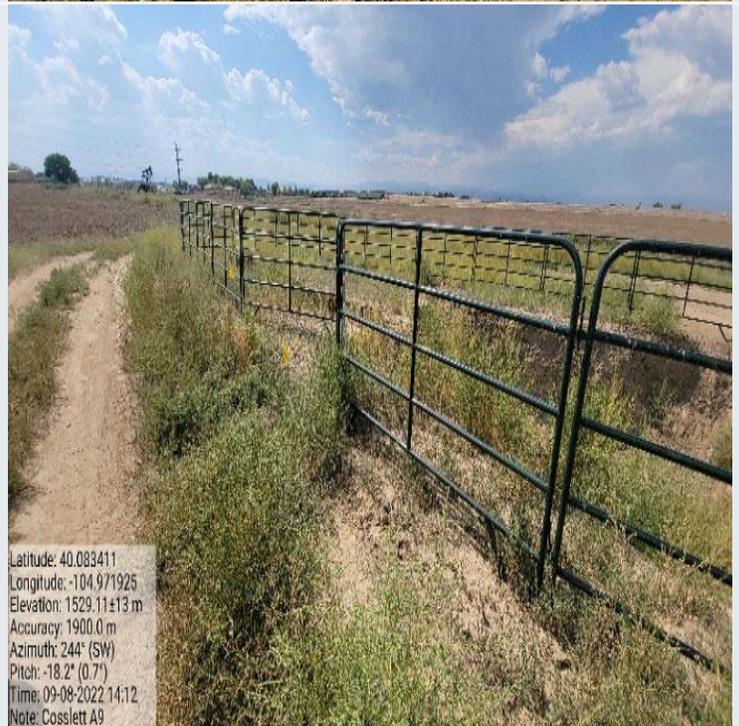
**Question:** Open excavation properly fenced/covered (in accordance with Rule 913.b.(5)B.i.)?

**Response:** Yes

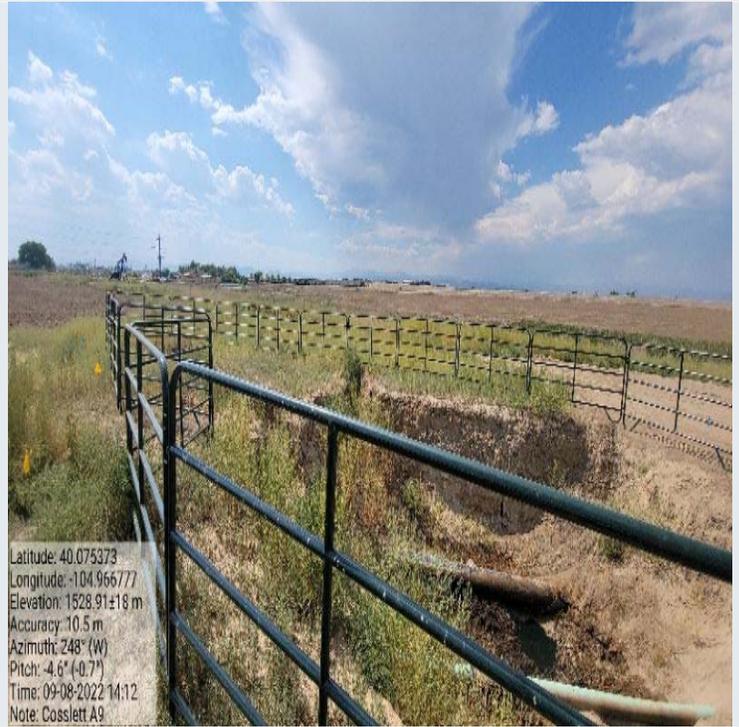
**Question:** Open excavation properly fenced/covered (in accordance with Rule 913.b.(5)B.i.)?

**Response:** Yes

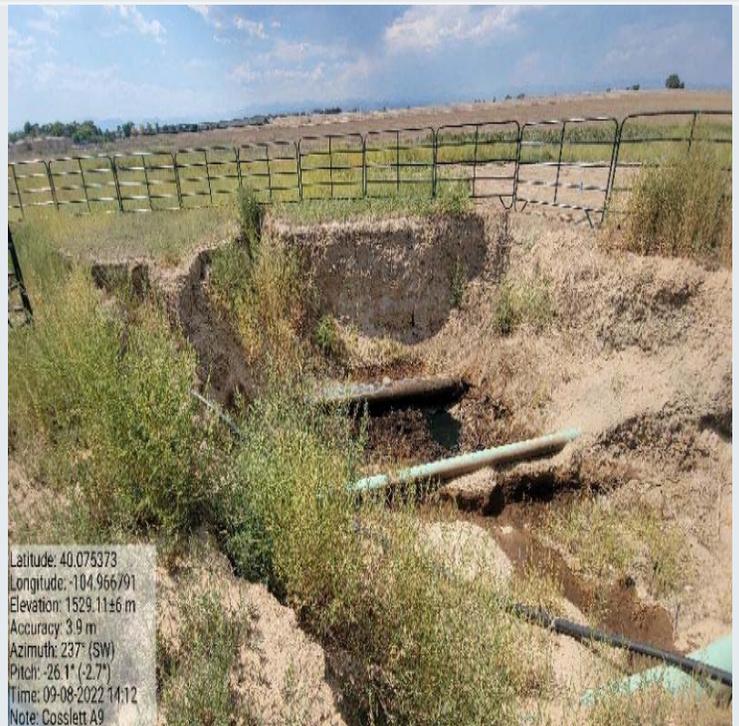
**Question:** Exposed buried/underground flowlines within excavation?

**Response:** Yes

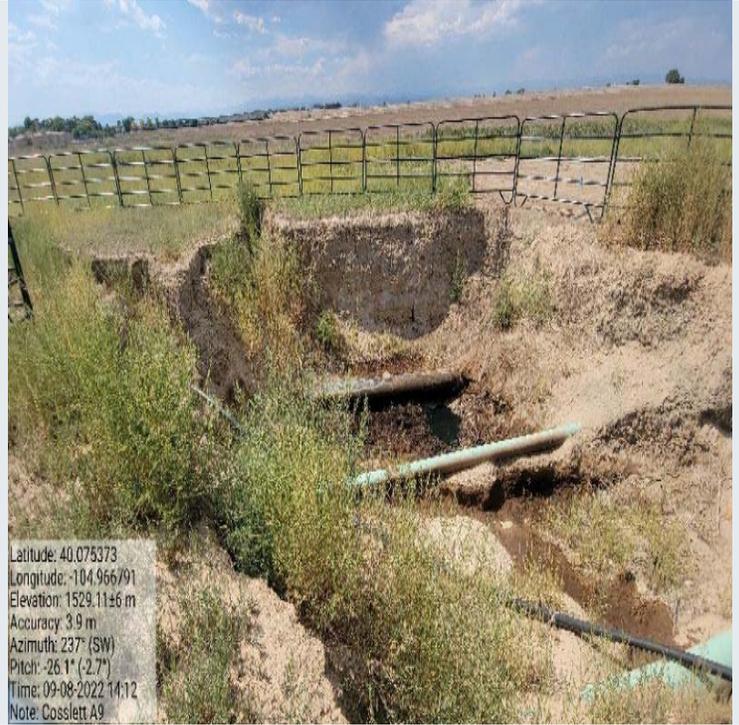
**Question:** Site free of unused equipment, weeds, debris/trash?

**Response:** No

**Notes:** Weeds overgrown throughout the site

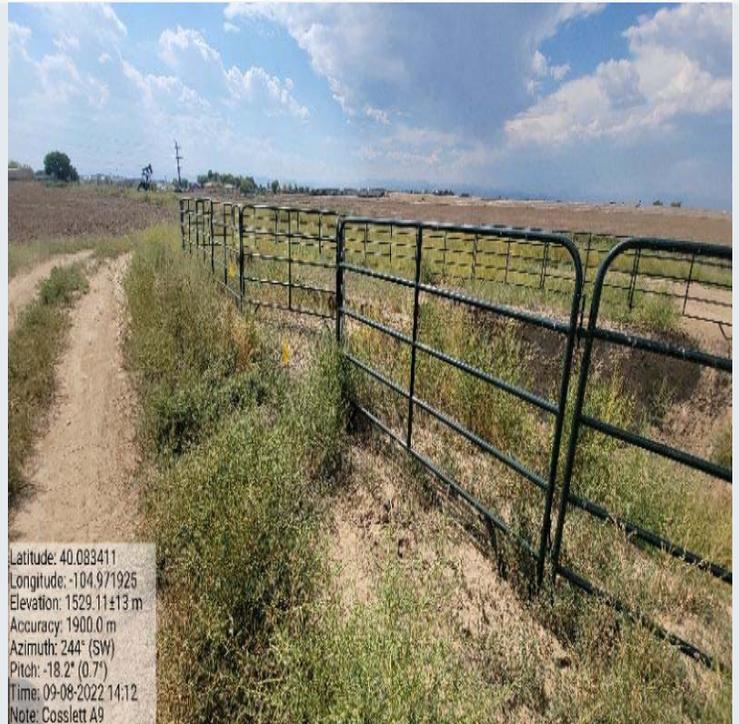
**Question:** Site free of unused equipment, weeds, debris/trash?

**Response:** No

**Notes:** Weeds overgrown throughout the site
