# Inspection Photos

Operator: EOG Resources Inc - #27742

Location Name: Kaline Unit-612N94W /23NWNW

Inspection Document #: 702800690

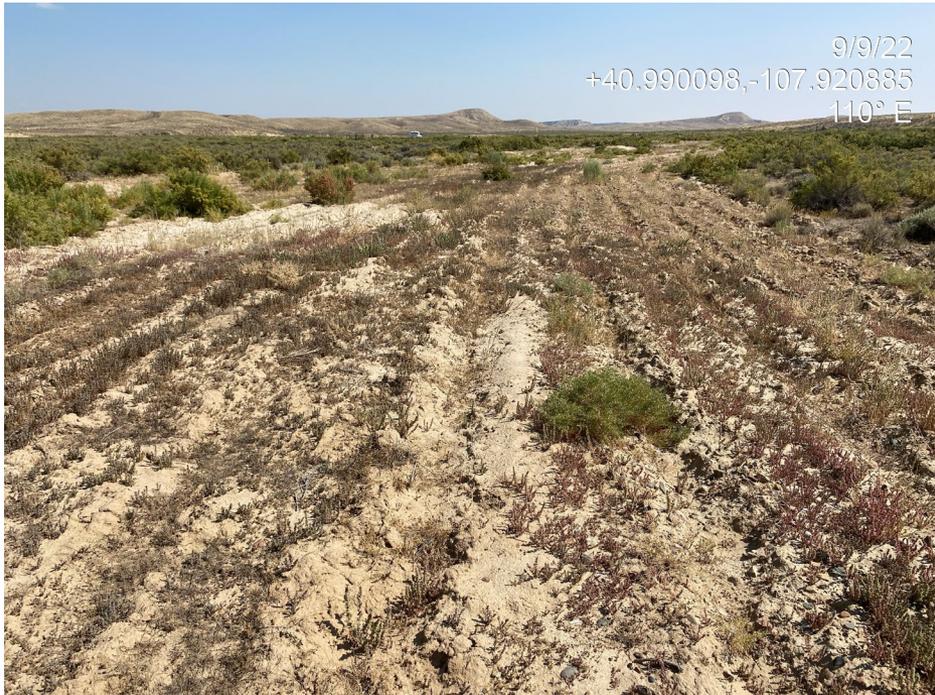
**Photo 1.** Photo taken to the southeast of the Location shows the access road is dominated by bare ground and kochia, an annual undesirable plant species/weed.

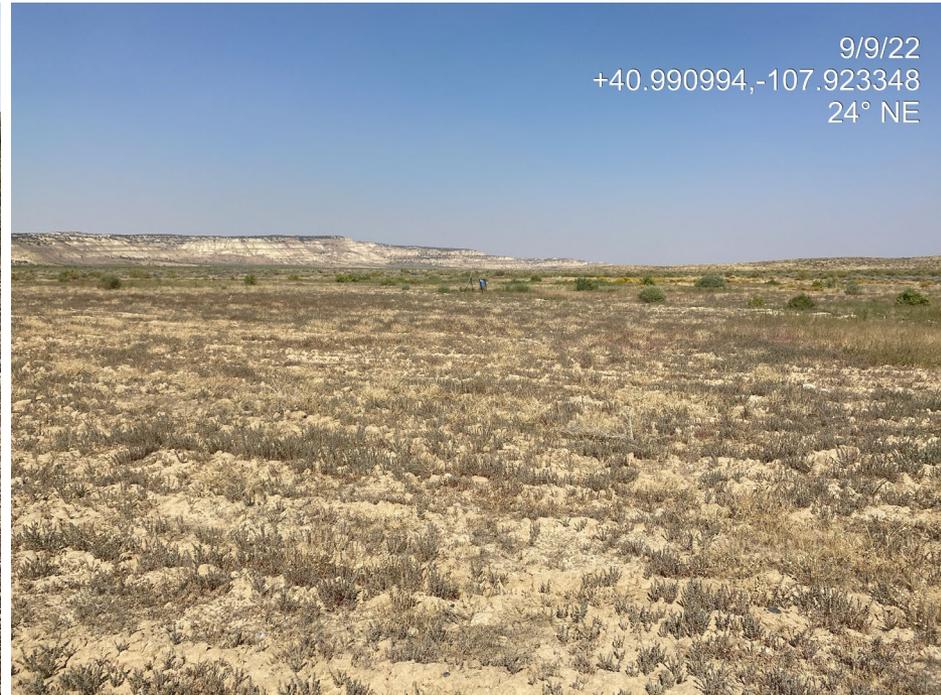
**Photo 2.** Photo taken from the southwest shows an overview of the Location. The species shown colonizing the Location in this photo are kochia (annual undesirable plant species) and halogeton (noxious weed).

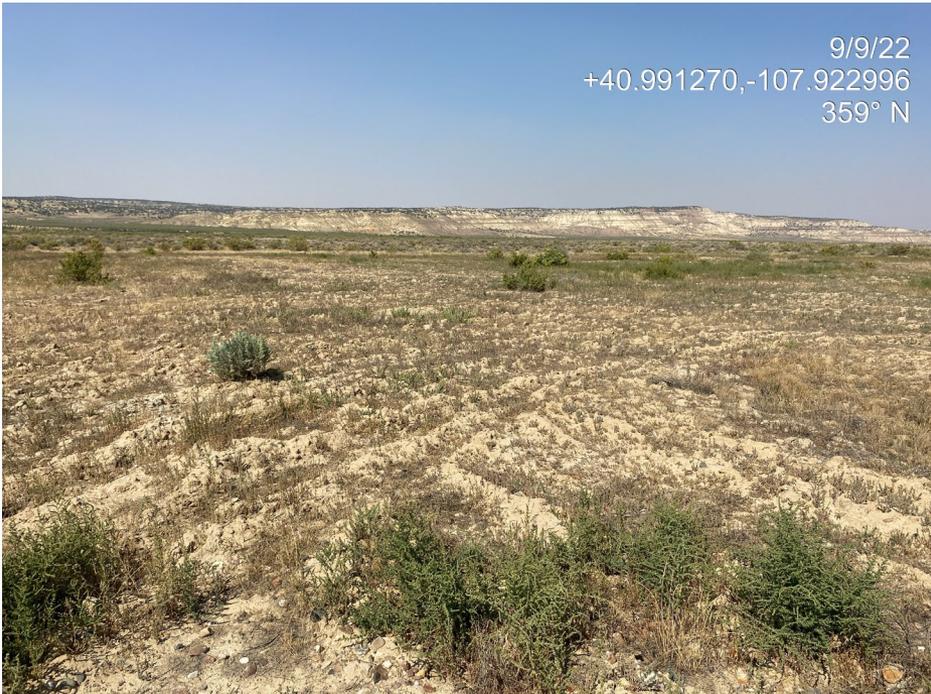
**Photo 3.** Photo taken from the center of the Location shows an overview to the north. Native shrubs (fourwing saltbush, sagebrush, rabbitbrush, greasewood) are sparsely colonizing the Location. Grasses which appear to have been seeded (western wheatgrass) are rare.

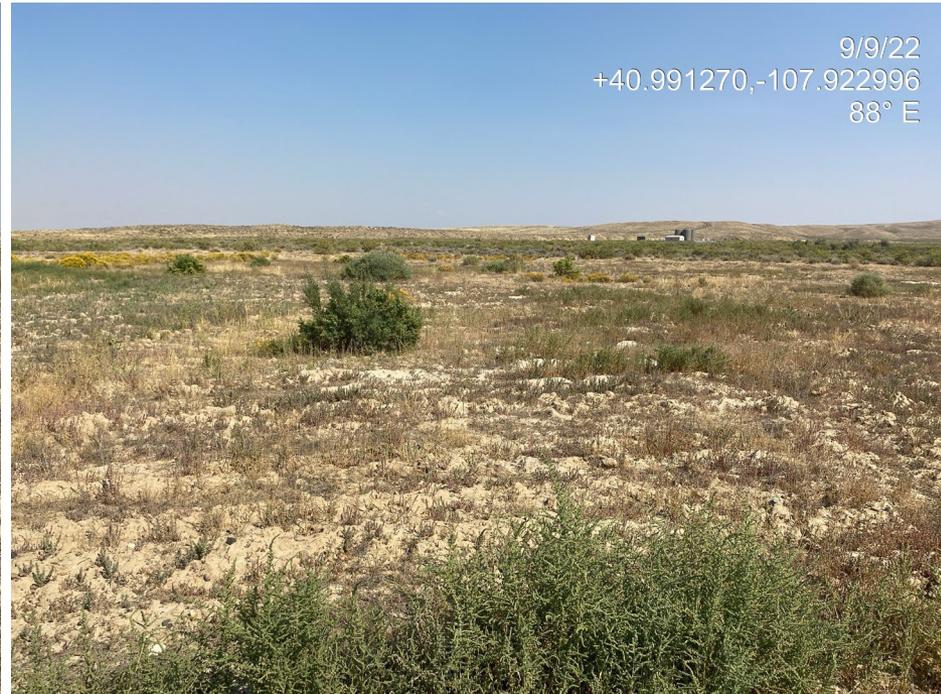
**Photo 4.** Photo taken from the center of the Location shows an overview to the east.

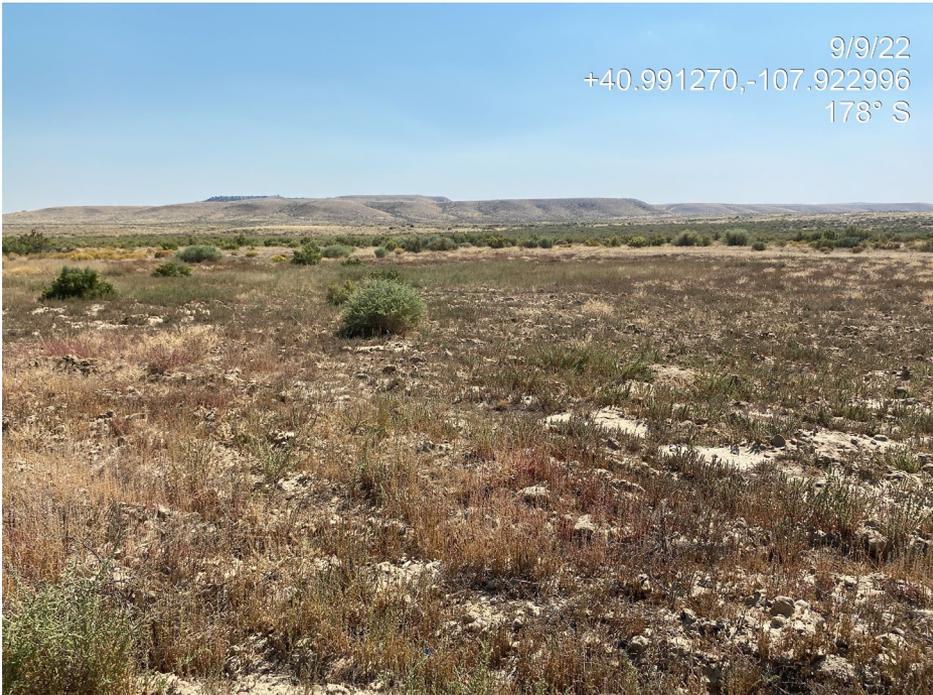
9/9/22  
+40.991270,-107.922996  
178° S

**Photo 5.** Photo taken from the center of the Location shows an overview to the south.

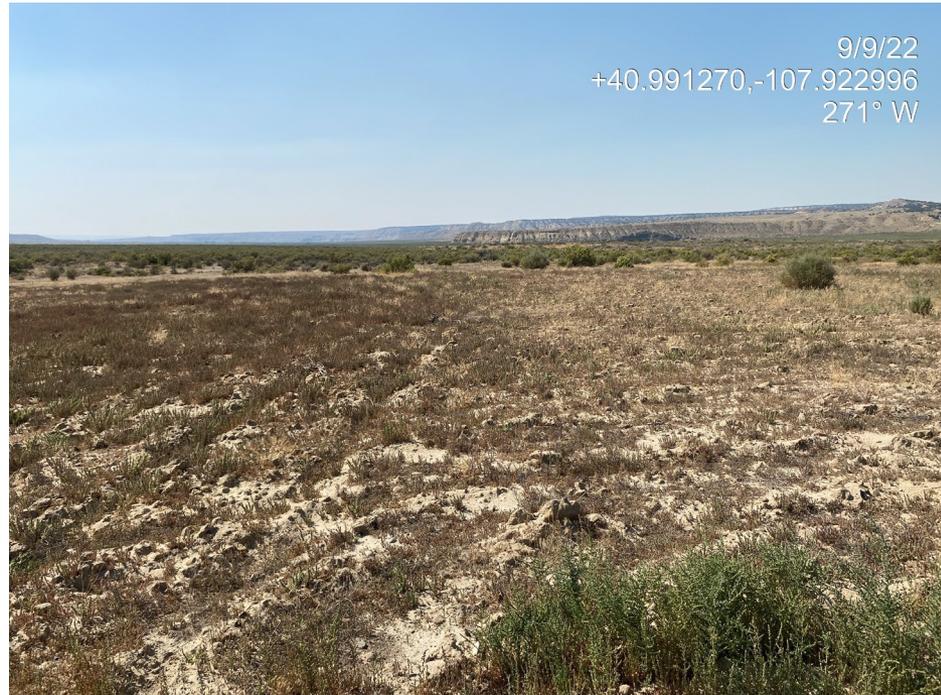
9/9/22  
+40.991270,-107.922996  
271° W

**Photo 6.** Photo taken from the center of the Location shows an overview to the west.

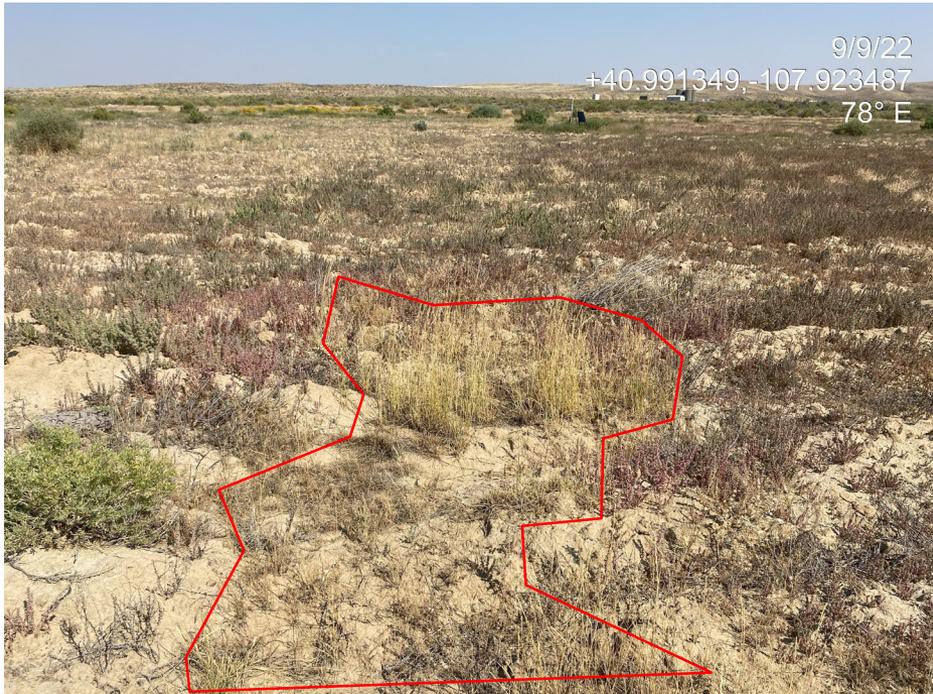
**Photo 7.** Photo taken from the west of the Location shows a small patch of western wheatgrass, a native perennial grass which appears to have been seeded, but is rare and largely unsuccessful.

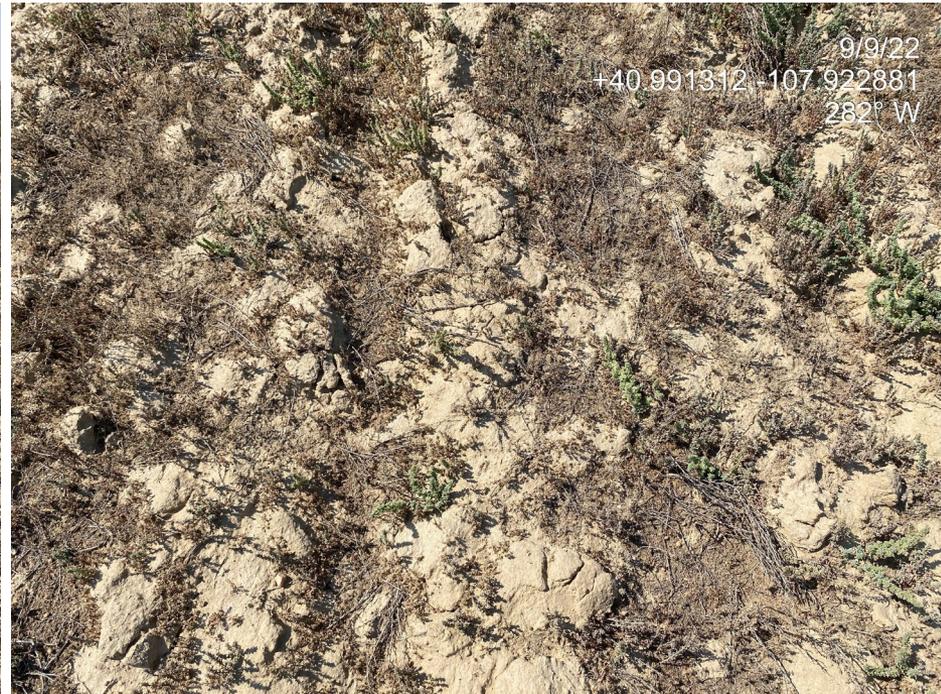
**Photo 8.** Photo taken from the center of the Location shows a close-up of the dominant vegetation community consisting of kochia (annual undesirable plant species) and halogeton (noxious weed).

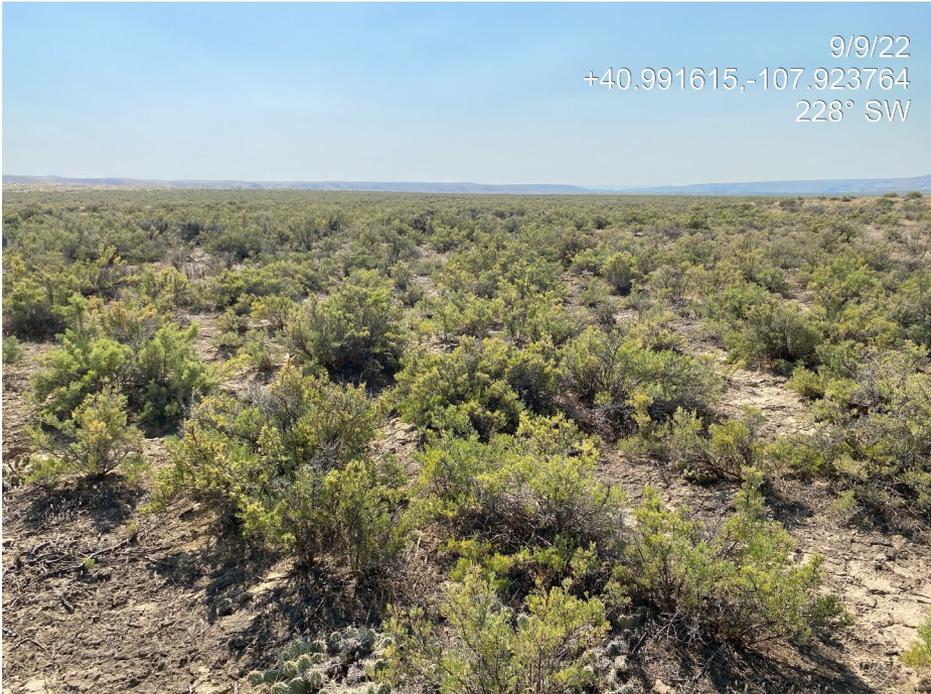
**Photo 9.** Photo shows the reference area vegetation community to the northwest of the Location. Species in the reference community include greasewood, sagebrush, saltbush spp., Sandberg bluegrass and needle-and-thread grass.

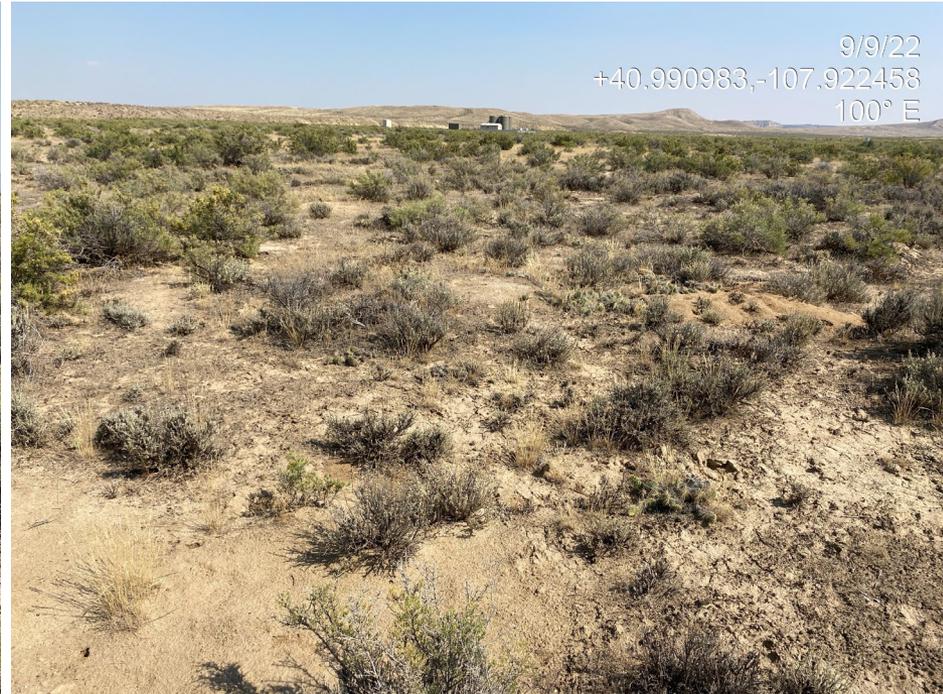
**Photo 10.** Photo shows the reference area vegetation community to the southeast of the Location. Species in the reference community include greasewood, sagebrush, saltbush spp., Sandberg bluegrass and needle-and-thread grass.

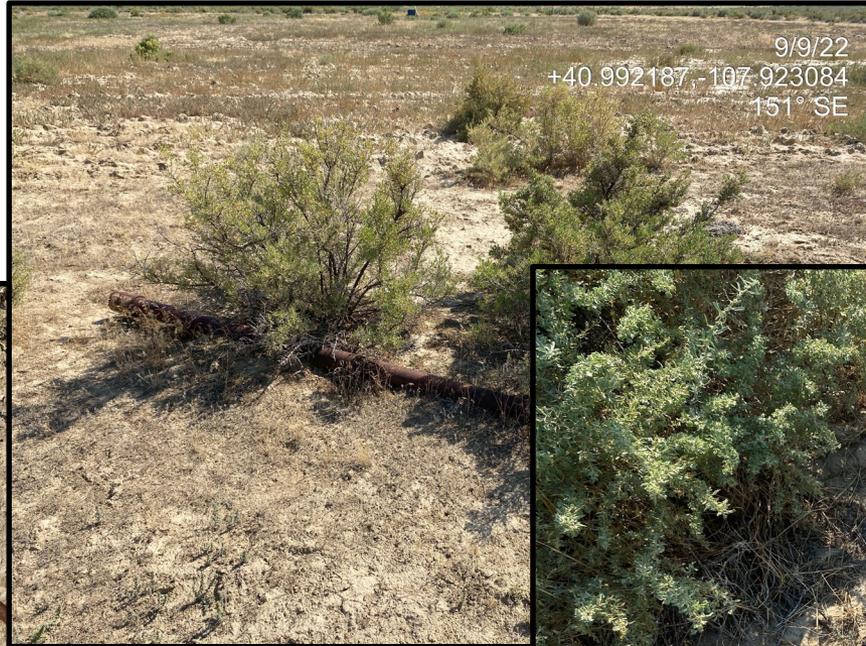
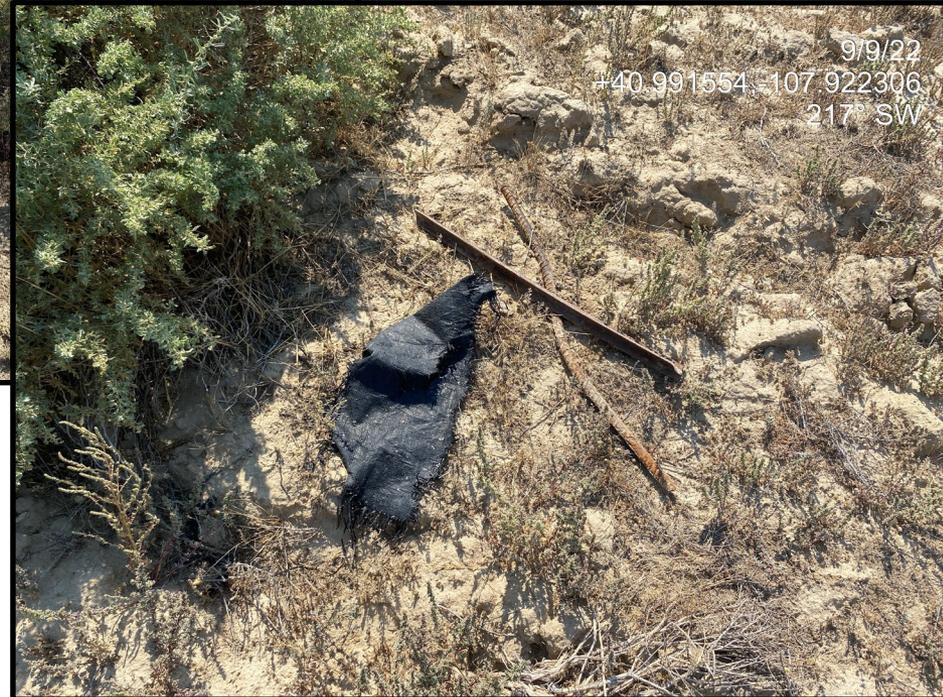
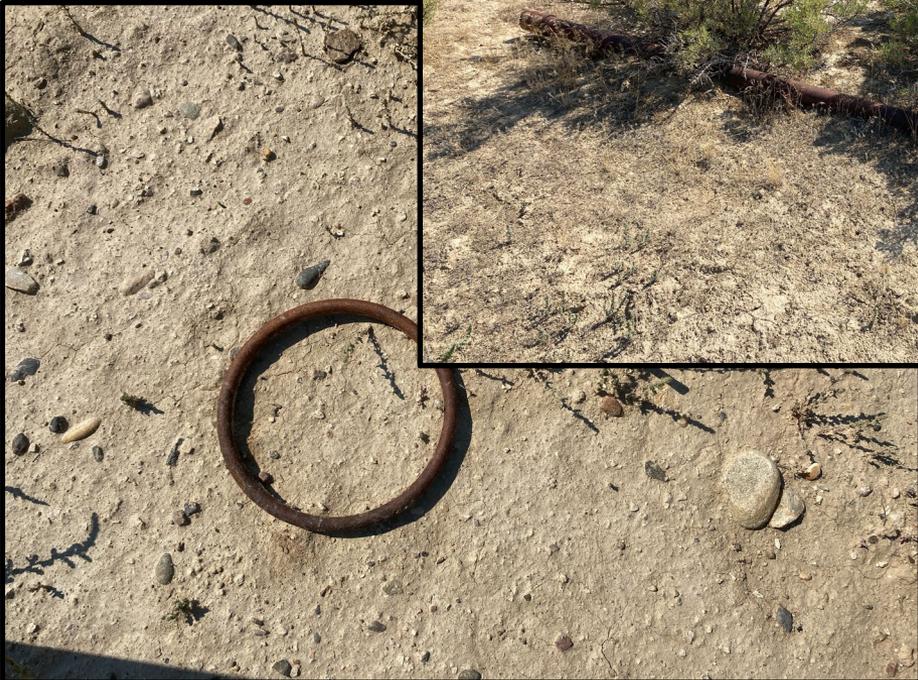
Photo 11. Photos show examples of trash/debris on Location.
