Inspection Photos

Operator: Crowheart Energy LLC - #10776

Location Name: Kaline SWD-612N94W /23NENW

Inspection Document #: 702800692

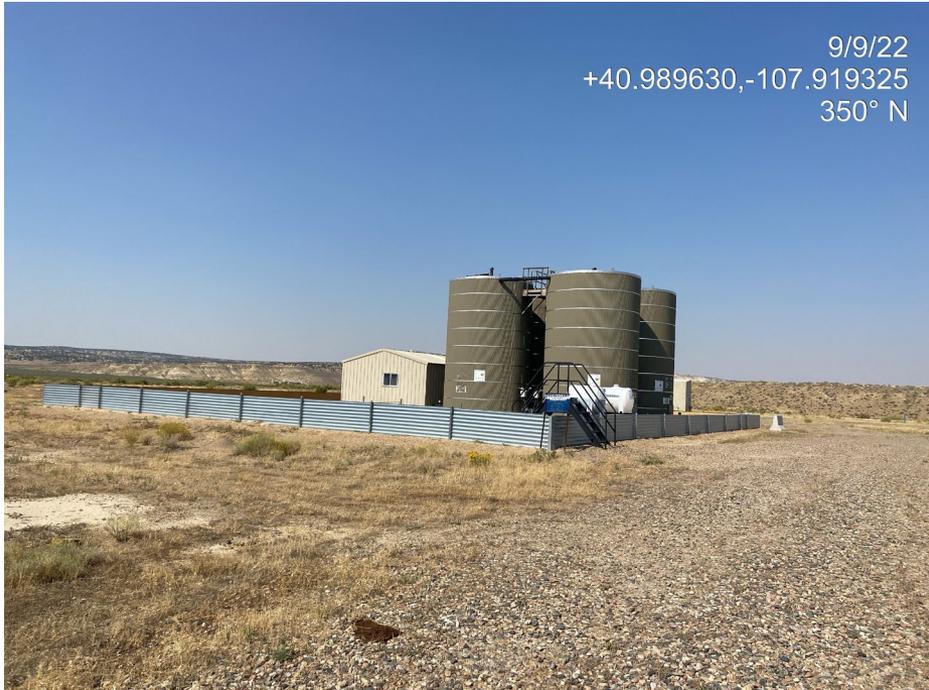
Photo 1. Photo taken from the south, at the Location entrance shows an overview of the Location.

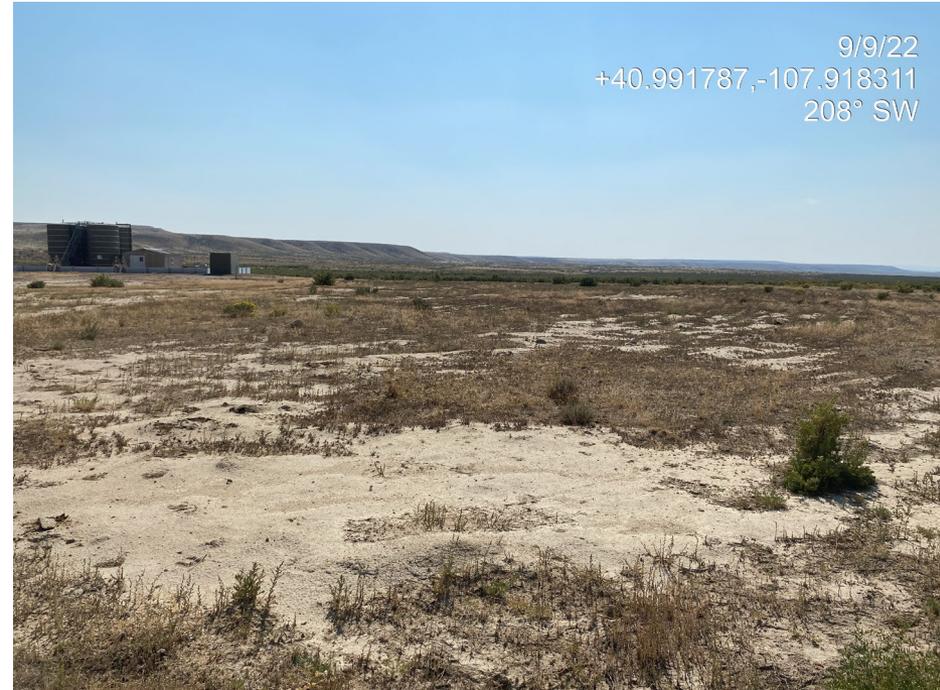
Photo 2. Photo taken from the north shows an overview of the Location including interim areas.

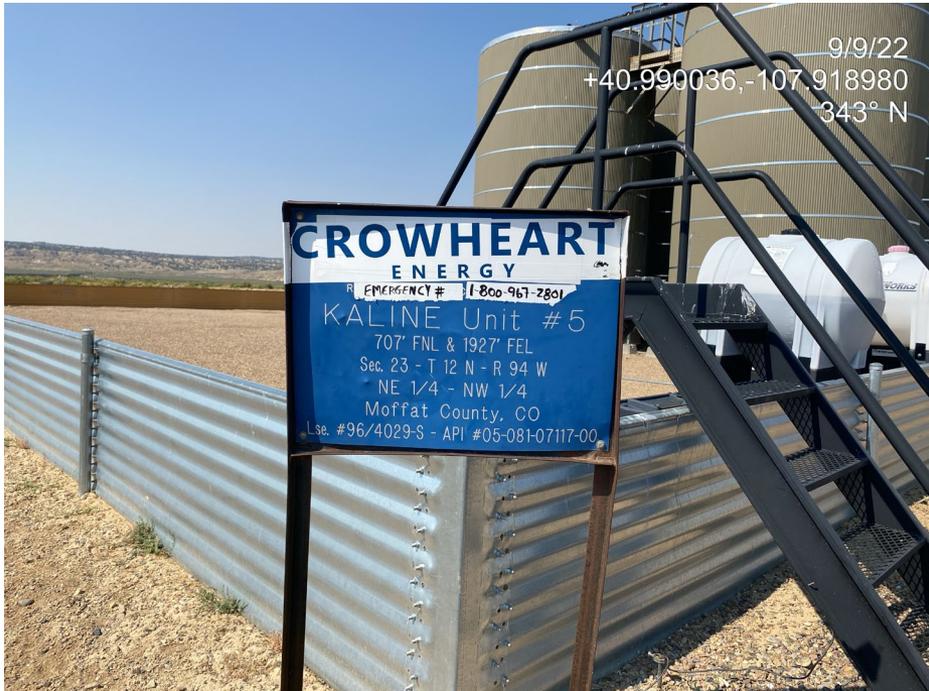
Photo 3. Photo shows the tank battery sign. Operator name has been updated. Emergency number on sign has been updated and is in service. Sign does not comply with Rule 605; Telephone number for local emergency services (911 where available) and the public road used to access the tank battery site are not posted.

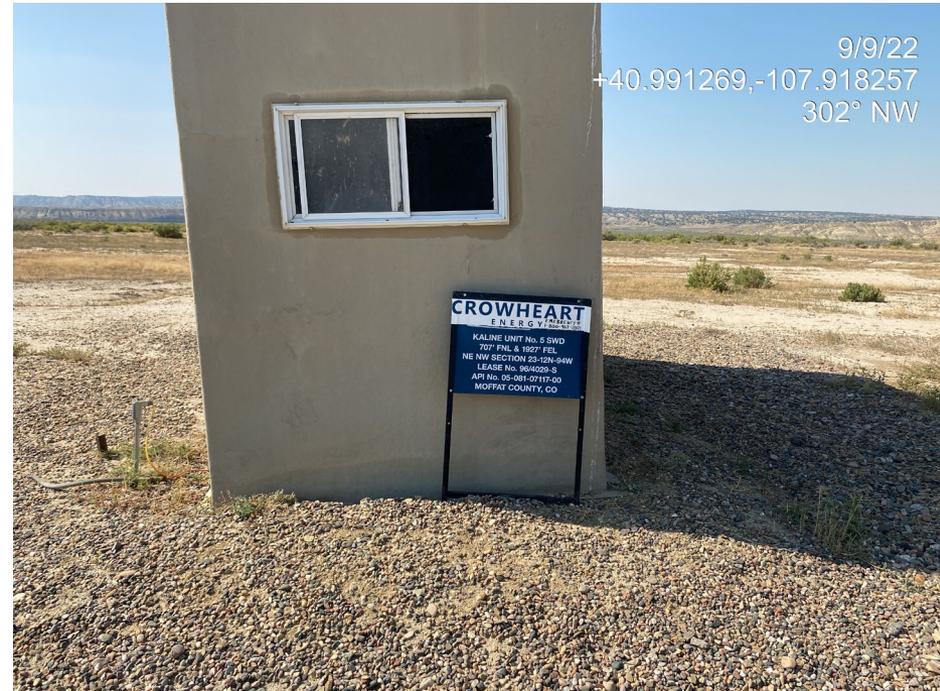
Photo 4. Photo shows the well sign. Operator name has been updated. Emergency number on sign has been updated and is in service.

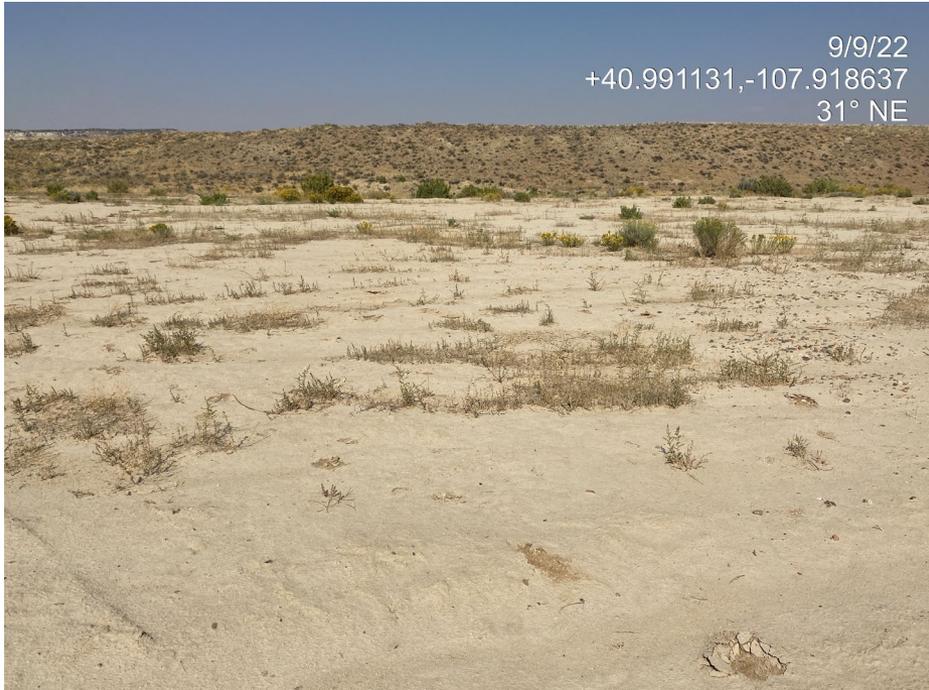
Photo 5. Photo taken from the center of the Location shows an overview of the interim area. Bare ground dominates. The shorter plants which dominate the photo are kochia (annual undesirable plant species). The taller green and yellow plants are rabbitbrush (native shrubs) which are scattered.

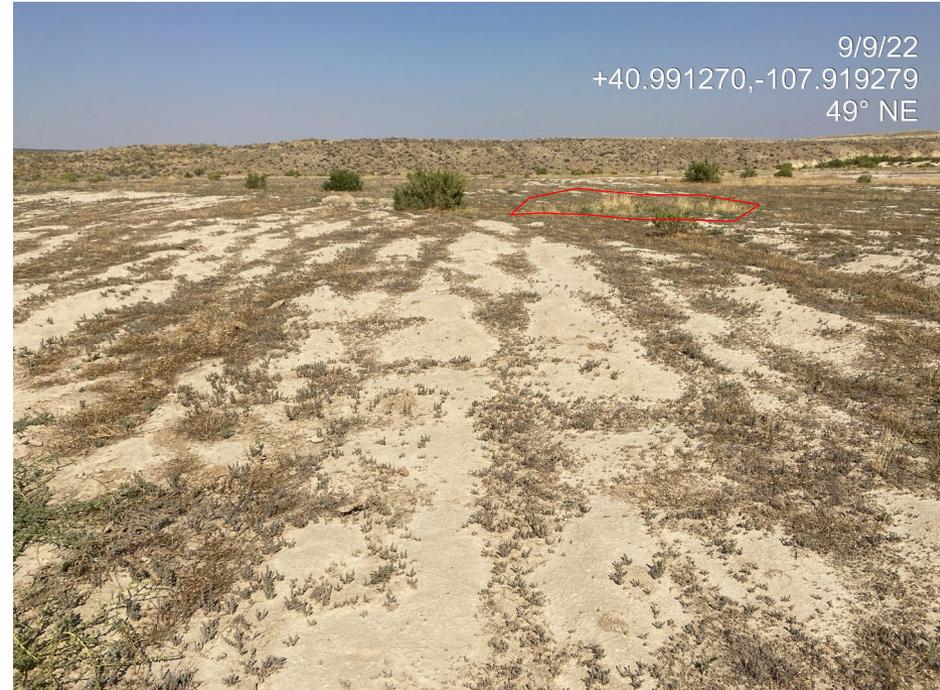
Photo 6. Photo taken from the west of the Location shows an overview of the interim area. The red polygon indicates a patch of western wheatgrass (native, perennial grass) which appears to have been seeded but is rarely present. The plant throughout the photo is kochia.

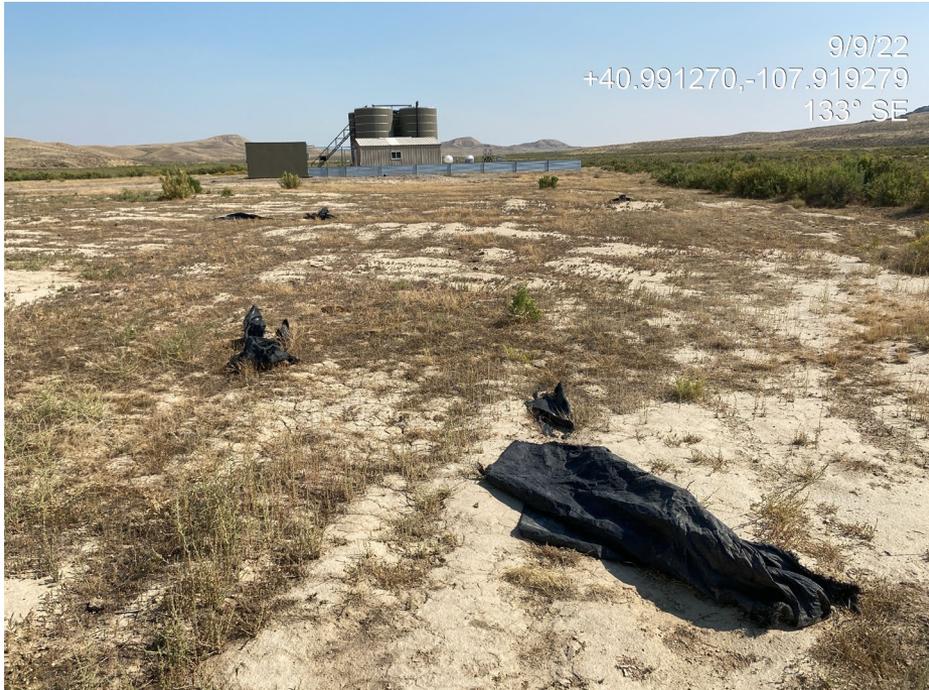
Photo 7. Photo taken from the west of the Location shows interim area vegetation. Photo also shows trash/debris.

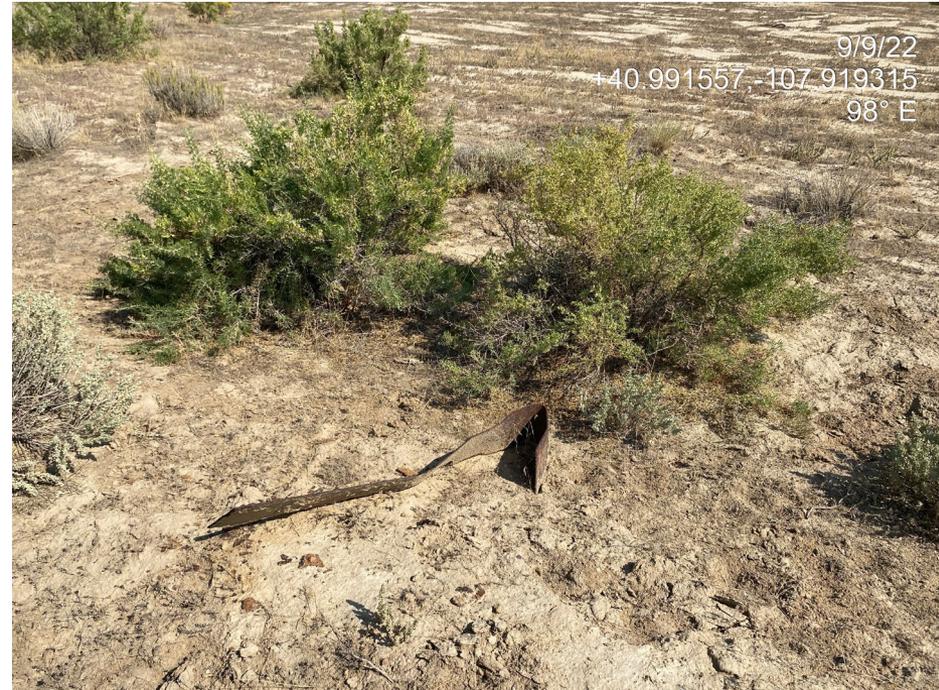
Photo 8. Refer to Photo 7 comment.
