Inspection Photos and Issue Report

Operator: CHEVRON USA INC - 16700

Location #314707

Rio Blanco County, CO

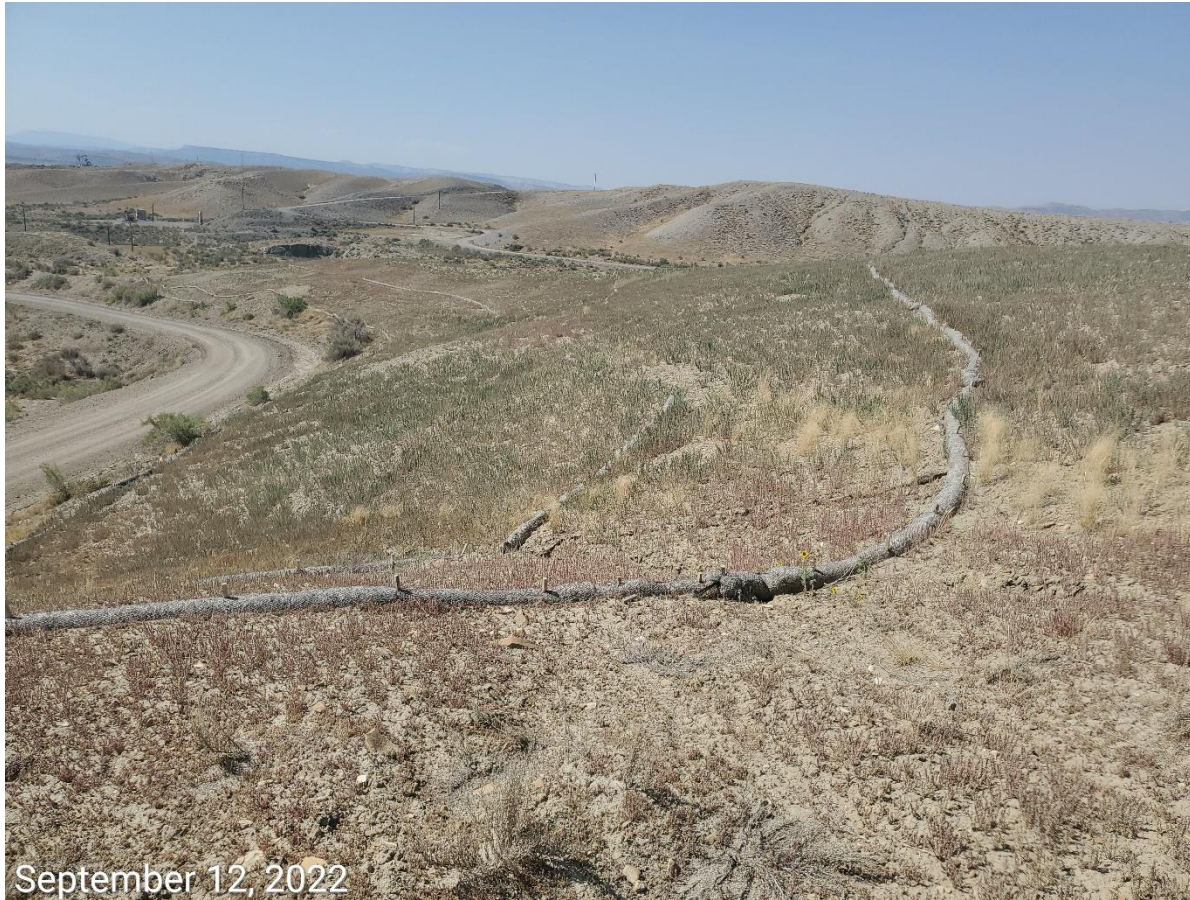
Photo 1: Photo an overview of the Location. Photo shows vegetation is predominantly a Noxious Weed (Halogeton) monoculture; desirable perennial vegetative germination/establishment not observed.

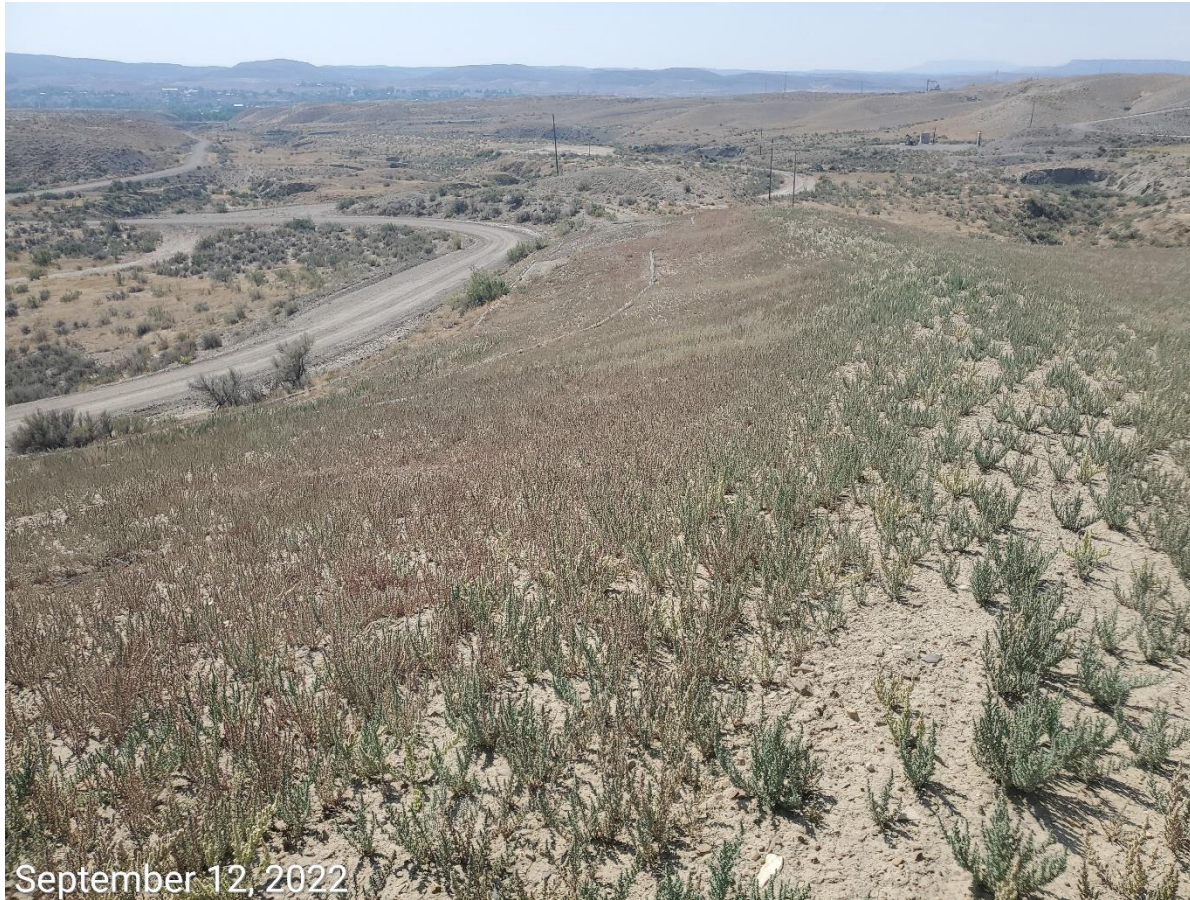
Photo 2: Photo an overview of the Location. Photo shows vegetation is predominantly a Noxious Weed (Halogeton) monoculture; desirable perennial vegetative germination/establishment not observed.

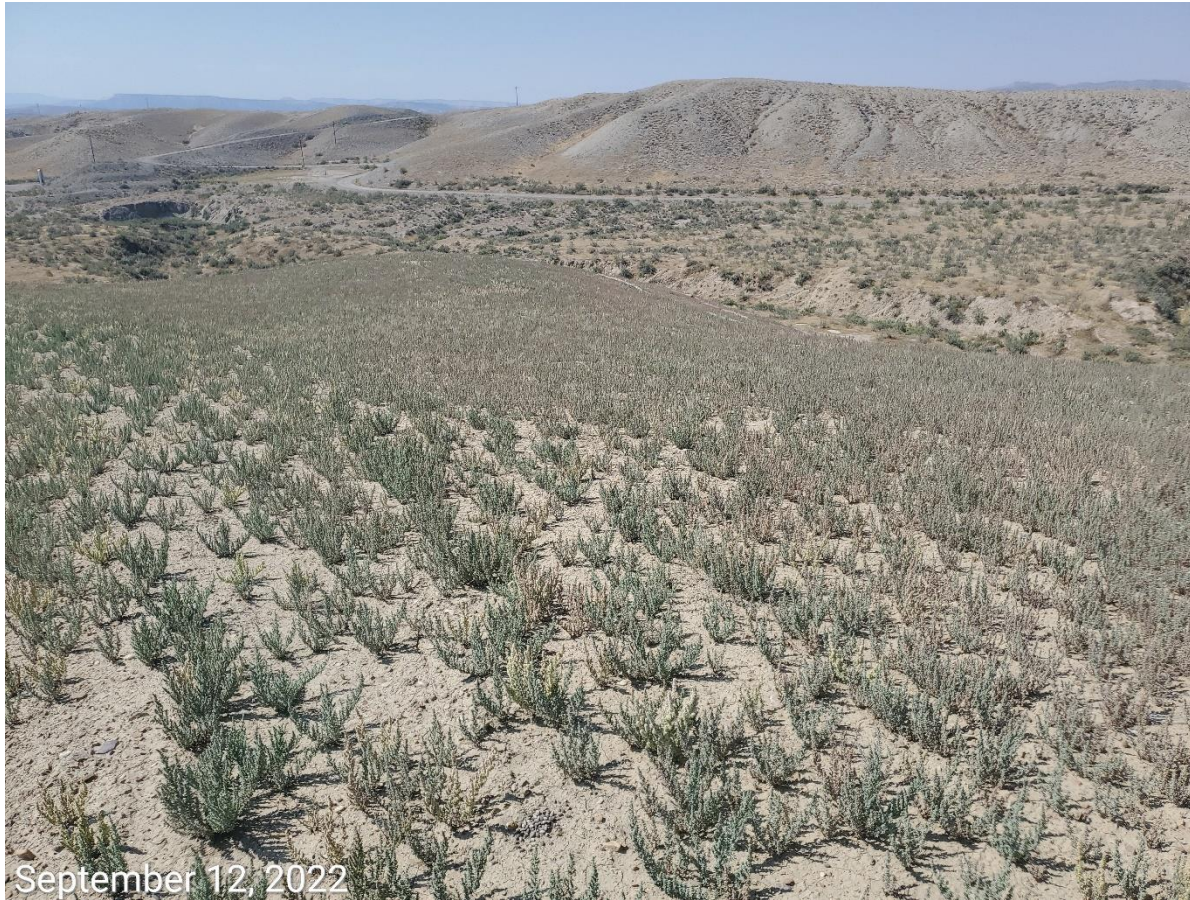
Photo 3: Photo an overview of the Location. Photo shows vegetation is predominantly a Noxious Weed (Halogeton) monoculture; desirable perennial vegetative germination/establishment not observed.

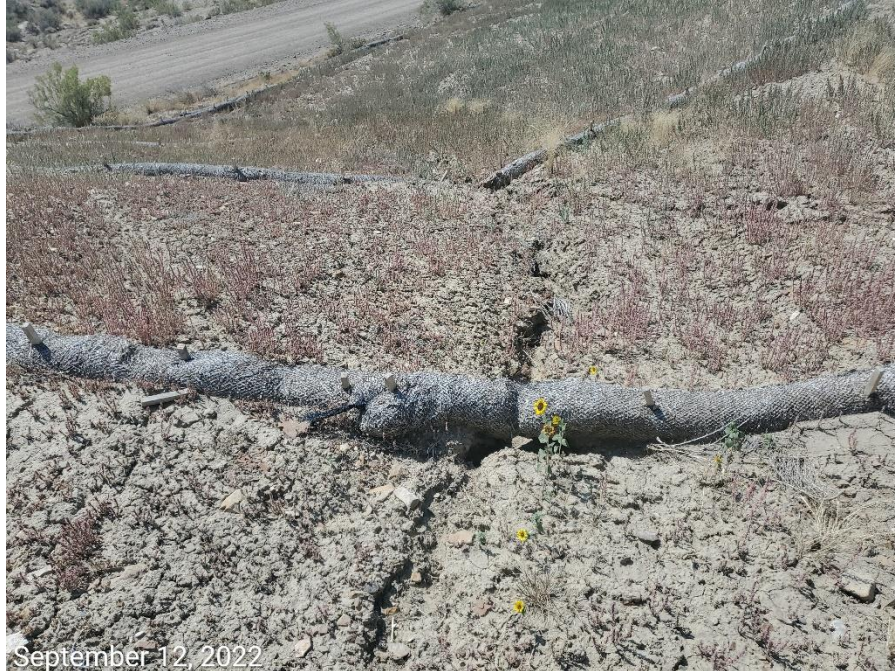
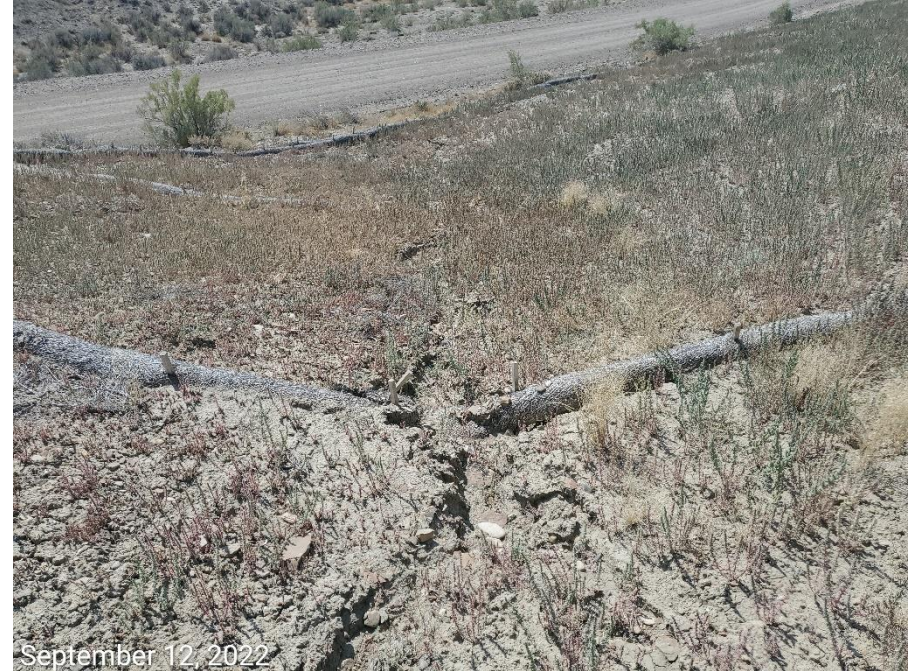
Photo 4: Photos 4-5 are examples showing BMPs to manage stormwater runoff in a manner that minimizes erosion, degradation and sediment transport are missing or insufficient; erosion degradation evident throughout slopes of the Location; erosion logs (straw wattles) have not been maintained in proper functioning condition, and appear insufficient alone in order to stabilize the soils.

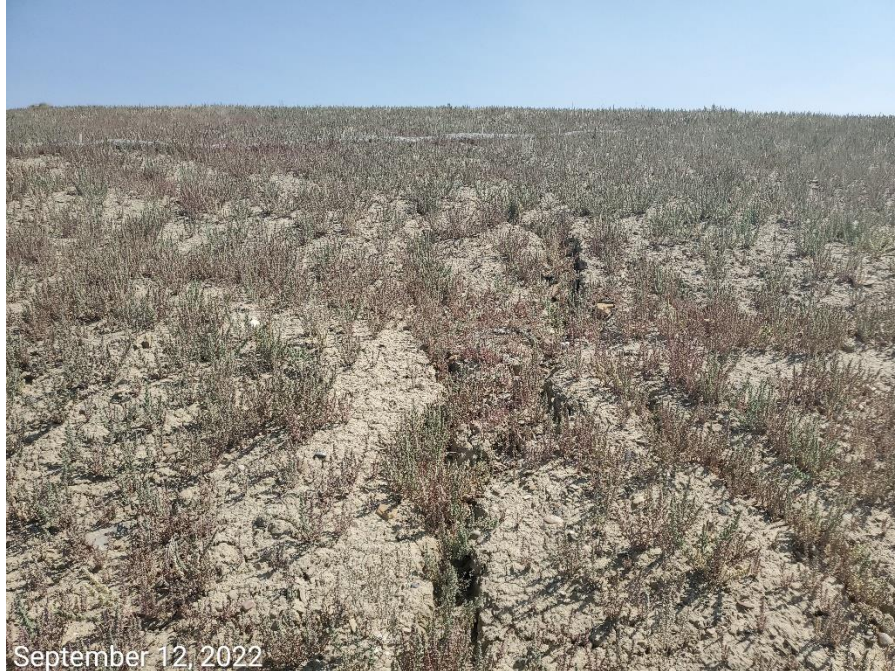
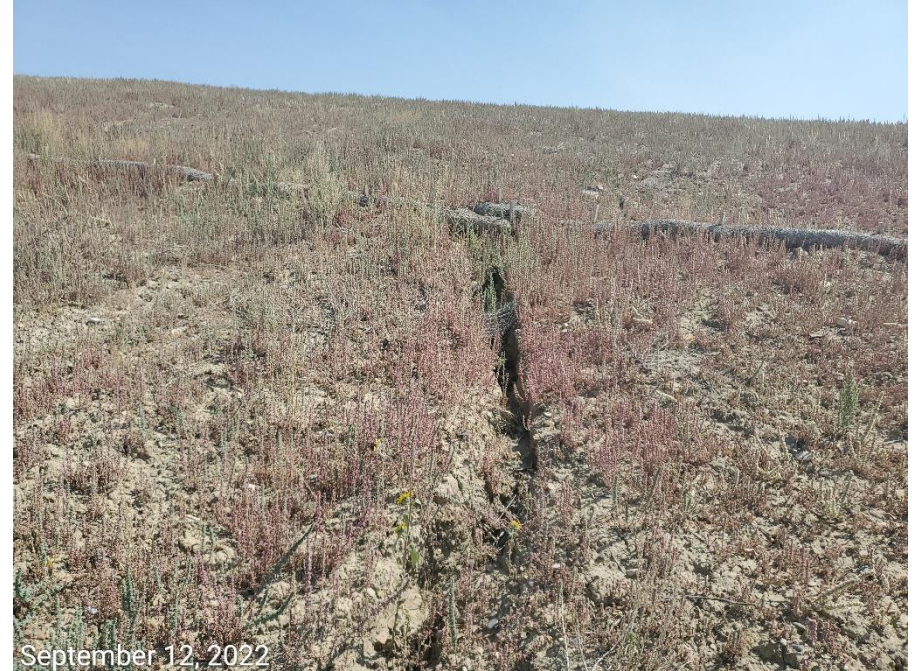
Photo 5: See comments under photo 4.
