Inspection Photos and Issue Report

Operator: CHEVRON USA INC - 16700

Location #314661

Rio Blanco County, CO

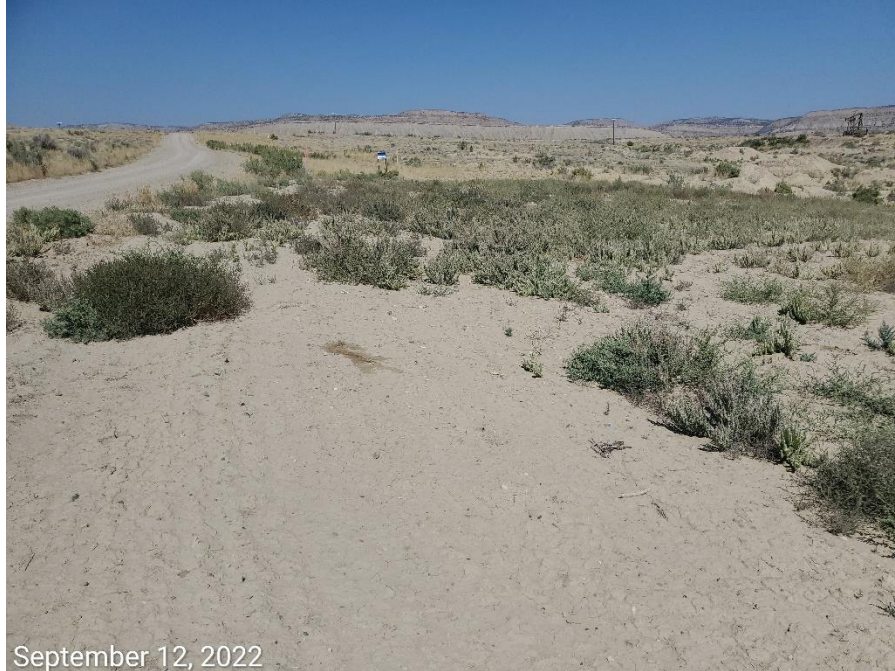
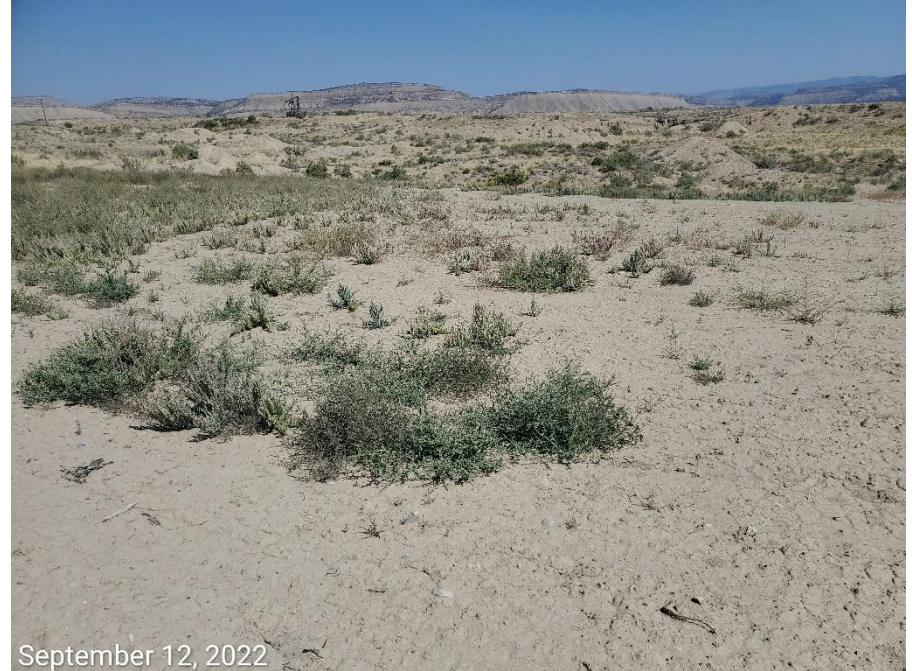
Photo 1: Photos 1-2 taken from the west end of the Location. Photos provide an overview of the Location from north, northeast southeast to south.

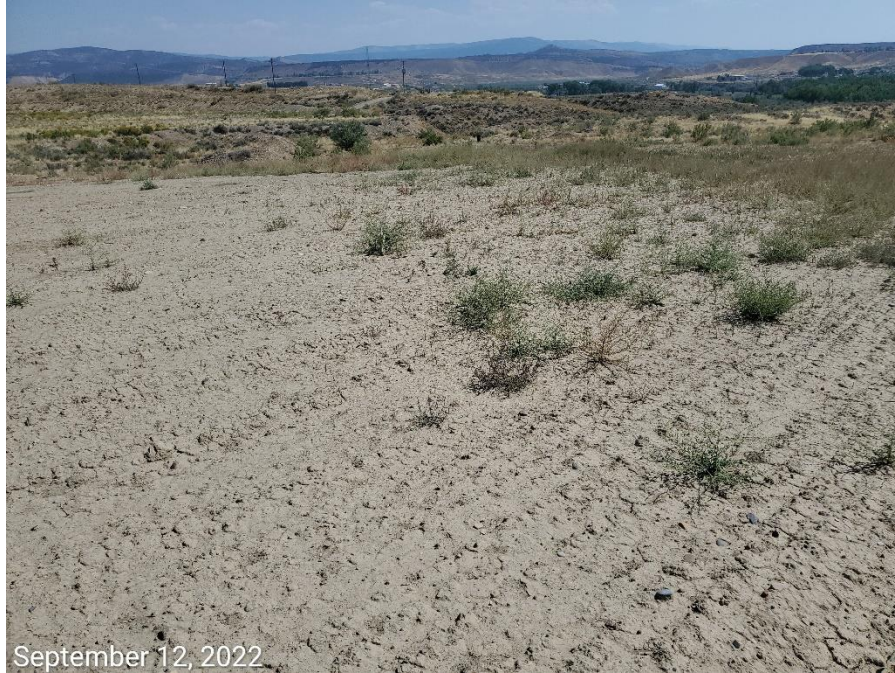
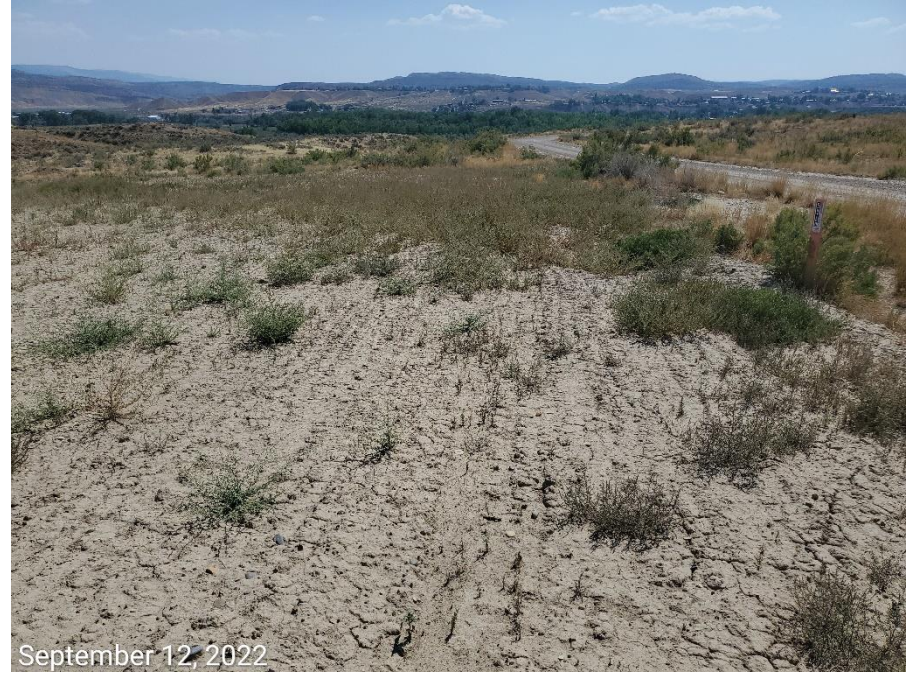
Photo 2: See comments under photo 1.

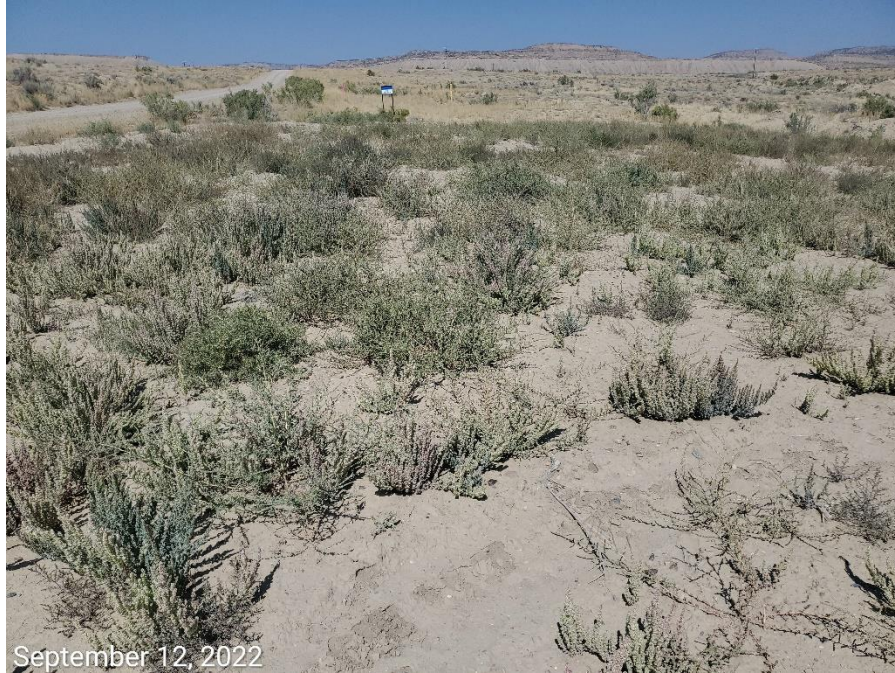
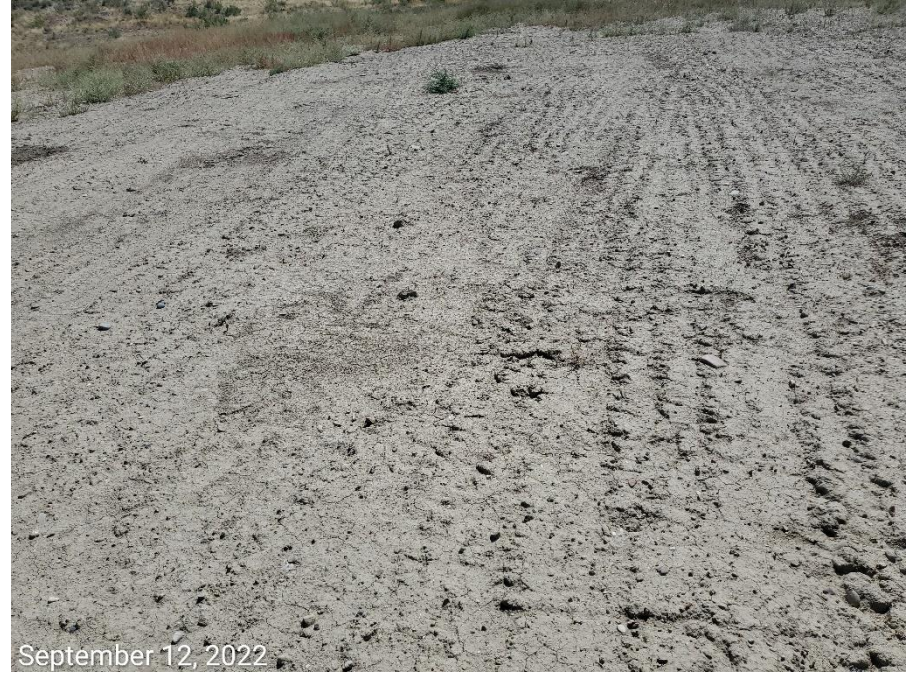
Photo 3: Photos examples showing Location is either vegetated predominantly by Undesirable and Noxious Plant species, or is bare soil; desirable perennial plant germination/establishment not observed.

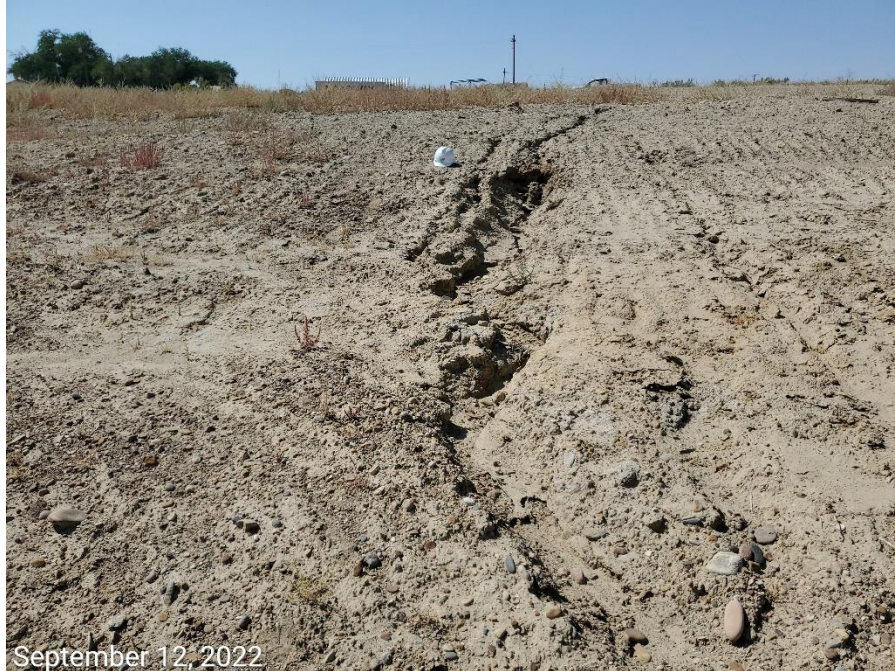
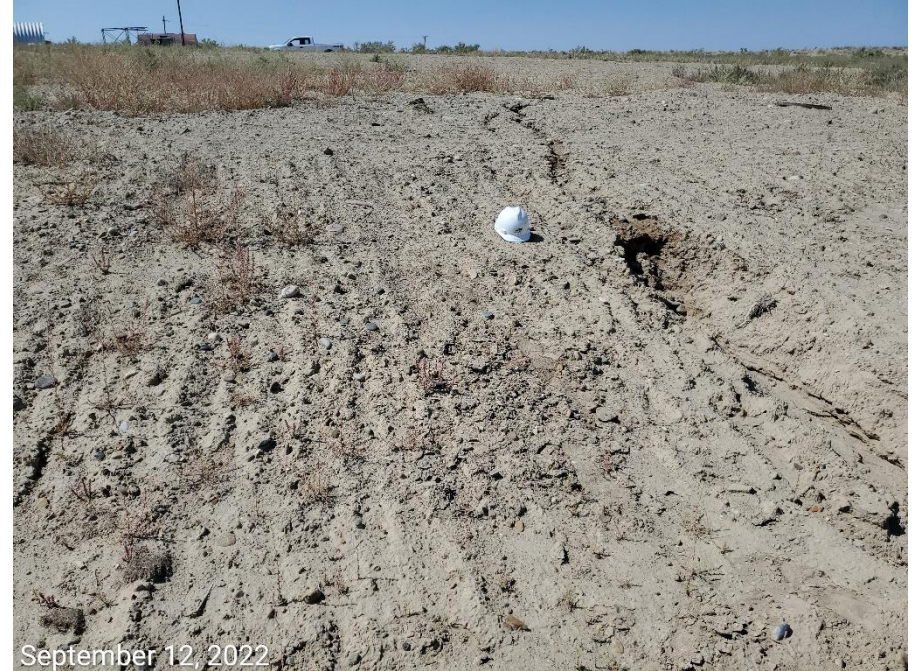
Photo 4: Photos 4-5 examples showing erosion degradation observed on the Location. BMPs to minimize erosion, degradation are missing or insufficient. Operator appears to have either seeded or tracked parallel to the slope, rather than up and down hill, resulting in vertical grooves and ridges which facilitated rilling and gully erosion. Hard hat used for reference.

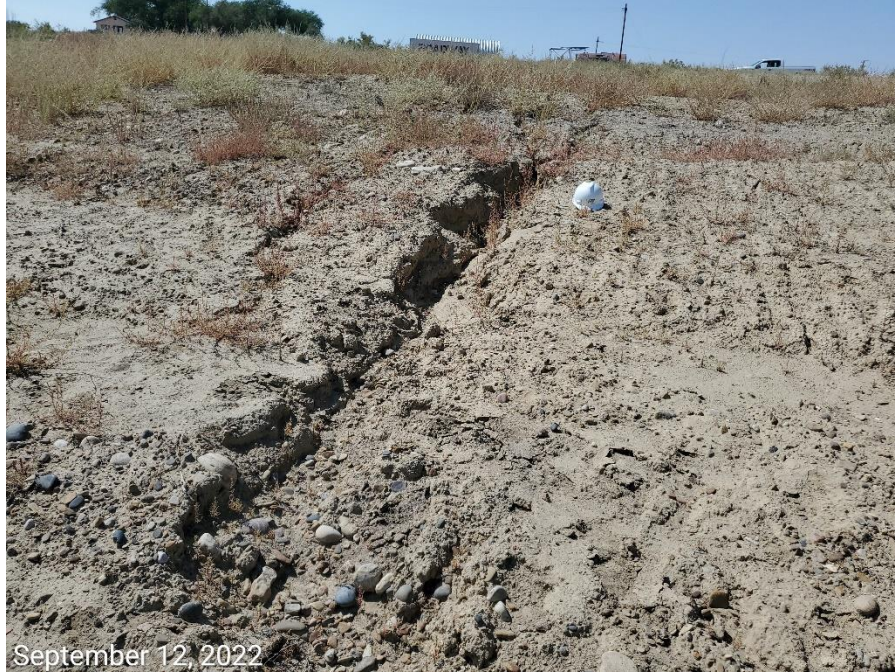
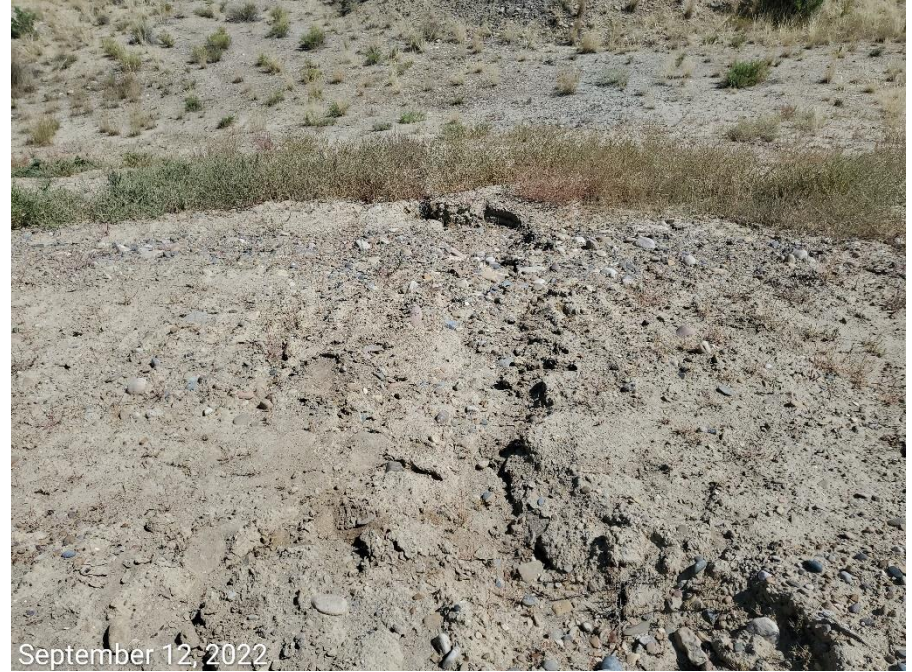
Photo 5: See comments under photo 4
