Inspection Photos

API: 071-07766

Operator: EVERGREEN NATURAL RESOURCES

Inspection Date: 9/16/2022

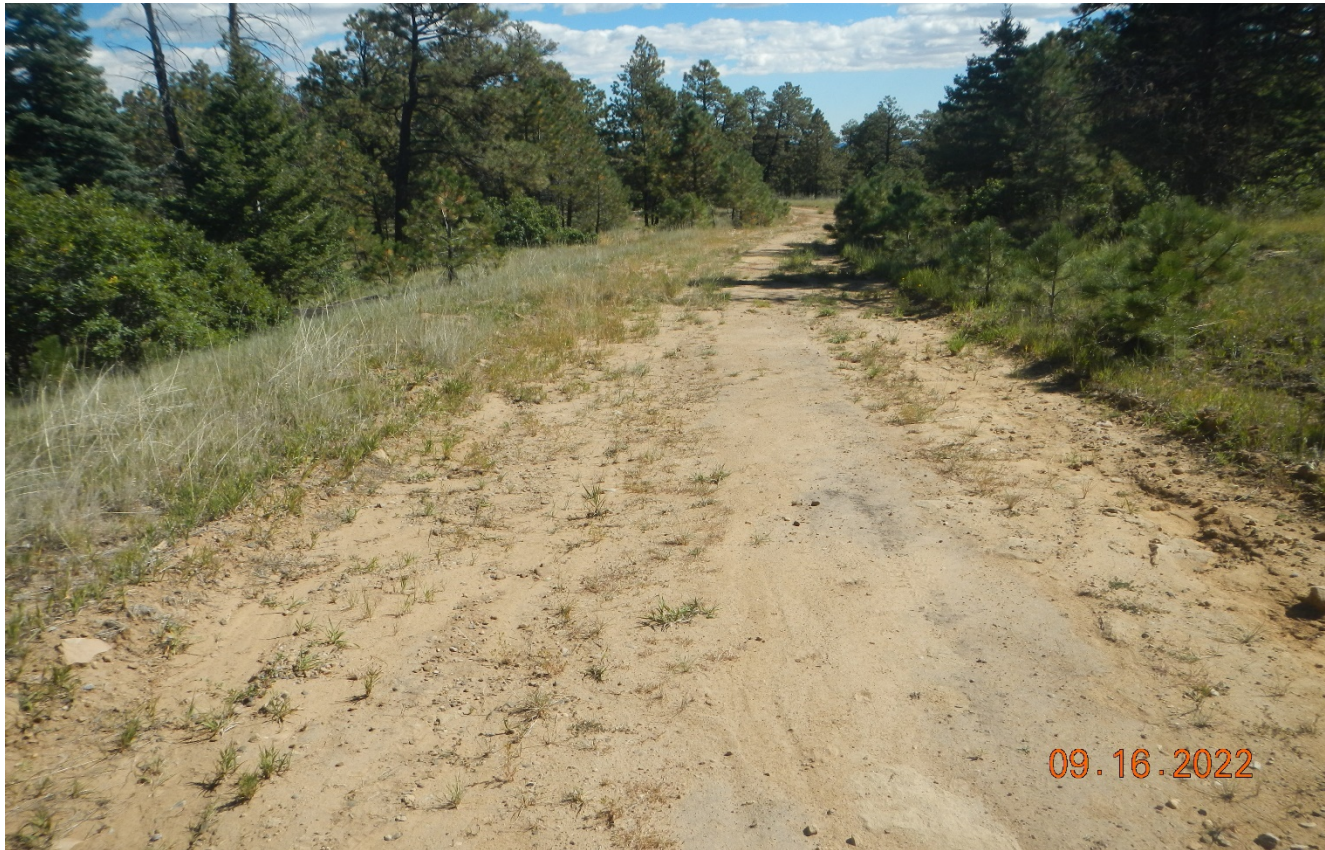
Photo 1. Facing northeast along the access road.

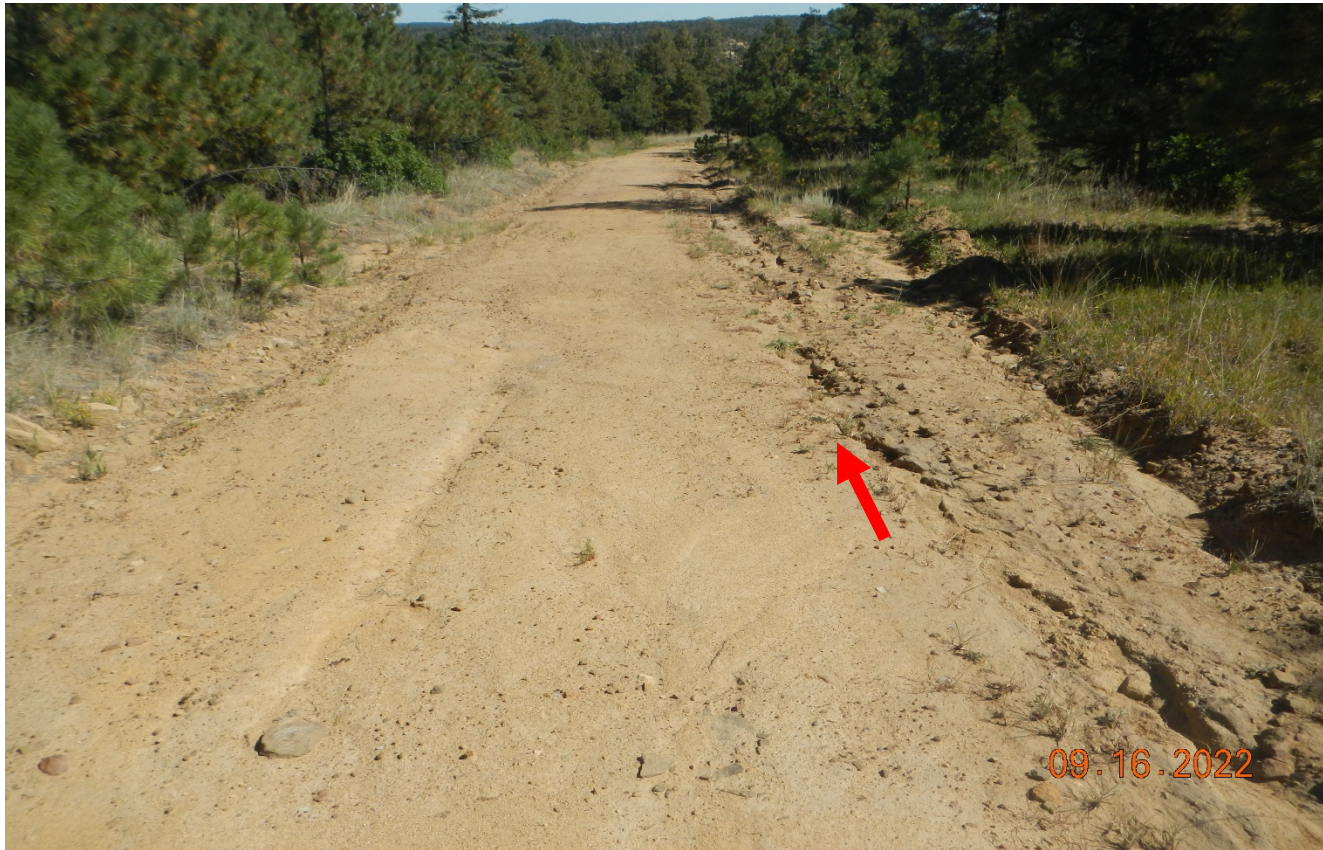
Photo 2. This area of the road needs additional work due to signs of stormwater flowing past the diversion ditch on the right which is beginning to create erosion down the road.

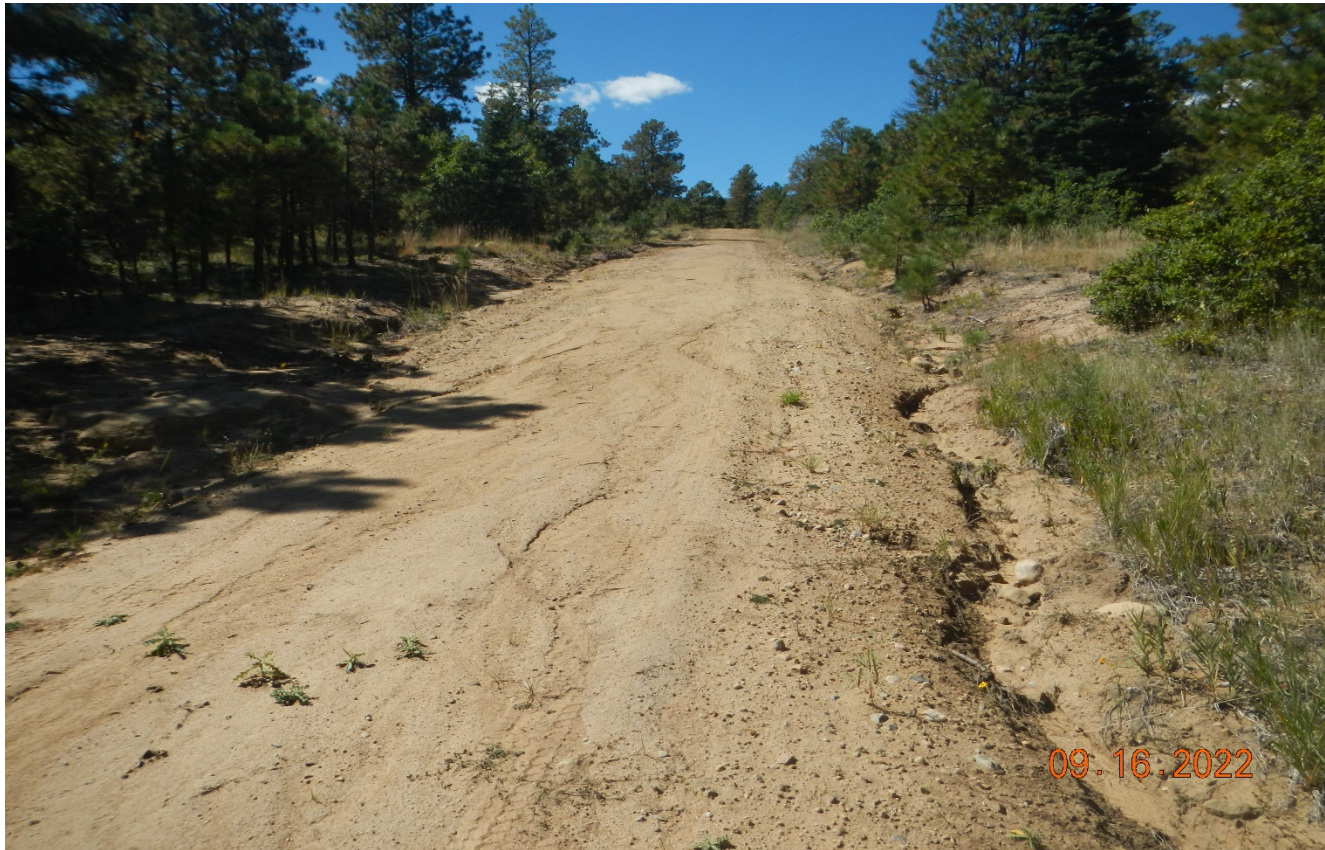
Photo 3. Facing back to the south west. There is erosion beginning to occur along the roadsides and additional BMP's are needed in this area.

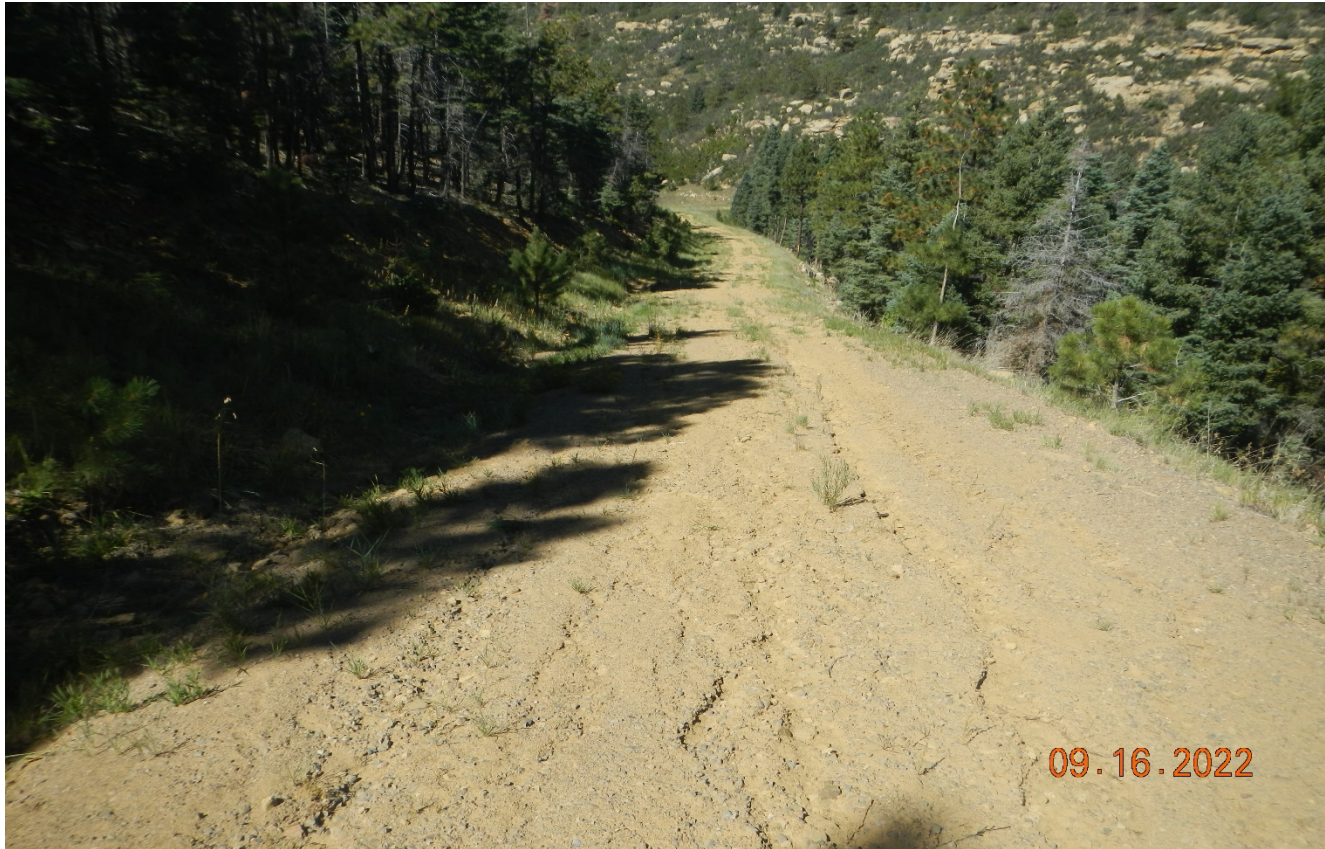
Photo 4. Facing northwest toward road turns down the hill side into the canyon. There is some initial signs of erosion down the road which may require additional BMP's such as a water bar.

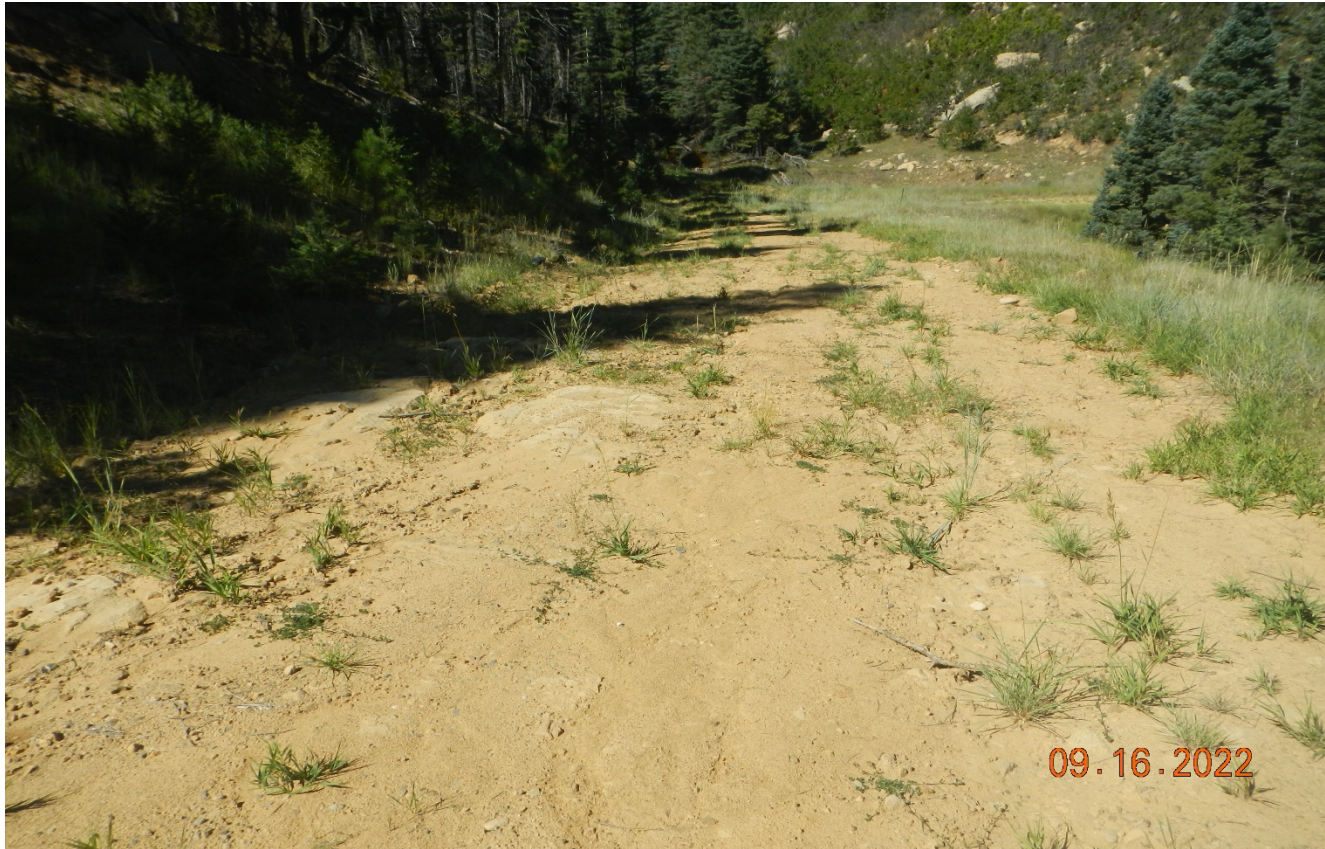
Photo 5. The road was graded down to the canyon bottom and erosion was repaired. This area has a long stretch without culverts and may require additional stabilization or vegetation establishment. This area was previously observed to be eroded.

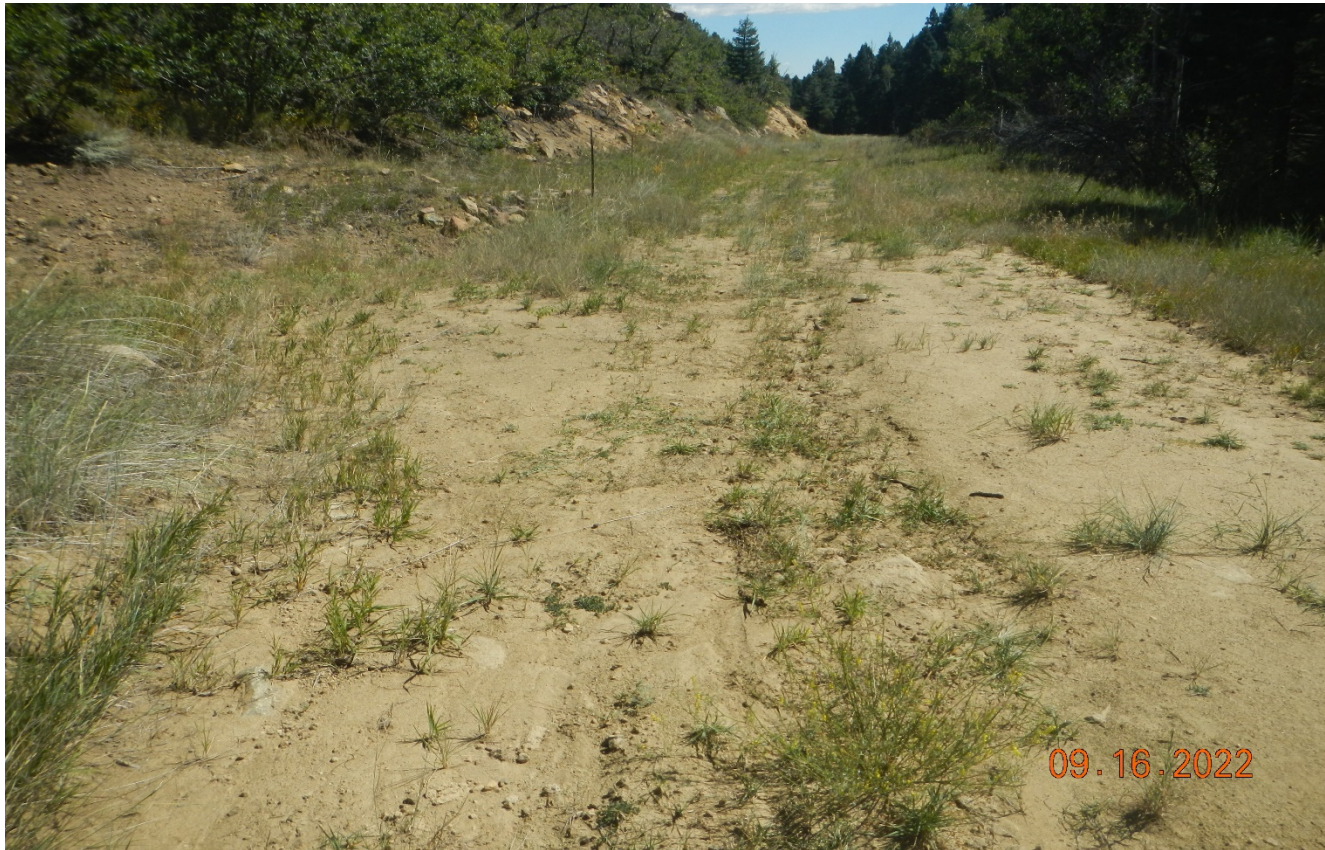
Photo 6. Facing east along the access road. This area may need some hand work to get stormwater better directed toward the culvert.

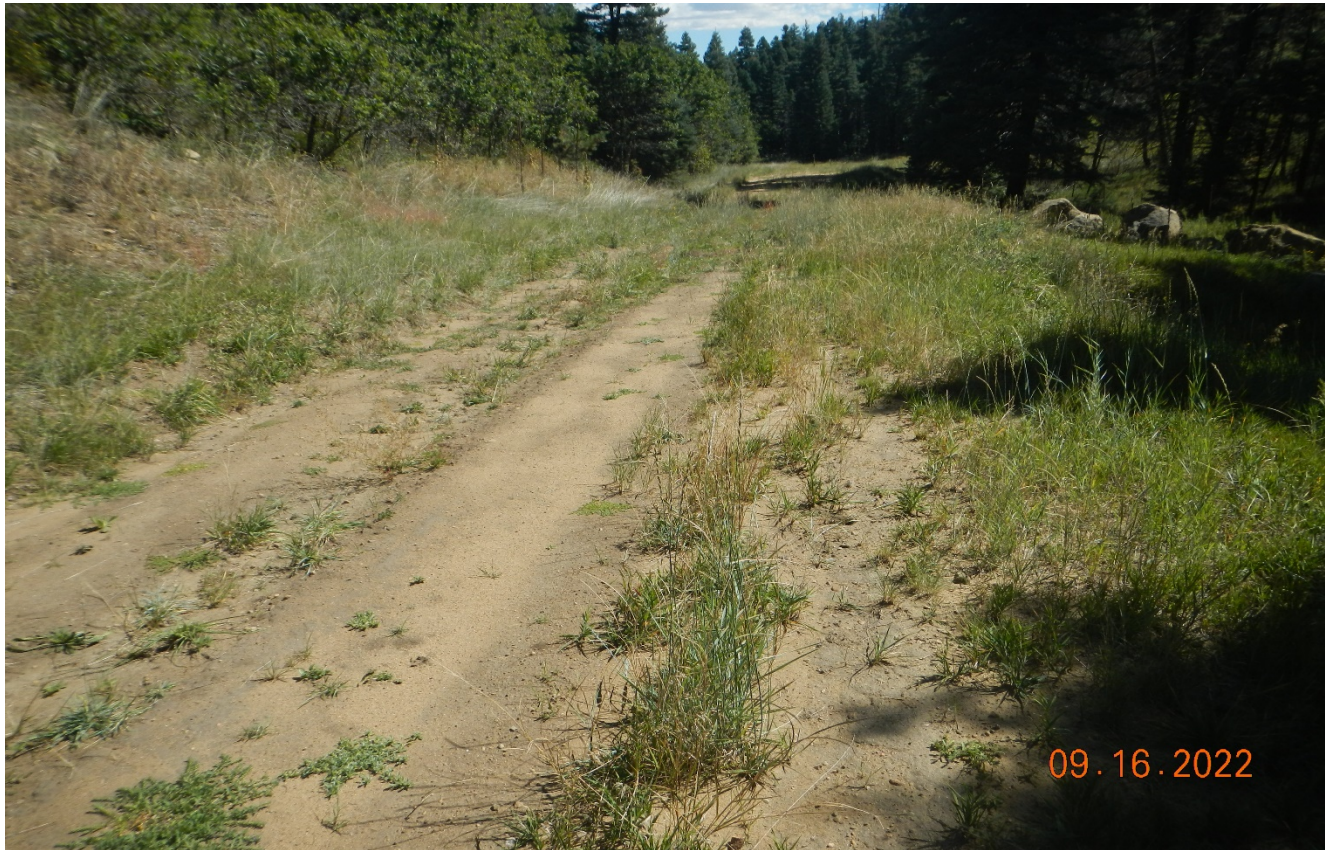
Photo 7. Facing east along the access road.

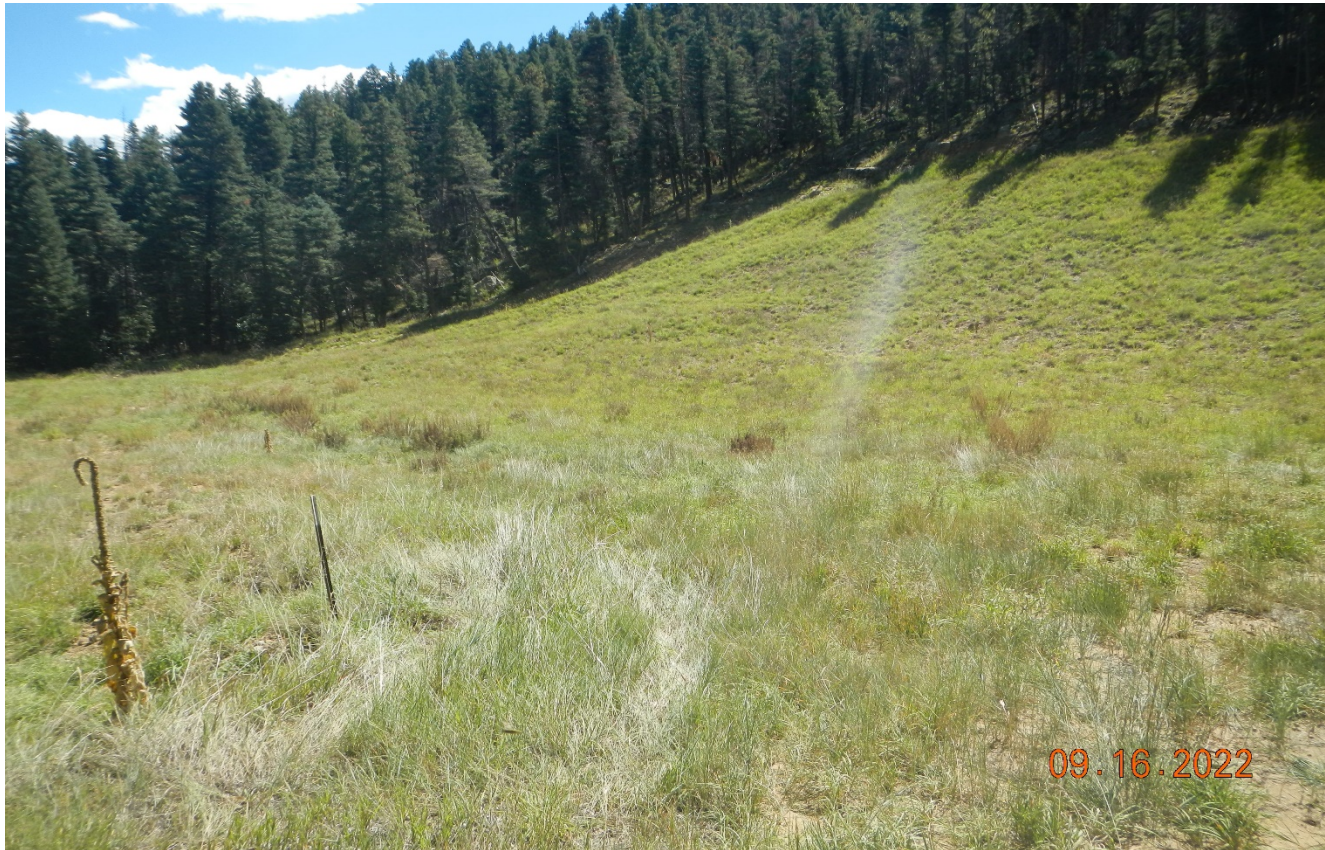
Photo 8. Facing southwest toward the location. The location is recontoured and reclaimed.
