Inspection Photos

API: 071-09178

Operator: EVERGREEN NATURAL RESOURCES

Inspection Date: 9/16/2022

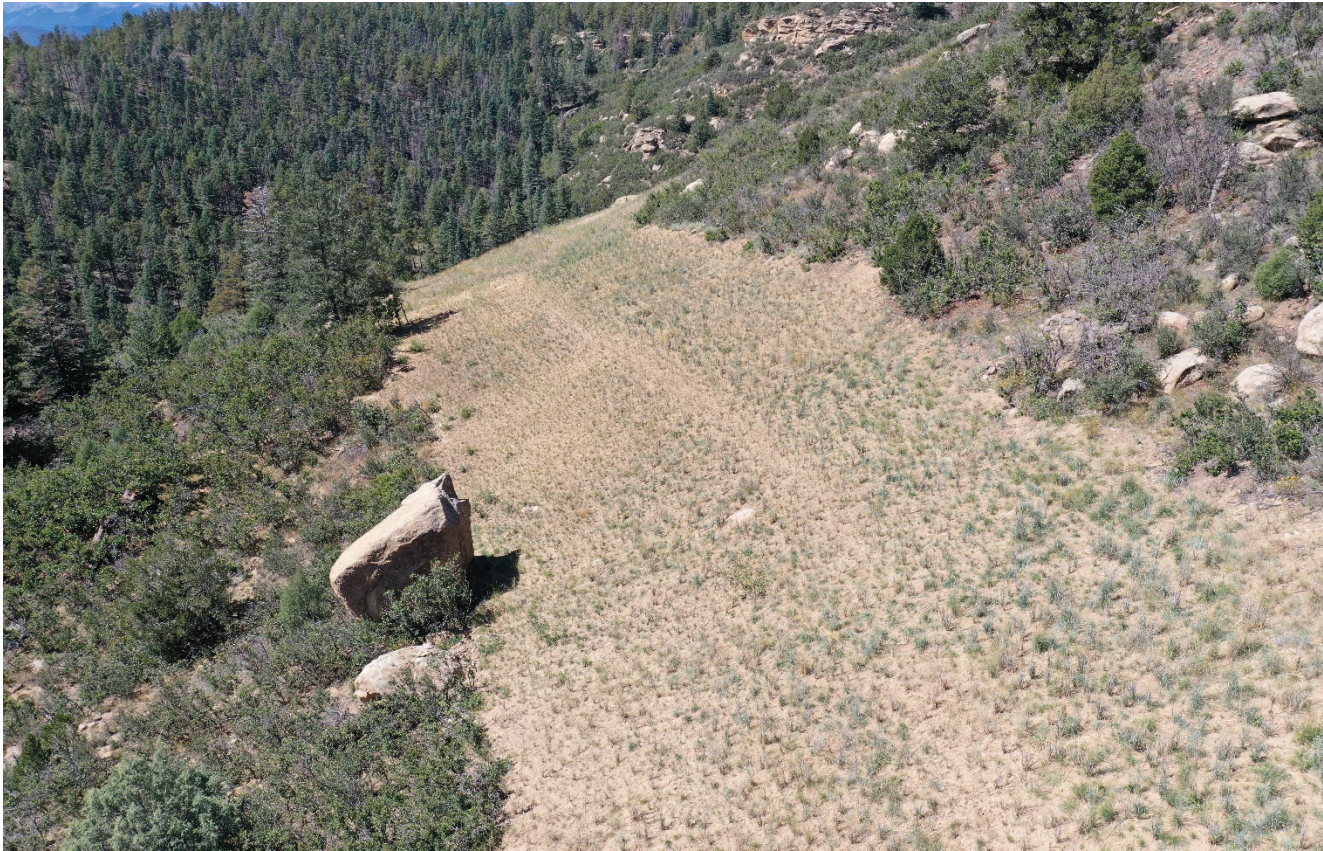
Photo 1. Drone aerial photo facing west toward the reclaimed access road.

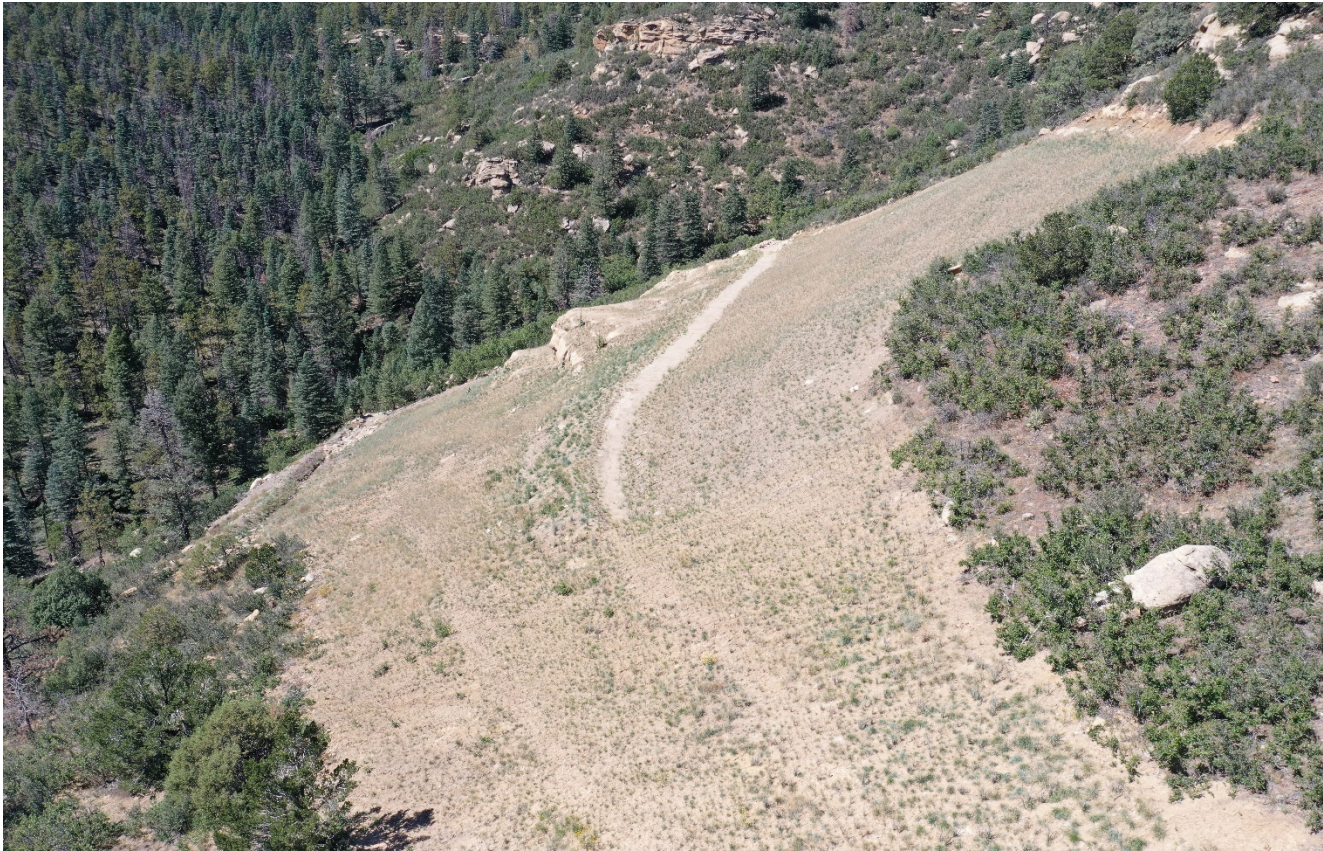
Photo 2. Drone aerial photo facing northwest toward the reclaimed location.

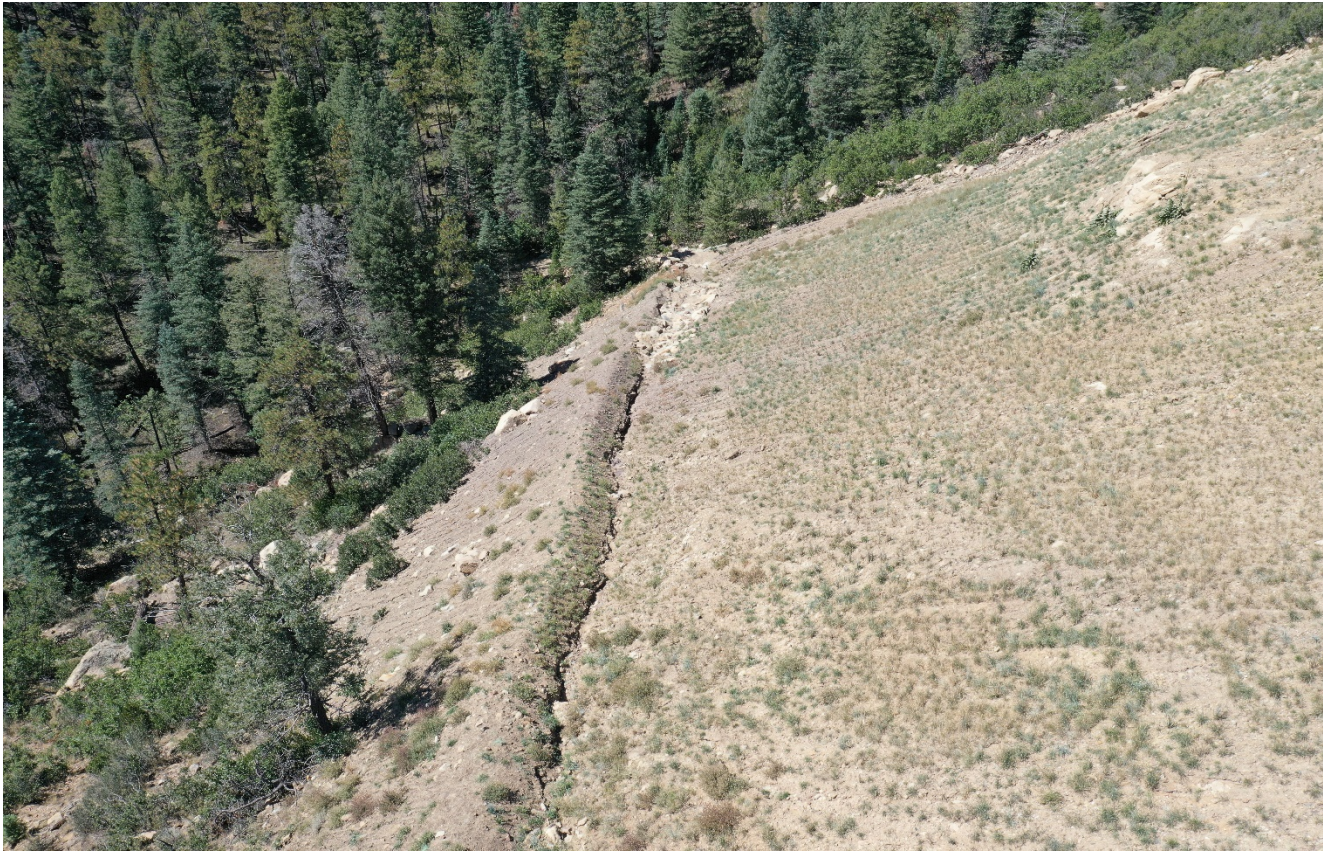
Photo 3. Facing west down at the location. A large berm was installed at the bottom of the location. There appears to be deep erosion into the berm where rock was not installed. BMP's such as rock check dams may be need to prevent accelerated erosion.

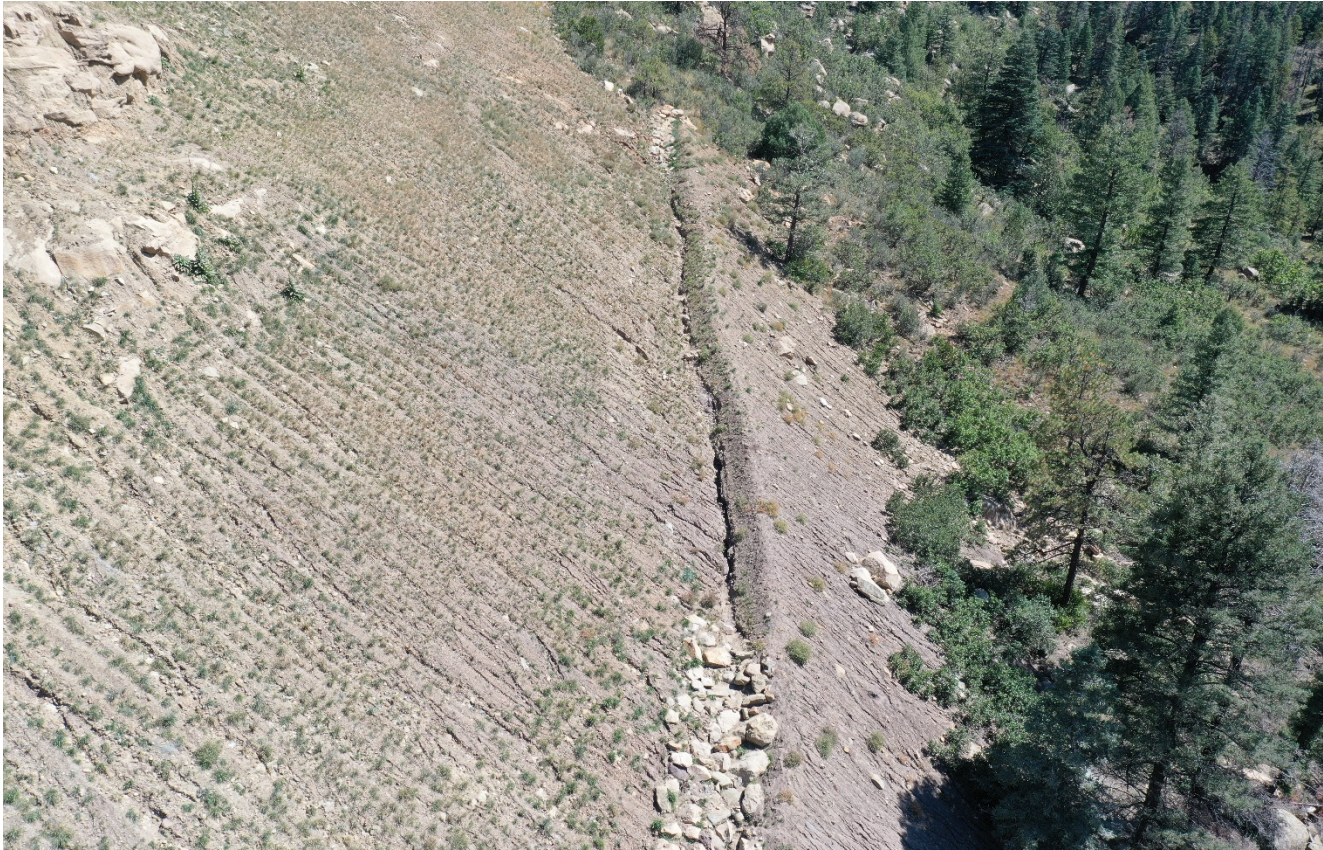
Photo 4. Facing east down at the location. A large berm was installed at the bottom of the location. The area to the right of the berm does not appear to have vegetation establish and may need to be hand seeded this fall.

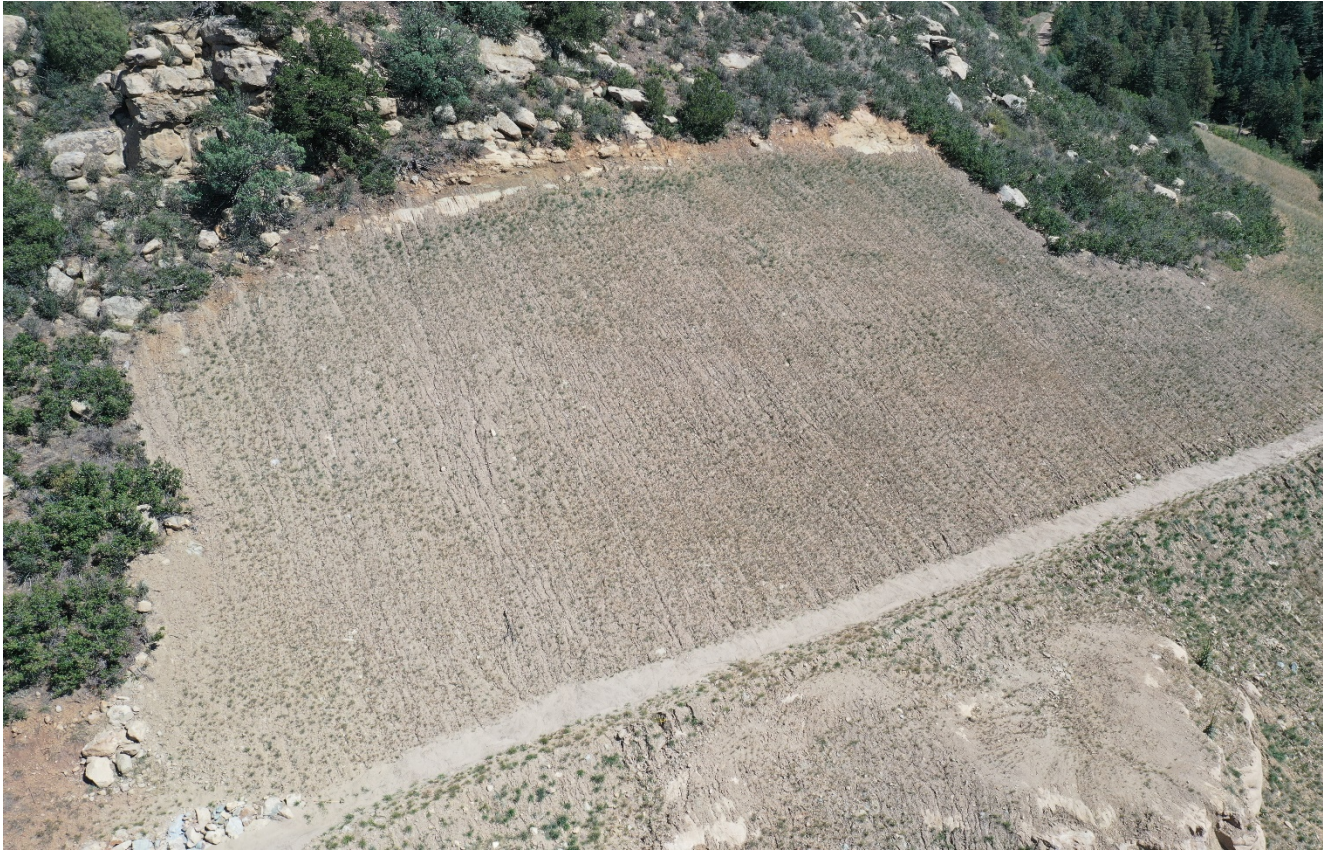
Photo 5. Facing toward the upper portion of the location. There is vegetation beginning to establish however additional BMP's may need to be installed.

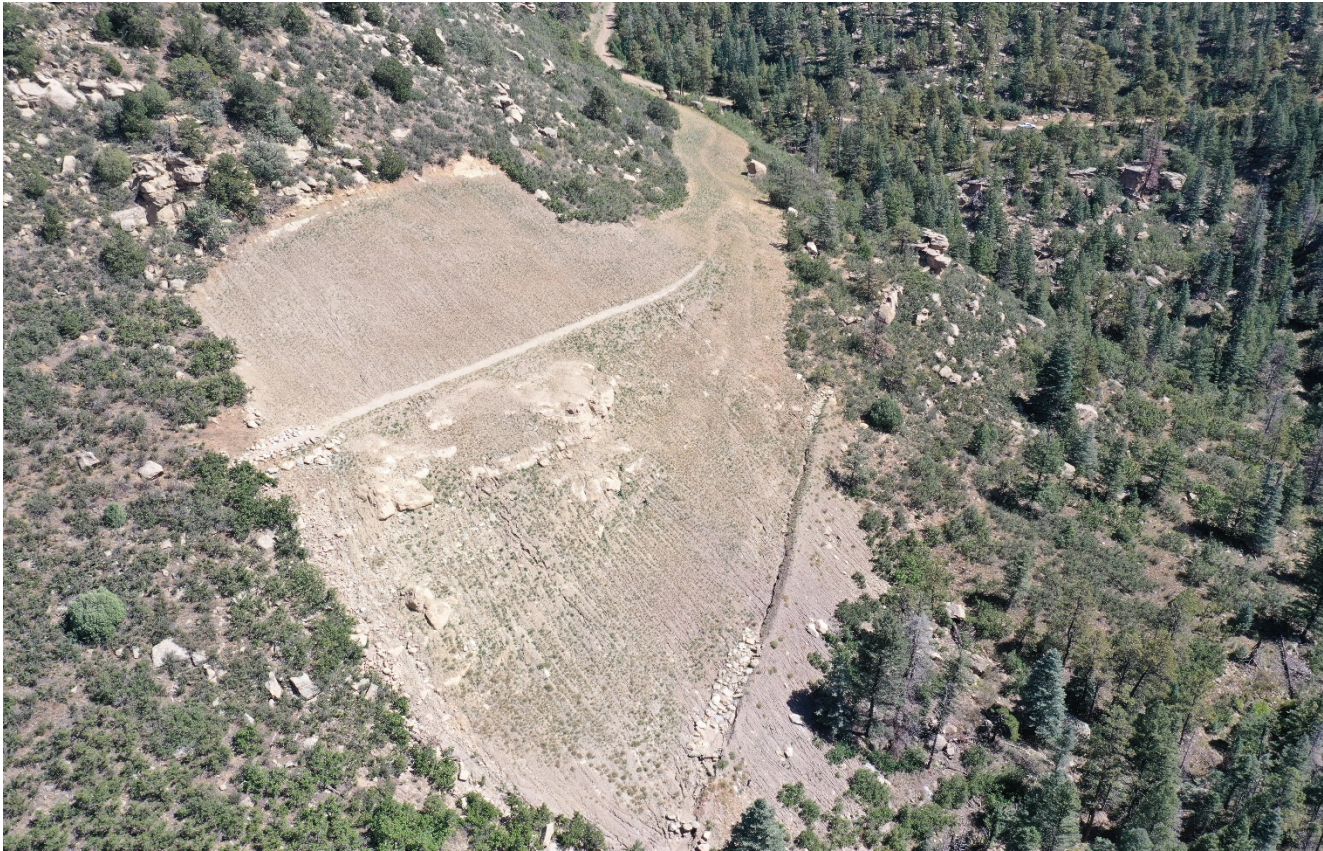
Photo 6. Facing northwest toward the recontoured location.
