Final Reclamation and Stormwater Inspection

Operator: PRIME OPERATING COMPANY - 72118

Location ID: 303303

Location Name: LANGENDOERFER #14-24

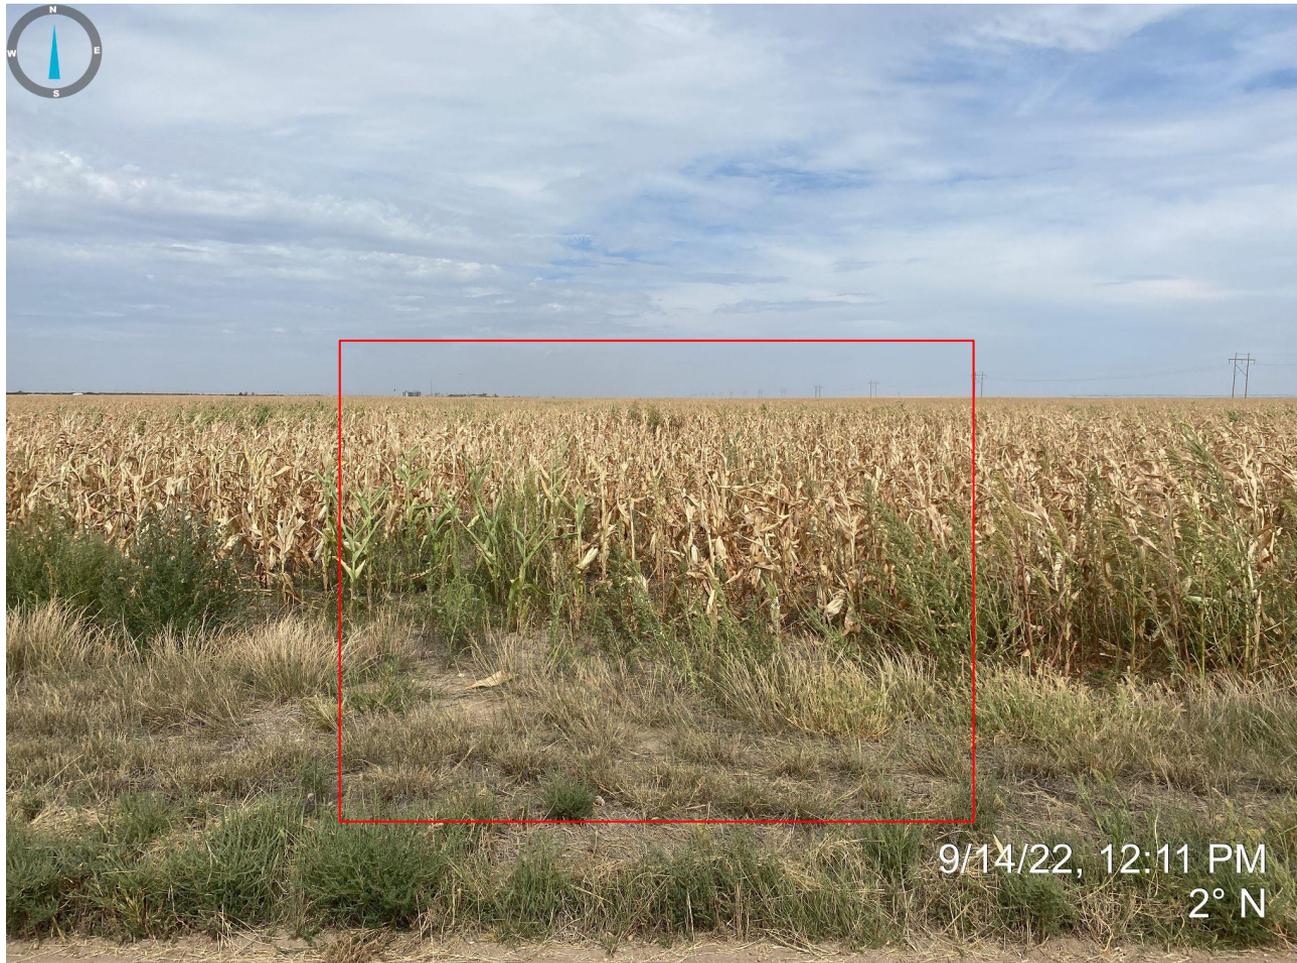
Photo 1. Taken from county road, facing north. Photo illustrates old access road entrance into field; it appears access road has been reclaimed with disturbance area reflective of reference area crop. Red outline is approximate location of entrance.

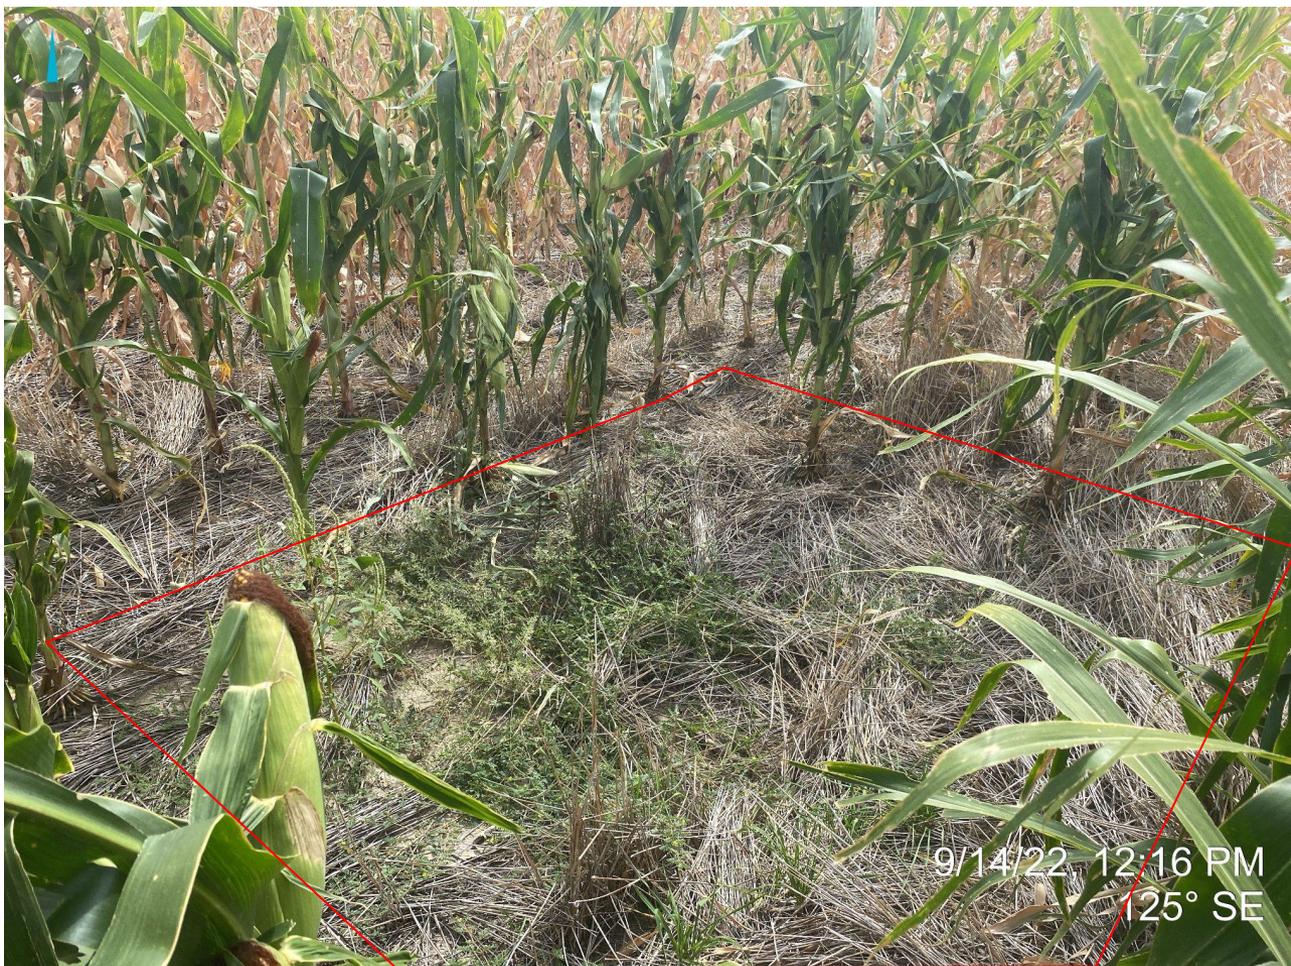
Photo 2. Taken from center portion of location, facing southeast; close up. Photo illustrates an area approximately 10' x 10' in size that is subsided, void of uniform vegetation cover, and not reflective of reference area crop.

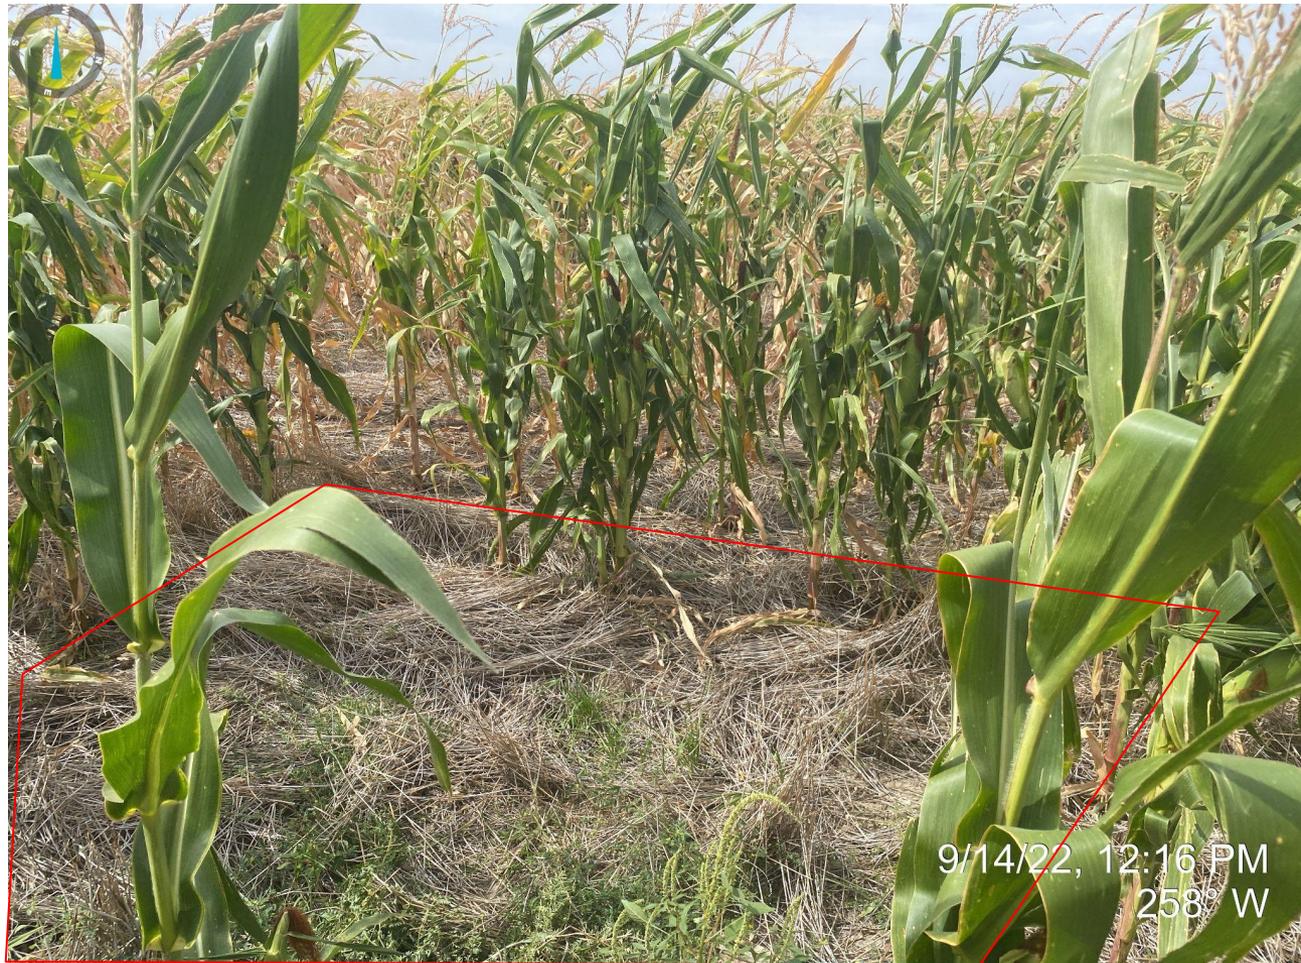
Photo 3. Facing west, see comments in photo 2.

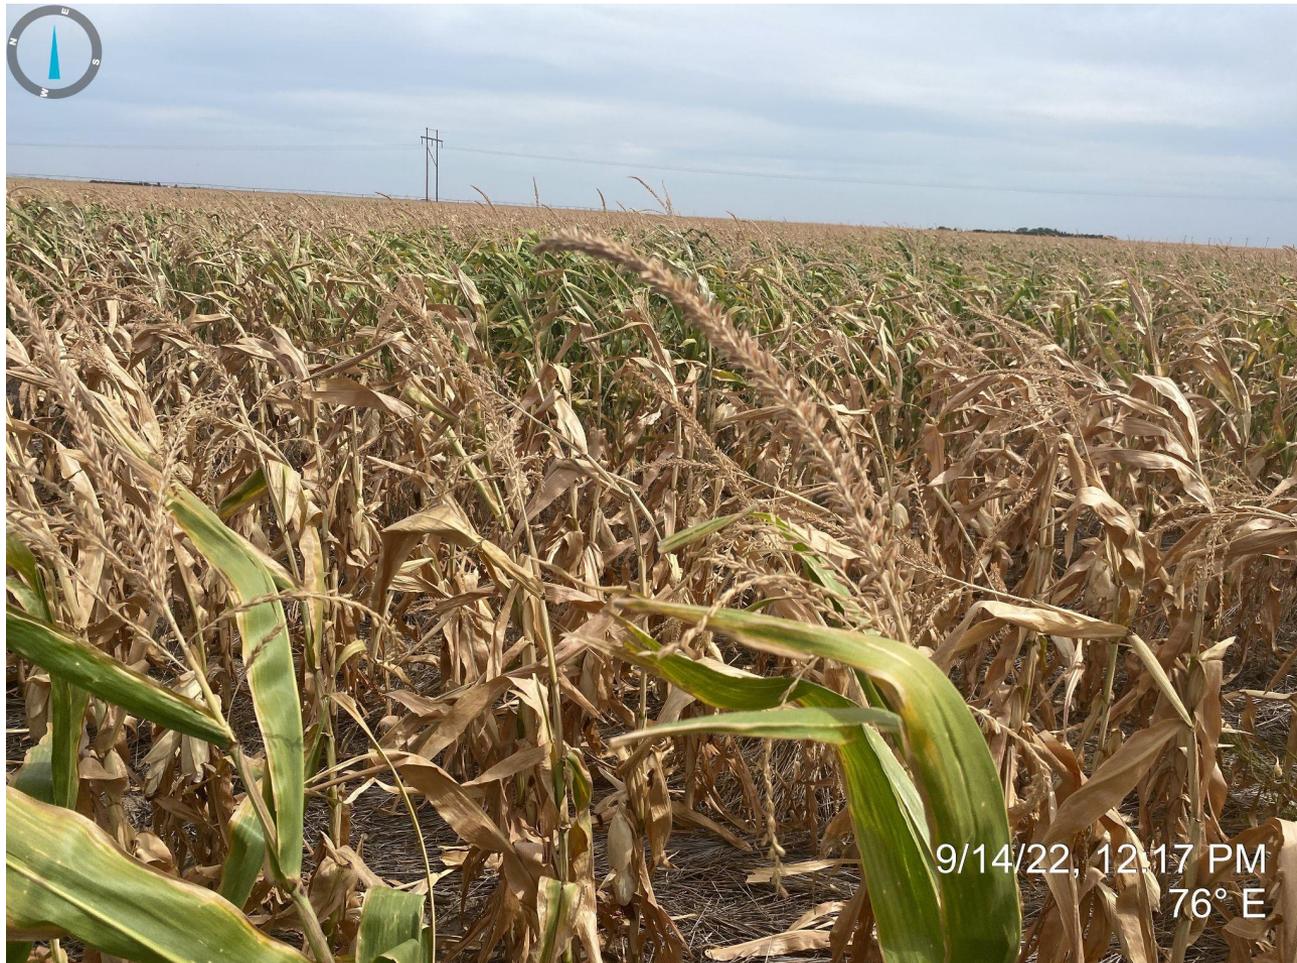
Photo 4. Reference area photo taken east of location, facing east.
