Inspection Photos

Operator: KP Kauffman Company Inc - #46290

Location Name: McCallum Unit-69N79W /3SENE

Inspection Document #: 702800701

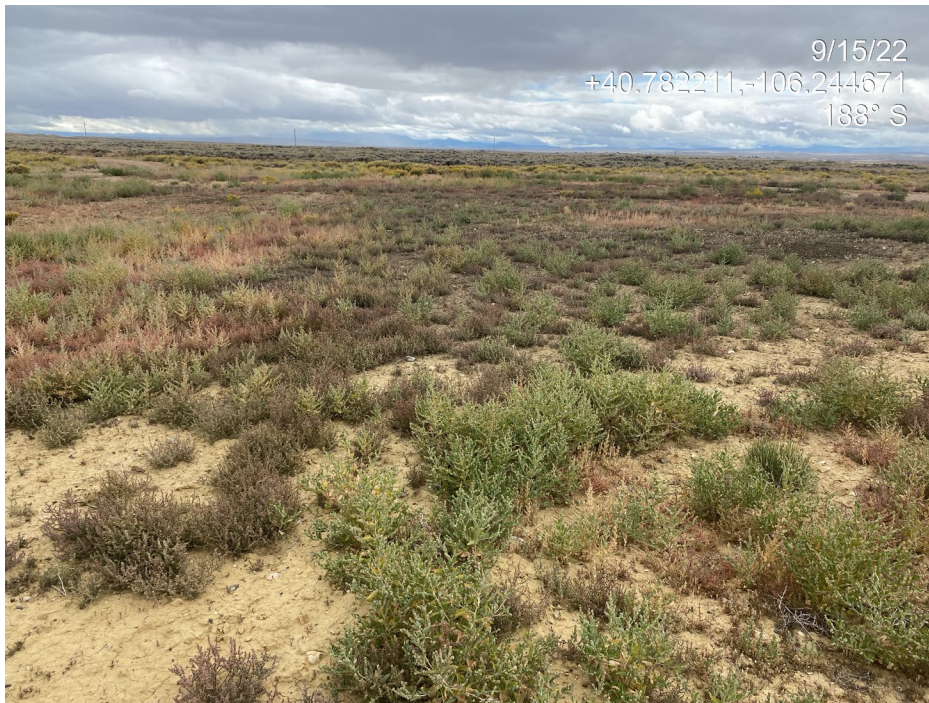
Photo 1. Photo taken from the north shows an overview of the Location. Plant species in the photo are annual undesirable plant species/weeds. Seeded plant species were not observed.

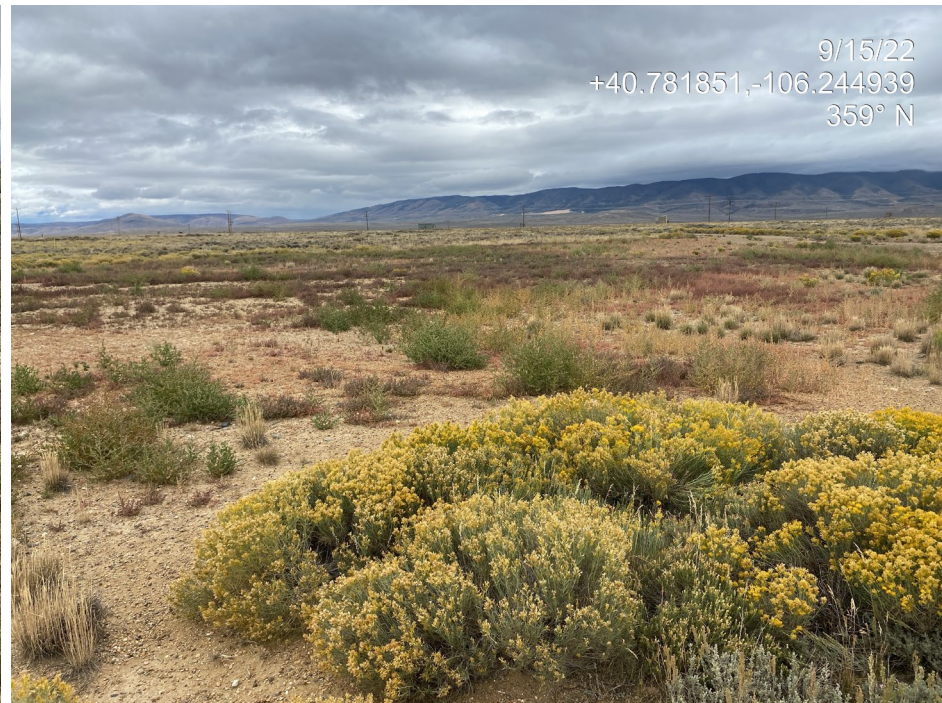
Photo 2. Photo taken from the north shows an overview of the Location. Plant species in the photo are annual undesirable plant species/weeds.

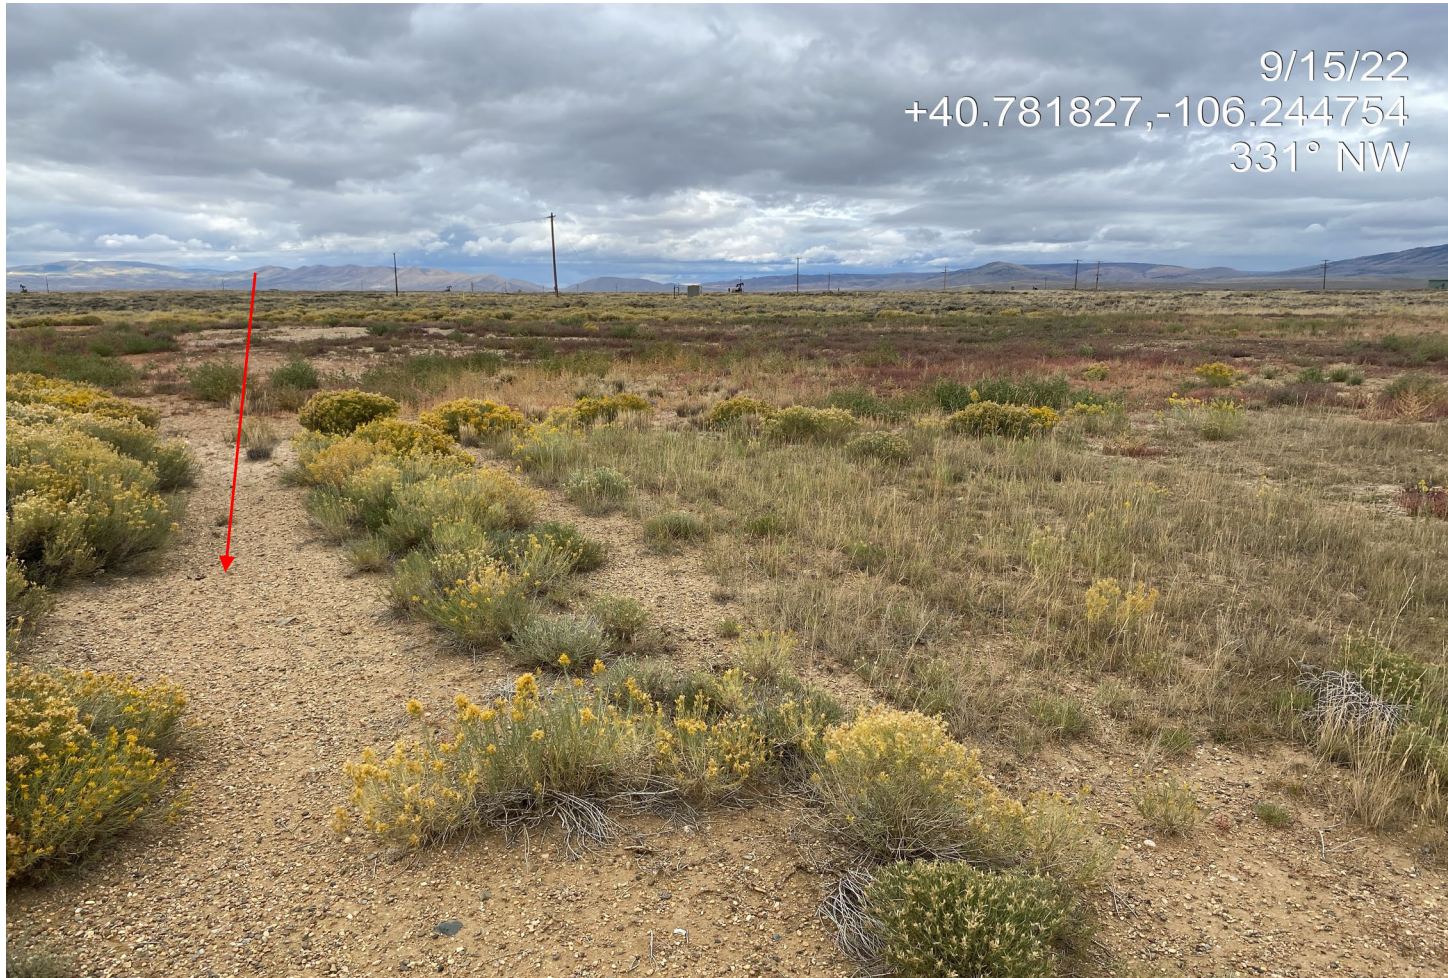
Photo 3. Photo taken from the south of the Location show the access road has not been reclaimed.

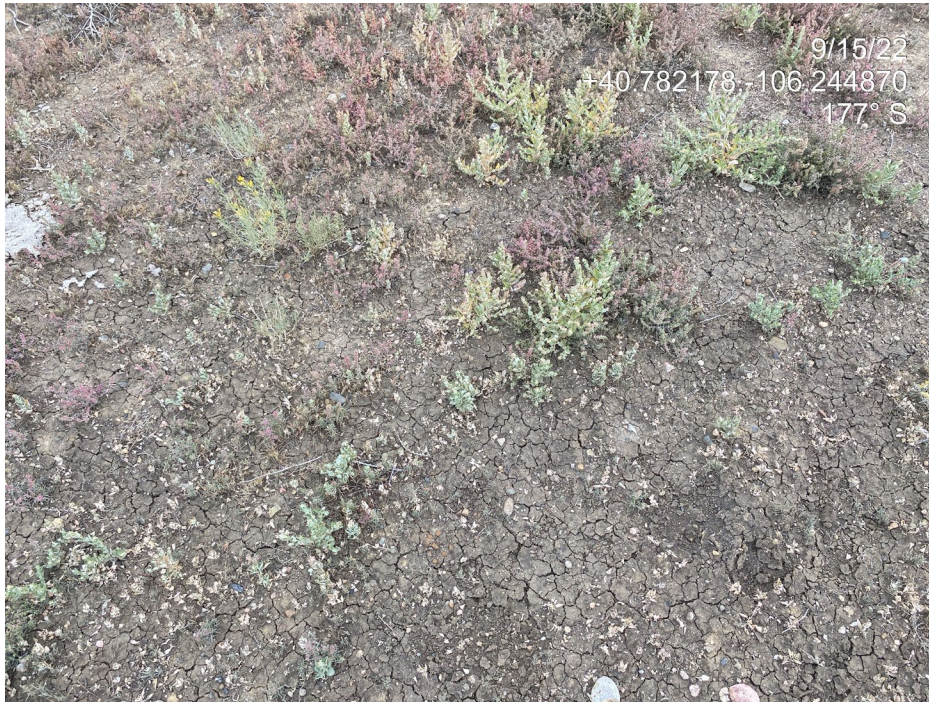
Photo 4. Photo taken from the north of the Location shows the soil surface. Plant species in the photo include Kochia, Russian thistle and tumbling saltweed (annual, undesirable plant species/weeds).

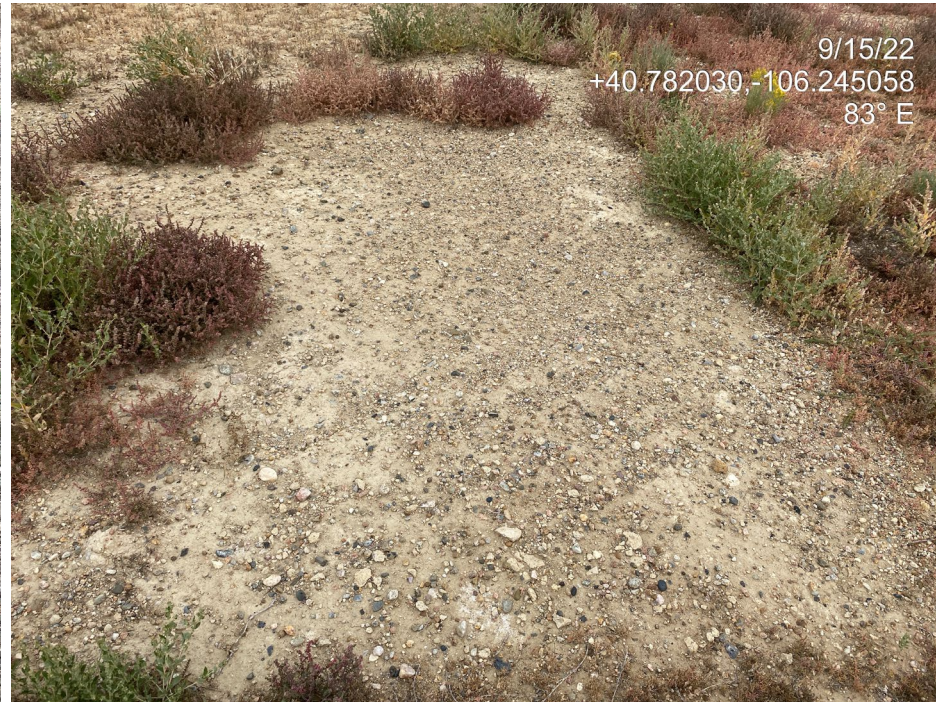
Photo 5. Photo taken from the west of the Location shows the soil surface. Plant species in the photo include Kochia, Russian thistle and tumbling saltweed (annual, undesirable plant species/weeds). Soils appear compacted.

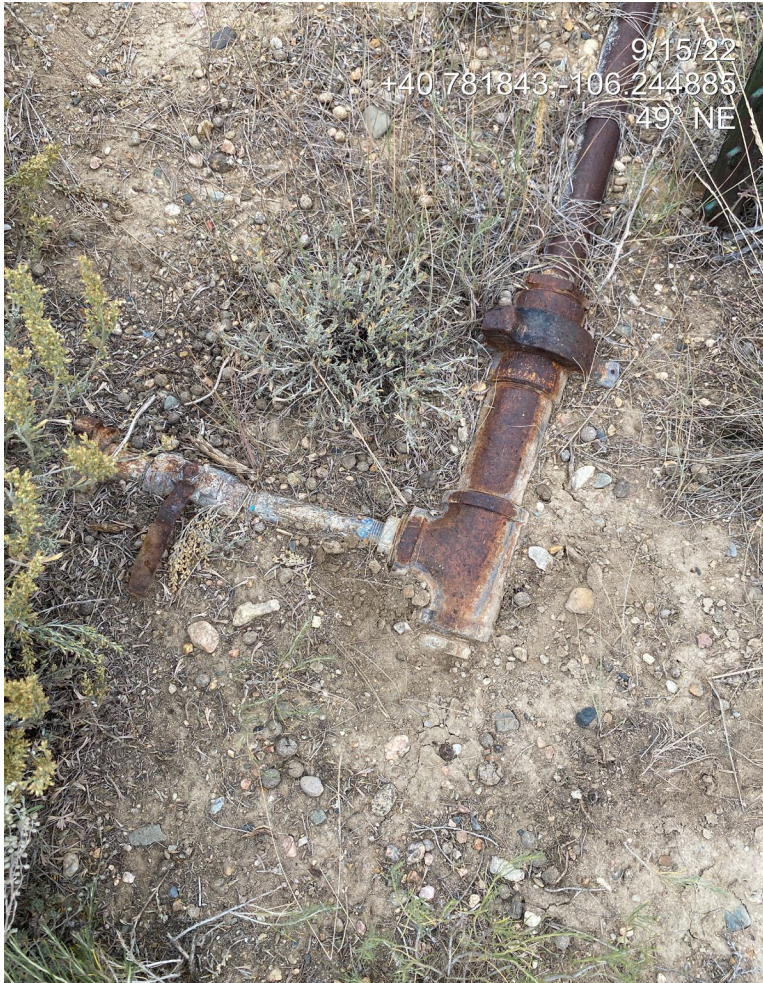
Photo 6. Photo taken from the south of the Location shows flowline equipment remains.

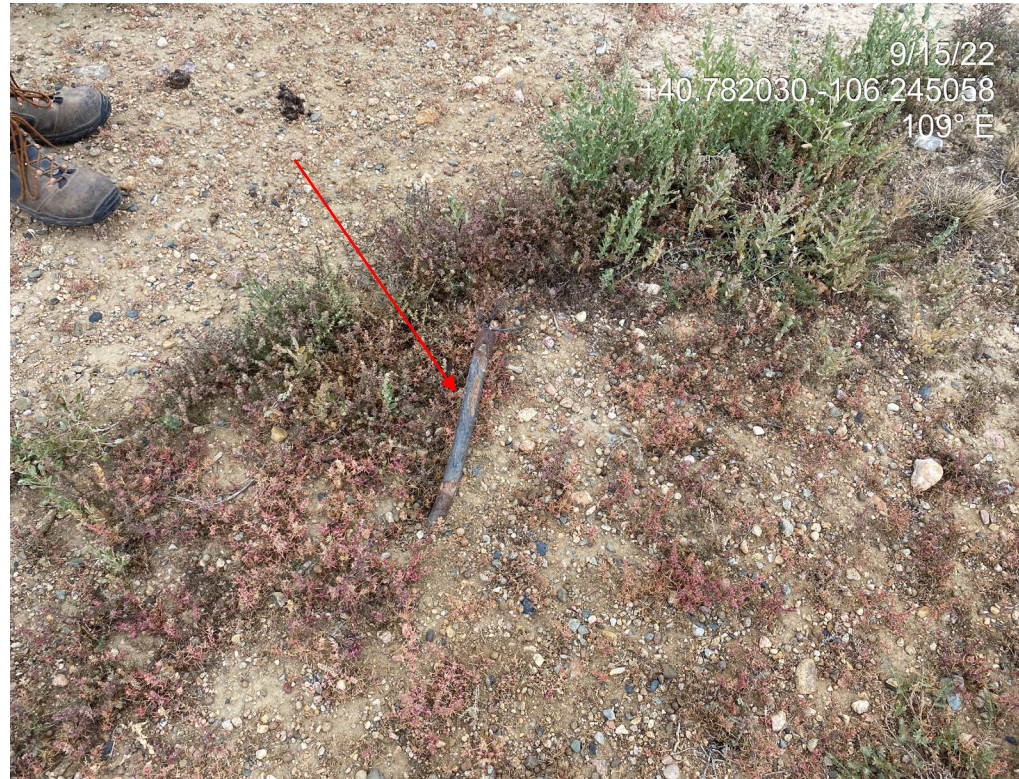
Photo 7. Photo taken from the west of the Location shows pipe equipment remains.
