Inspection Photos and Issue Report

Operator: LARAMIE ENERGY LLC #10433

Location #312417

Mesa County, CO

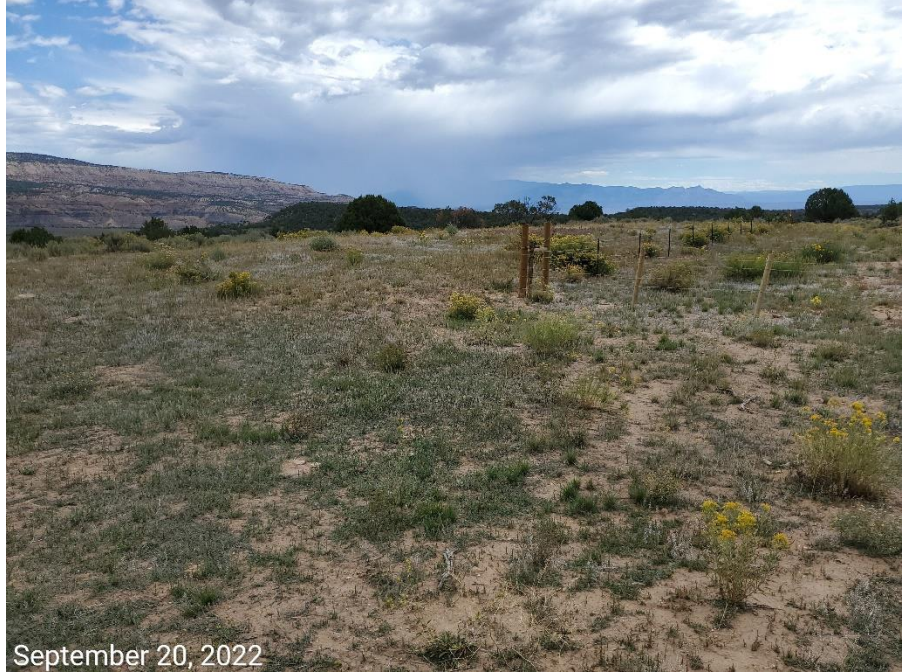
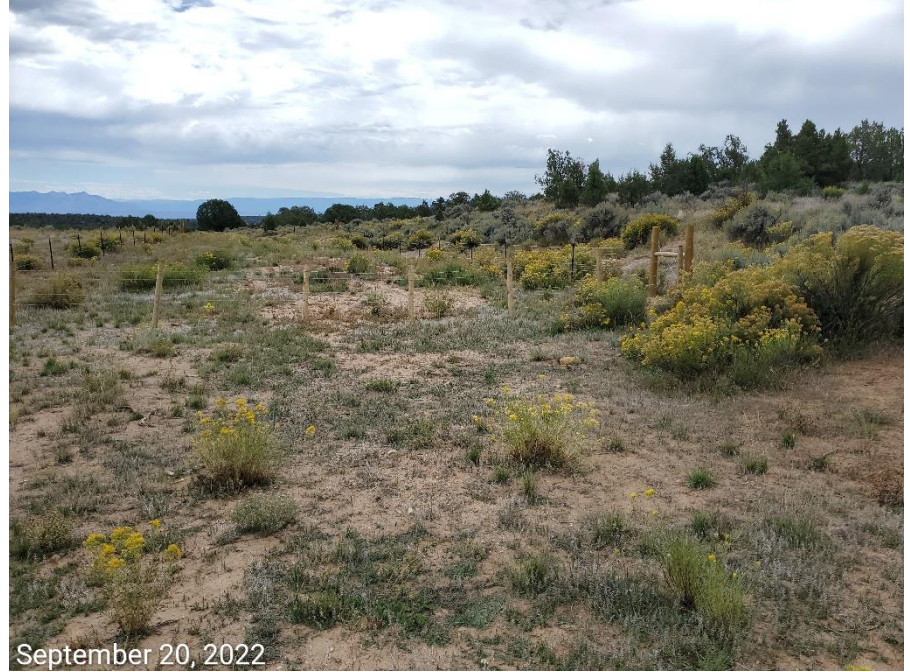
Photo 1: Photos provide overview of the Location.

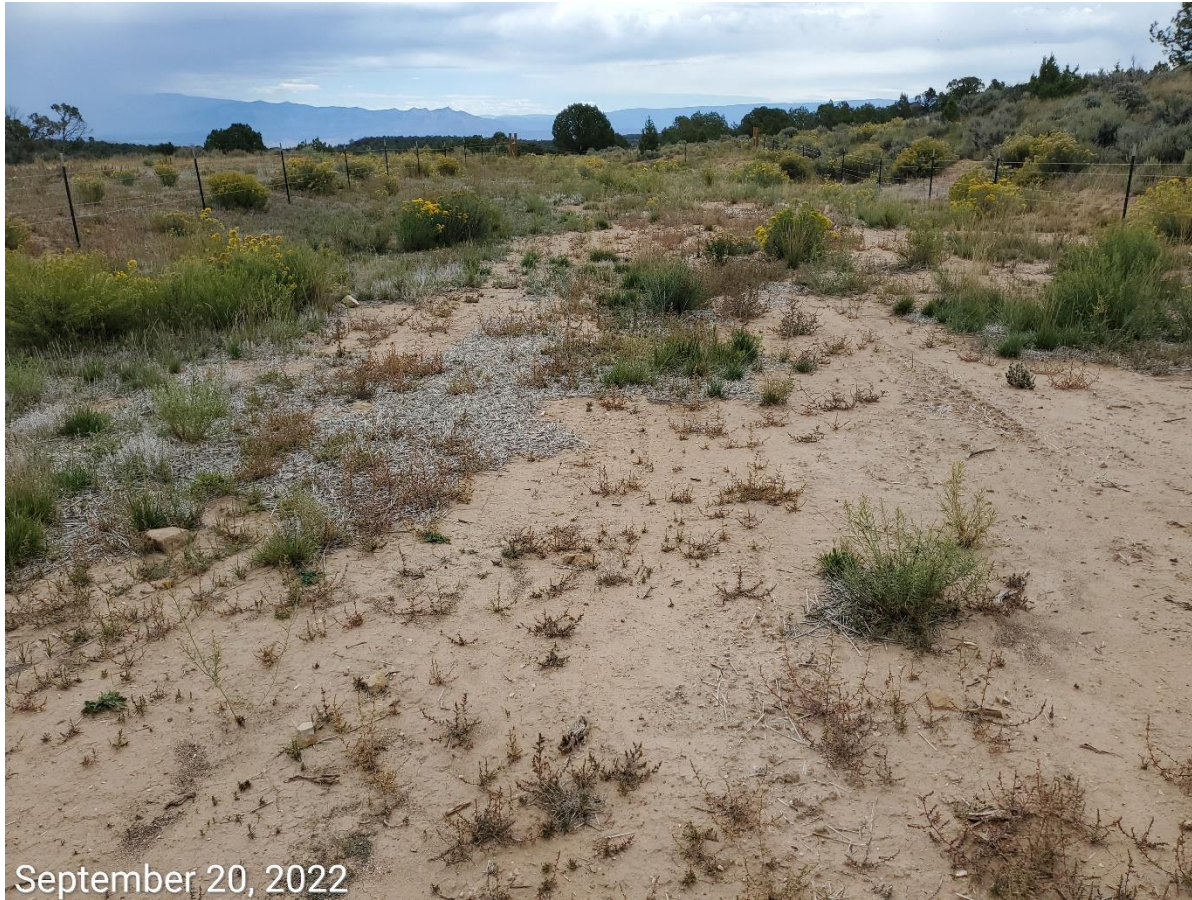
Photo 2: Photo taken from the Location, and shows areas within the site where uniform desirable vegetative establishment/germination is not progressing towards 1004 uniform standards.

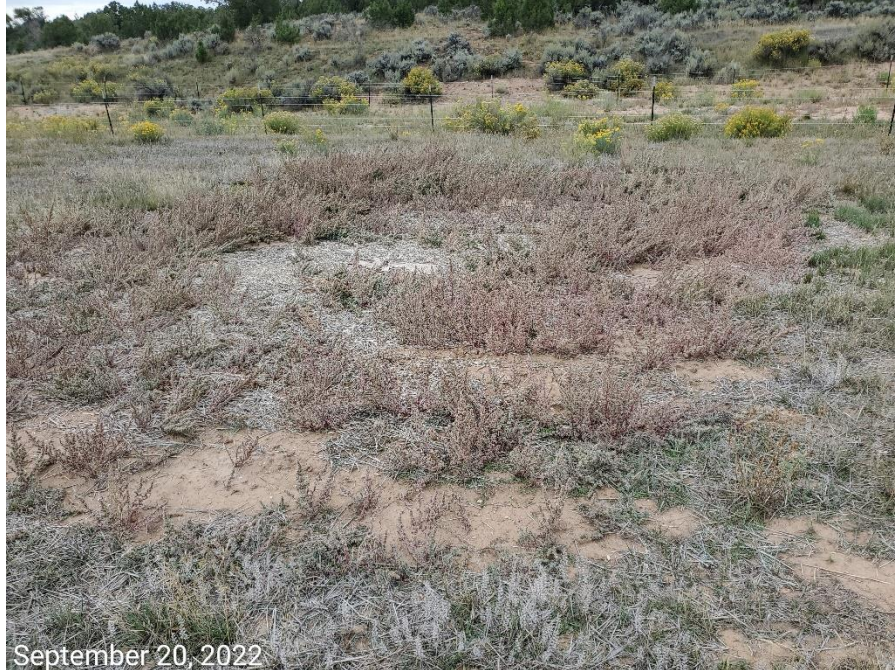
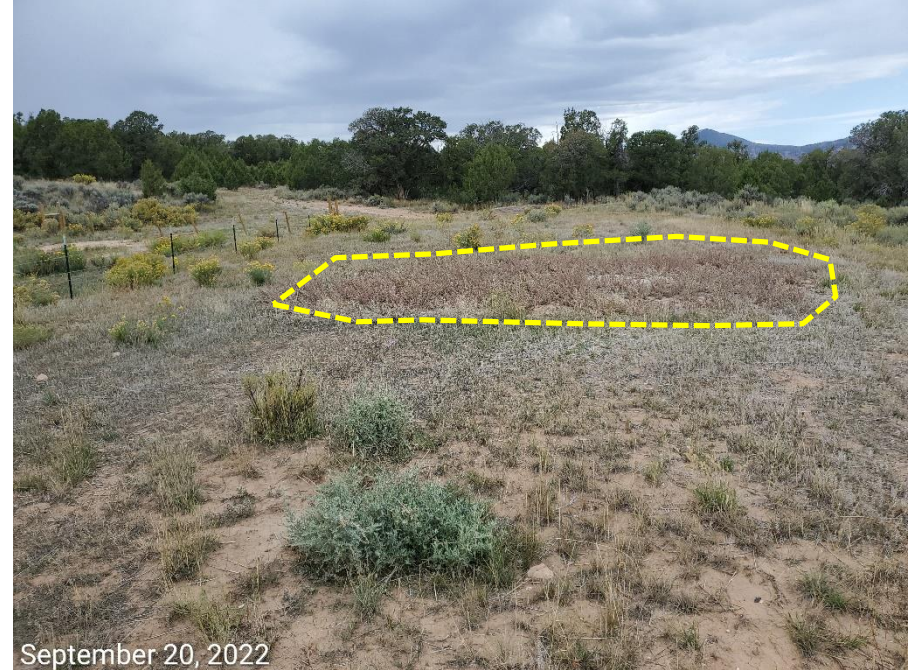
Photo 3: Photo shows a patch of Undesirable Plant Species (Halogeton) established on the Location. Noxious plant Species not observed within the immediate, adjacent reference areas.

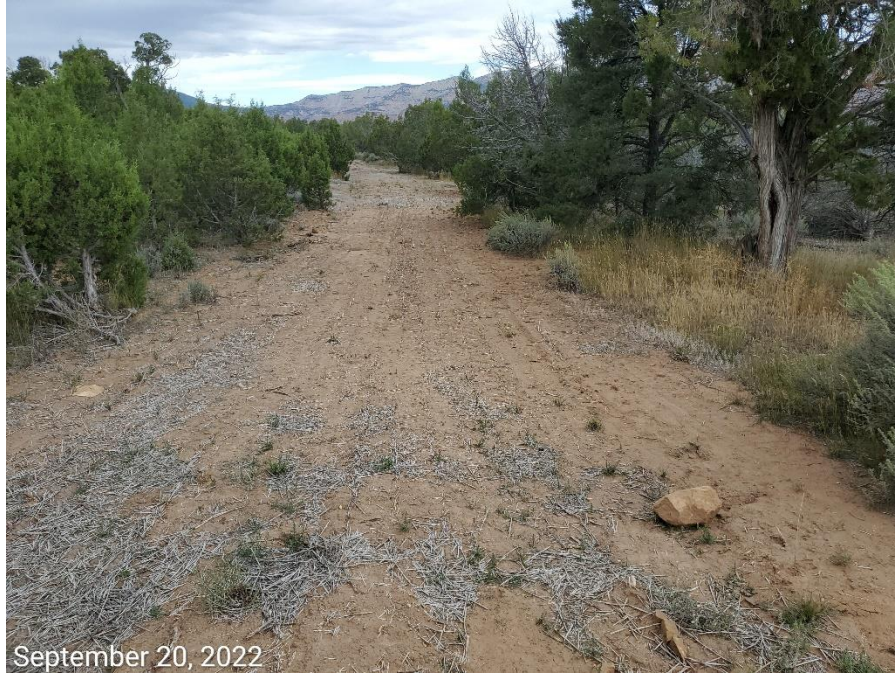
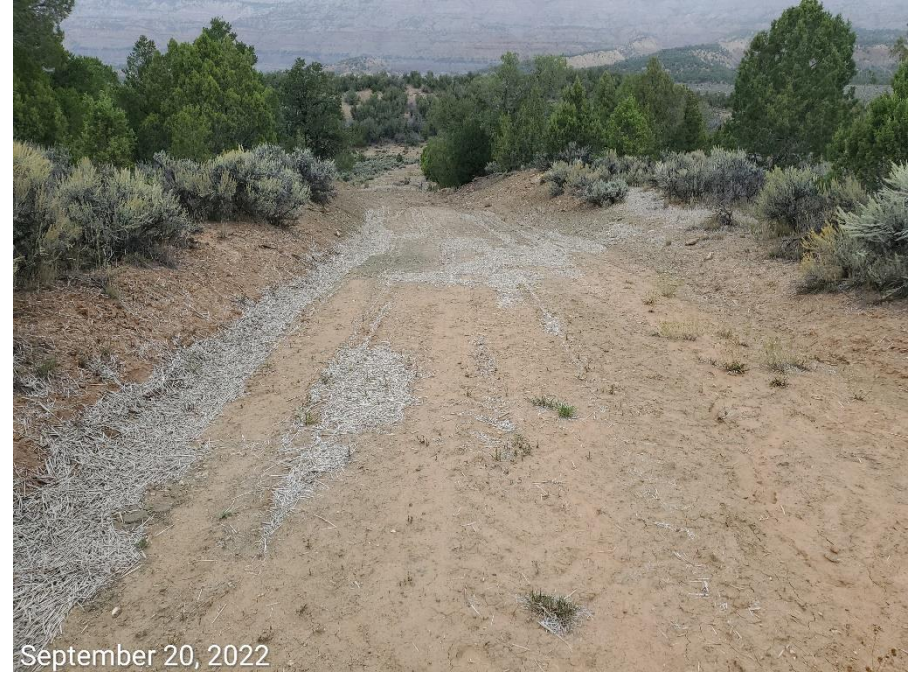
Photo 4: Photos examples showing areas along the access road where uniform desirable vegetative establishment/germination is not progressing towards 1004 uniform standards. Additional reclamation efforts required within these areas of the road.

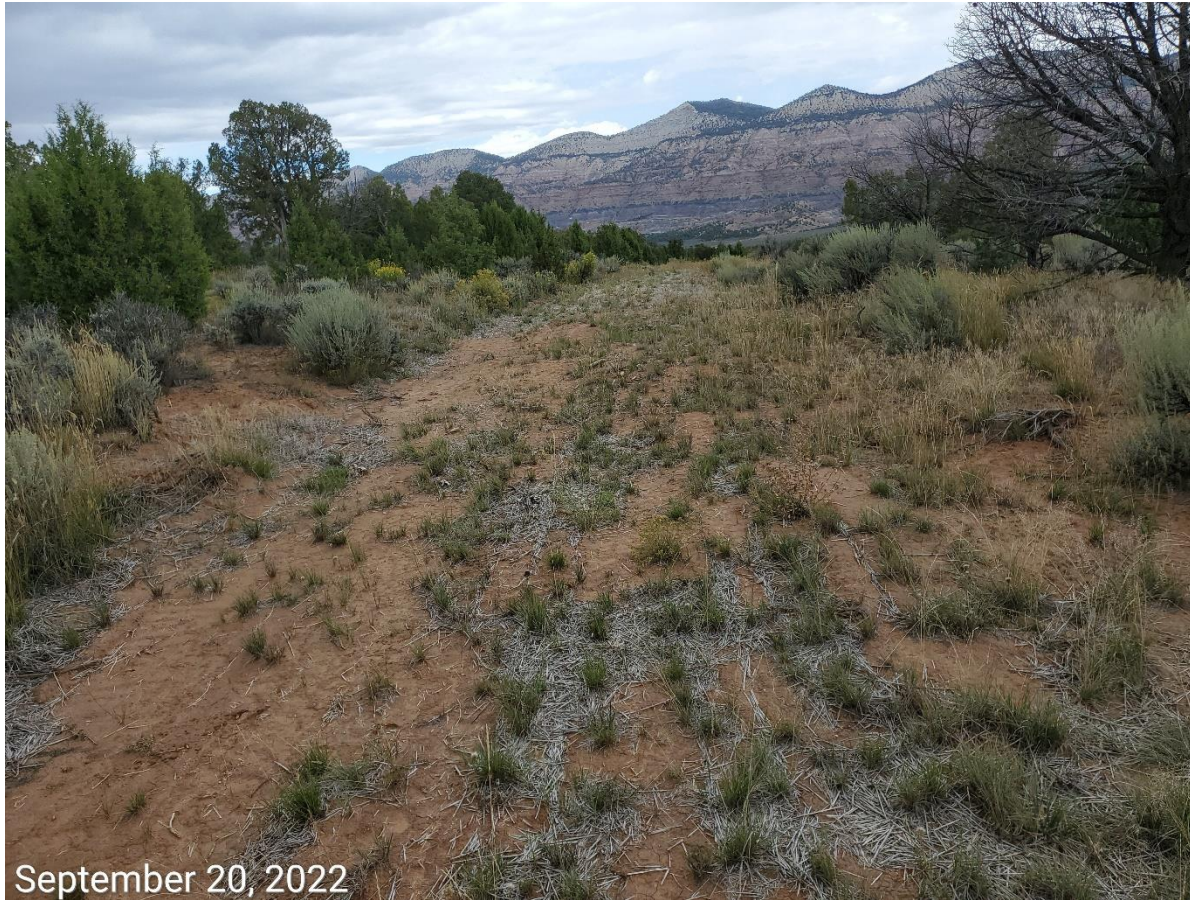
Photo 5: Photo example of areas along the access road that are progressing towards 1004 standards.

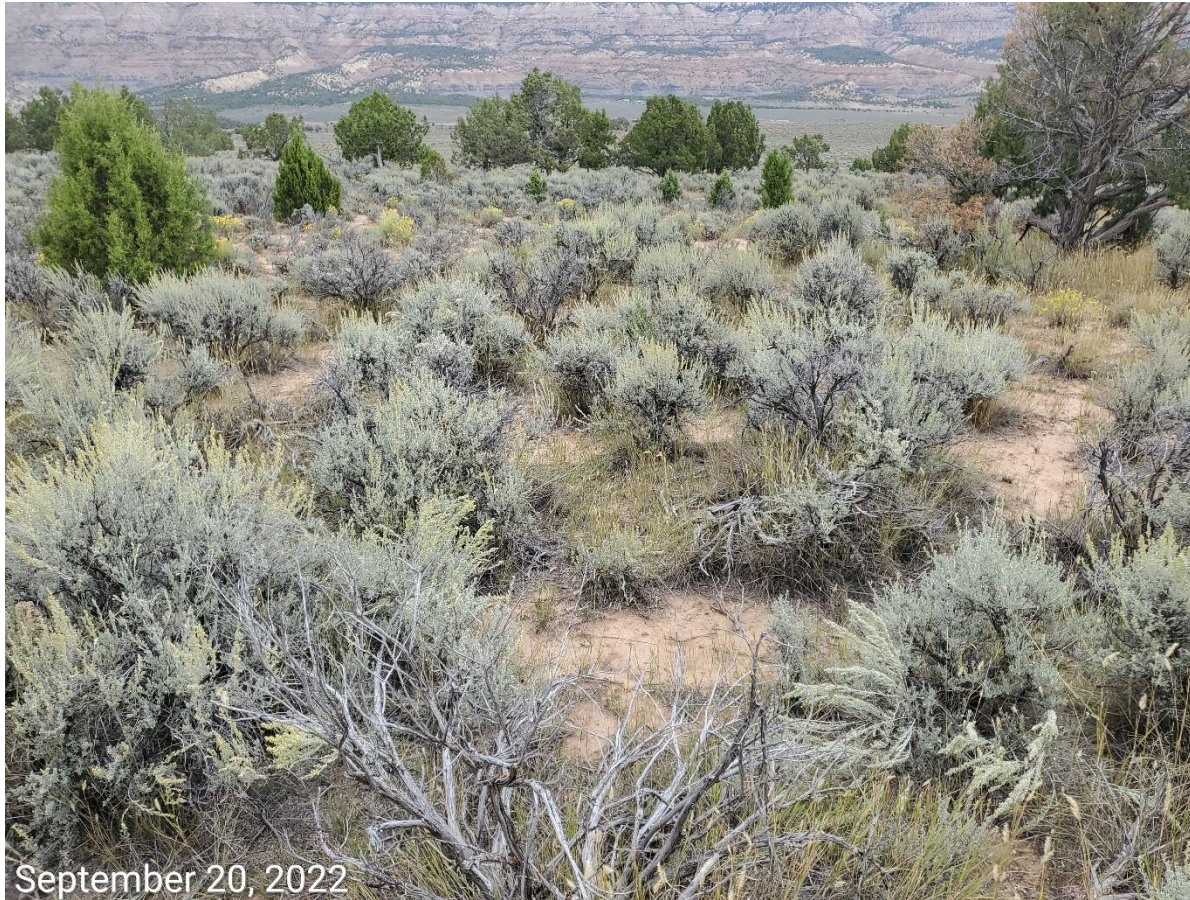
Photo 6: Photo example of the adjacent reference areas.
