Final Reclamation Inspection

Operator: PDC ENERGY INC - 69175

Location ID: 331583

Inspection Photos
Location Name: Fickel 31-21
Location ID: 331583

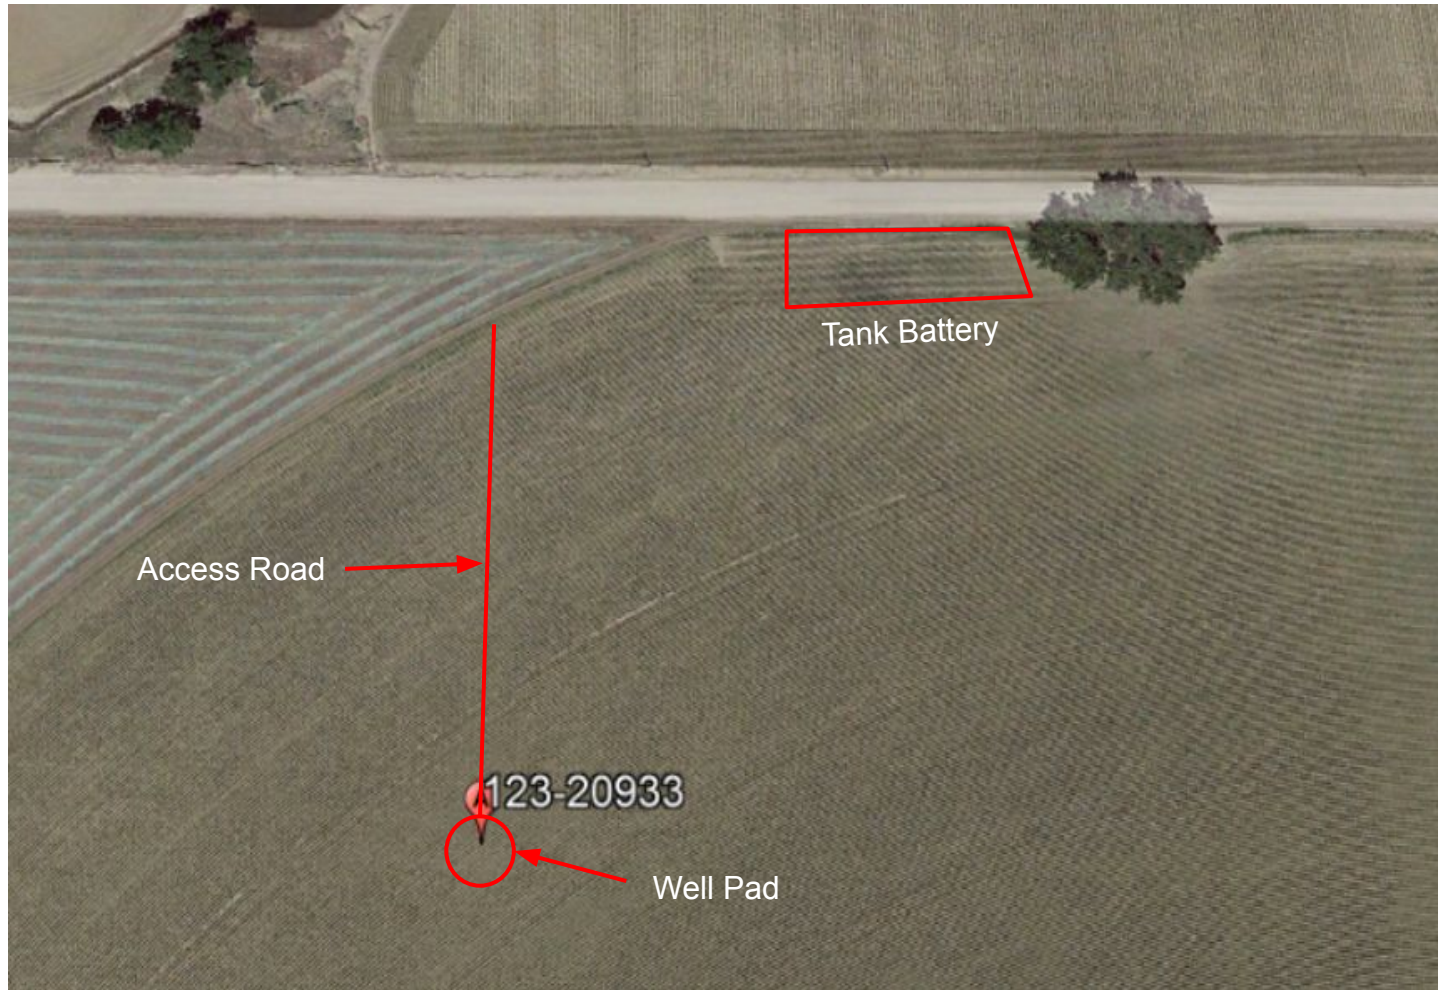
Photo 1. 2021 aerial imagery of the well pad, access road and tank battery.

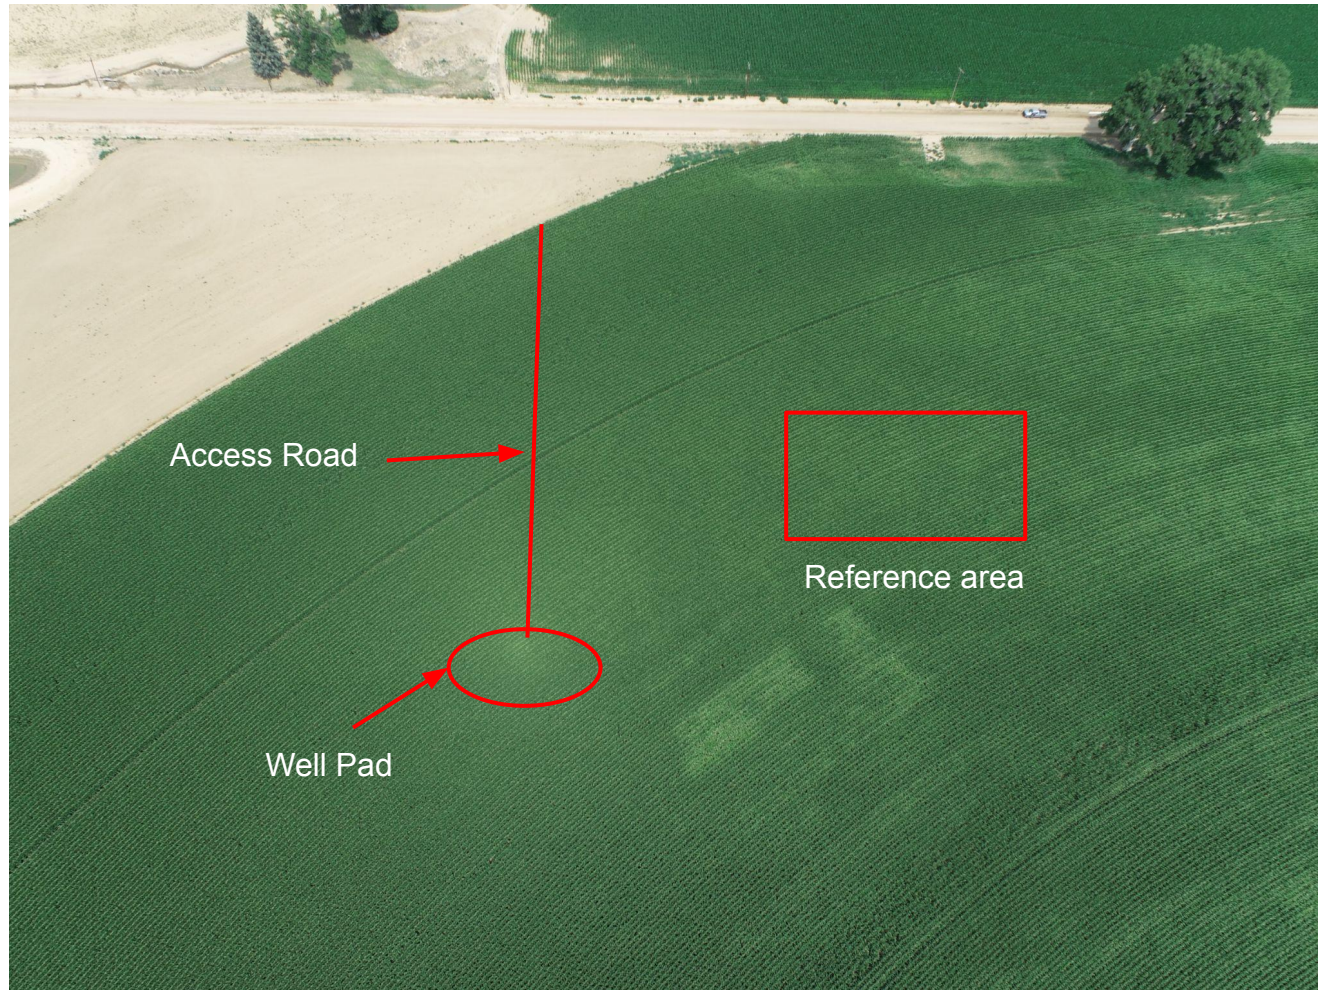
Photo 2. Overview photo of the well pad, access road, and reference area taken from the southern edge, facing north, using a drone. Note: well pad and access road appear consistent with adjacent crop reference area.

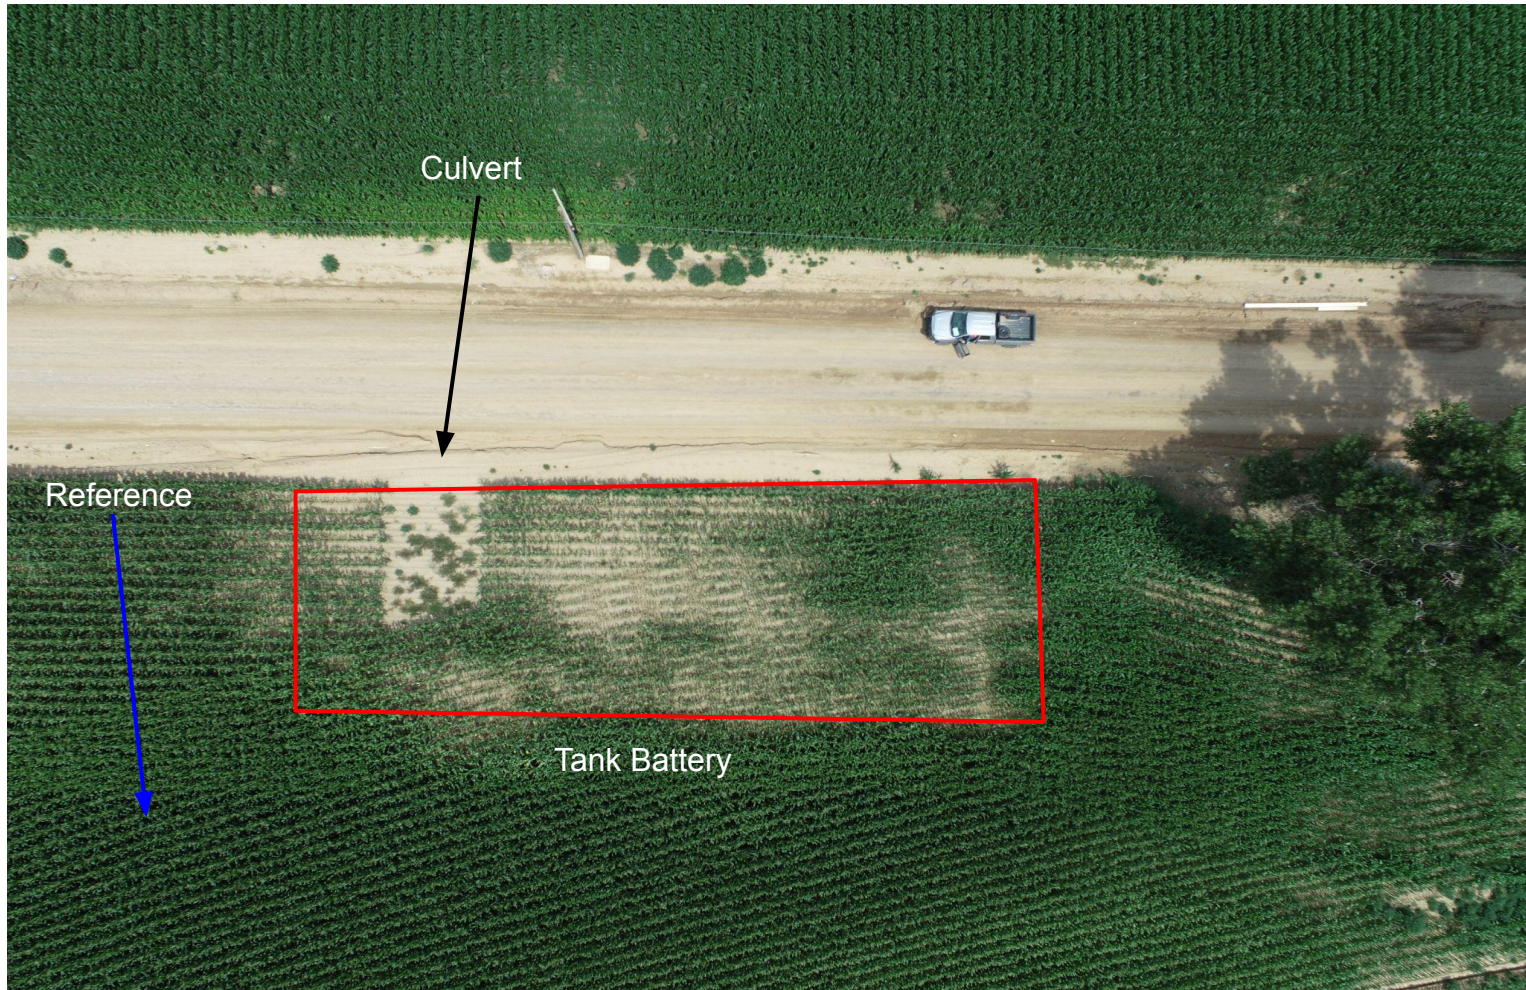
Photo 3. Overview photo of the tank battery taken from the southern edge facing north using a drone. Note: tank battery shows stunted crop growth and does not appear consistent with adjacent reference crop area indicated by blue arrow. Culvert location also displayed and indicated by black arrow (see photo 5).

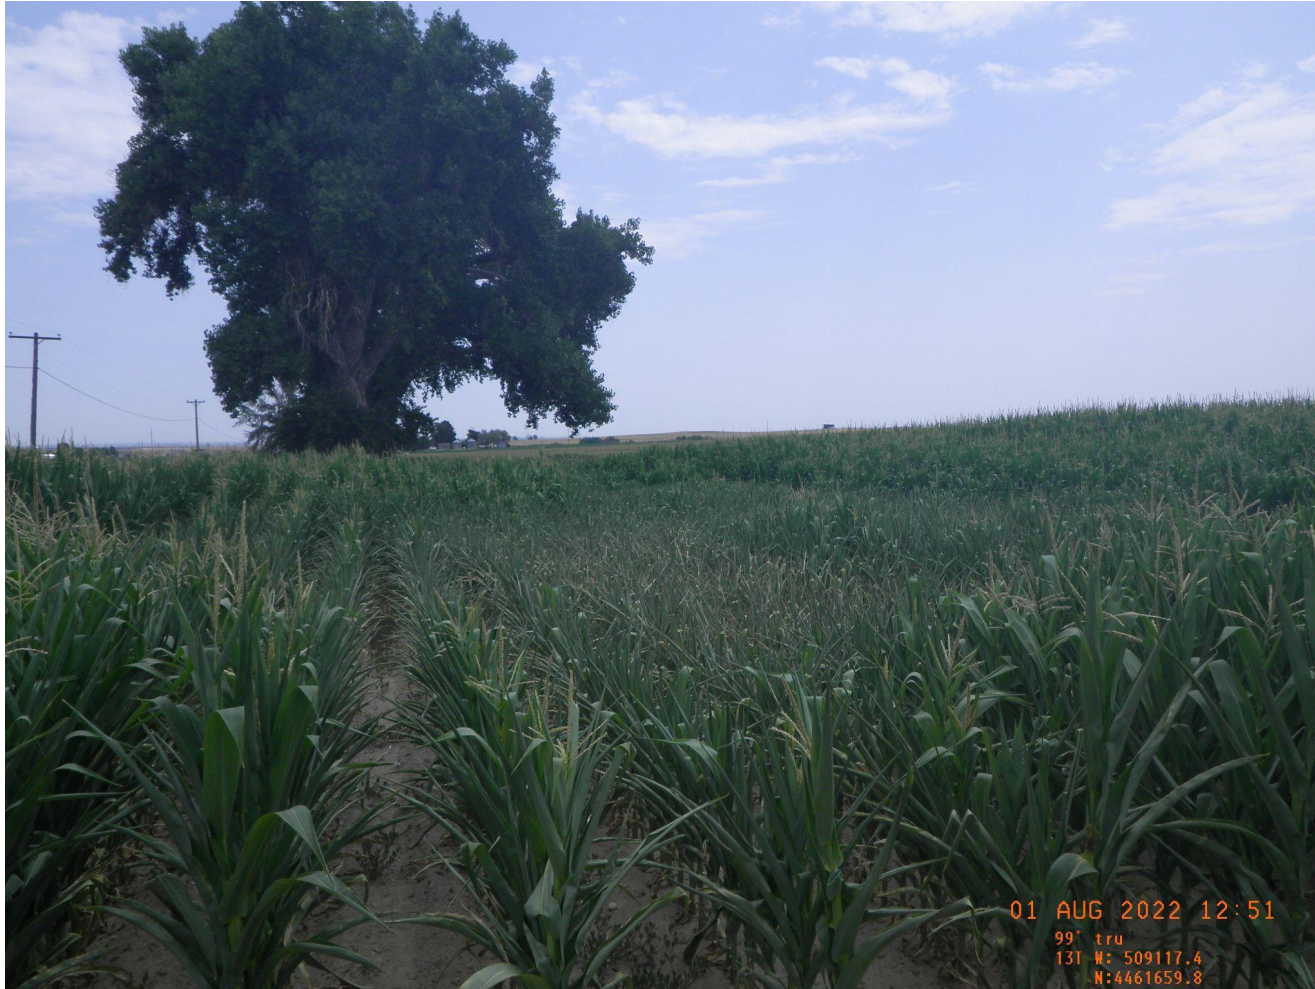
Photo 4. Overview ground photo of the tank battery taken from the western edge facing east. Photo shows stunted crop growth at the tank battery disturbance area.

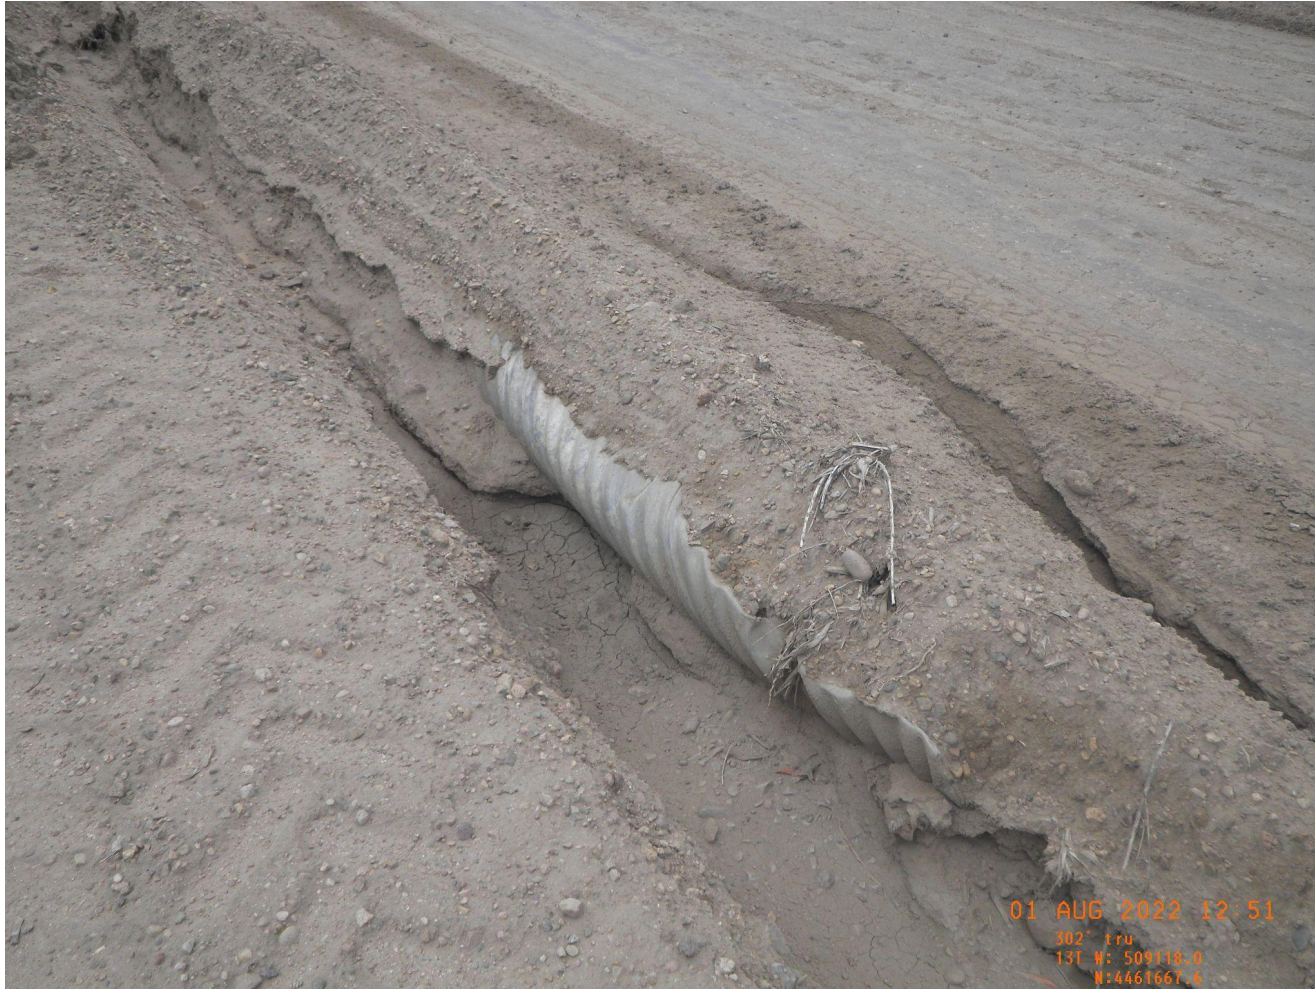
Photo 5. Removed culvert left on site located at the northern edge of the tank battery.
