Inspection Photos

Operator: Bonanza Creek Energy Operating Company
LLC - #8960

Location Name: North Park Coal-69N78W /18NWSW

Inspection Document #: 702800720

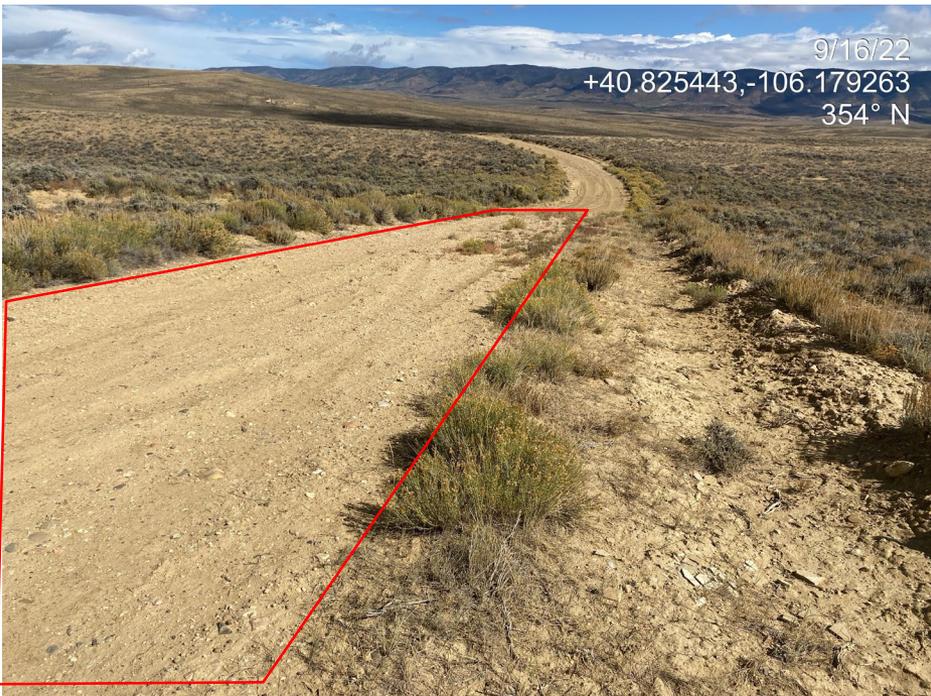
Photo 1. Photo shows one of two spur roads which converge into the Location access road. Photo shows the eastern portion of unreclaimed road which is approximately 40 yards long.

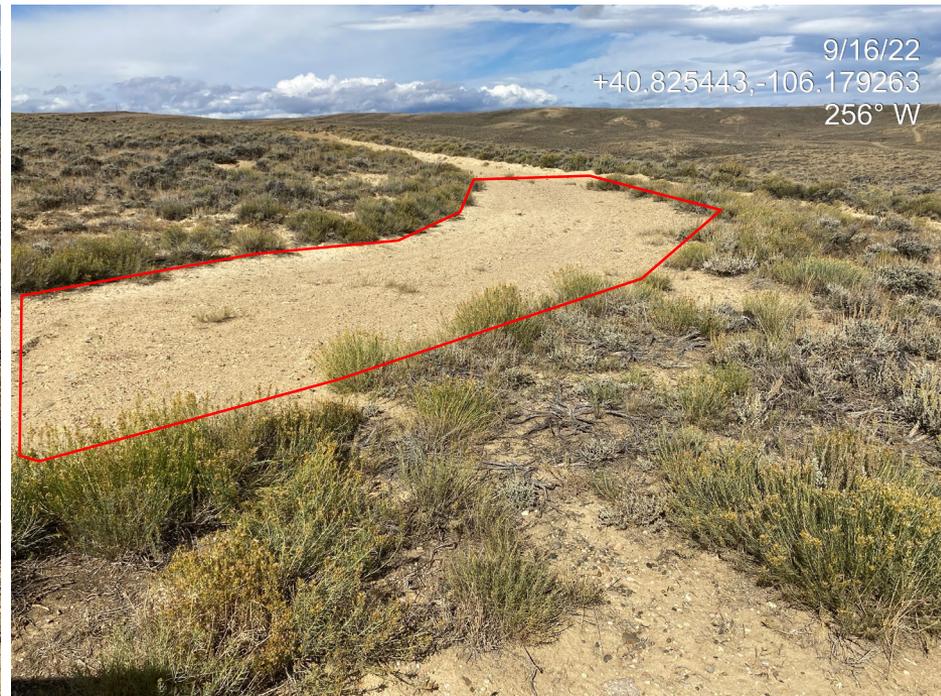
Photo 2. Photo shows one of two spur roads which converge into the Location access road. Photo shows the western portion of unreclaimed road which is approximately 30 yards long.

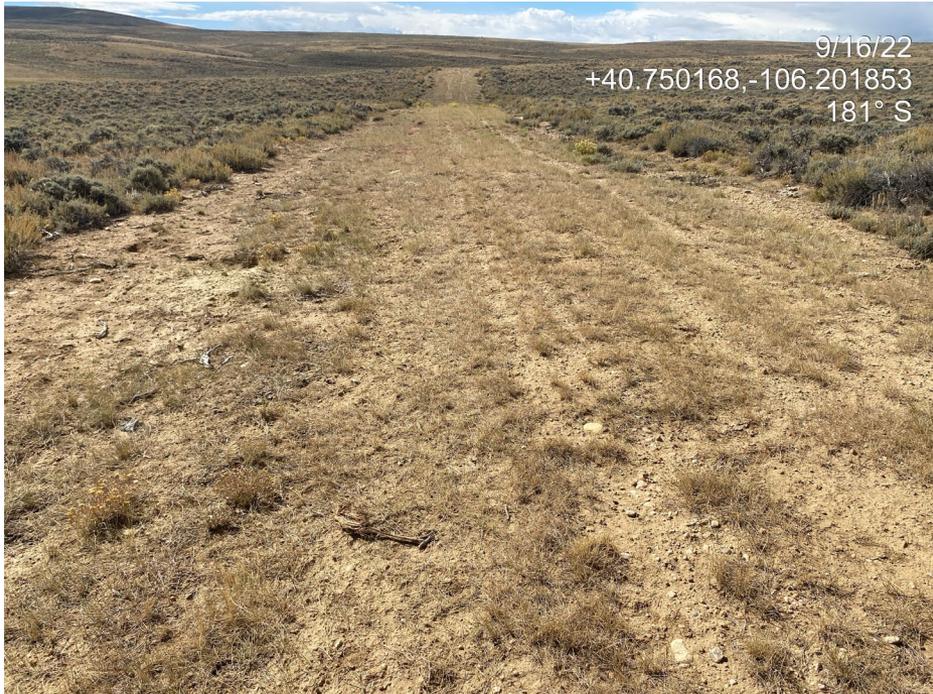
Photo 3. Photo taken to the north shows the majority of the Location access road (~0.26 miles) has been reclaimed and is vegetated with perennial grasses.

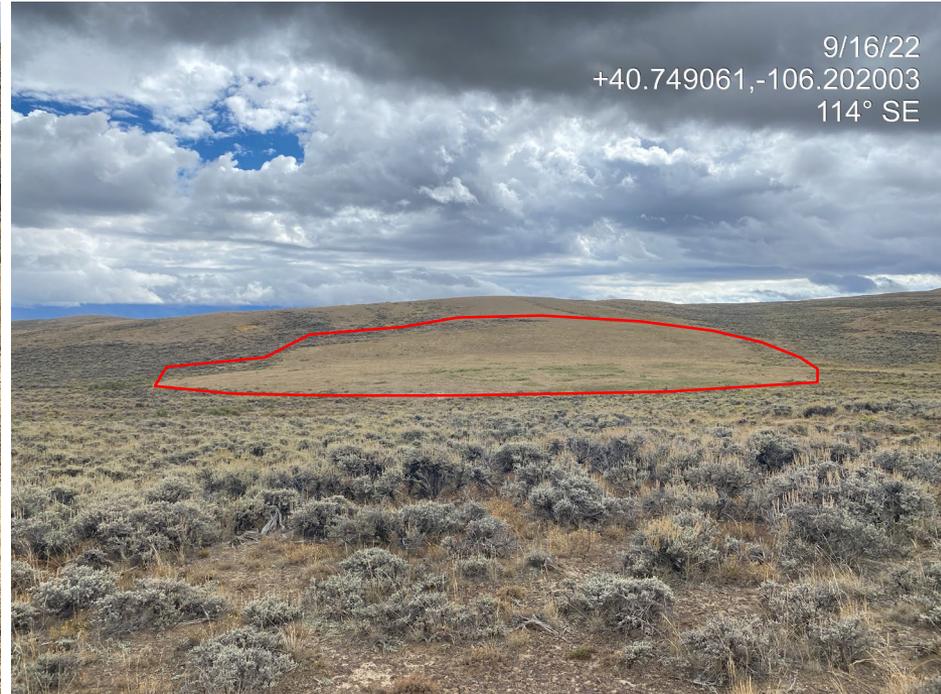
Photo 4. Photo taken to the northwest shows an overview of the reclaimed Location.

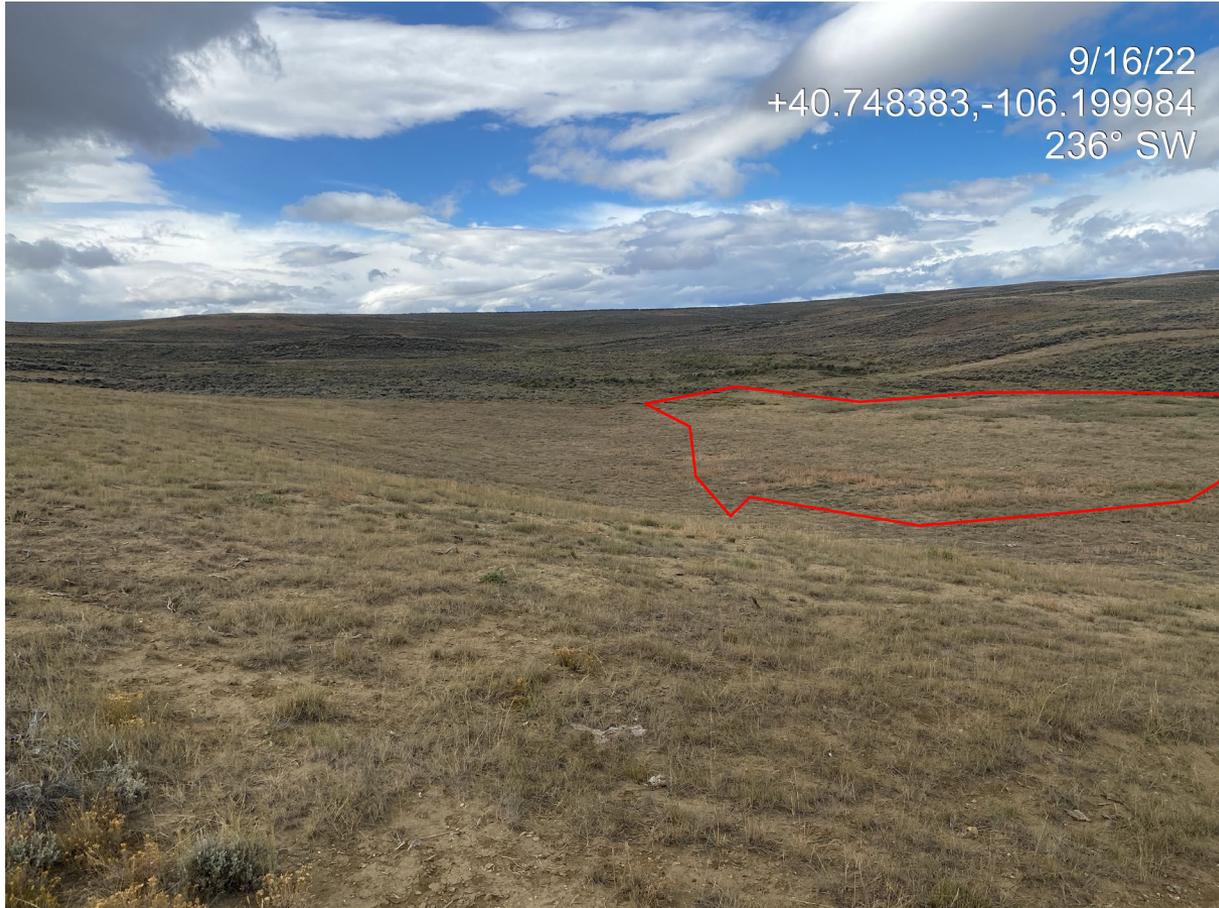
Photo 5. Photo taken to the east shows an overview of the reclaimed Location. Portions of the Location are dominated by perennial grasses. Areas at the west of the Location have poor perennial establishment and high cover of annual undesirable plant species/weeds (red polygon).

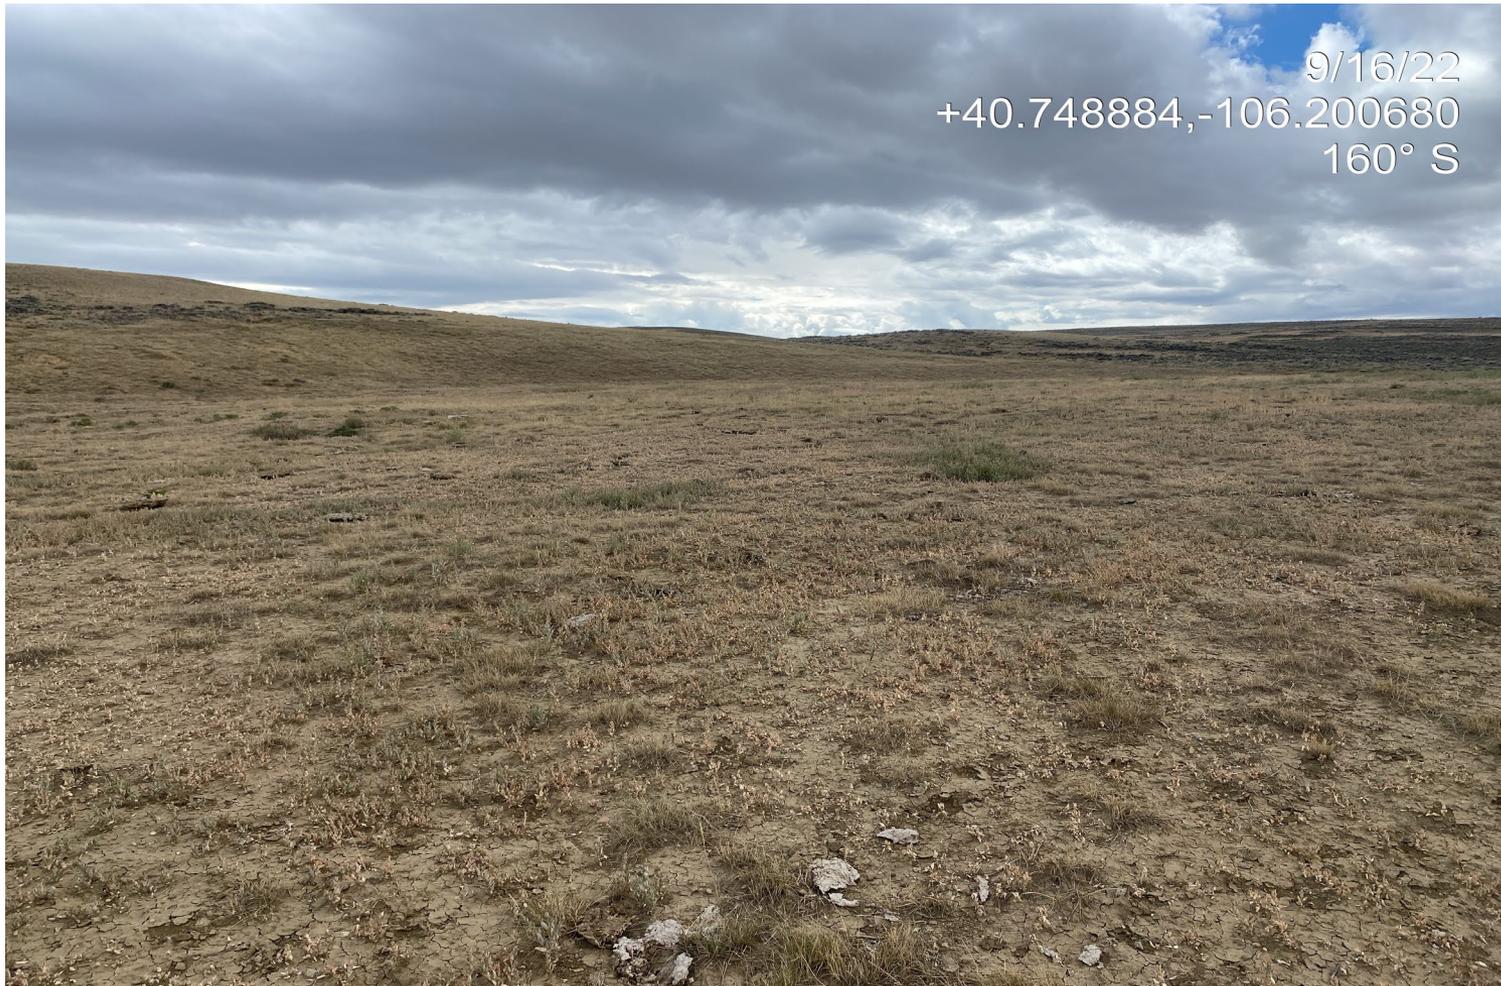
Photo 6. Photo taken from the northwest of the Location shows an area with poor perennial establishment and high cover of annual undesirable plant species/weeds (tumbling saltweed).

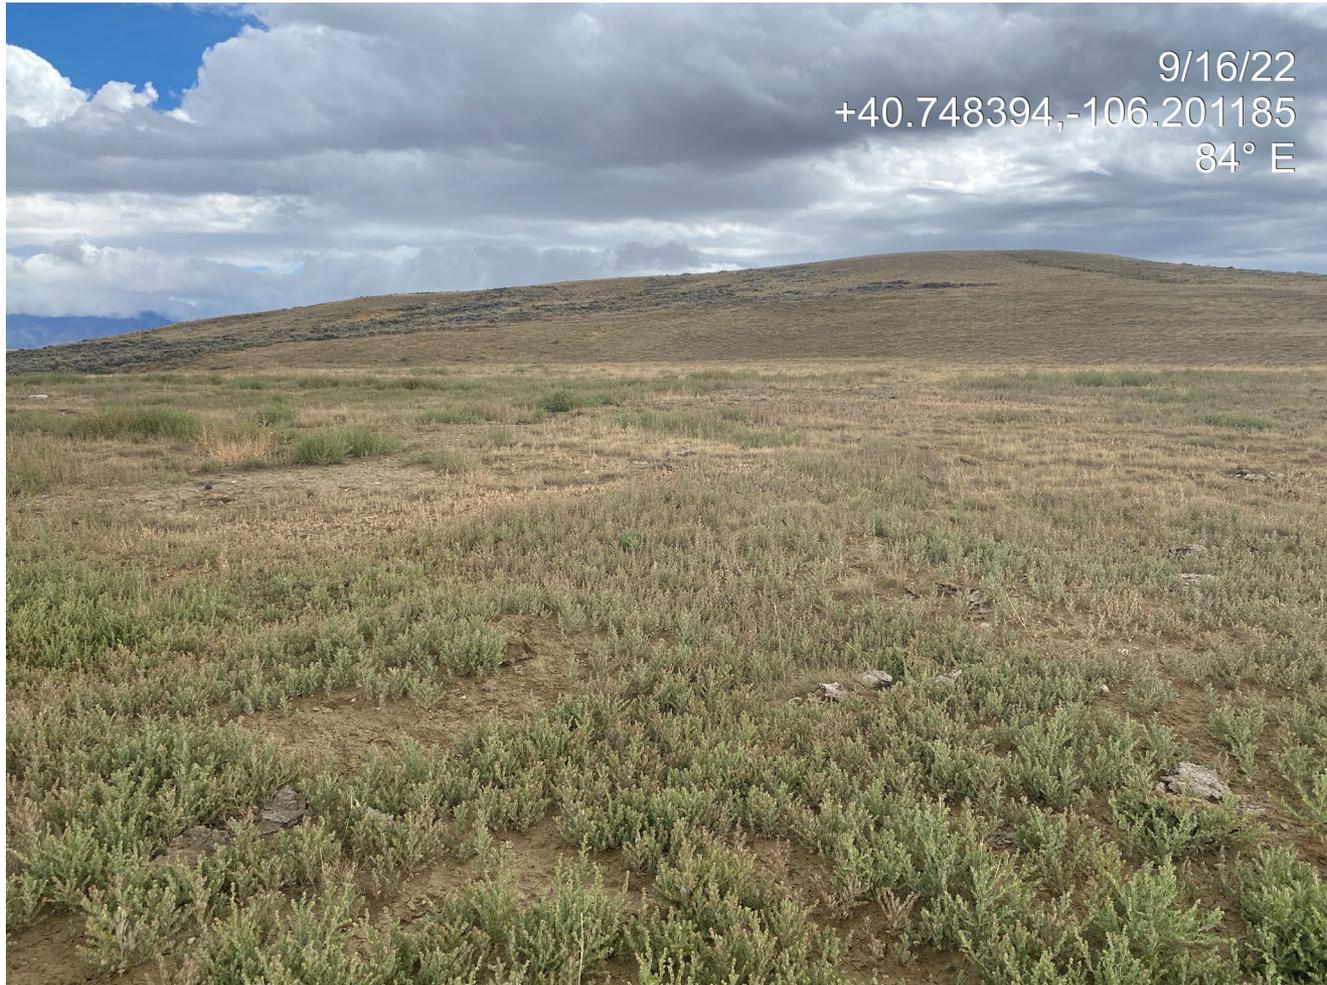
Photo 7. Photo taken from the west of the Location shows an area with poor perennial establishment and high cover of annual undesirable plant species/weeds (tumbling saltweed).

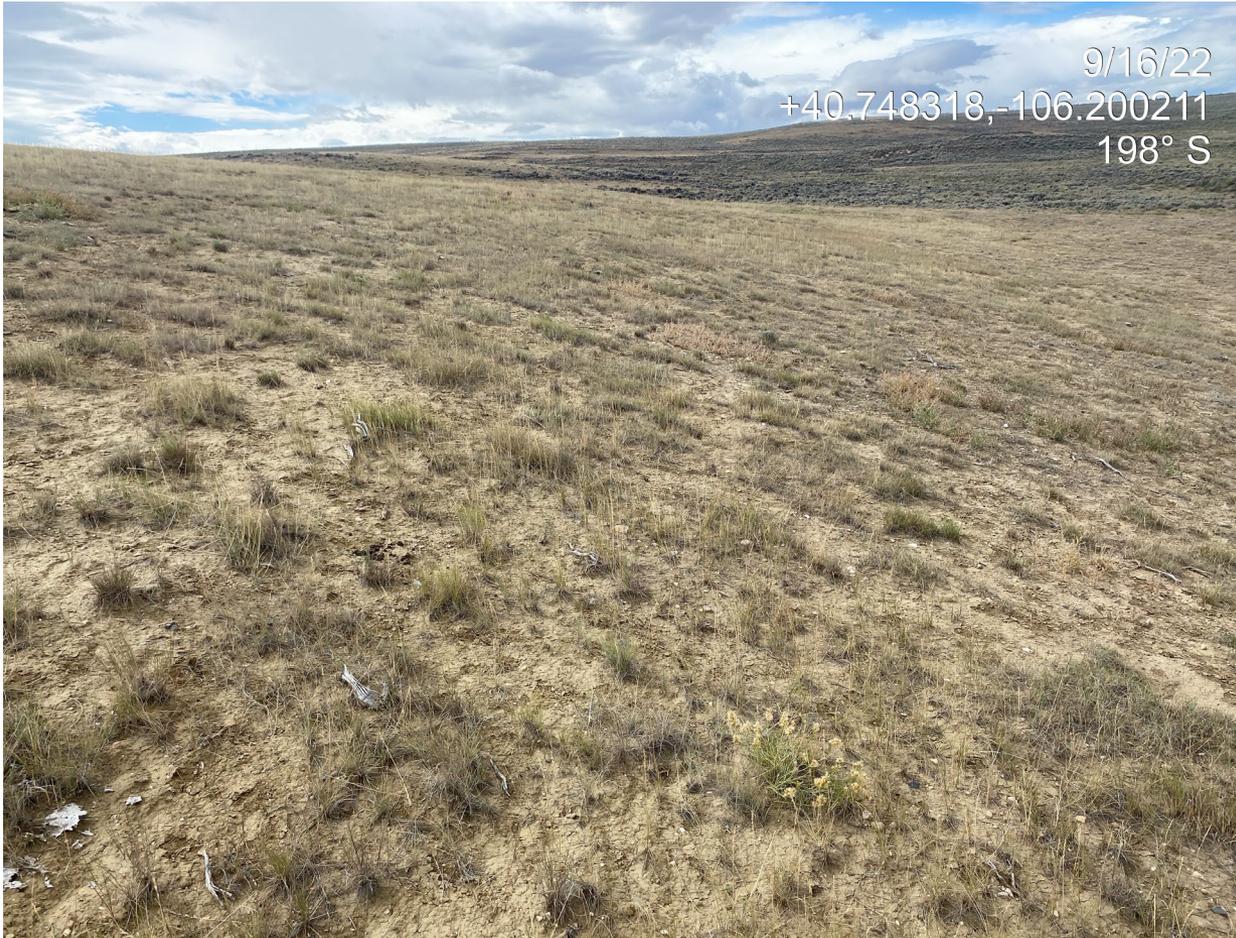
Photo 8. Photo shows an area at the east of the Location which is dominated by desirable perennial grasses.

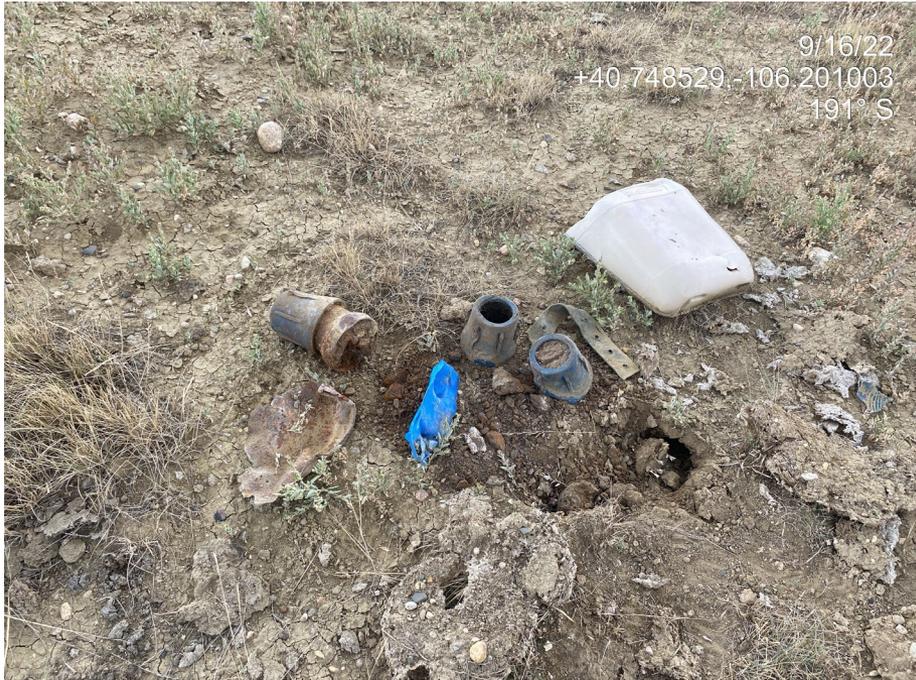
Photo 9. Photo shows a variety of trash/debris from the Location.

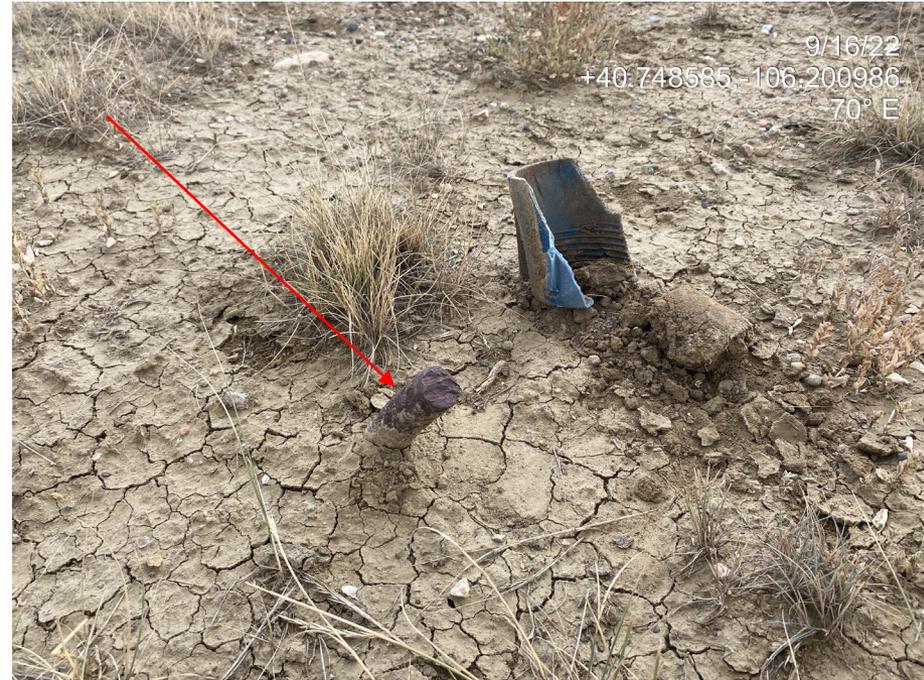
Photo 10. Photo shows a metal rod sticking out of the ground at the northwest of the Location.

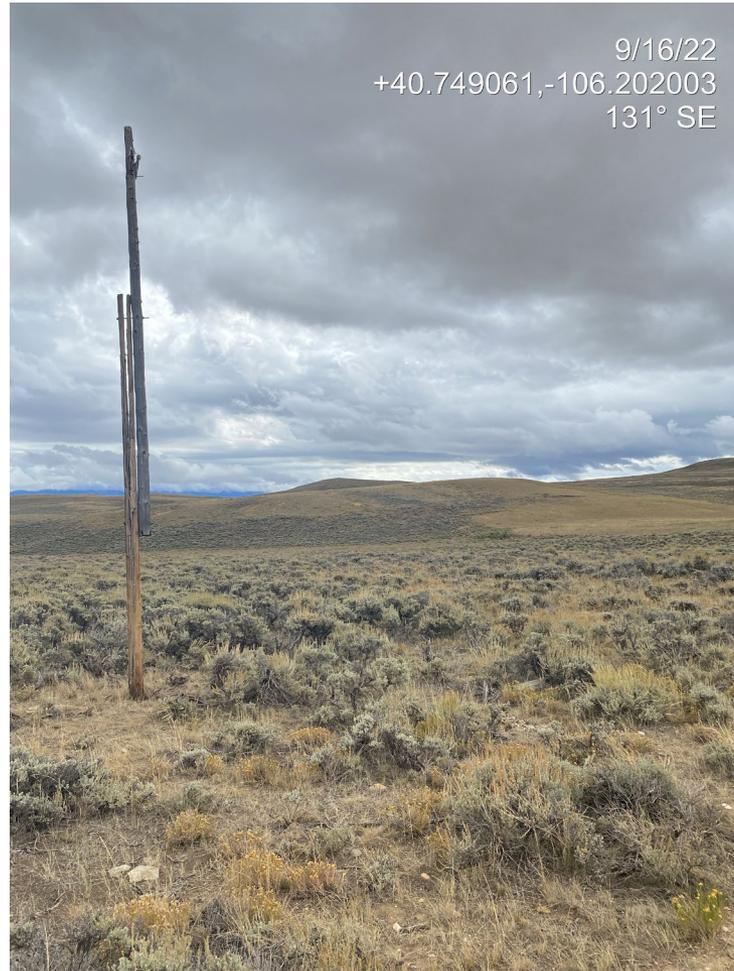
Photo 11. Photo taken to the north, on the Location access road shows an abandoned utility pole which must be removed.

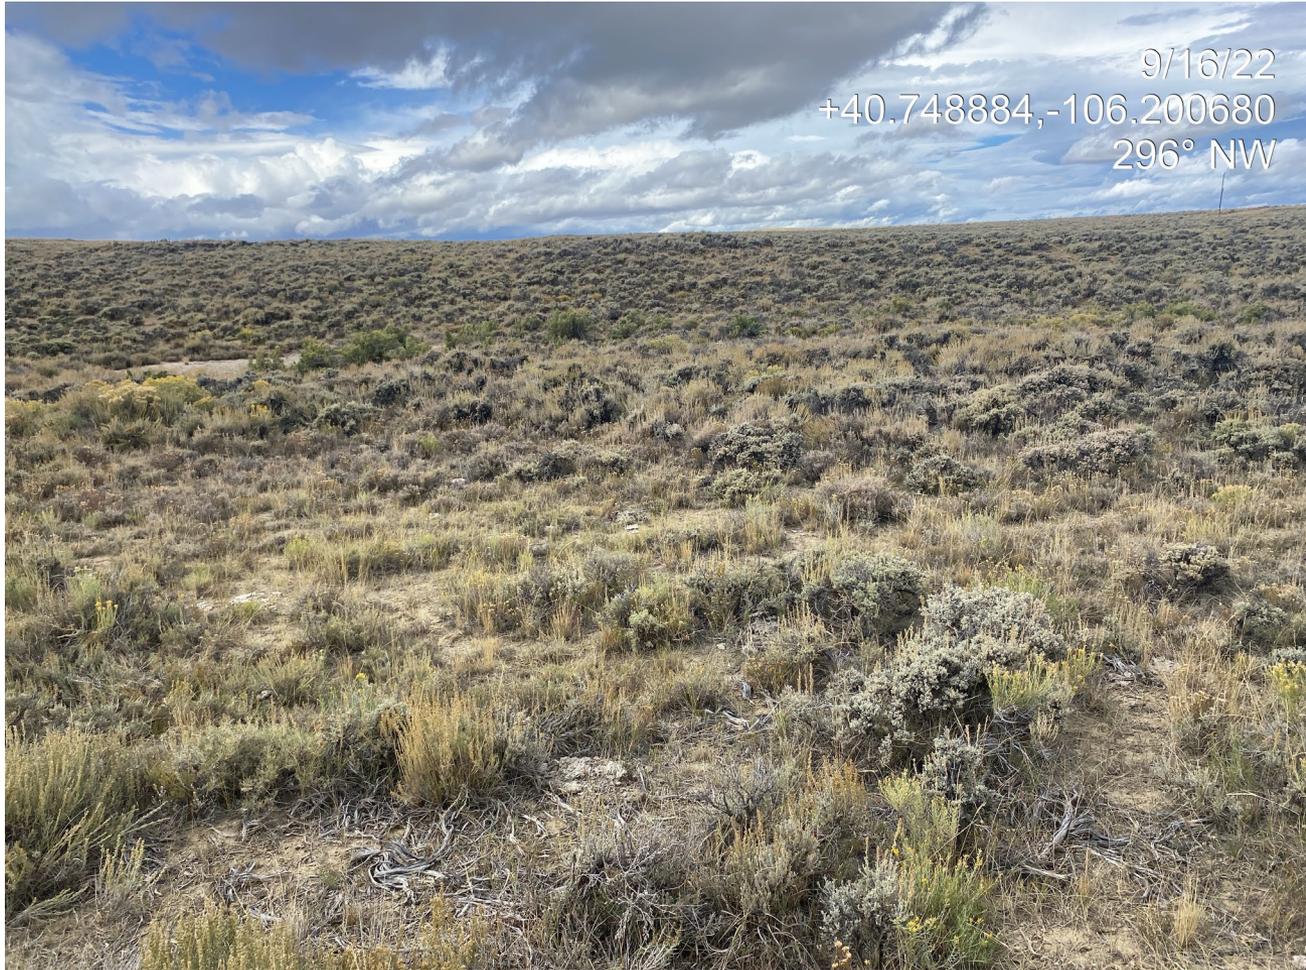
Photo 12. Photo taken to the north of the Location shows reference area vegetation.
