Final Reclamation Inspection

Operator: PDC ENERGY INC - 69175

Location ID: 306513

Inspection Photos
Location Name: DALTON-67N66W 24NESW
Location ID: 306513

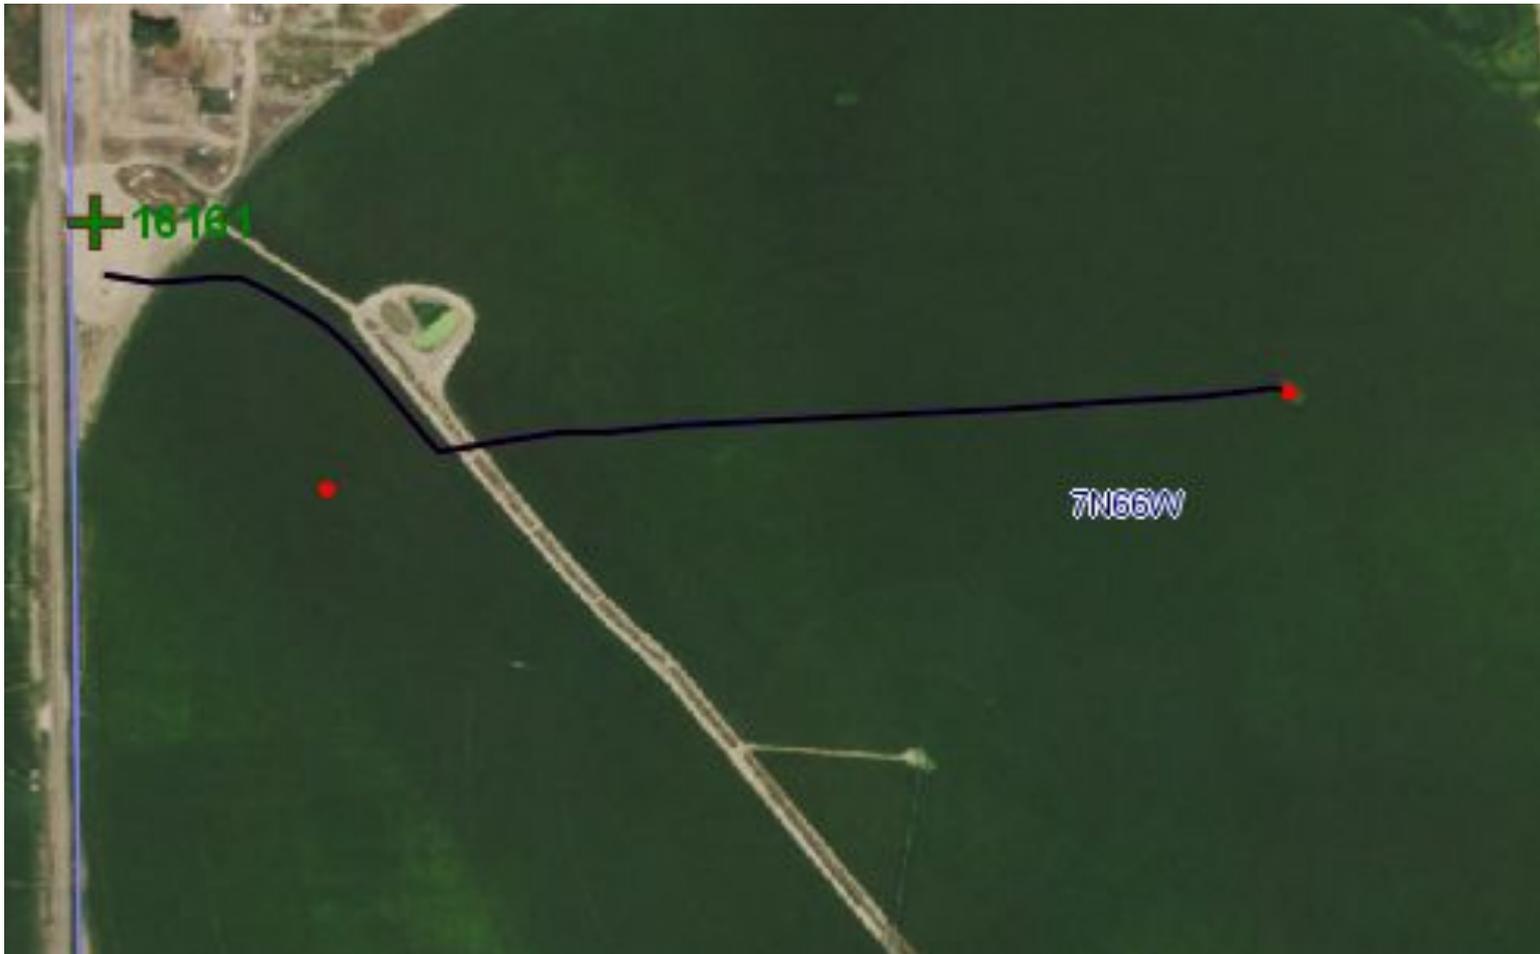
Photo 1. COGCC GISOnline aerial imagery from 2019 illustrates the well location, flowline and associated offsite tank battery. Flowlines removed per Form 44.

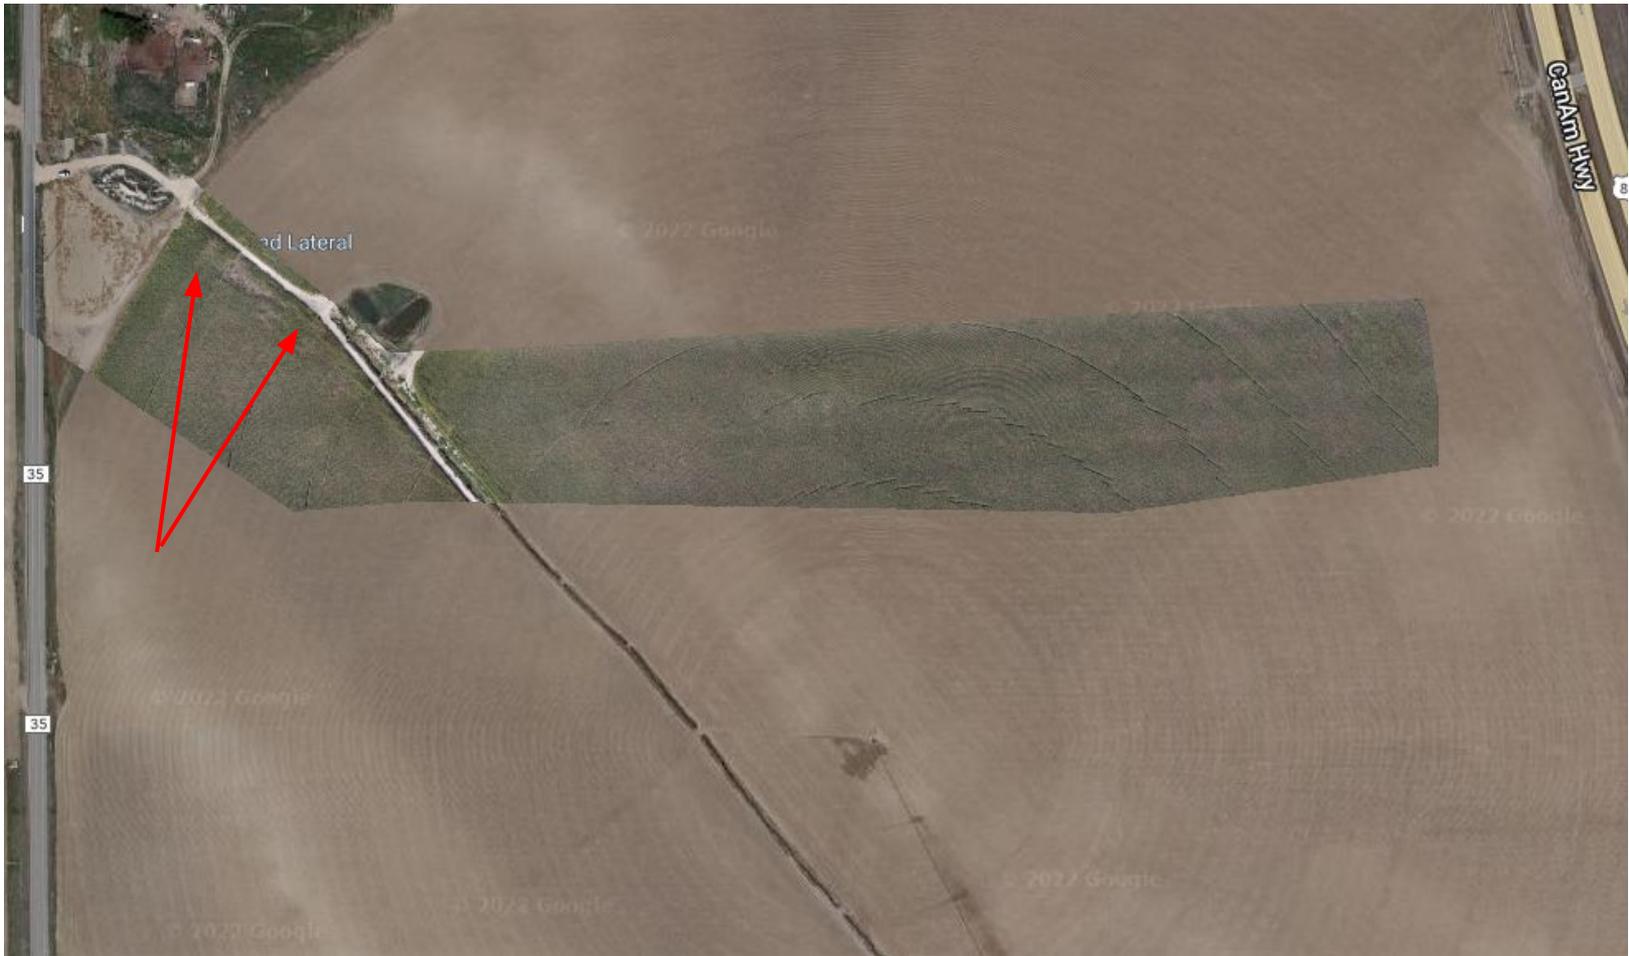
Photo 2. COGCC drone orthomosaic imagery illustrating the well location, flowline and associated offsite tank battery. There appears to be a vegetative issue along a portion of the flowline (red arrows).

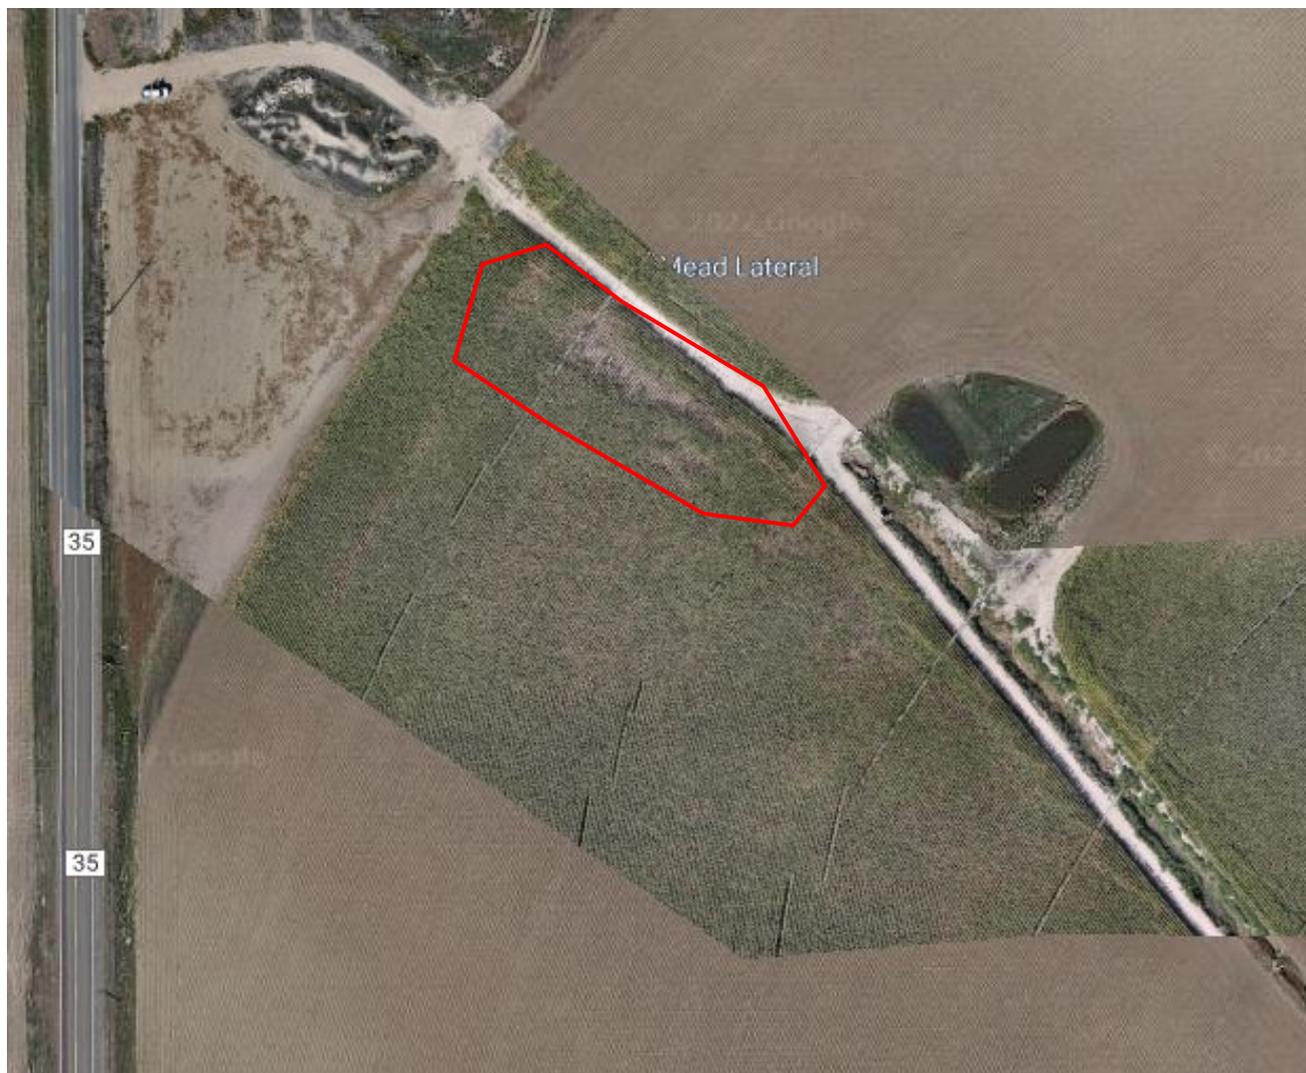
Photo 3. COGCC drone orthomosaic imagery illustrates an ~200' flowline length where crop growth is not reflective of reference areas.

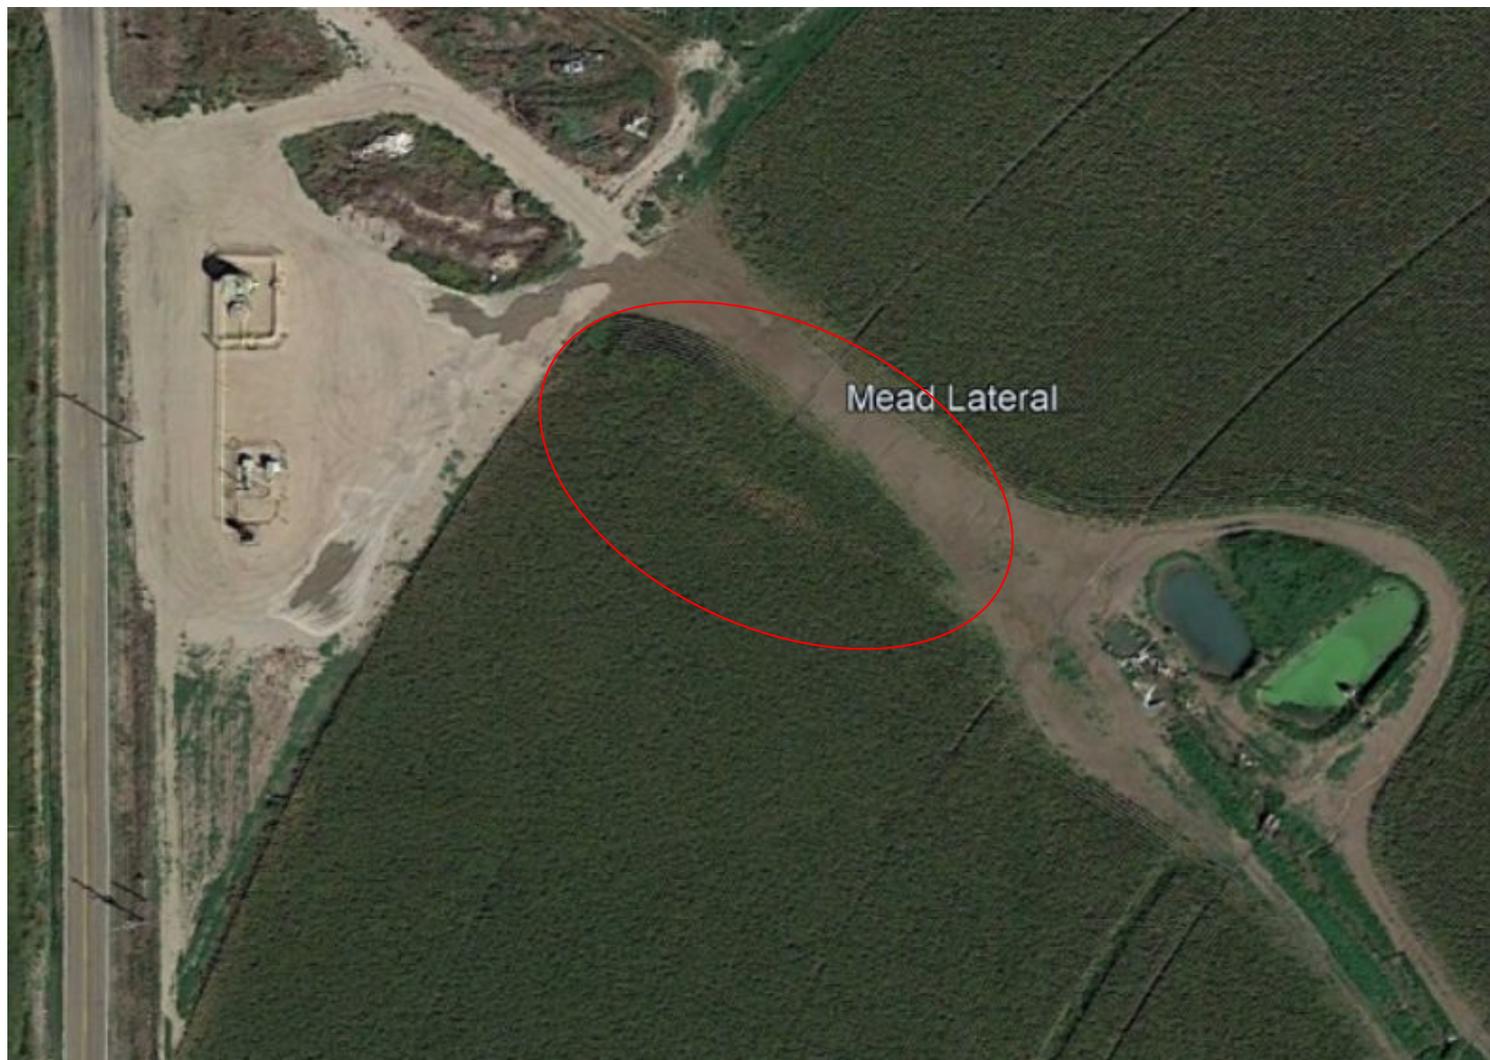
Photo 4. Google Earth aerial imagery from 9/7/2016 illustrates there may have been previous vegetative issues associated with the flowline area.

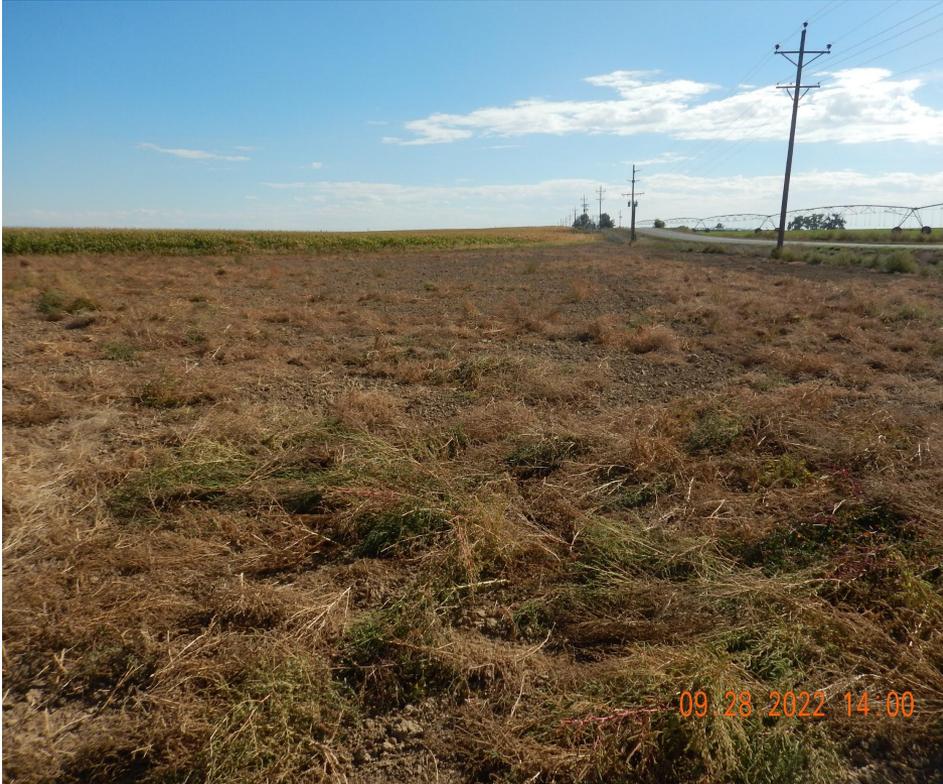
Photo 5. Photo taken from the associated offsite tank battery, facing South. Photo illustrates all equipment has been removed and the tank battery is not within crop production.

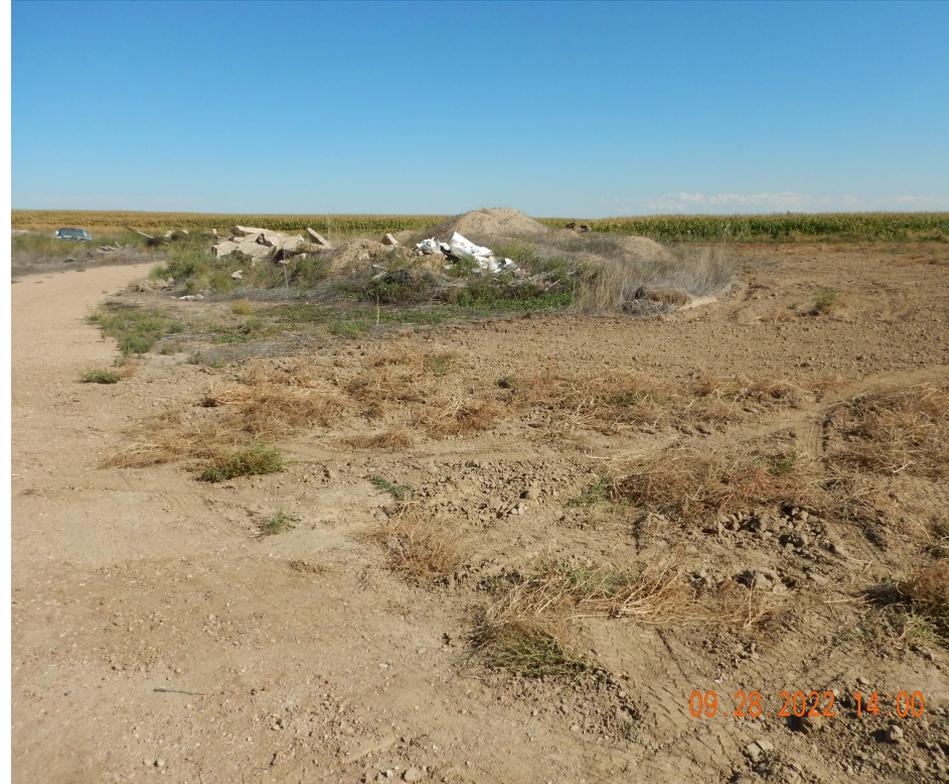
Photo 6. Photo taken from the associated offsite tank battery, facing East. See comments under Photo 5.
