Final Reclamation Inspection

Operator: PDC ENERGY INC - 69175

Location ID: 306513

Inspection Photos
Location Name: DALTON-67N66W 24NESW
Location ID: 306513

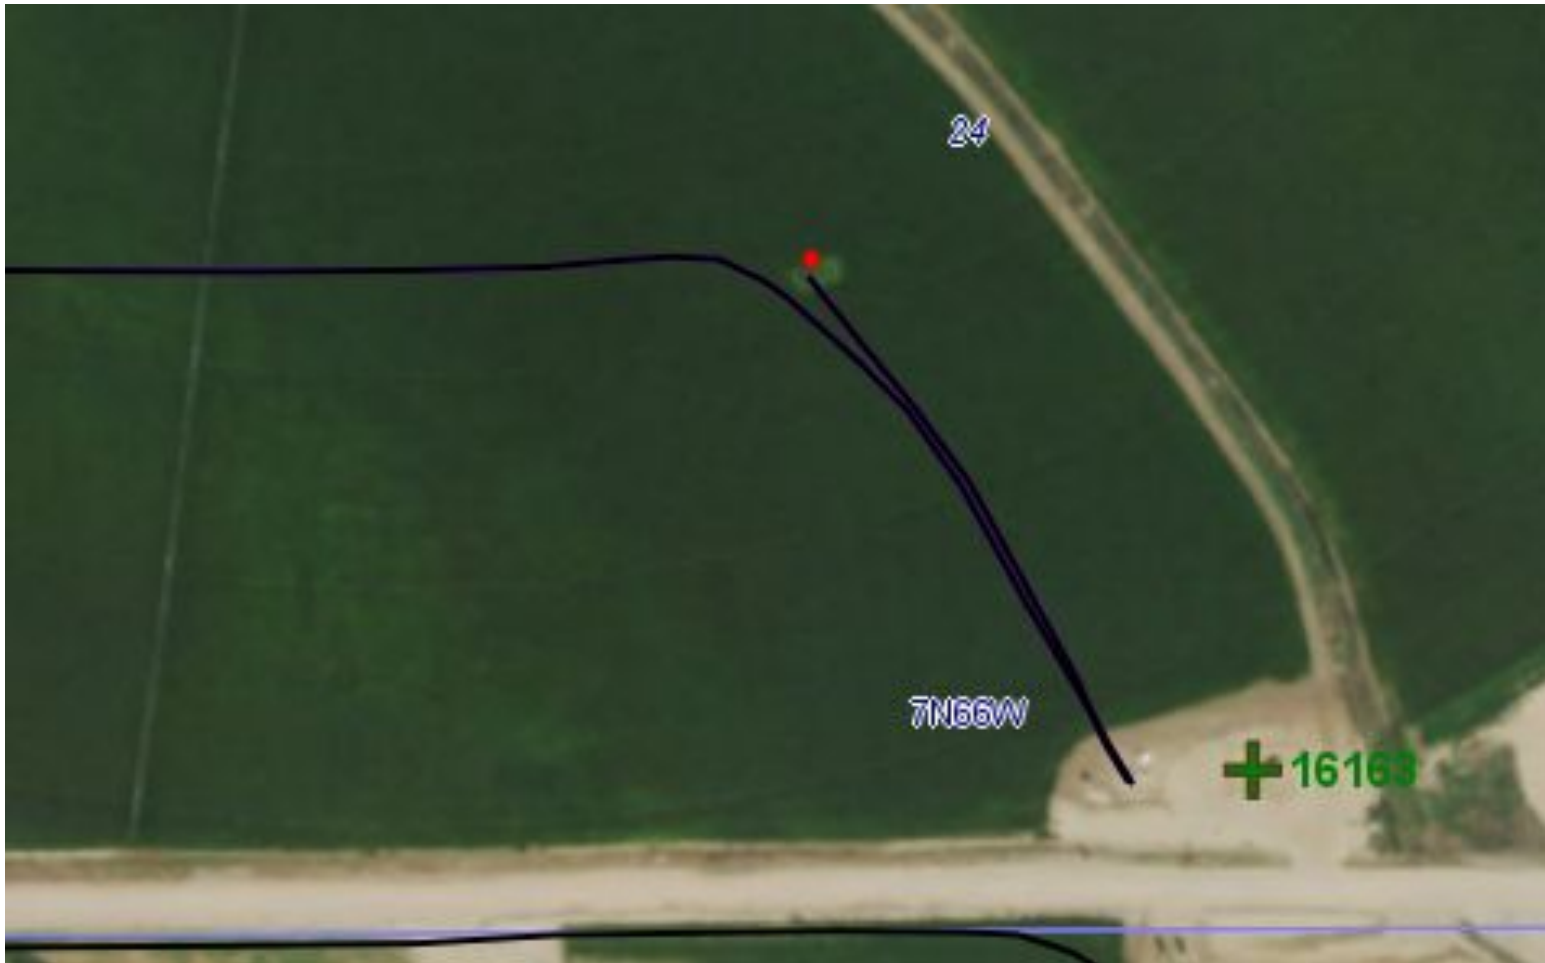
Photo 1. COGCC GISOnline aerial imagery from 2019 illustrates the well location, flowline and associated offsite tank battery. Flowlines removed per Form 44.

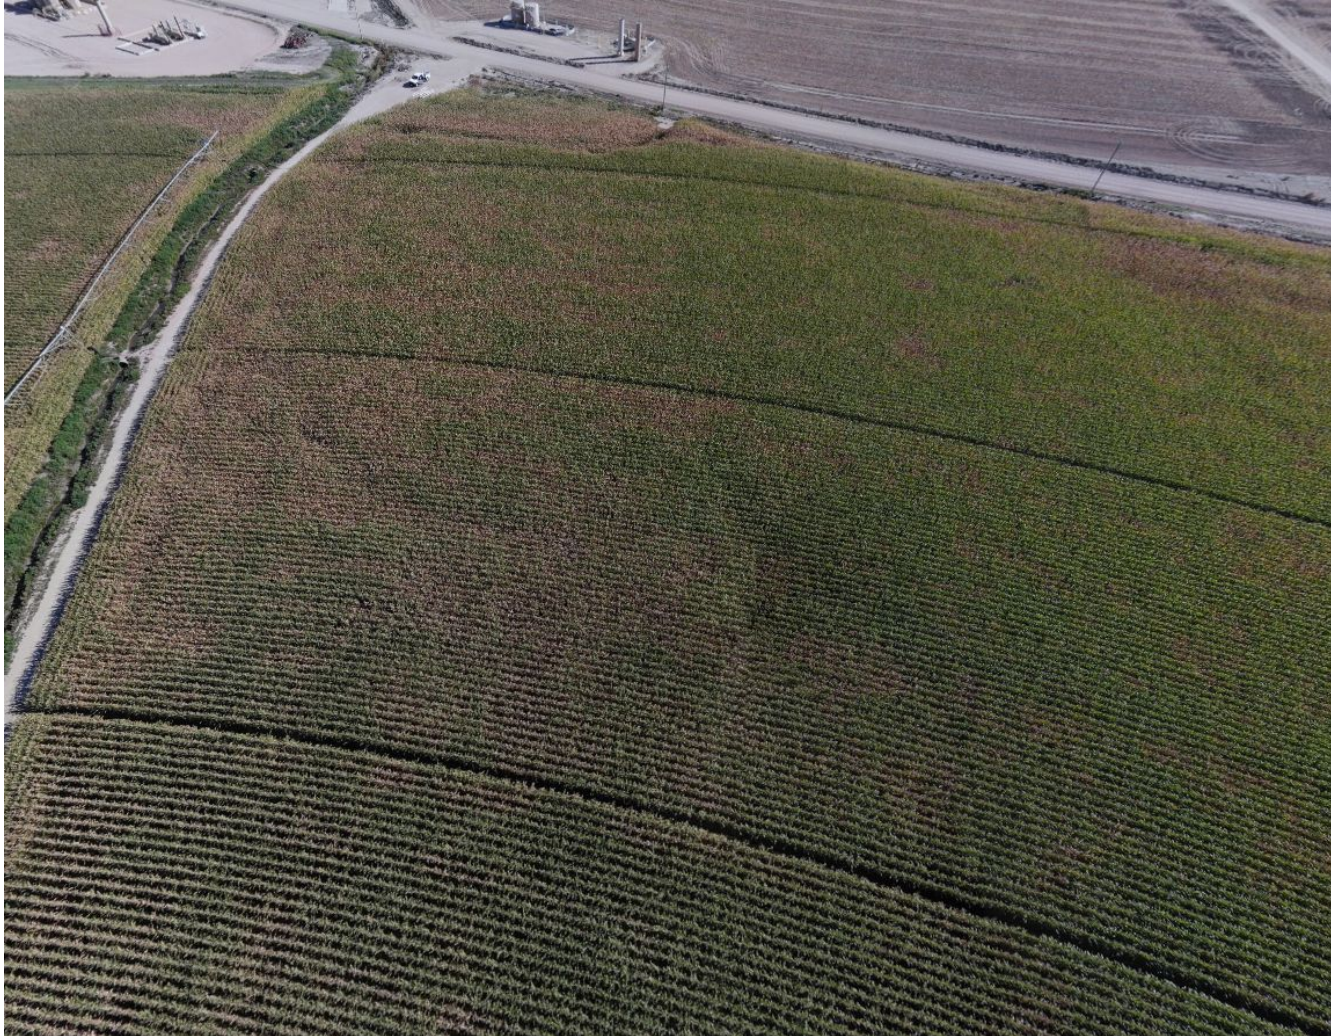
Photo 2. COGCC drone aerial imagery illustrating the well location, flowline and associated offsite tank battery. Crop growth appears reflective along the flowline and well location but there are vegetative issue observed at the tank battery.

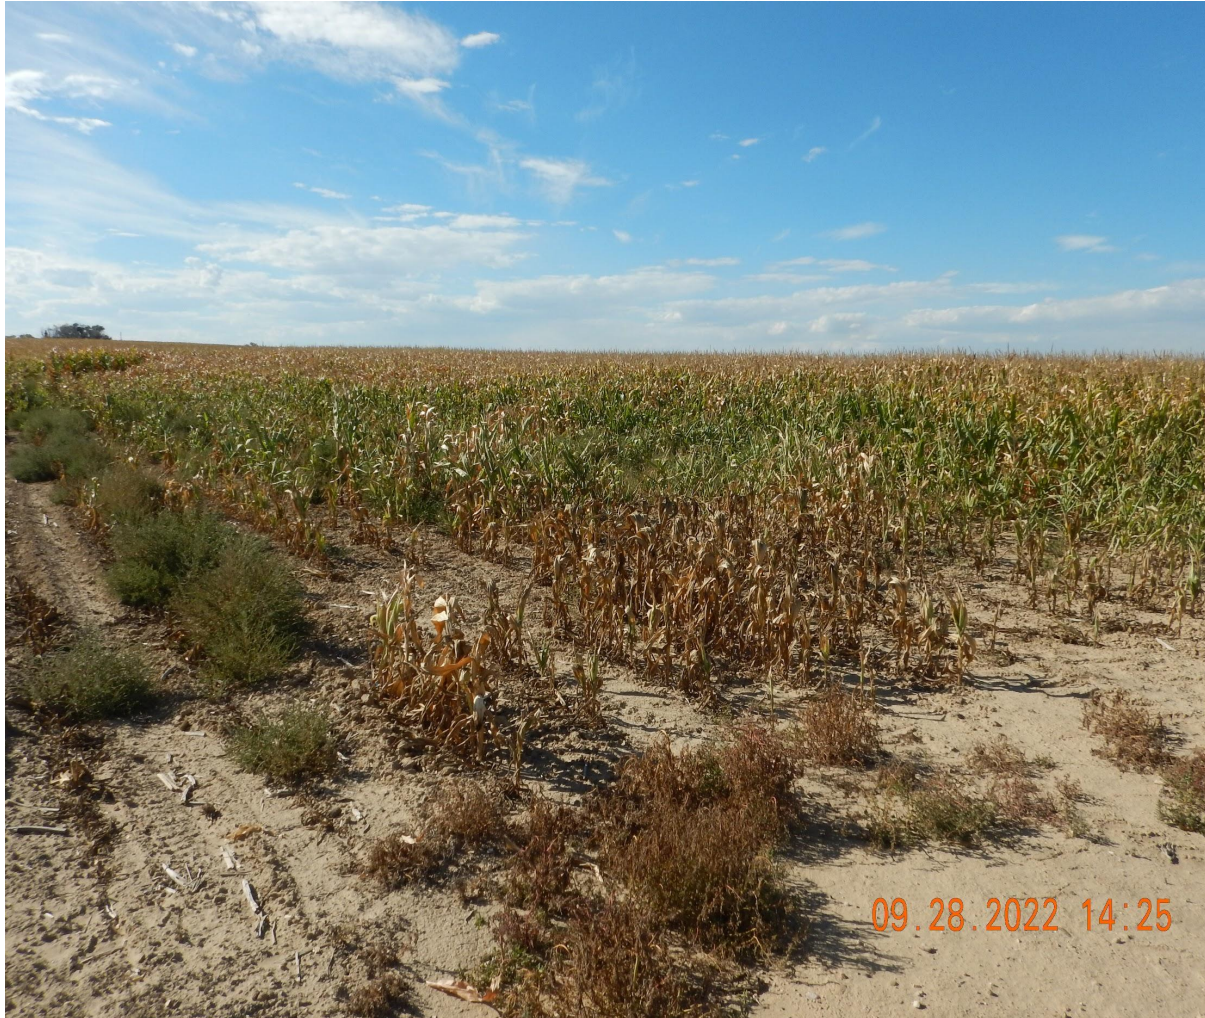
Photo 3. Photo taken from the associated offsite tank battery, facing West. Photo illustrates an approximate 30' x 50' area of stunted corn growth.
